# **Henvey Inlet Wind**

## **Water Assessment and Waterbody Report**

## Henvey Inlet Wind Energy Centre – Water Assessment and Waterbody Report - Final

60341251

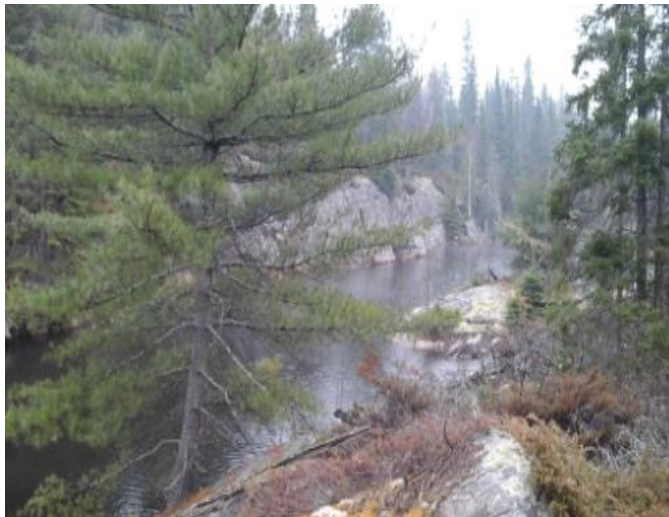
Photograph 1. Beaver pond between bedrock slopes and at crest of slope. General view of most of study area, looking upstream from approximately 25 m downstream of CL. ↑

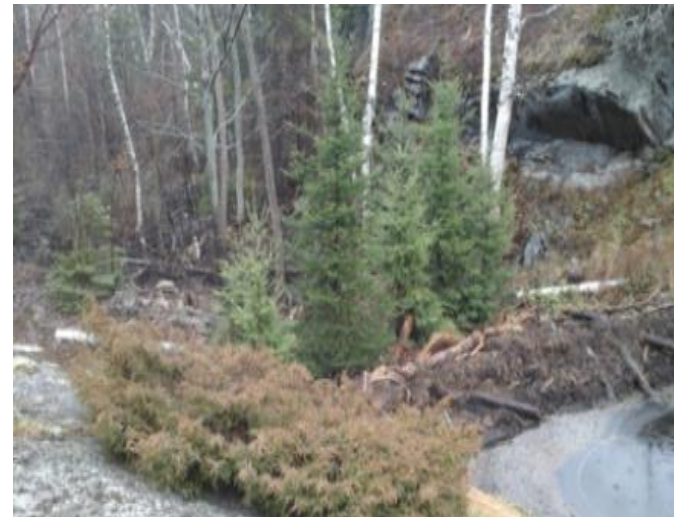
Photograph 2. Two beaver dams on slope. Approximately 20-25 m DS of centreline. ↑

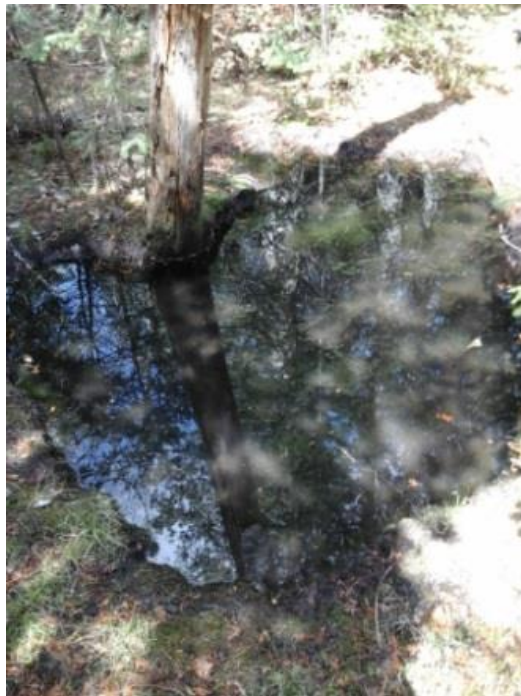
Photograph 1. Spring is located well outside of the study area. Was observed during period trying to identify watercourse location. ↑

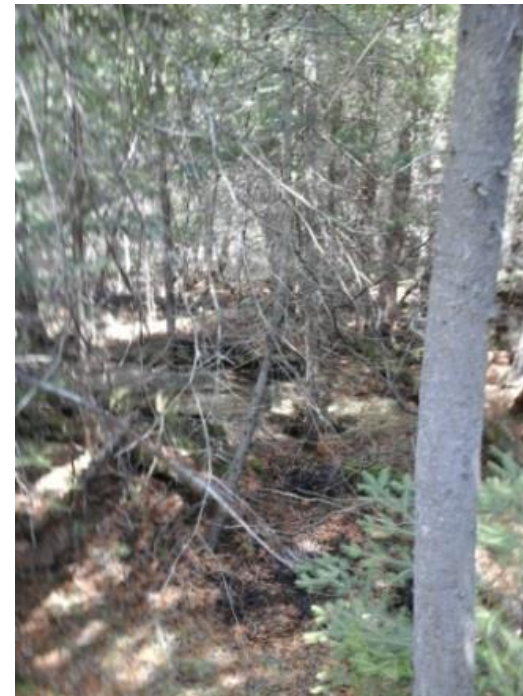
Photograph 2. Site overview. No watercourse present. ↑

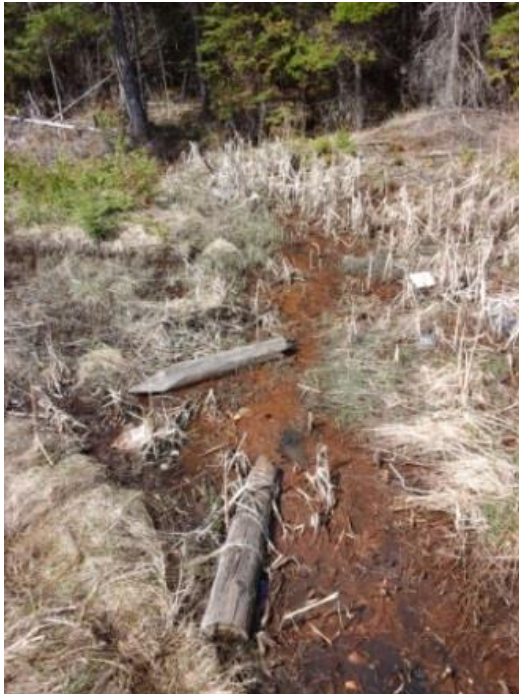
Photograph 1. Looking upstream from culvert. ↑

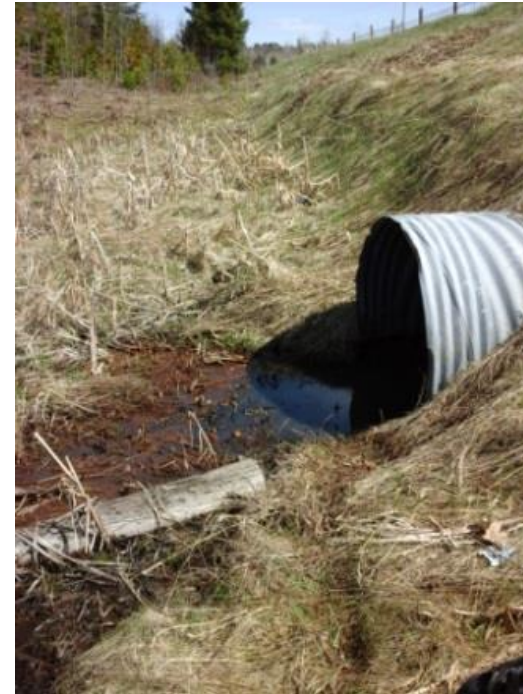
Photograph 2. Culvert discharging water underneath Highway 69. ↑

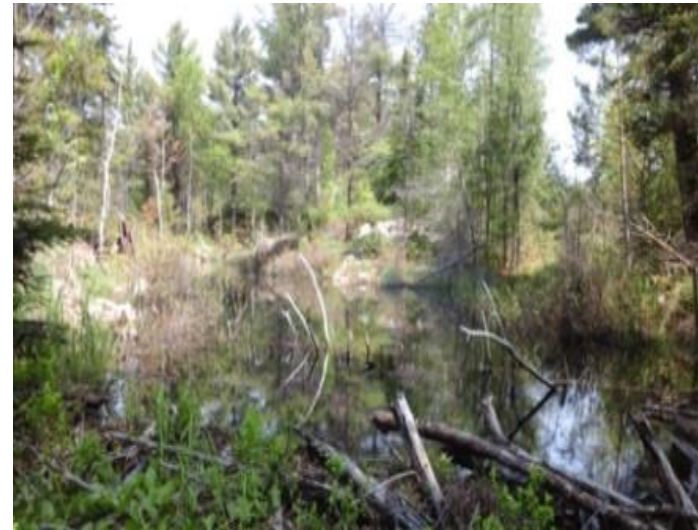
Photograph 2. Upstream 50 m. Beaver dam upstream of centre line. ↑

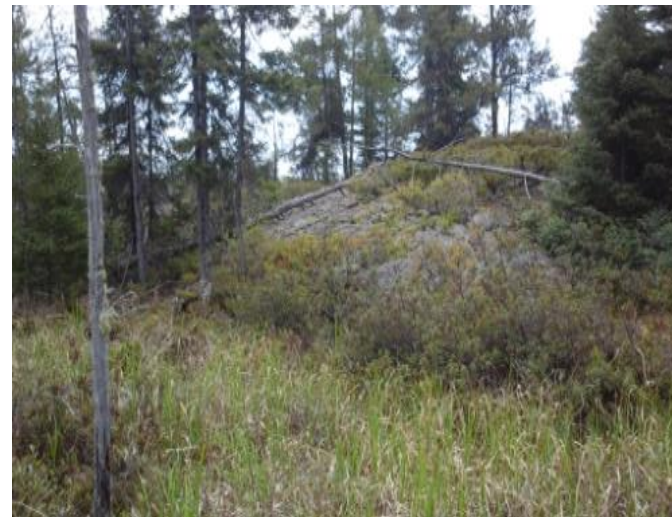
Photograph 2. Facing south from CL. Bedrock outcrop/point <5 m south of CL. Road alignment could be moved to cross over bedrock and reduce footprint in fen. ↑

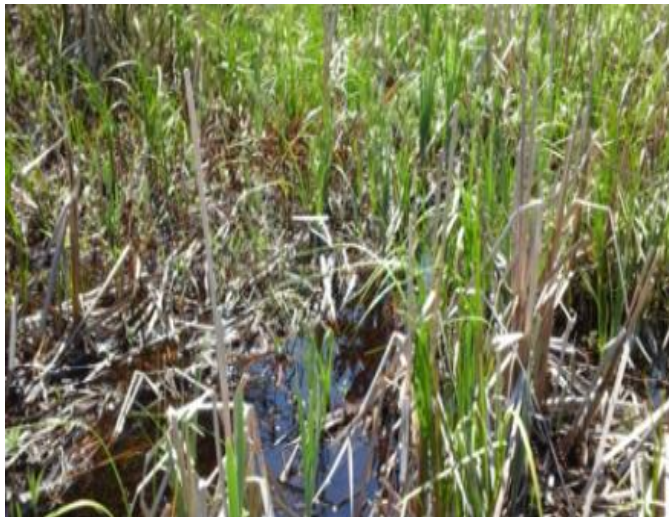
Photograph 1. Small wetland, cattails present between rock outcrops. Some Upland vegetation. Looking DS toward CL from US 50 m. ↑

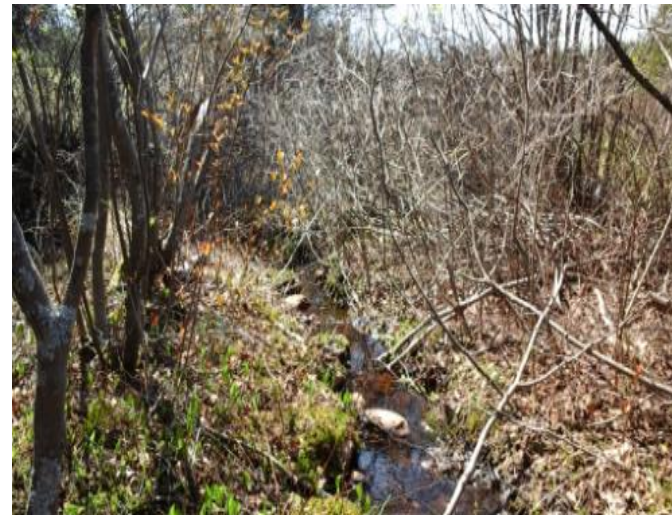
Photograph 2. Channel upstream of crossing flowing from beaver dam through alder thicket. ↑

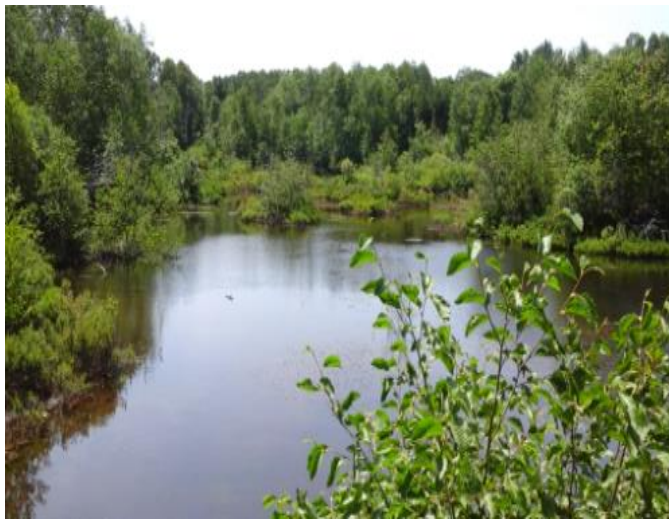
Photograph 1 Looking west at large pond from centre point atop gravel fill to east of large pond separating large pond from small stagnant pond. ↑

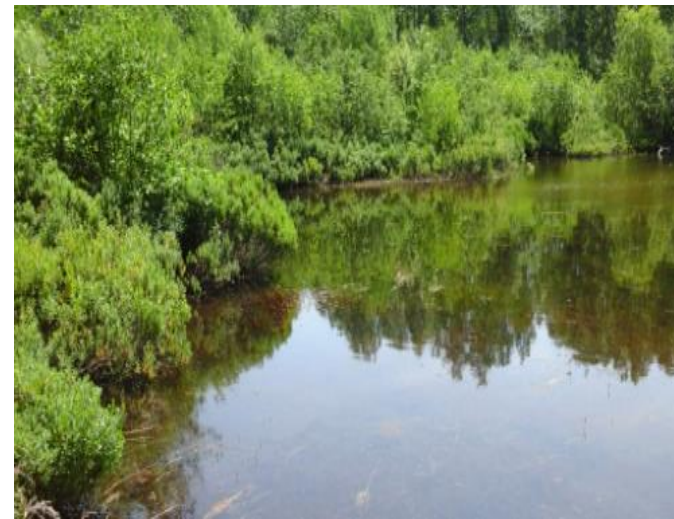
Photograph 2. Looking south from the north shore of the large pond. This view includes part of pond within area of disturbance. ↑
