# Henvey Inlet Wind Transmission Line

## **Appendix B5. Route A Waterbodies, Fish Habitat and Aquatic Ecosystems Environmental Baseline Report**

## Water Bodies, Fish Habitat and Aquatic Ecosystems Environmental Baseline Report Transmission Line Route A – Final Draft

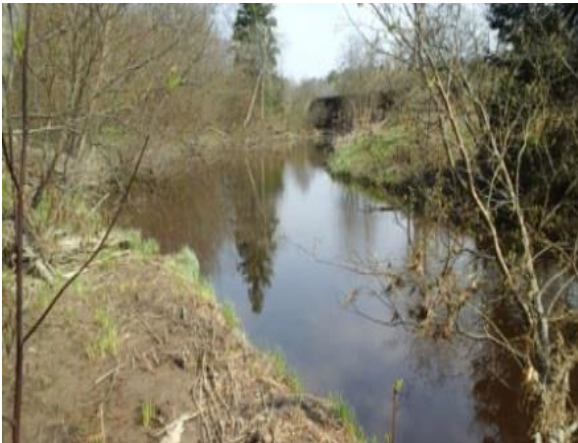
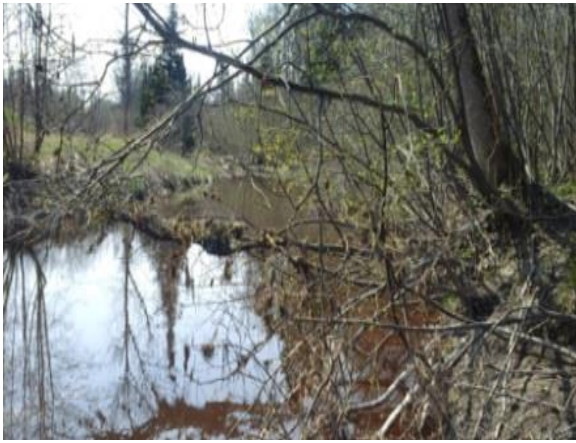
Feature ID	Investigation Date	Type of Waterbody	Description of Site	Feature Description	Feature Sensitivity												
WB-A-M3-3	May 8 <sup>th</sup> , 2015	Permanent Stream	CP rail line and water crossing, black ash, bur oak swamp above right bank. Rail above left bank running along channel, crossing watercourse downstream of transmission line crossing	<p>Channel of slow-moving flats along rail line. Unstable banks of erodible soils. Moderate flow at time of inspection but debris line and floodplain indicate the watercourse experiences significant flow. Depth from top of water approximately 1 m and debris in riparian shrubs from high flows up to approximately 1.5 m above water. Silt dominant (75) with clay and sand present. Habitat mostly provided by overhanging riparian shrubs and grasses. Rail bridge downstream provides habitat/cover via piers and accumulated woody debris. Cyprinids observed.</p> <table><tr><td>Fish Habitat?</td><td>Direct</td></tr><tr><td>MWW (m)</td><td>10.0</td></tr><tr><td>MBW (m)</td><td>11.0</td></tr><tr><td>MWD (m)</td><td>1.5</td></tr><tr><td>MBD (m)</td><td>2.5</td></tr></table>	Fish Habitat?	Direct	MWW (m)	10.0	MBW (m)	11.0	MWD (m)	1.5	MBD (m)	2.5	Moderate

Fish Habitat?	Direct																
MWW (m)	10.0																
MBW (m)	11.0																
MWD (m)	1.5																
MBD (m)	2.5																
<p>Photo 1. View of downstream (north) reach looking towards crossing from approximately 30 m upstream ↑</p>							<p>Photo 2. View of upstream reach towards crossing from approximately 35 m downstream ↑</p>										
WB-A-M5-4	May 6 <sup>th</sup> , 2015	Permanent Stream	Rock barren, forest and wetland surrounding either side of stream	<p>Wide, shallow channel of slow moving flats. Previously dammed by beavers but currently breached and inactive. Left bank of watercourse is a steep rockbarren cliff, heavily vegetated with grass shrubs and trees. Right bank of watercourse is more flat and is vegetated with trees and shrubs. Both banks slope towards the watercourse. There is evidence of erosion on the left bank, but it is now stabilized by vegetation and bedrock. Submerged aquatic vegetation bordering thalweg. Watercourse wide within the area assessed, but narrows into a more defined channel downstream. Some trees growing in the watercourse and a few are growing on the banks providing suitable shade for fish. Banks well vegetated. Assessed at high water levels.</p> <table><tr><td>Fish Habitat?</td><td>Direct</td></tr><tr><td>MWW (m)</td><td>25.00</td></tr><tr><td>MBW (m)</td><td>29.00</td></tr><tr><td>MWD (m)</td><td>1.0</td></tr><tr><td>MBD (m)</td><td>1.0</td></tr></table>	Fish Habitat?	Direct	MWW (m)	25.00	MBW (m)	29.00	MWD (m)	1.0	MBD (m)	1.0	Moderate

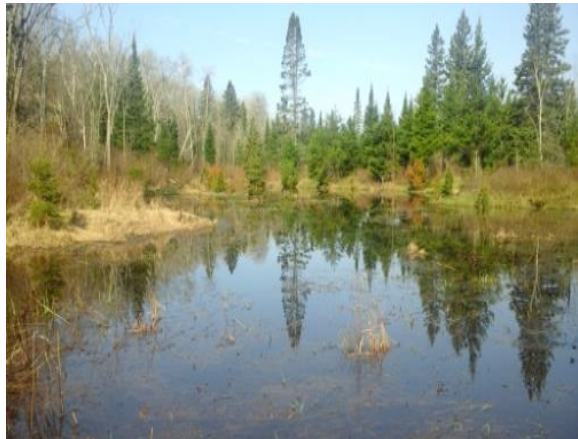
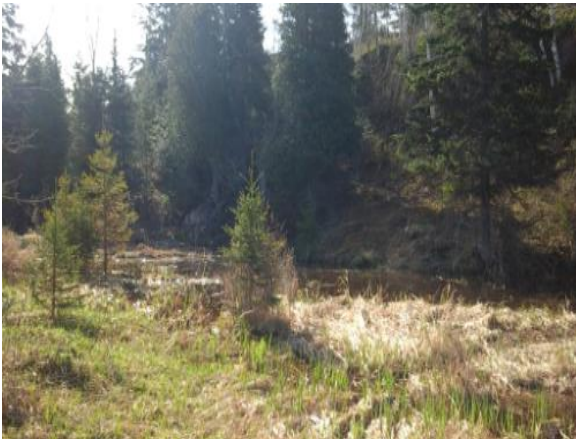
Fish Habitat?	Direct																
MWW (m)	25.00																
MBW (m)	29.00																
MWD (m)	1.0																
MBD (m)	1.0																
<p>Photo 1. View of upstream reach from crossing. Wide channel of slow moving flats. ↑</p>							<p>Photo 2. View of downstream reach from crossing. Old beaver dam separates upstream and downstream reaches. ↑</p>

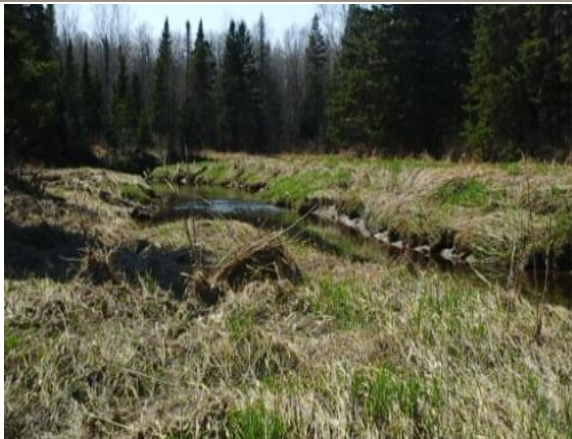
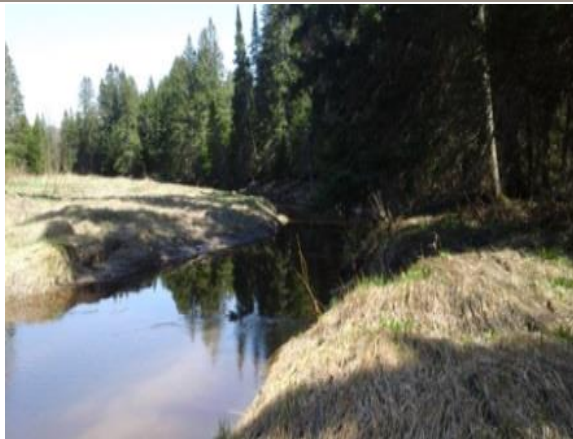
Feature ID	Investigation Date	Type of Waterbody	Description of Site	Feature Description	Feature Sensitivity												
WB-A-M6-5	May 6 <sup>th</sup> , 2015	Permanent Stream	Grass and scrubland/meadow bordering channel, forest beyond.	<p>Defined channel with (e.g., flats) low velocities, fine substrates and turbid water. Banks are unstable and eroded/slumping. Bank height approximately 0.75 to 1 m (from water's edge). Cyprinids observed; adult <i>Ephemeroptera</i> observed.</p> <table><tr><td>Fish Habitat?</td><td>Direct</td></tr><tr><td>MWW (m)</td><td>8.0</td></tr><tr><td>MBW (m)</td><td>9.0</td></tr><tr><td>MWD (m)</td><td>1.8</td></tr><tr><td>MBD (m)</td><td>2.6</td></tr></table>	Fish Habitat?	Direct	MWW (m)	8.0	MBW (m)	9.0	MWD (m)	1.8	MBD (m)	2.6	Moderate

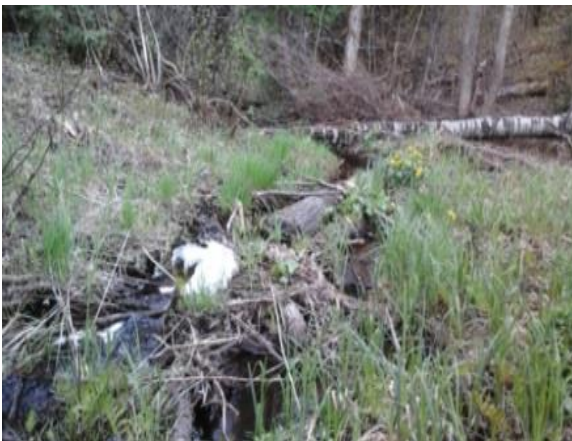
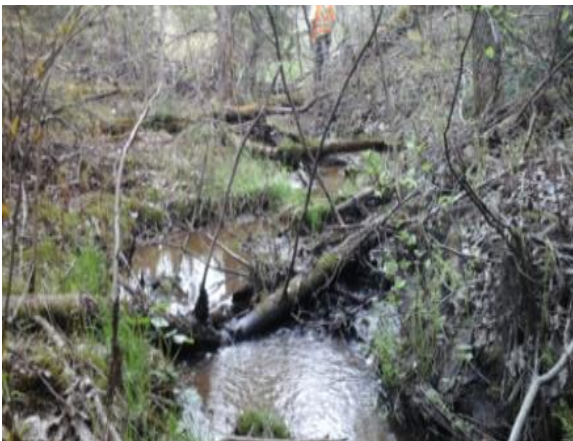
WB-A-M7-12	May 15 <sup>th</sup> , 2015	Permanent Stream	Area assessed is located just south of highway 522 and just east of point where T-line splits from highway. Adjacent land use is forest and highway.	<p>Flowing channel originates from pond upstream. Watercourse flows over an impassable series of waterfalls upstream, and seeps through highway embankment. The most significant barrier is the highway embankment; there is no crossing structure through the highway embankment. Beaver dam downstream of highway and small bedrock drop provide significant natural barriers. Riffle/run/pool sequences over mostly fine substrates through forest, flowing to river downstream. Heavy scour and sediment load at outlet pool. Fish observed in outlet pool at highway. Upstream of highway has potential to support isolated population of tolerant forage fish (i.e., Central Mudminnow).</p> <table><tr><td>Fish Habitat?</td><td>Direct</td></tr><tr><td>MWW (m)</td><td>1.90</td></tr><tr><td>MBW (m)</td><td>3.10</td></tr><tr><td>MWD (m)</td><td>0.18</td></tr><tr><td>MBD (m)</td><td>-</td></tr></table>	Fish Habitat?	Direct	MWW (m)	1.90	MBW (m)	3.10	MWD (m)	0.18	MBD (m)	-	Moderate

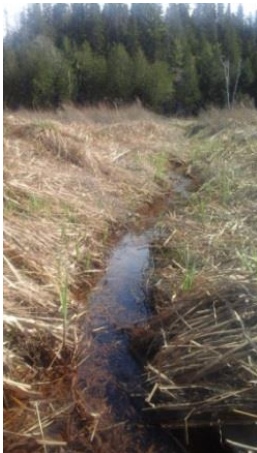
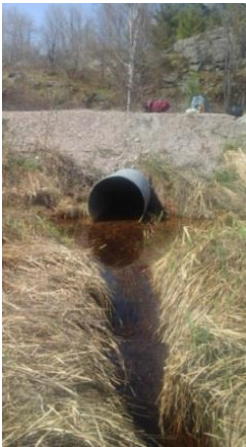
Fish Habitat?	Direct																
MWW (m)	1.90																
MBW (m)	3.10																
MWD (m)	0.18																
MBD (m)	-																
WB-A-M9-6	May 5 <sup>th</sup> , 2015	Permanent Stream	Channel flows through extensive meadow. Highway 522 crossing and OFSC trail crossing.	<p>Downstream of highway is a naturally straight channel flowing through meadow with moderate flow and is characterized as a slow run. . Like WB-A-M9-7, the assessed watercourse is a tributary to a downstream waterbody running east to west outside of the study area. Upstream of highway is drainage ditch. Channel flows to larger watercourse just over 50 m downstream.</p> <table><tr><td>Fish Habitat?</td><td>Indirect</td></tr><tr><td>MWW (m)</td><td>0.65</td></tr><tr><td>MBW (m)</td><td>0.50</td></tr><tr><td>MWD (m)</td><td>0.20</td></tr><tr><td>MBD (m)</td><td>0.40</td></tr></table>	Fish Habitat?	Indirect	MWW (m)	0.65	MBW (m)	0.50	MWD (m)	0.20	MBD (m)	0.40	Low

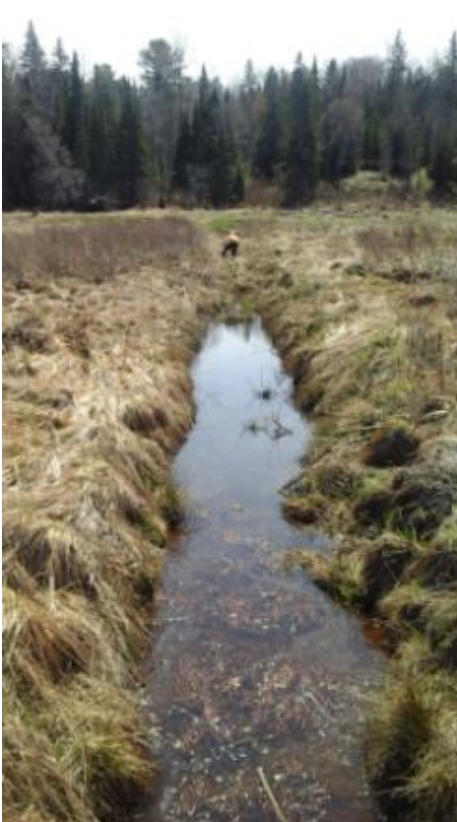
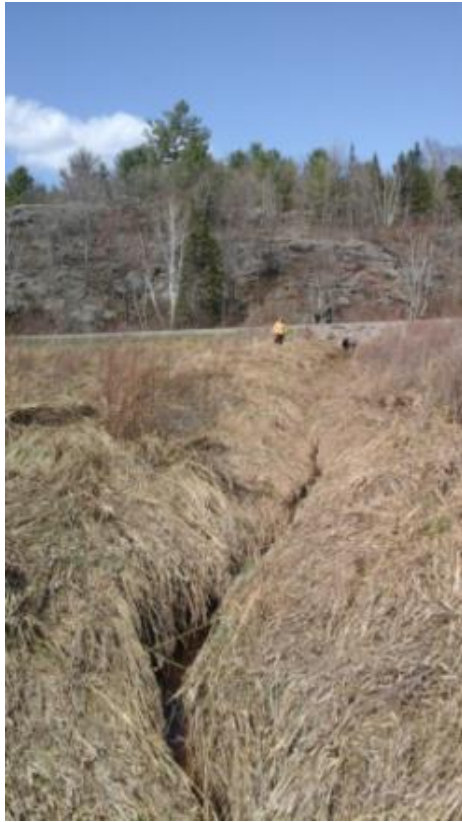
Feature ID	Investigation Date	Type of Waterbody	Description of Site	Feature Description	Feature Sensitivity					
WB-A-M9-7	May 5 <sup>th</sup> , 2015	Permanent Stream	Meadow from highway to river crossing further south. Forest bordering location >50 m away on either side of channel. OFSC trail also crosses here.	Channel flowing from culvert at highway. Fairly wide channel for first 12 m (~2 m wide), then narrows to 0.3 m as it flows closer to the river south of study area. Conditions on the south side of the highway similar to those on the south side. Several wetlands on the north side of the highway drain southward and there are several culverts draining the low lying area assessed north to south underneath the highway. This, in combination with the observed deep cut channel, suggests that this waterbody flows year round. Channel substrate is dominated by silt, with some detritus, clay and sand. Upstream of highway is drainage ditch (man-made). Deeply entrenched watercourse flows through large meadow heavily vegetated with grasses and some small shrubs. There is a stream running east to west downstream of the study area. The assessed channel is a tributary of the downstream waterbody. Drainage ditch upstream of highway has similar habitat/dimensions as downstream and does not directly support fish due to passage barriers (perched CSP and low-flow conditions)	Low

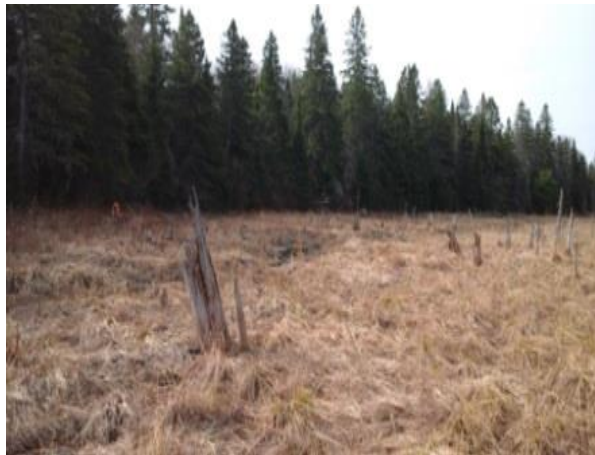
Fish Habitat?	Indirect	MWW (m)
Fish Habitat?	Indirect									
MWW (m)	1.10									
MBW (m)	1.40									
MWD (m)	0.20									
MBD (m)	-									
WB-A-M12-8	May 4 <sup>th</sup> , 2015	Permanent Pond	Meadow marsh with channel of standing water bordered by forest and highway	Channel of standing water through meadow marsh; no flow or fish passage from upstream of highway. No culvert; water appears to seep through boulder embankment. Potential connectivity to habitat downstream. Appears to have previously been dammed. Poorly drained. Proposed crossing location immediately south of highway; no water crossing under highway. No access for fish from north of highway. No fish observed.	Low

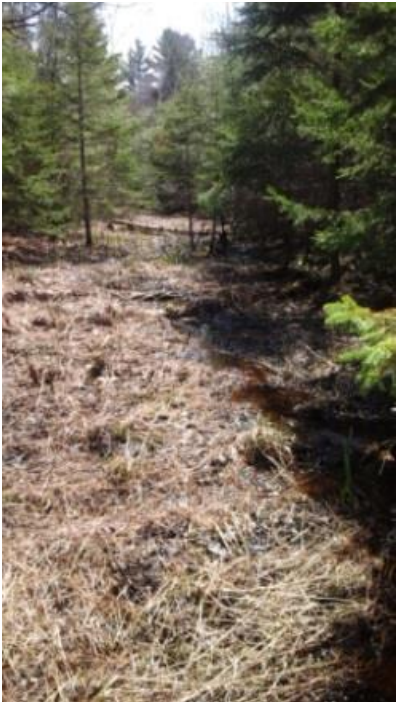
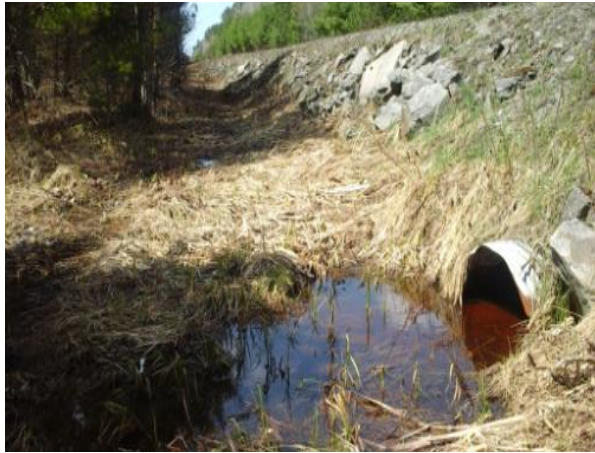
Feature ID	Investigation Date	Type of Waterbody	Description of Site	Feature Description	Feature Sensitivity												
WB-A-M17-9	May 5 <sup>th</sup> , 2015	Intermittent Stream	Highway and forest. Waterbody directly south of highway 522.	<p>Ephemeral swale/wetland pocket not directly supporting fish habitat in study area. Densely vegetated with grass and other water tolerant terrestrial species. Habitat conditions upstream of highway are consistent with the surveyed area downstream of highway.</p> <table><tr><td>Fish Habitat?</td><td>Indirect</td></tr><tr><td>MWW (m)</td><td>2.00</td></tr><tr><td>MBW (m)</td><td>10.00</td></tr><tr><td>MWD (m)</td><td>0.13</td></tr><tr><td>MBD (m)</td><td>-</td></tr></table>	Fish Habitat?	Indirect	MWW (m)	2.00	MBW (m)	10.00	MWD (m)	0.13	MBD (m)	-	Low

MBD (m)	-																
						<p>Photo 1. View of reach downstream of culvert on south side of Hwy 522. Channel becomes more defined on south side of Highway 522. ⬆</p>	<p>Photo 2. View of culvert and possible drainage ditch input south of Hwy 522 ⬆</p>										
WB-A-M18-10	May 5 <sup>th</sup> , 2015	Permanent Stream	Channel bordered by meadow marsh, just south of Highway 522 Channel is bordered by Highway 522, and runs just upstream. Channel fed by upstream beaver pond.	<p>Small, incised channel flowing from beaver dam through small marsh meadow. Fish passage impeded at beaver dam and highway embankment. Fish observed in beaver pond (Brook Stickleback). Meadow wet in some areas. Mean width of meadow 18 m. Morphological measurements taken where the channel was defined. Focus of assessment area is downstream of highway. Beaver dam is at crossing location; suggest moving the crossing slightly to the south to avoid beaver dam separating upstream and downstream reaches immediately at centre line</p> <table><tr><td>Fish Habitat?</td><td>Direct</td></tr><tr><td>MWW (m)</td><td>0.50</td></tr><tr><td>MBW (m)</td><td>0.60</td></tr><tr><td>MWD (m)</td><td>0.25</td></tr><tr><td>MBD (m)</td><td>-</td></tr></table>	Fish Habitat?	Direct	MWW (m)	0.50	MBW (m)	0.60	MWD (m)	0.25	MBD (m)	-	Low

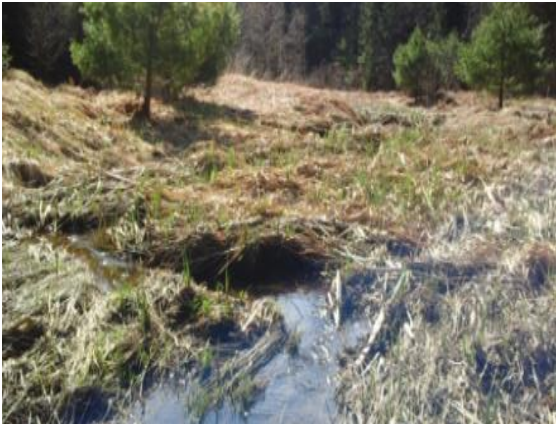
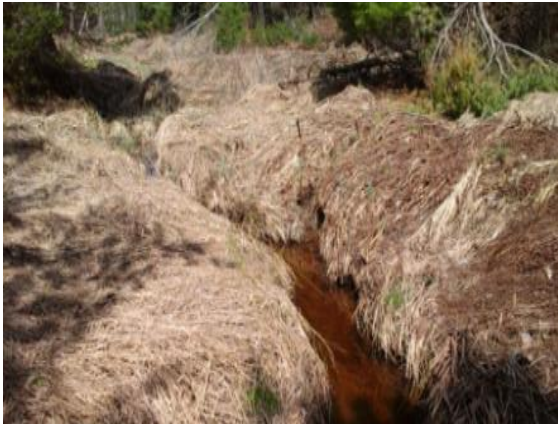
Fish Habitat?	Direct																
MWW (m)	0.50																
MBW (m)	0.60																
MWD (m)	0.25																
MBD (m)	-																
						<p>Photo 1. View of watercourse and study area downstream of beaver dam and highway. Somewhat defined channel through meadow/marsh. Channel narrow (0.1 to 0.35 m) and deep. ⬆</p>	<p>Photo 2. View of reach upstream of highway crossing. Impassable downstream beaver dam separates upstream and downstream reaches. ⬆</p>

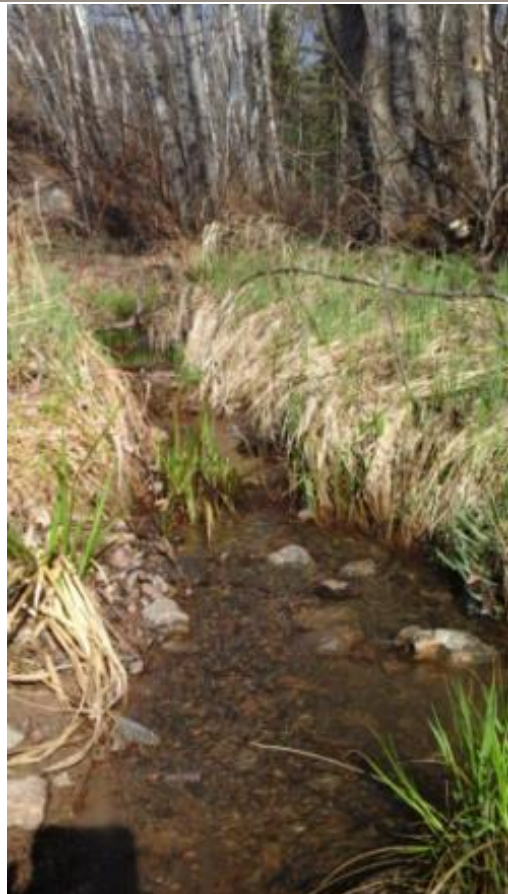
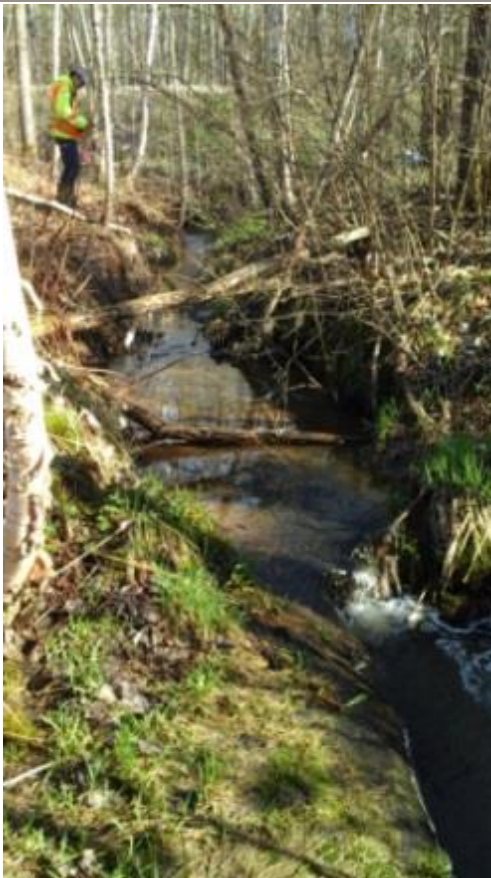
Fish Habitat?	Direct																
MWW (m)	0.75																
MBW (m)	0.90																
MWD (m)	0.15																
MBD (m)	0.40																
						<p>Photo 1. View of stream upstream of crossing and Hwy 522. Bedrock substrate with deposits of sand and gravel. ⬆</p>	<p>Photo 2. View of study area downstream of crossing, facing upstream. Moderate flow with good vegetation growth on banks. Some evidence of undercut banks. ⬆</p>
