NORTH KENT 1

Construction Vibration Monitoring Report

Report Number: 1668031-2000-R02

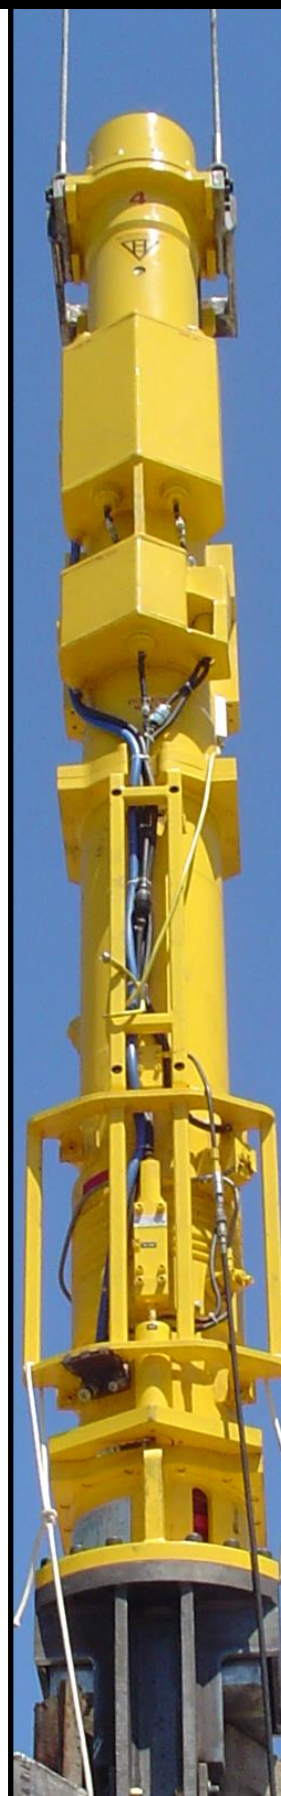
Ram mass:	4,630 lbs (2 100 kg)
Rated Energy:	53,200 ft•lbs (72 kJ)
Stroke at Rated Energy:	11.5 ft (3.5 m) 35 blows per minute
Maximum Physical Stroke:	13.1 ft (4.0 m)
Range of Operation:	4.5-11.5 ft (1.4-3.5 m) 56-35 blows per minute
Kinetic Energy at Rated Stroke:	32,010 ft•lbs (43.4 kJ)
Hammer Weight - bare hammer:	9,300 lbs (4 220 kg)
Weight with Typical USA-Style Box Lead Guides:	9,800 lbs (4 450 kg) 26 in (660 mm) guides
Typical Direct-Drive Housing:	1,850 lbs (840 kg) 21 in (530 mm) opening
Total Typical Operating Weight:	11,650 lbs (5 280 kg) (with guides, trip, and drive housing)
Fuel Tank Capacity:	12.0 US Gal. (45 L)
Oil Tank Capacity:	4.0 US Gal. (15 L)
Overall Length:	17.5 ft (5.3 m)
Length including Direct-Drive Housing:	19.8 ft (6.0 m)
Minimum Box Lead size:	21 in (533 mm)

B-21 4,630 lb Piston			
BPM	Stroke (ft)	Potential Energy (ft•lb)	Velocity (ft/s)
35	11.8	54,630	22.5
36	11.2	51,860	22.0
37	10.6	49,080	21.5
38	10.0	46,300	21.0
39	9.5	43,990	20.5
40	9.1	42,130	20.0
41	8.6	39,820	19.5
42	8.2	37,970	19.0
43	7.8	36,110	18.5
44	7.5	34,730	18.0
45	7.2	33,340	17.5
46	6.9	31,950	17.0
47	6.6	30,560	16.5
48	6.3	29,170	16.0
49	6.0	27,780	15.5
50	5.8	26,850	15.0
51	5.6	25,930	14.6
52	5.4	25,000	14.2
53	5.2	24,080	13.8
54	5.0	23,150	13.4
55	4.8	22,220	13.0
56	4.6	21,300	12.6

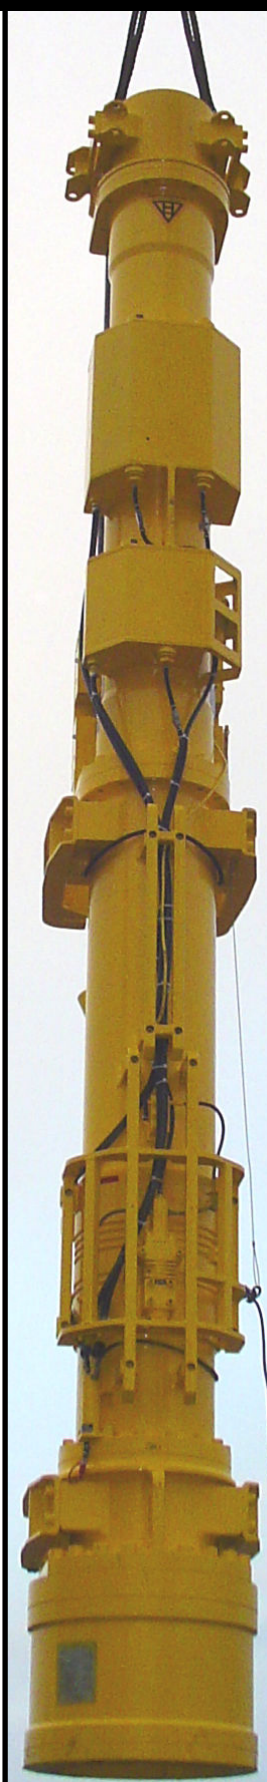
Ram mass:	7,050 lbs (3 200 kg)
Rated Energy:	81,080 ft•lbs (110 kJ)
Stroke at Rated Energy:	11.5 ft (3.5 m) 35 blows per minute
Maximum Physical Stroke:	13.0 ft (4.0 m)
Range of Operation:	4.5-11.5 ft (1.4-3.5 m) 56-35 blows per minute
Kinetic Energy at Rated Stroke:	50,040 ft-lbs (67.8 kJ)
Hammer Weight - bare hammer:	14,110 lbs (6 400 kg)
Weight with Typical USA-Style Box Lead Guides:	14,570 lbs (6 610 kg) 26 in (660 mm) guides
Typical Direct-Drive Housing:	1,850 lbs (840 kg) 21 in (530 mm) opening
Total Typical Operating Weight:	16,420 lbs (7 450 kg) (with guides, trip, and drive housing)
Fuel Tank Capacity:	19.0 US Gal. (72 L)
Oil Tank Capacity:	6.5 US Gal. (25 L)
Overall Length:	20.1 ft (6.1 m)
Length including Direct-Drive Housing:	21.7 ft (6.6 m)
Minimum Box Lead size:	26 in (660 mm)

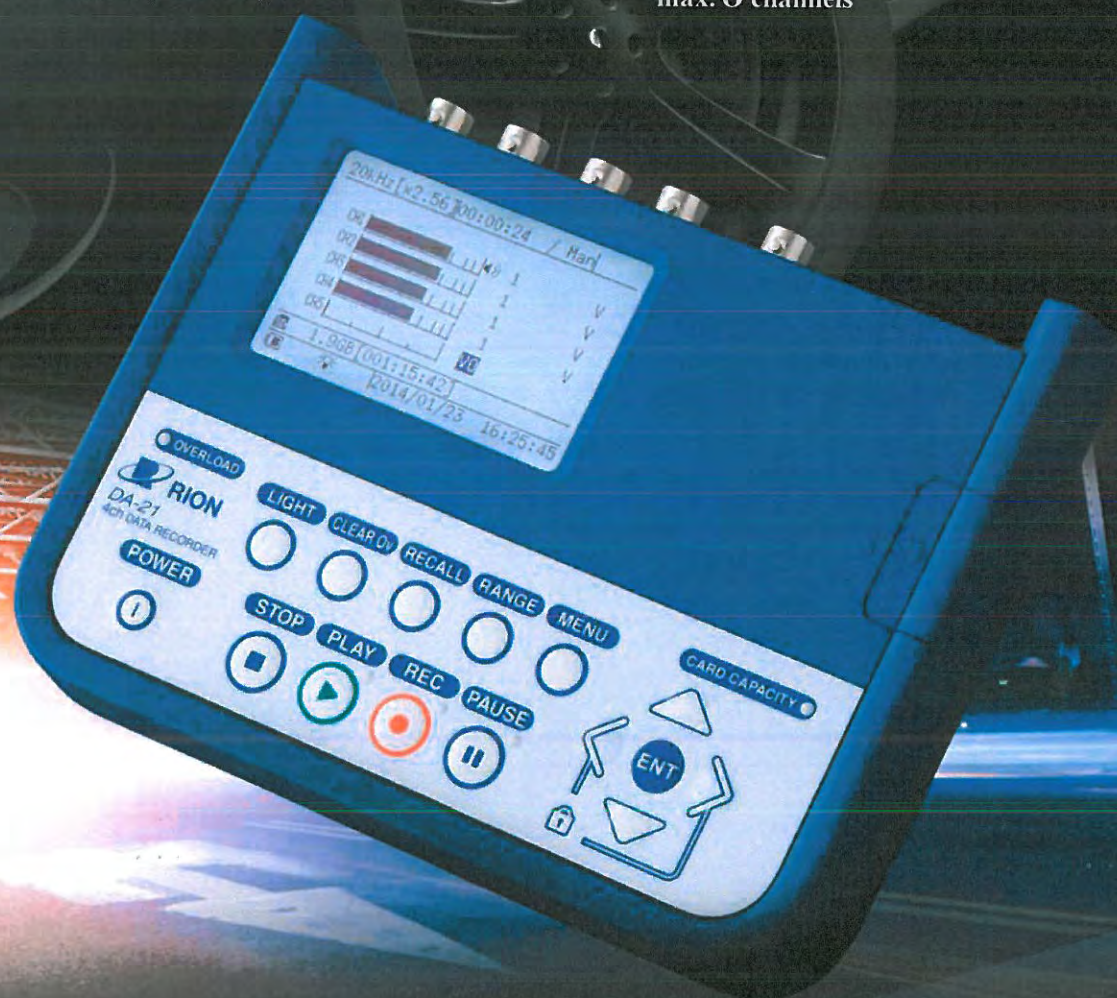
The 4 channel Data Recorder DA-21 is capable of recording acoustic / vibration waveforms and various electrical signals in the field. Recorded data are saved in WAVE format on SD cards and can be imported into a computer for waveform analysis and other processing tasks.

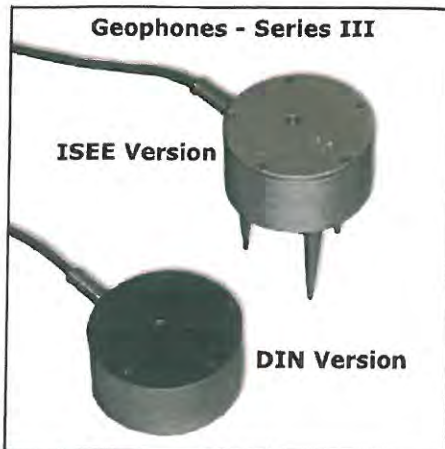
Standard Geophone

Measures ground motion in three orthogonal directions. The sensor includes three ground spikes for soft surfaces or can be bolted to hard surfaces.

PART NUMBER	718A3301
RESPONSE STANDARD	DIN 45669-1 CLASS 1
FREQUENCY RANGE	1 TO 315 Hz
VELOCITY RANGE	UP TO 10 in/s (254 mm/s)
RESOLUTION	0.000625in/s (0.0159mm/s)
SENSOR DENSITY	133 lbs/ft ³ (2.13 g/cc)
CABLE LENGTH	6 ft (2 m)
MAXIMUM CABLE LENGTH	3250 ft (1000 m)
REQUIRED SOFTWARE	BLASTWARE COMPLIANCE

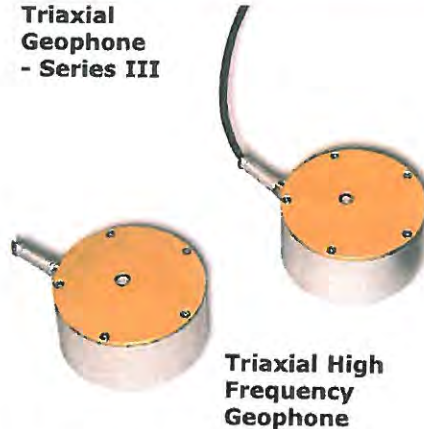
Triaxial High Frequency Geophone

Measure high frequency, high amplitude vibrations in three orthogonal directions. Designed for near field monitoring of blasting activities.

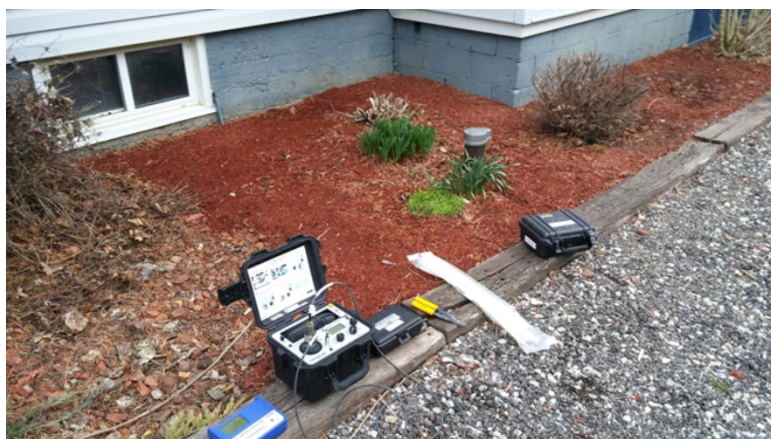
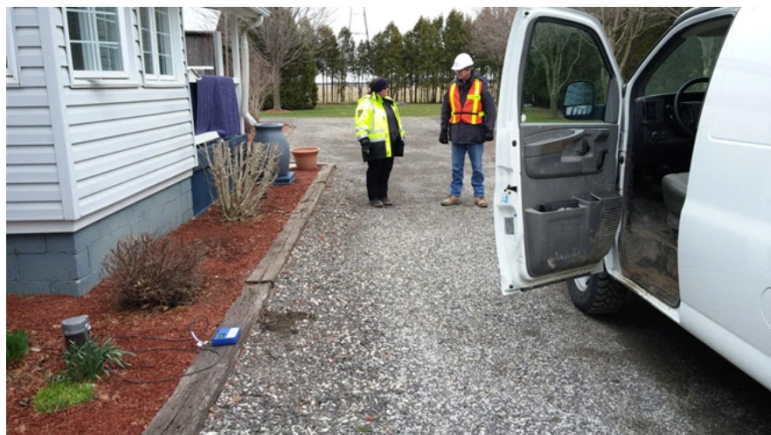
Well 1. Top photograph illustrates checking of accelerometers prior to mounting on well casing. Bottom photograph illustrates conditions near well casing.

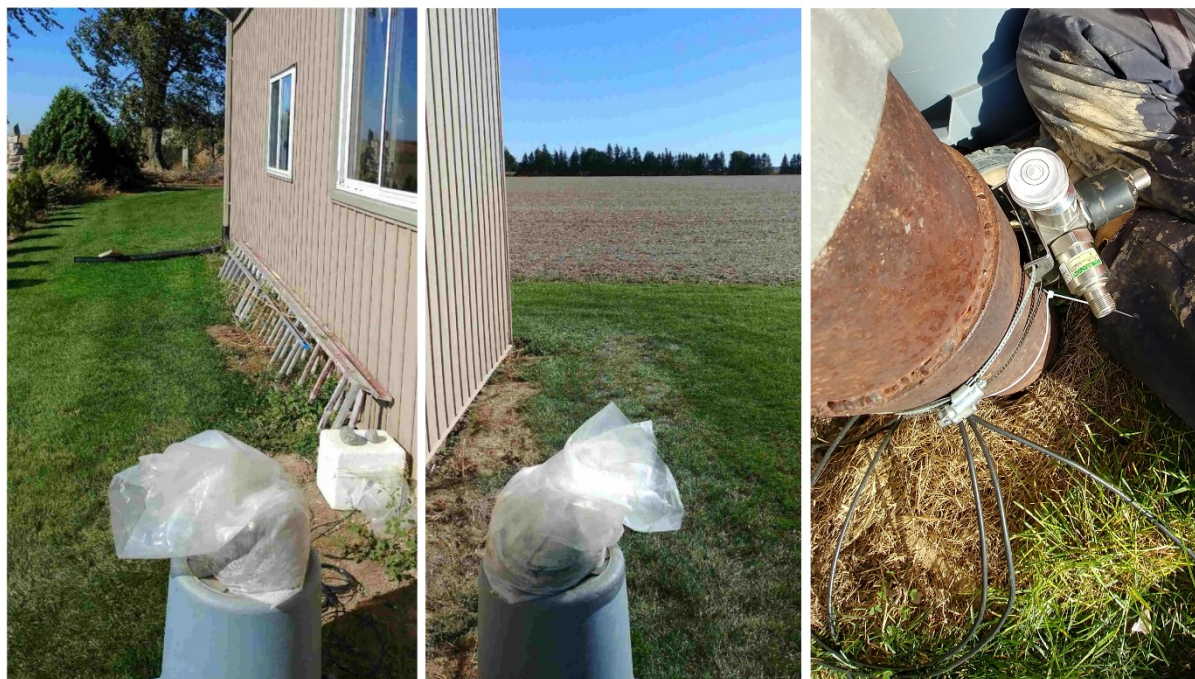
Well 1A. Photographs showing well covered with pail for protection of accelerometers. Left photograph looking north, center photograph looking south and right photograph showing accelerometers mounted on casing.

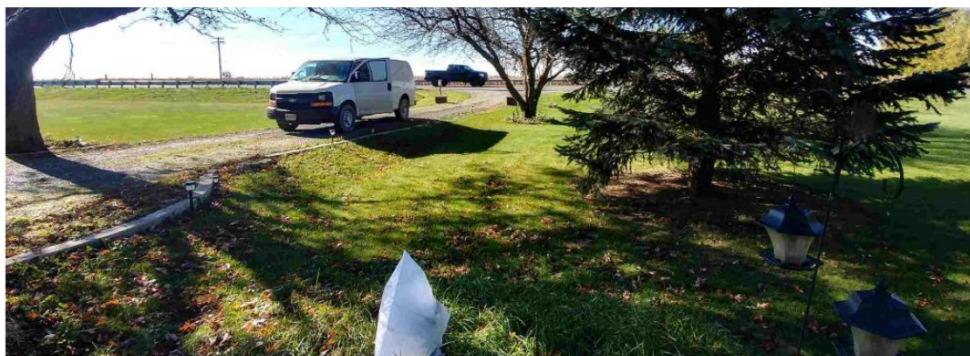
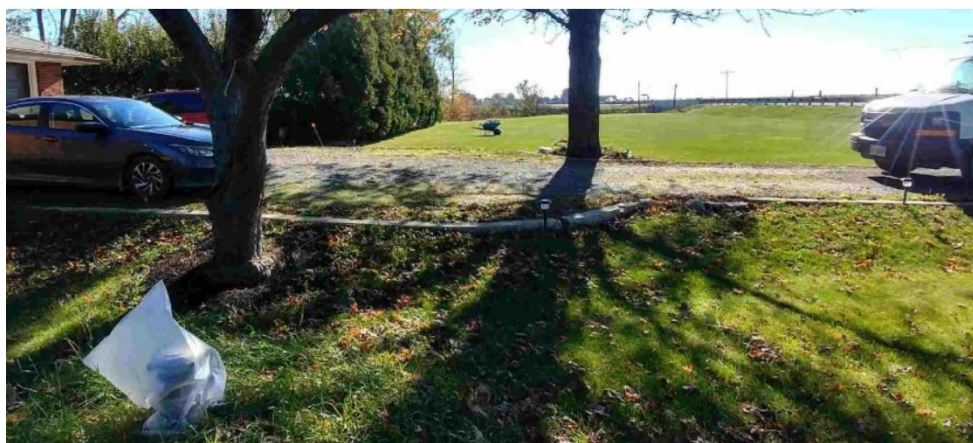
Well A. Photographs showing well covered for protection of accelerometers. Top photograph looking west, bottom photograph looking south.

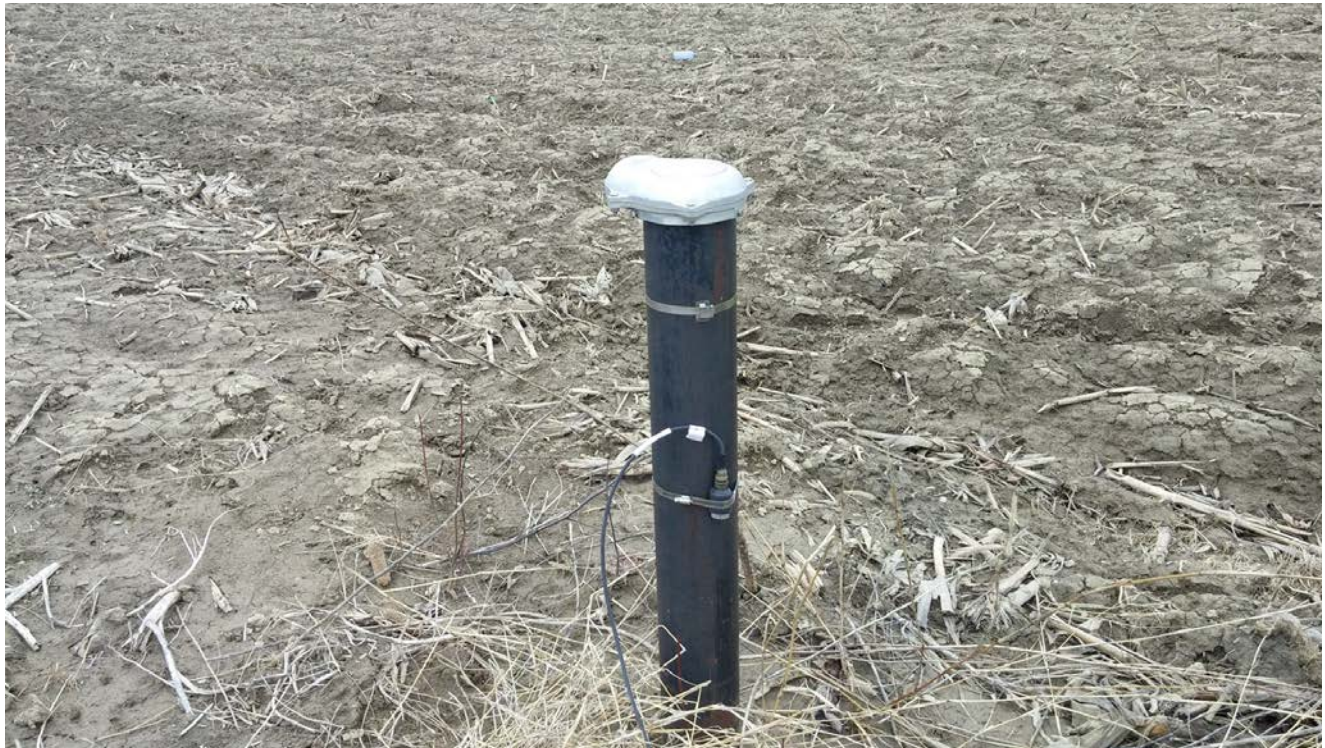
Well 2. Vented well cap showing accelerometer mounted during Phase 1 test pile vibration monitoring test program.

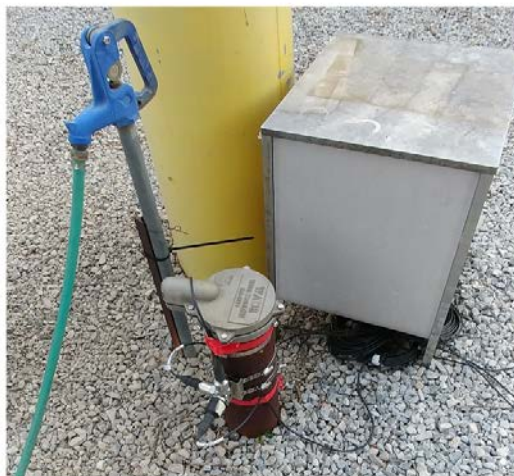
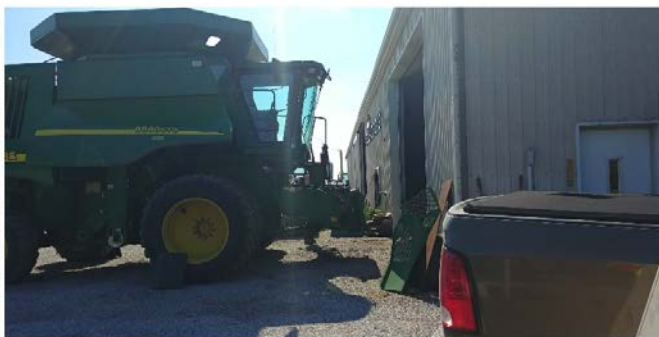
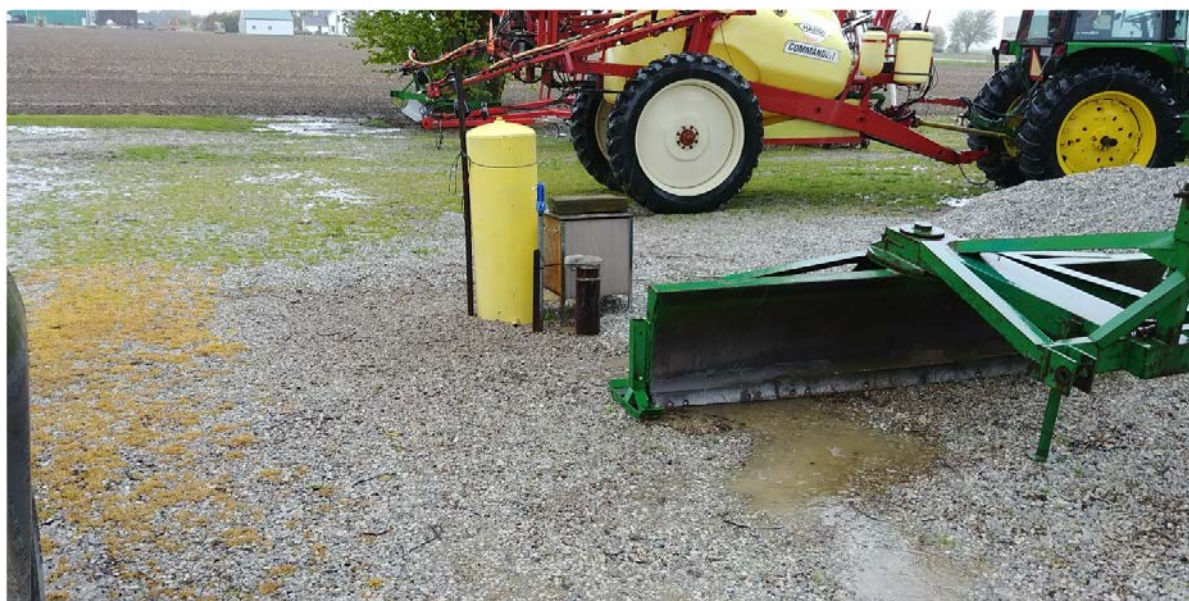
Well 3. Accelerometers mounted to well casing (left). Pressure tank (yellow) shown behind well casing. Well casing cap fitted with vent. Right and bottom photographs illustrate conditions near well casing and bottom photo illustrates existing band clamp with wires running between vented cap and casing.

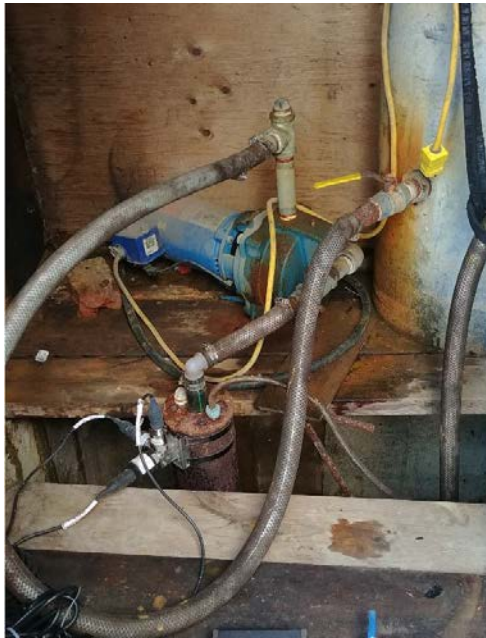
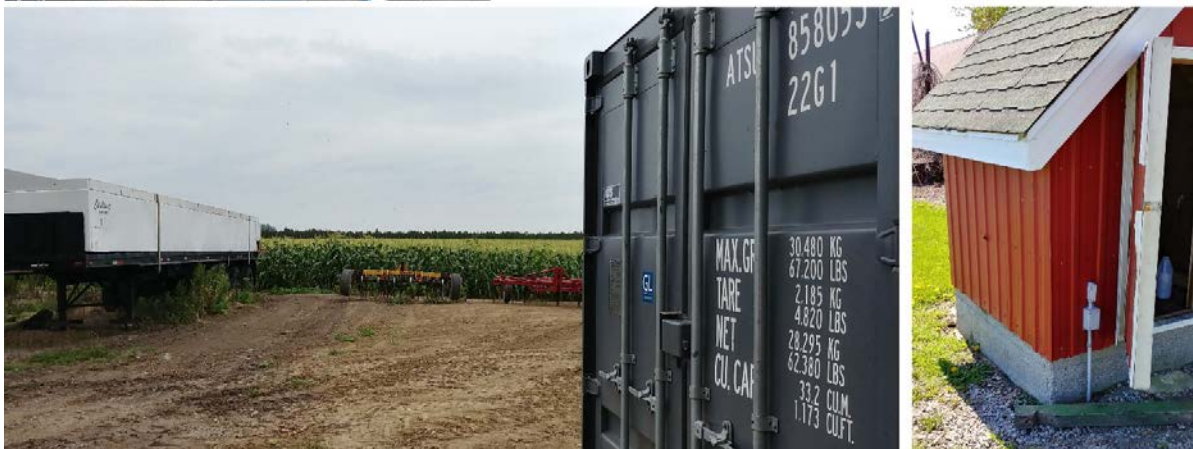
Well 4. Accelerometers mounted to well casing (left) with pump installed on September 6, 2017 also shown. Pressure tank shown to right of well casing. Photographs below illustrate well house and site conditions near well.

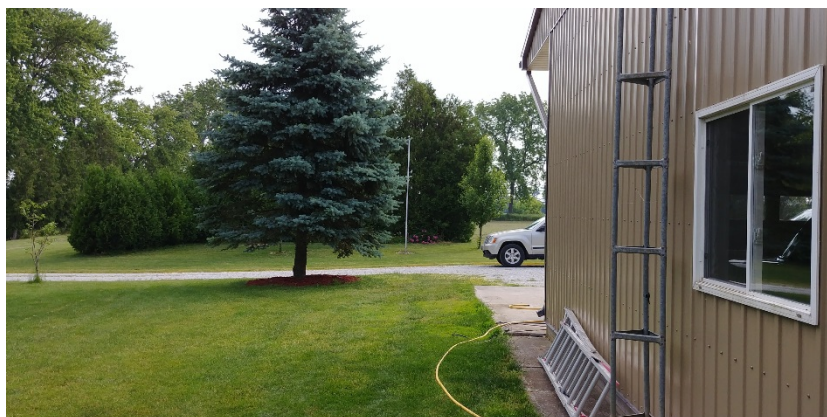
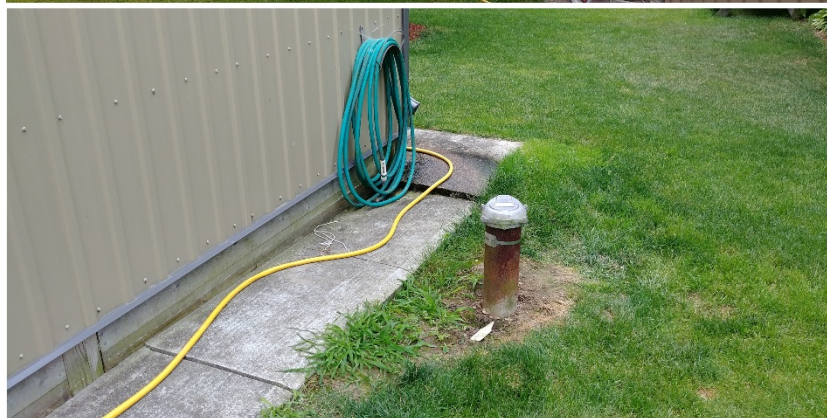
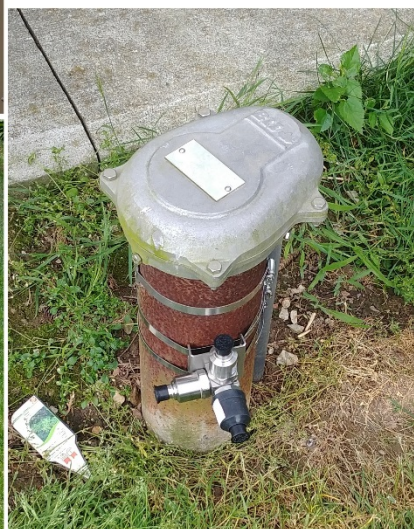
Well 5. Accelerometers mounted to well casing (bottom right). Photographs below and left illustrate site conditions near well.

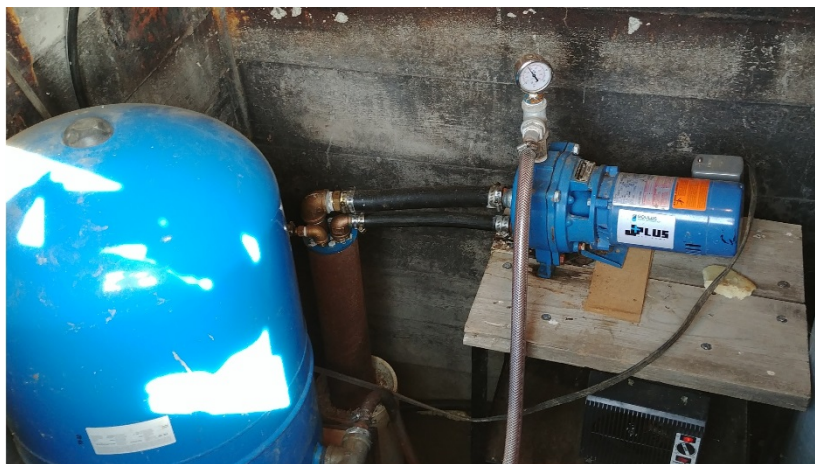
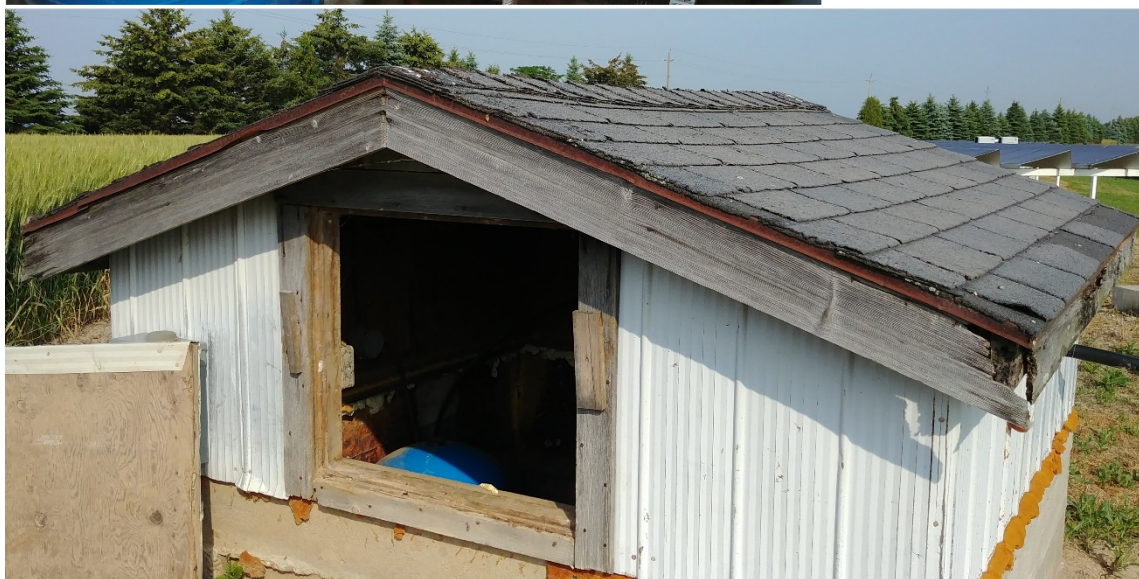
Well 6. Photograph at left illustrates well casing, pump and pressure tank. Bottom photograph illustrates well house and nearby conditions.

- **Well 6:** The pump for Well 6 is mounted in close proximity to the well casing (see Appendix C). Approximately 1 minute after driving of Pile 1 for turbine T12 concluded, a loaded tractor-trailer dump truck drove by on the road near Well 6 causing sufficient vibration to be noticed by the Golder well attendant. At the same time, the resident was hammering in a nearby shed. During well monitoring, mechanical systems associated with the farm silos were observed to be operating from time to time. Farm equipment and crop transport trucks entered and left the site within approximately 105 m of the well. A small bridge used for farm equipment to cross a local open drain is located within 60 m of the well.

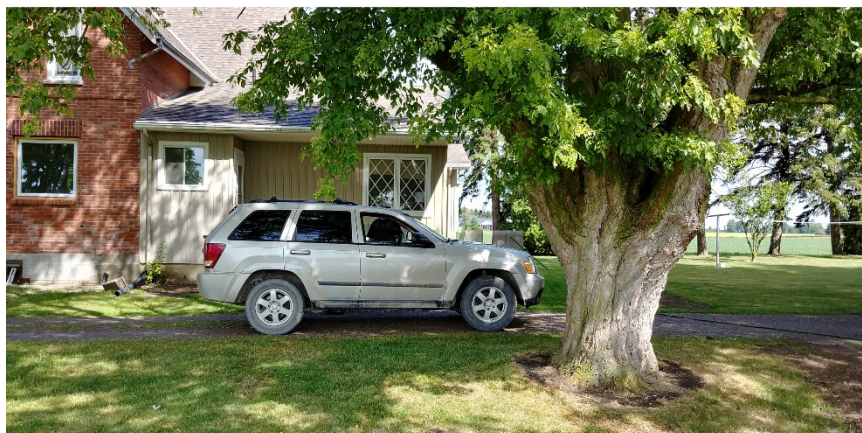
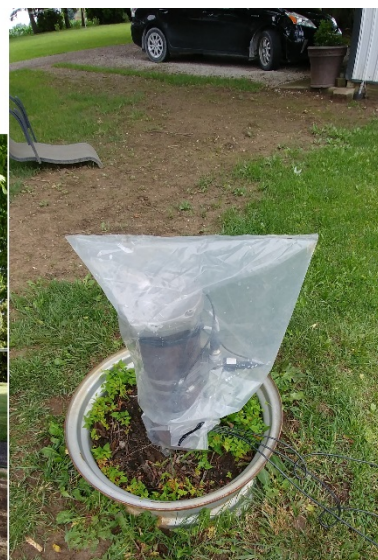
Well 7. Photograph at right illustrates well casing with accelerometers mounted to casing and bag for rain cover. Well casing located between home (lower left) and garage (upper right corner, right photograph).

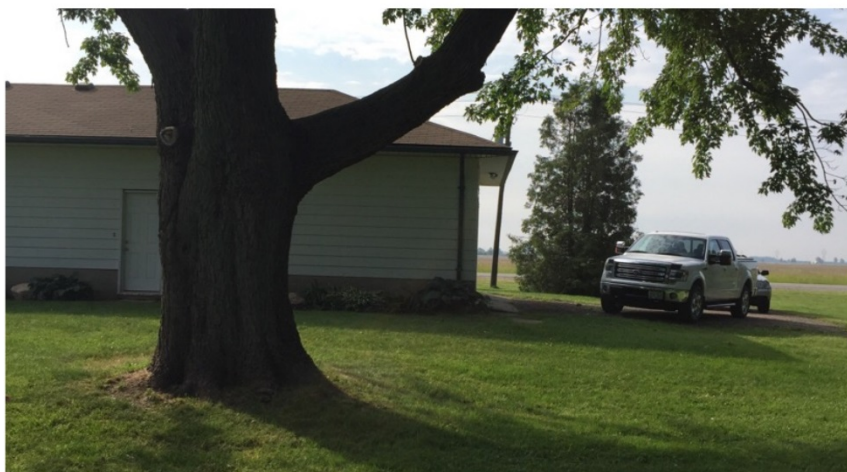
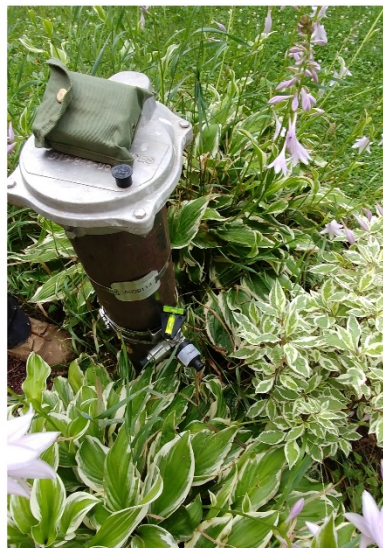
Well 8. Photograph at right illustrates well with accelerometers mounted to casing. Photograph below illustrates conditions near well.

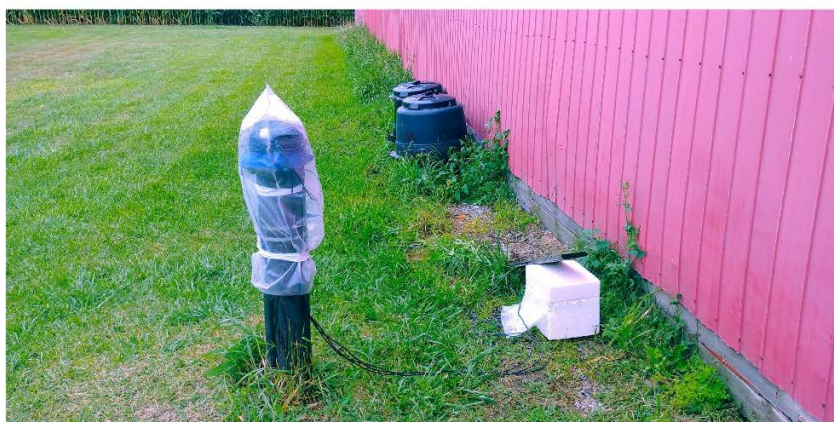
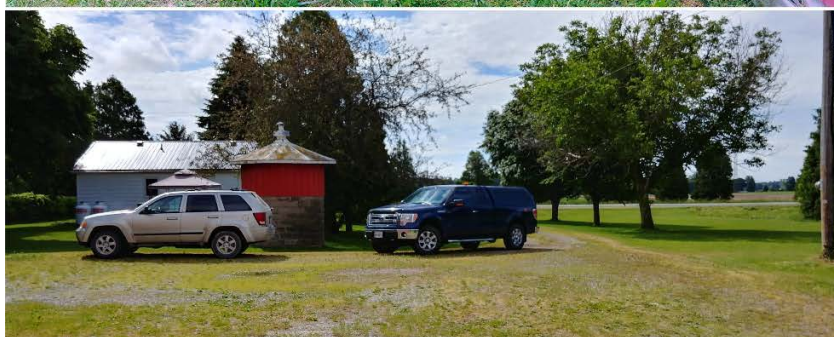
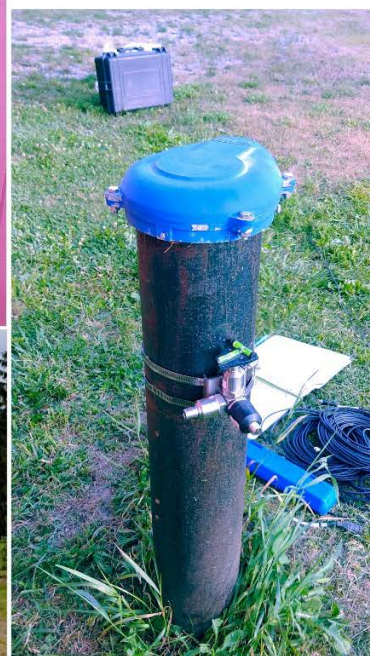
Well 9. Photograph at right illustrates well casing with accelerometers mounted to casing. Conditions near well casing illustrated in photographs below where barn, within which pump was located near well casing, and driveway leading to barn.

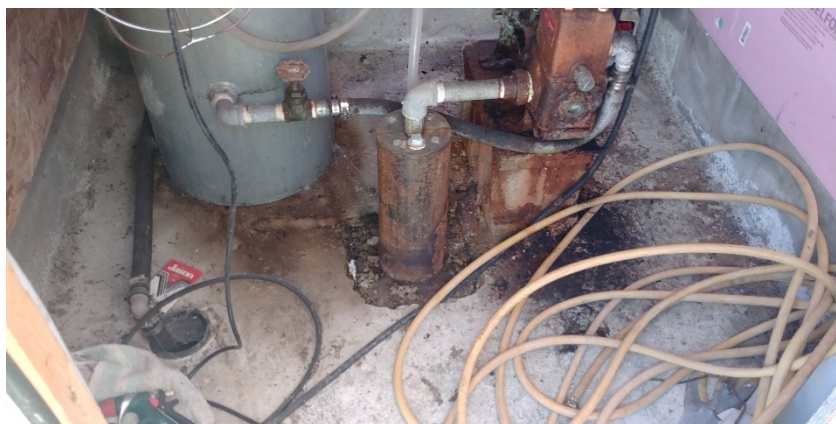
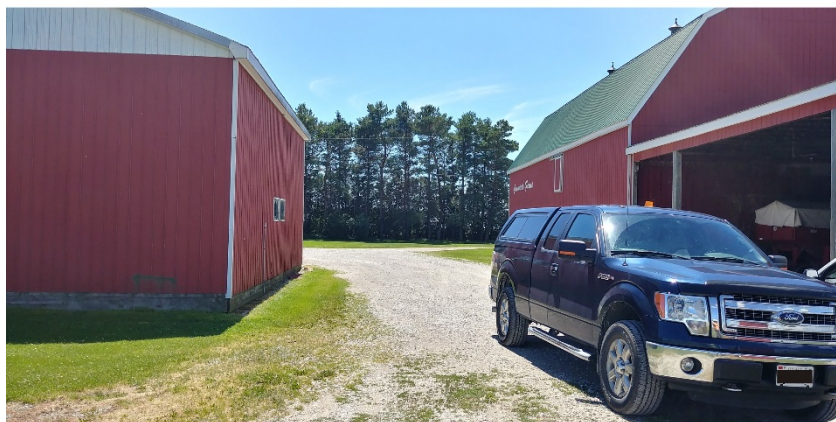
Well 10. Photograph at upper left illustrates proximity of well casing, pump and tank. Accelerometers mounted to casing shown below. Conditions near well casing illustrated in lower left photograph.

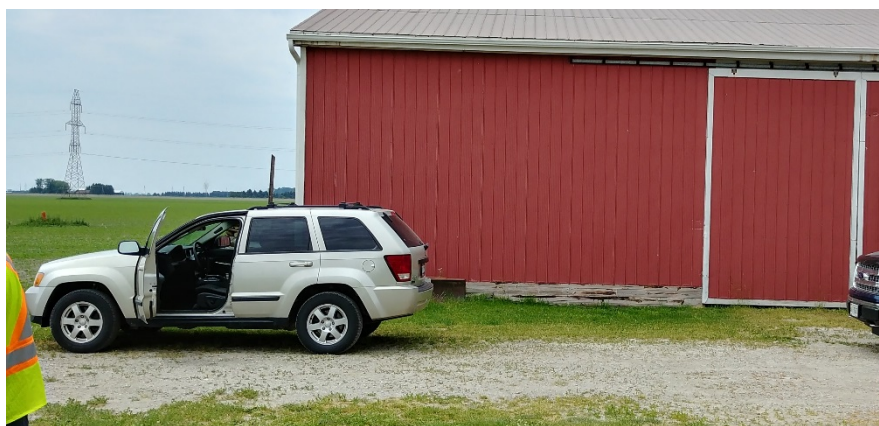
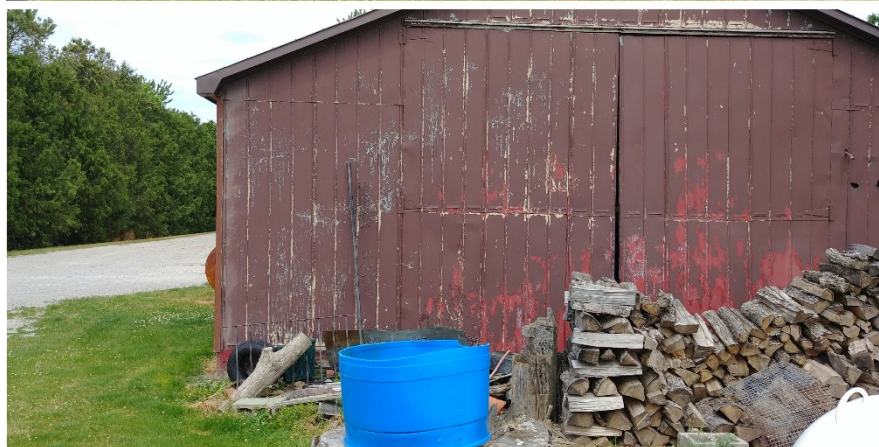
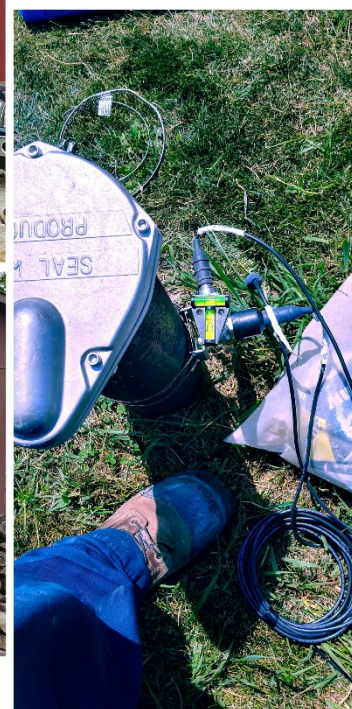
Well 11. Accelerometers mounted to casing shown lower right. Conditions near well casing illustrated in photographs at left.

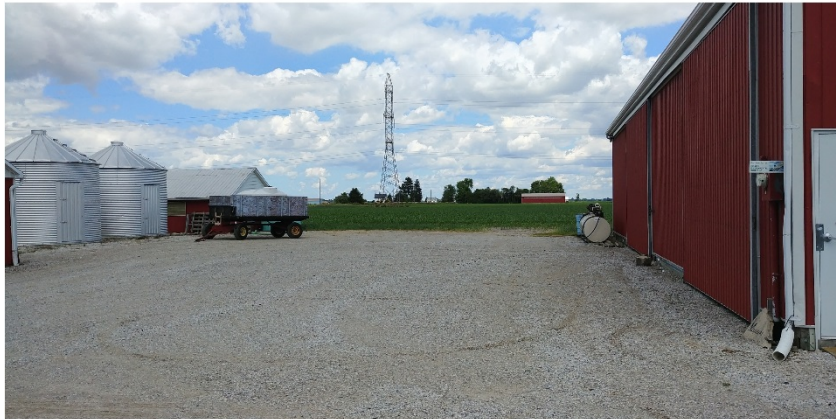
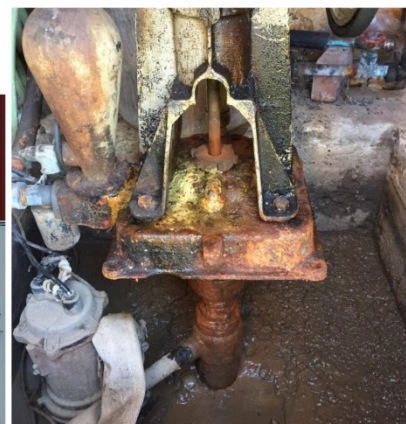
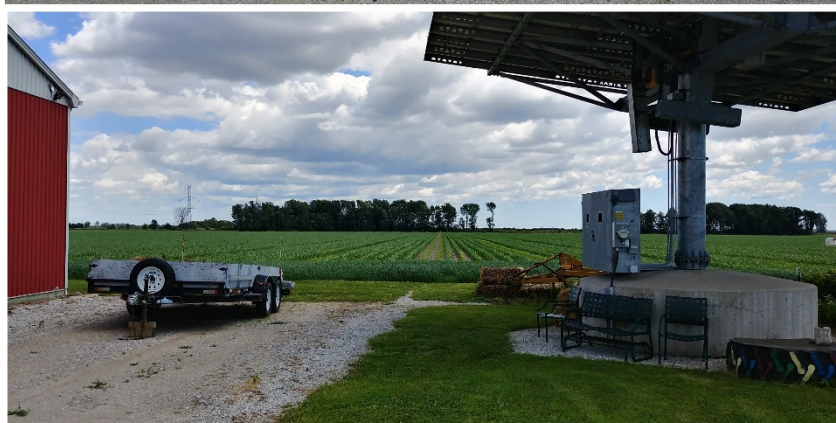
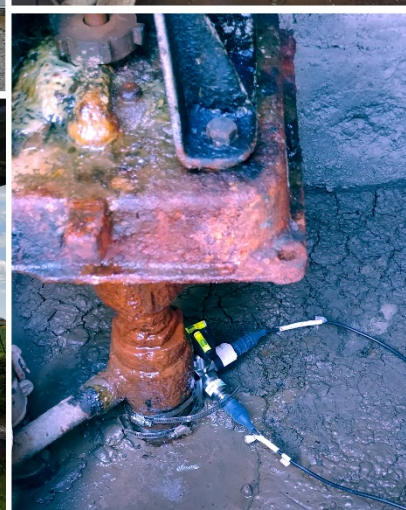
Well 12. Photograph at top right illustrates well casing with pump mounted on top of casing. Lower right photograph shows accelerometers mounted on casing. Conditions near well casing illustrated in photographs below.

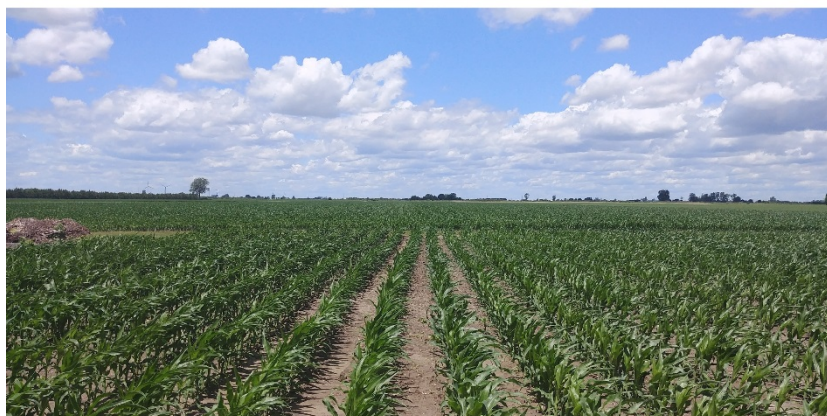
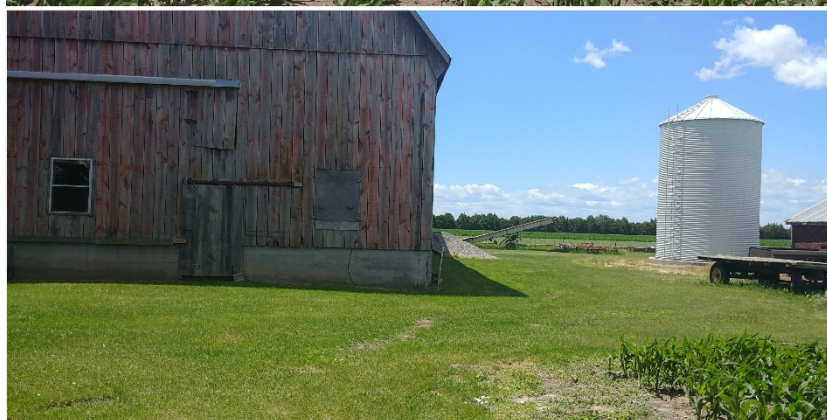
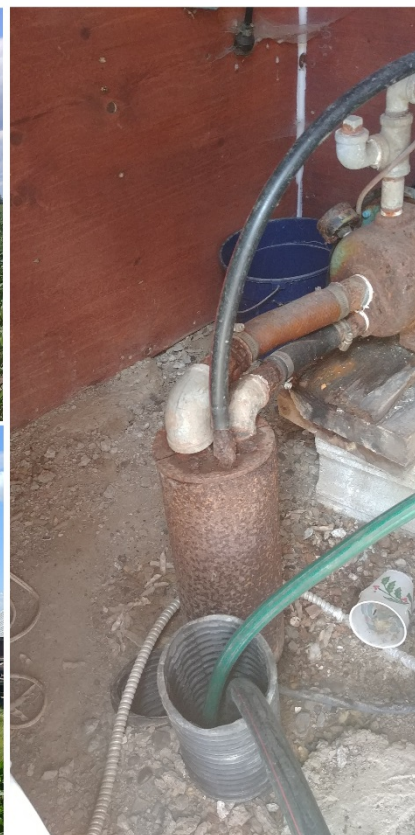
Well 13. Photograph at right illustrates well casing with pump mounted immediately adjacent to pump. Photographs at left illustrate conditions near well casing.

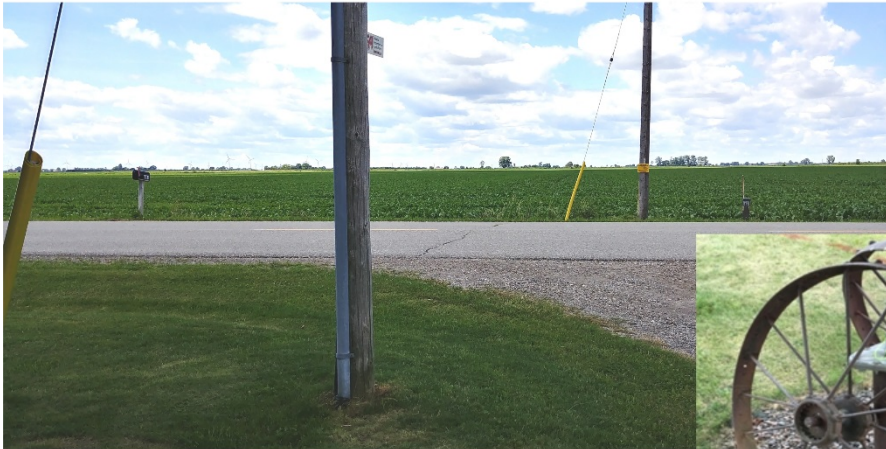
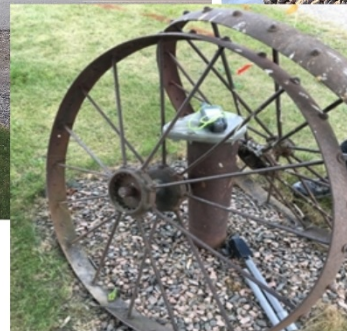
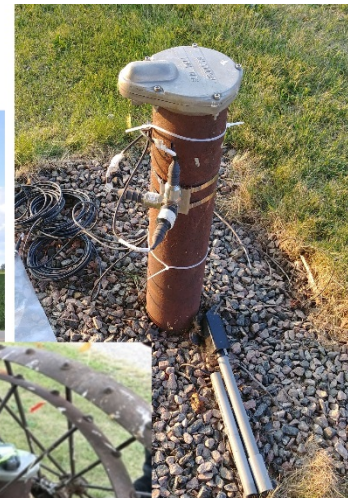
Well 14. Photograph at right illustrates well with accelerometers mounted on casing. Photograph below, taken from well location, illustrates proximity of well casing to roadway and transverse pavement crack.
