HERITAGE IMPACT ASSESSMENT

**SP Belle River Wind LP
Belle River Wind Project
Various Lots and Concessions
Former Townships of Maidstone, Rochester and
Tilbury West
Now Town of Lakeshore, Essex County, Ontario**

Report Number: 1404174-3000-R01

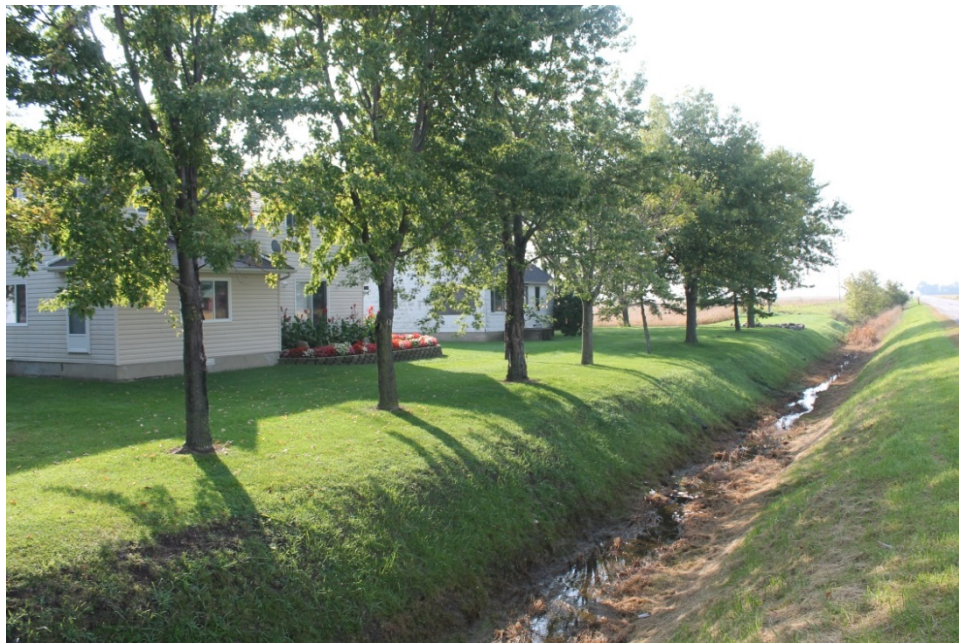
Plate 3: Drainage ditch along Lakeshore Road 305, looking east.

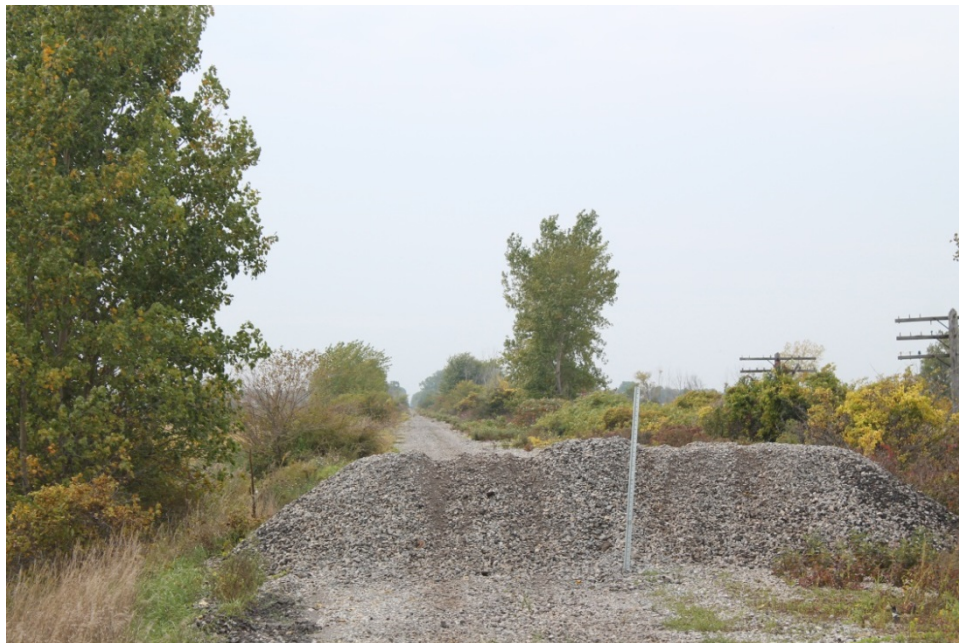
The Canada Southern Railway, financed by American investors, was incorporated in 1868 as the Erie and Niagara Extension Railway. Its name was changed to the Canada Southern Railway in 1869. In order to secure rail bridge access to the major border centres of Buffalo and Detroit, the company built a line, completed in 1873, that stretched across southwestern Ontario from Fort Erie to Amherstburg via St. Thomas. The western section of the rail line from St. Thomas to Amherstburg had a station in the Village of Comber just outside of the present Study Area. By 1876 the company had been taken over by the New York Central Railway system. The Canada Southern Railway Company remained the property of the New York Central Railway until 1968 when it was amalgamated into the Pennsylvania Central Railway. Conrail subsequently gained control of the rail line in 1976 when the Pennsylvania Central Railway declared bankruptcy. Passenger traffic on the rail line ended in 1979. The railway was purchased by the Canadian Pacific Railway and Canadian National Railway in 1983.²² The tracks of this rail line have been abandoned (Plate 10).

Plate 10: Earthworks of Canada Southern Railway, looking southwest from County Road 46.

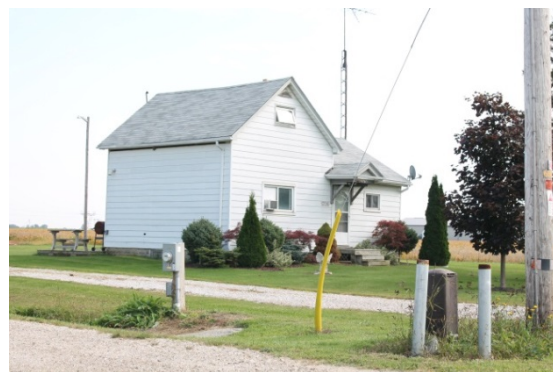
Site #1 – 1326 Belle River Road, Town of Lakeshore

Date: Early to mid-20th century

Description: One and a half storey vernacular farmhouse with gable roof and modern siding on a rusticated concrete block foundation.

Mitigation of Negative Impacts: Impacts were not identified; therefore mitigation is not recommended or necessary.

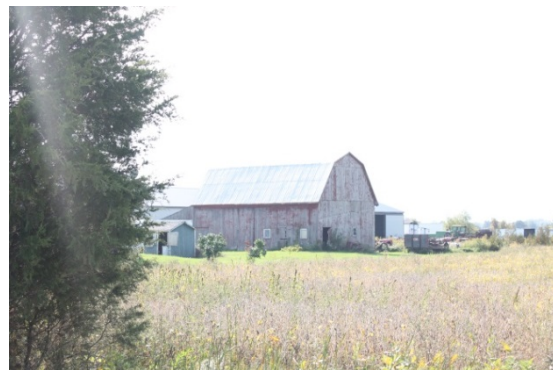
Site #2 – 1637 Myers Road, Town of Lakeshore

Date: Late 19th to early 20th century

Description: Timber frame barn with metal gambrel roof.

Mitigation of Negative Impacts: No direct or indirect impacts are anticipated; therefore no further mitigation is recommended.

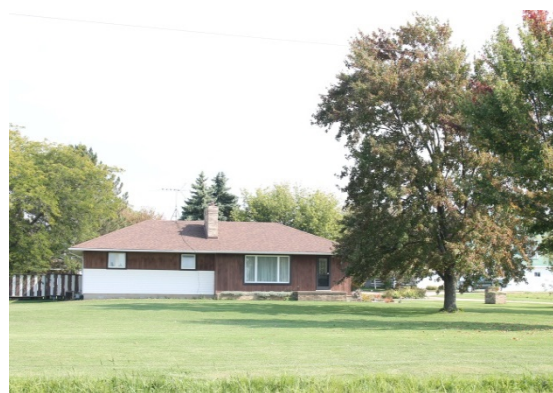
Site #3 – 1342 Myers Road, Town of Lakeshore

Date: Mid-20th century

Description: Single storey, hipped roof house with wood and synthetic siding on a concrete foundation.

Potential Direct and Indirect Impacts to the Heritage Attributes: CHVI was not identified, therefore impacts were not assessed.

Mitigation of Negative Impacts: Impacts were not identified; therefore mitigation is not recommended or necessary.

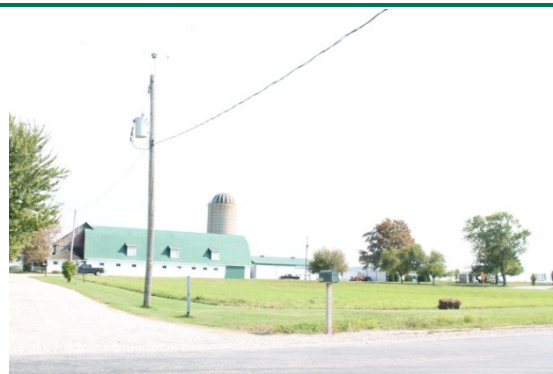
Date: Various (Late 19th/Early 20th century)

Description: Barn complex containing a timber frame barn with gable roof.

Mitigation of Negative Impacts: No direct or indirect impacts are anticipated, therefore no further mitigation is recommended.

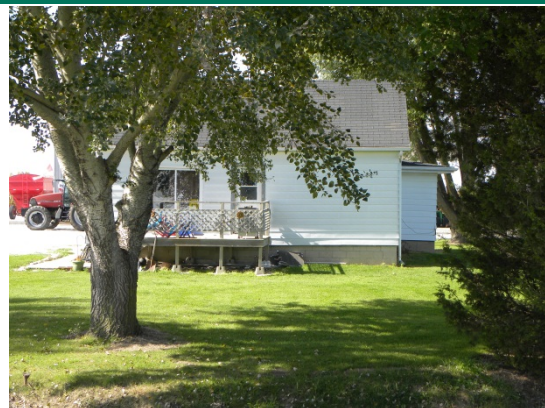
Site #4 – 1451 Lakeshore Road 125, Town of Lakeshore

Date: Late 19th/Early 20th century

Description: One and a half storey side gable vernacular farmhouse with modern roof cladding and siding on a concrete block foundation.

Mitigation of Negative Impacts: Impacts were not identified; therefore mitigation is not recommended or necessary.

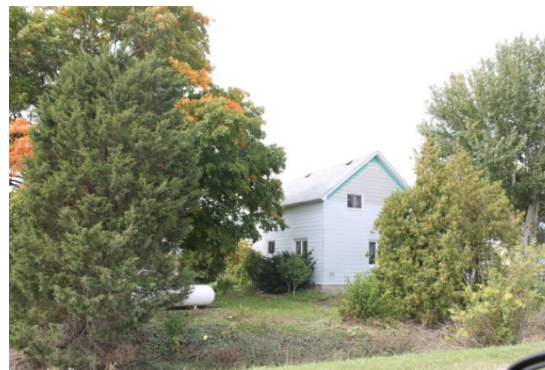
Site #5 – 1455 Lakeshore Road 125, Town of Lakeshore

Date: Late 19th/Early 20th century

Description: One and a half storey vernacular farmhouse with gable-pitched roof and modern siding on a concrete foundation.

Mitigation of Negative Impacts: Impacts were not identified; therefore mitigation is not recommended or necessary.

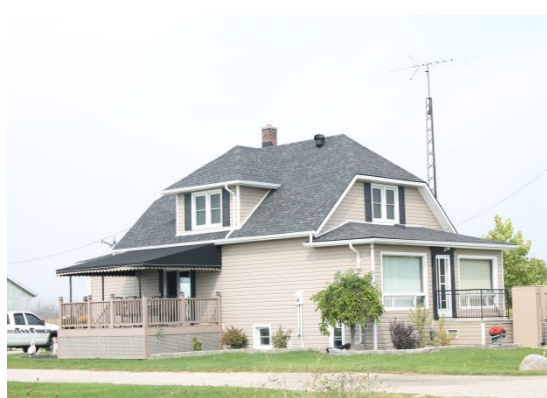
Site #6 – 1779 County Road 31, Town of Lakeshore

Date: Early 20th century

Description: One and a half storey, vernacular farmhouse with shallow hipped-gable roof and modern siding. Centrally located brick chimney.

Mitigation of Negative Impacts: No direct or indirect impacts are anticipated, therefore no further mitigation is recommended.

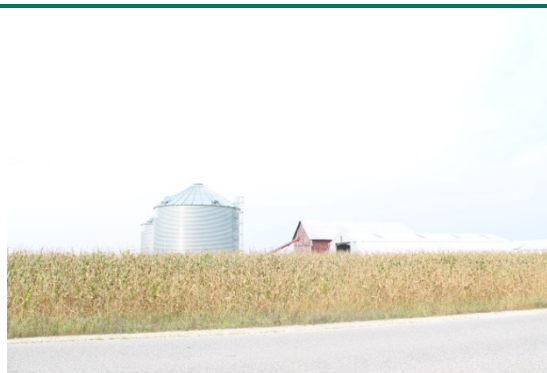
Date: Various (19th and 20th century)

Description: Farm complex with modern and historic buildings, contains timber frame barn with metal gable roof.

Mitigation of Negative Impacts: No direct or indirect impacts are anticipated, therefore no further mitigation is recommended.

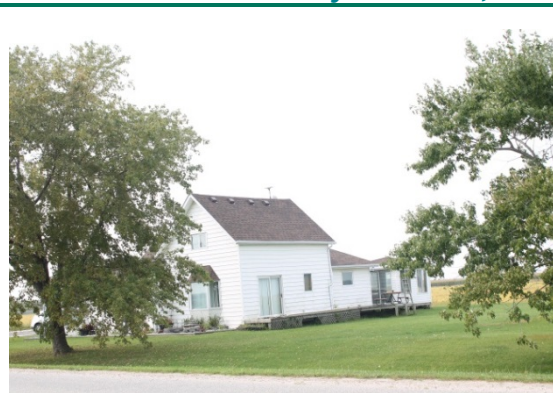
Site #7 – 1845 County Road 31, Town of Lakeshore

Date: Late 19th century

Description: One and a half storey vernacular farmhouse with gable roof and modern siding. Bay window on front façade and modern additions at rear.

Mitigation of Negative Impacts: Impacts were not identified; therefore mitigation is not recommended or necessary.

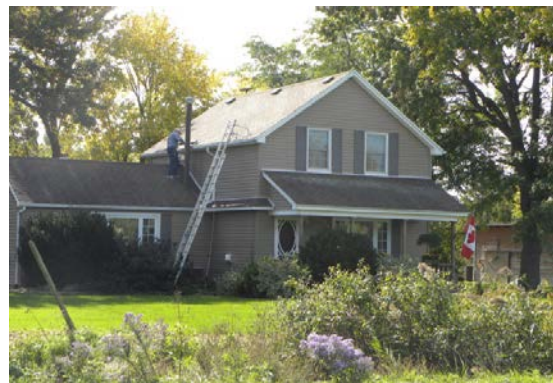
Site #8 – 2597 County Road 46, Town of Lakeshore

Date: Late 19th century

Description: One and a half storey vernacular farmhouse with gable roof and modern siding. Additions at side and rear façades.

Mitigation of Negative Impacts: Impacts were not identified; therefore mitigation is not recommended or necessary.

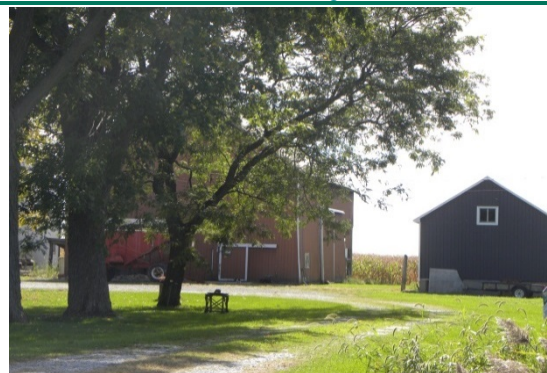
Site #8 – 2597 County Road 46, Town of Lakeshore

Date: Various (Late 19th/Early 20th century)

Description: Farm complex with modern and historic buildings, contains timber frame barn with gable roof.

Mitigation of Negative Impacts: No direct or indirect impacts are anticipated, therefore no further mitigation is recommended.

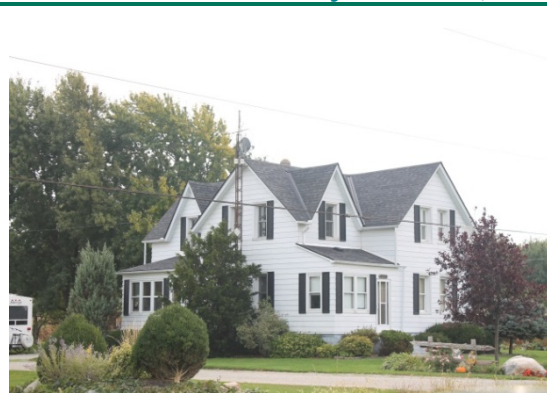
Site #9 – 1734 County Road 31, Town of Lakeshore

Date: Late 19th century

Description: One and a half storey vernacular farmhouse with cross-gable roof and modern siding on a concrete block foundation. Enclosed verandahs on front and side façades.

Mitigation of Negative Impacts: Impacts were not identified; therefore mitigation is not recommended or necessary.

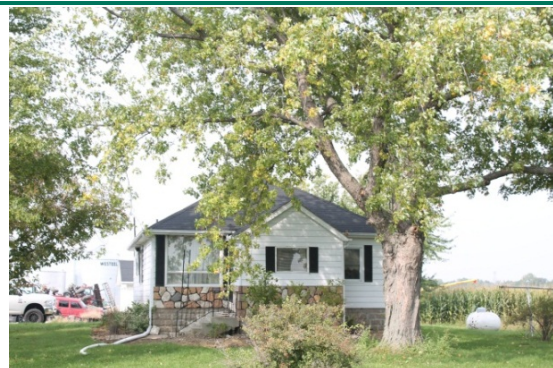
Site #10 – 1353 Lakeshore Road 129, Town of Lakeshore

Date: Early 20th century

Description: One storey vernacular farmhouse with a hipped roof and modern siding on a rusticated concrete block foundation.

Mitigation of Negative Impacts: Impacts were not identified; therefore mitigation is not recommended or necessary.

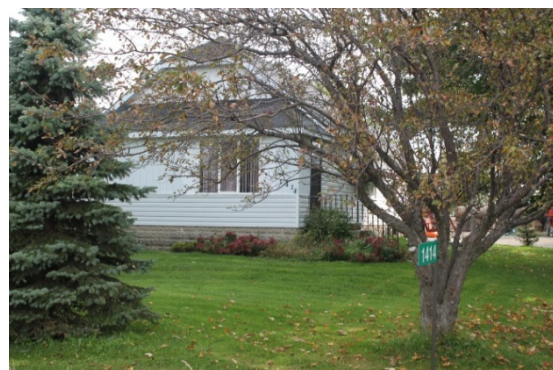
Site #11 – 1414 Lakeshore Road 129, Town of Lakeshore

Date: Early 20th century

Description: One and a half storey vernacular farmhouse with hipped gable roof and modern siding on a rusticated concrete block foundation

Mitigation of Negative Impacts: No direct or indirect impacts are anticipated, therefore no further mitigation is recommended.

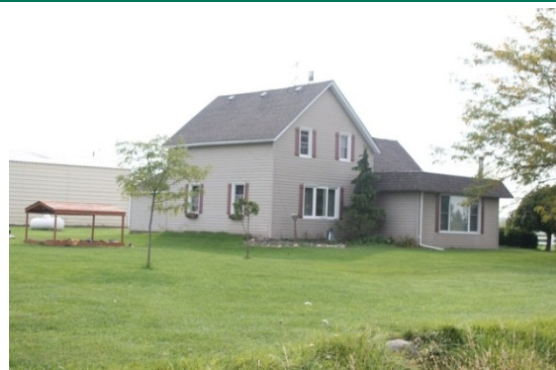
Site #12 – 1564 Lakeshore Road 129, Town of Lakeshore

Date: Various (19th to 20th century)

Description: One and a half storey vernacular farmhouse with a gable roof and modern siding. Several additions to side facades

Mitigation of Negative Impacts: No direct or indirect impacts are anticipated, therefore no further mitigation is recommended.

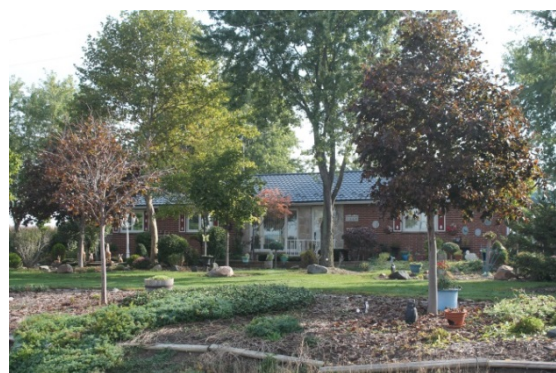
Site #13 – 1368 Rochester Townline Road, Town of Lakeshore

Date: Mid-20th century

Description: One storey Ranch style house with shallow gable roof, and exterior brick cladding.

Mitigation of Negative Impacts: Impacts were not identified; therefore mitigation is not recommended or necessary.

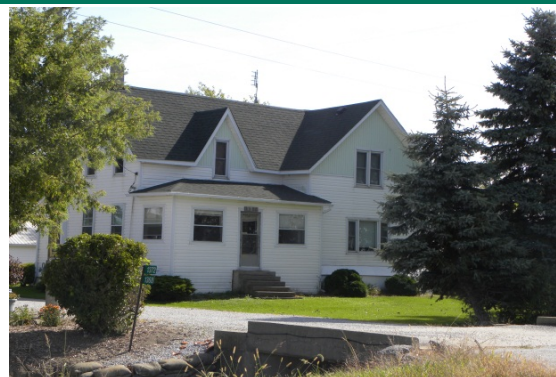
Site #14 – 1372 Rochester Townline Road, Town of Lakeshore

Date: Late 19th century

Description: One and a half storey vernacular farmhouse with cross gable roof and modern siding. Gable centrally located on front façade.

Mitigation of Negative Impacts: Impacts were not identified; therefore mitigation is not recommended or necessary.

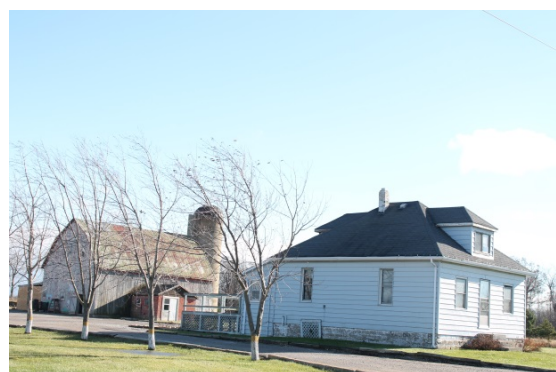
Site #15 – 1132 Lakeshore Road 115, Town of Lakeshore

Date: Various (19th and early 20th century)

Description: One and a half storey vernacular farmhouse with hipped gable roof and modern siding on a concrete block foundation.

Mitigation of Negative Impacts: No direct or indirect impacts are anticipated, therefore no further mitigation is recommended.
