Armow Wind Project

HERITAGE ASSESSMENT REPORT

SP Ontario Armow Wind Energy Project Various Communities, Municipality of Kincardine Bruce County, Ontario

Report Number: 11-1151-0247-4000-R01

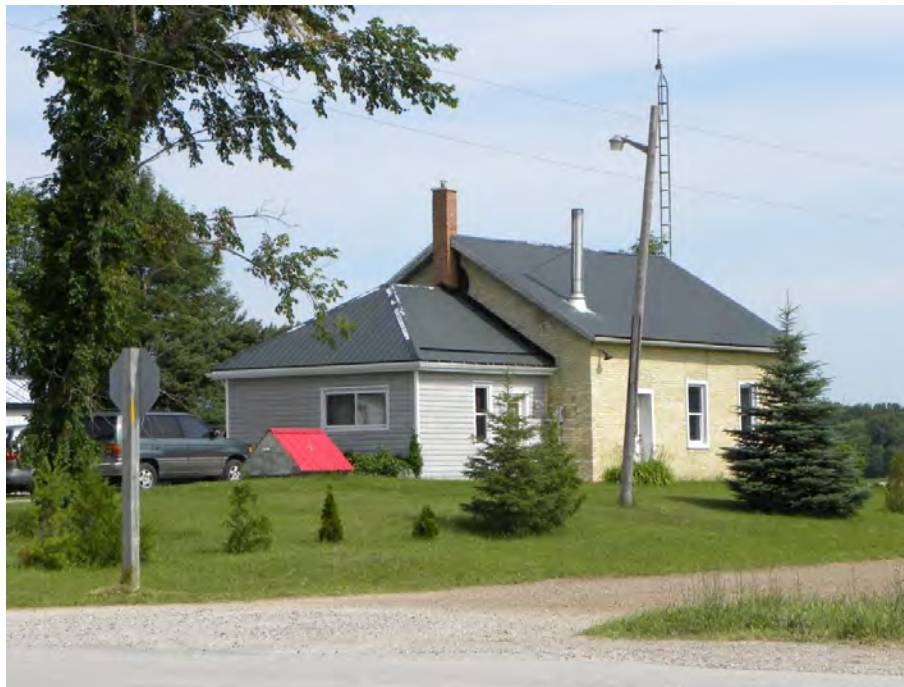
A school was constructed in 1873 on Lot 15, Concession 1 and would have acted as a place of assembly. In 2012 the school building has survived, but was converted to a private residence (Plate 5).

Plate 5: Former School No. 3, Bruce and Kincardine Townships, located on the northwest corner of Bruce Road 15 and Side Road 15 North.

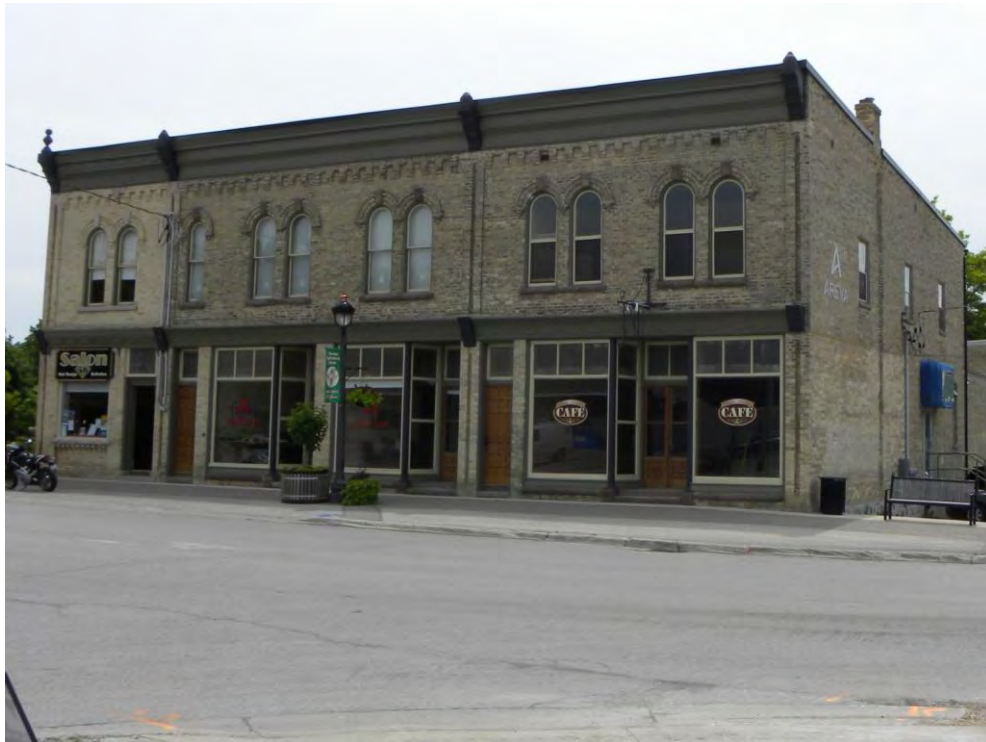
Plate 8: The McKellar Block located on the southeast corner of Main Street and King Street, Tiverton. The building is listed on the Heritage Home Registry prepared by the Municipality of Kincardine.

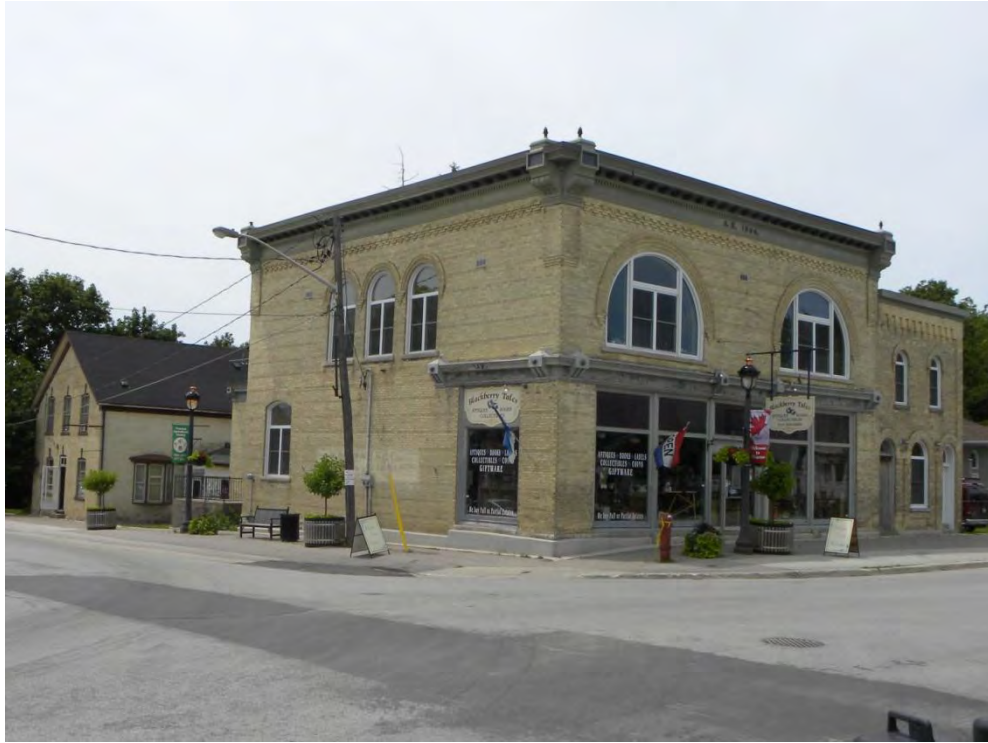
Plate 9: Blackberry Tales located on the southwest corner of Main Street and King Street. Constructed in 1904, the building is listed on the Heritage Home Registry prepared by the Municipality of Kincardine.

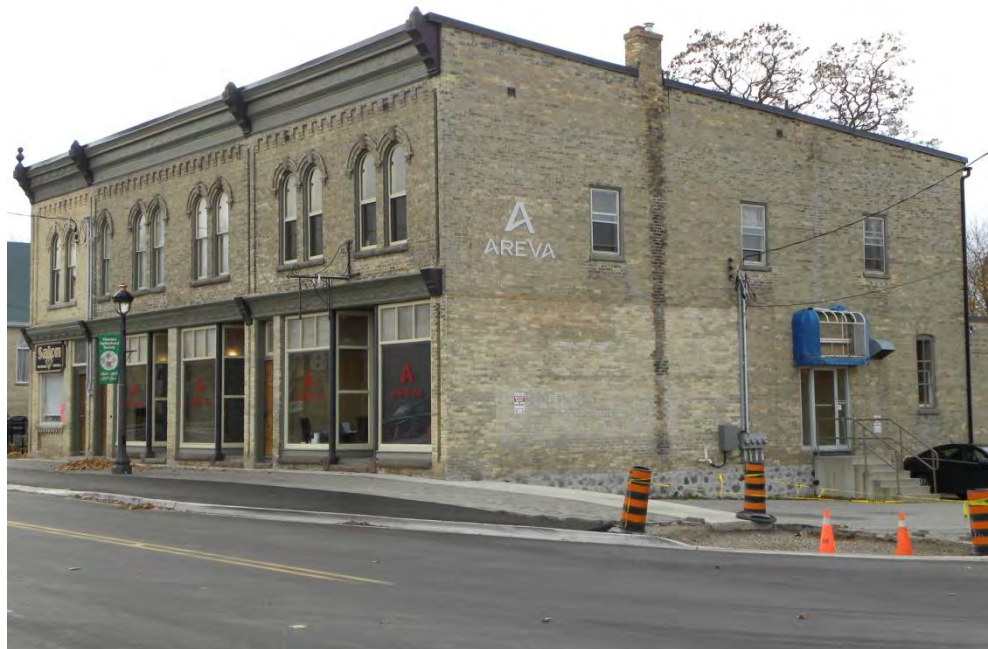
Plate 10: The McKellar Block, Tiverton, Ontario

The 1898 McKellar merchant block is listed as representative of Renaissance Revival architectural style (Plate 10).

This listed structure is not located at, adjacent to, or abutting the Project Location (Figure 2).

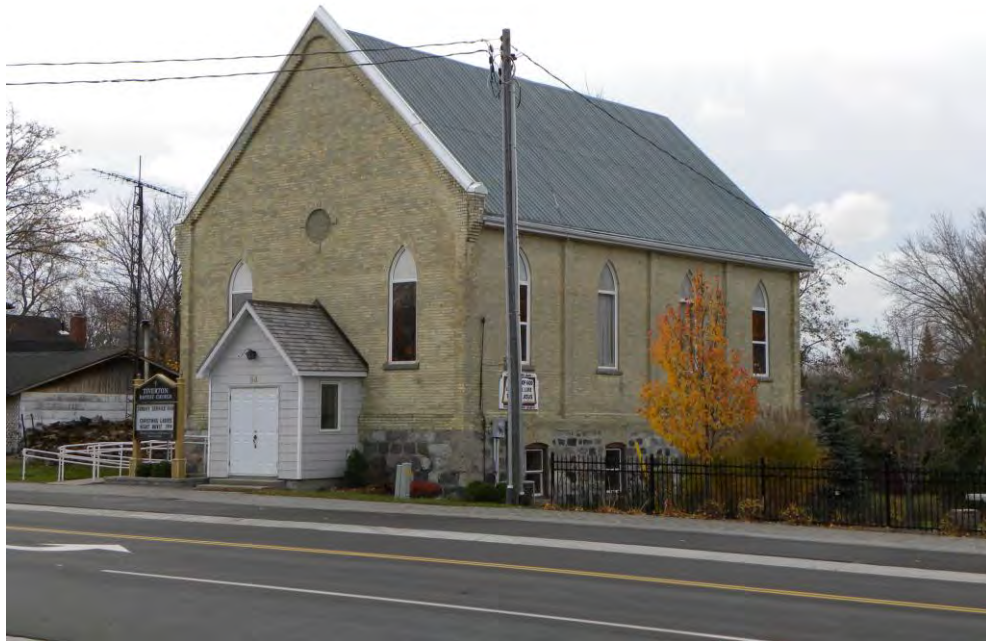
Plate 11: Tiverton Baptist Church, Tiverton, Ontario

The 1901 front gabled Tiverton Baptist Church is listed because of its vernacular gothic revival influences (Plate 11).

This listed structure is not located at, adjacent to, or abutting the Project Location (Figure 2).

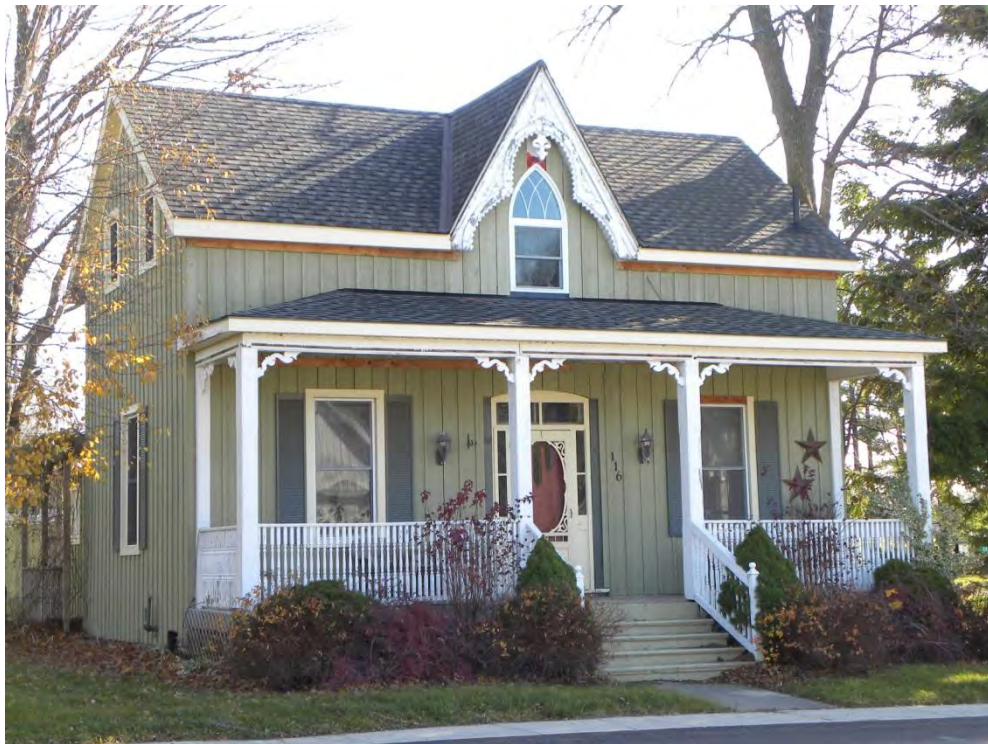
Plate 12: 116 King Street, Tiverton, Ontario

This private residence is listed because it was constructed with vernacular gothic revival design influences using timber board and batten materials (Plate 12).

This listed structure is not located at, adjacent to, or abutting the Project Location (Figure 2).

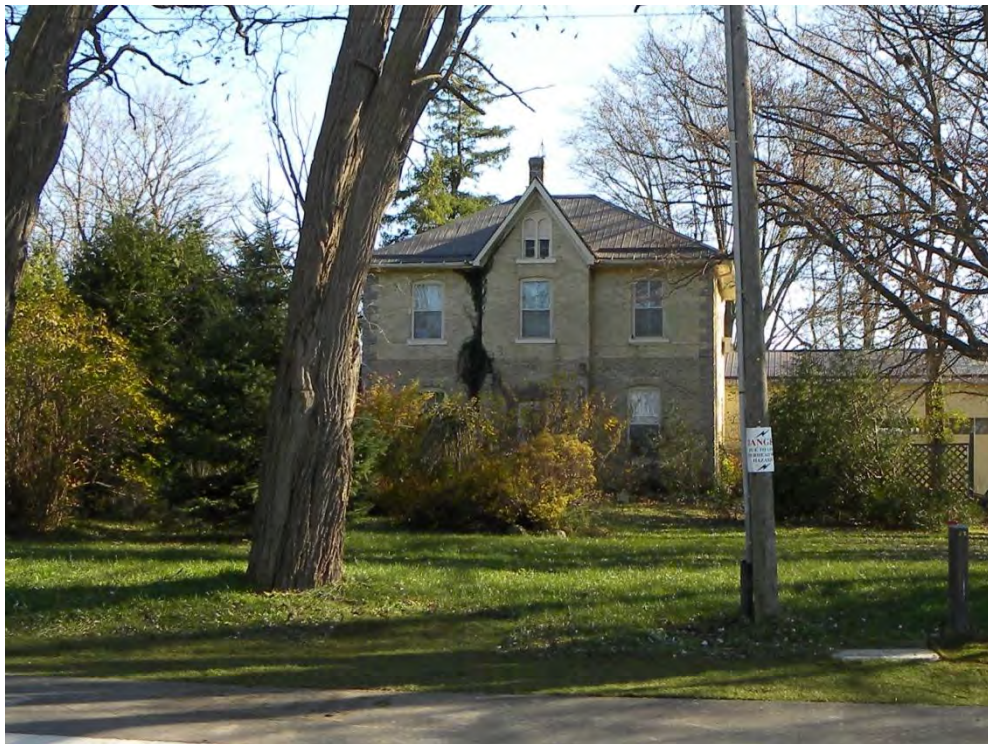
Plate 13: 140 King Street, Tiverton, Ontario

This private residence is listed because it was constructed with vernacular Italianate design influences (Plate 13).

This listed structure is not located at, adjacent to, or abutting the Project Location (Figure 2).

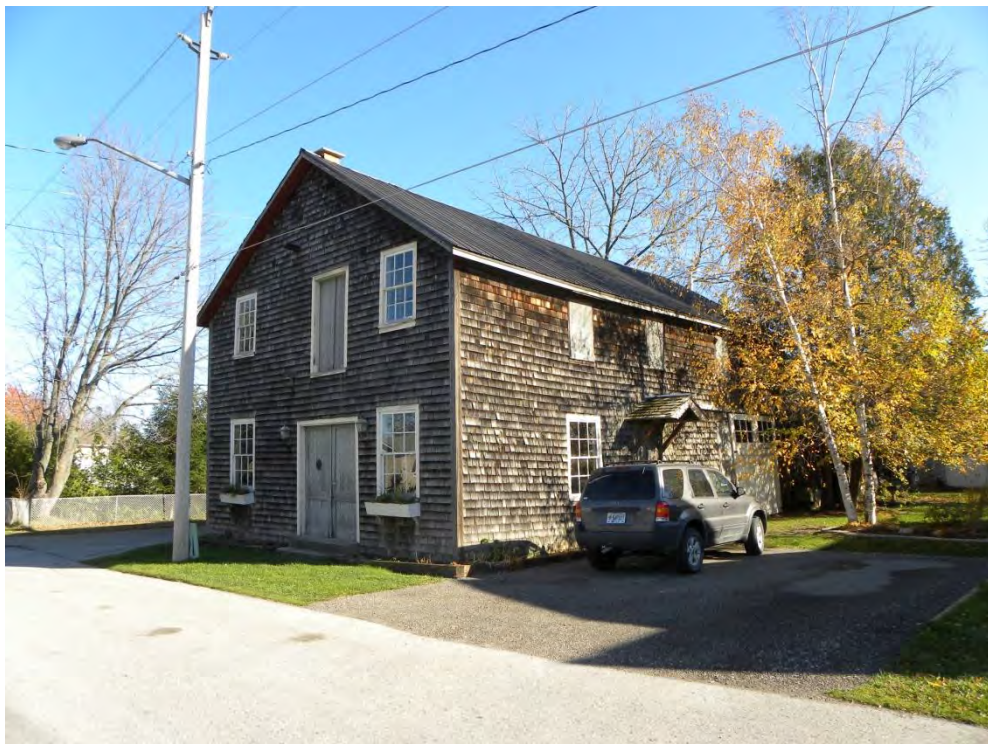
Plate 14: 20 Wickham Street, Tiverton, Ontario

This structure is listed because of the shingle style siding used in its construction (Plate 14).

This listed structure is not located at, adjacent to, or abutting the Project Location (Figure 2).

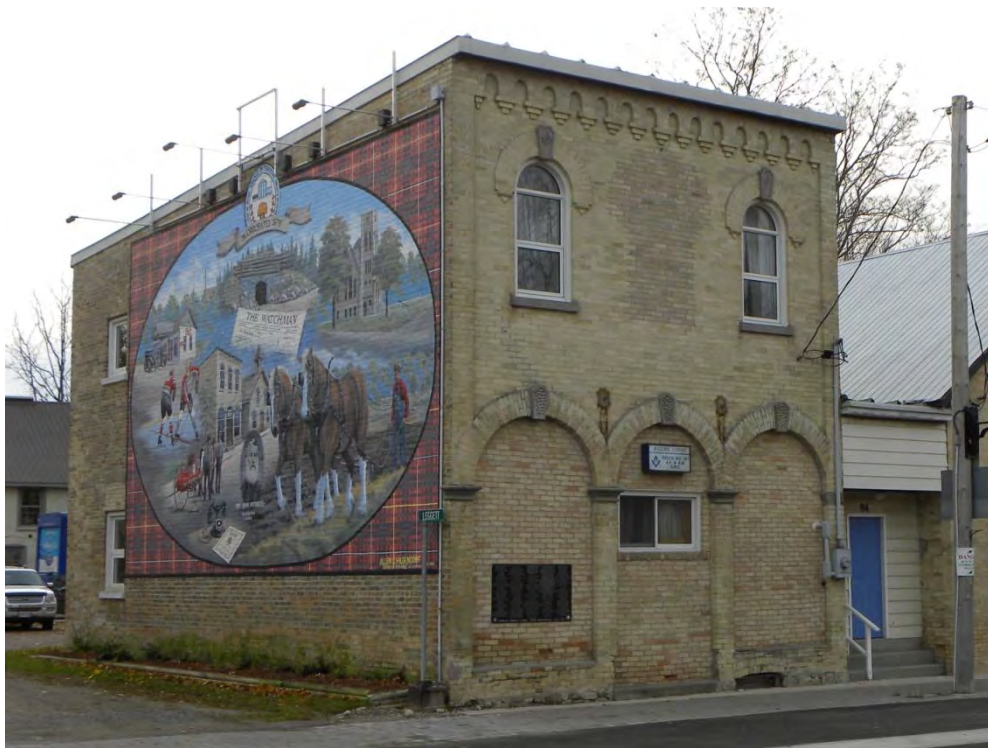
Plate 15: Bruce Lodge No. 341, 94 King Street, Tiverton, Ontario

The Bruce Lodge No. 341 is listed because it was designed and constructed by the well known local builder, George Clelland, in the Italianate style (Plate 15).

This listed structure is not located at, adjacent to, or abutting the Project Location (Figure 2).

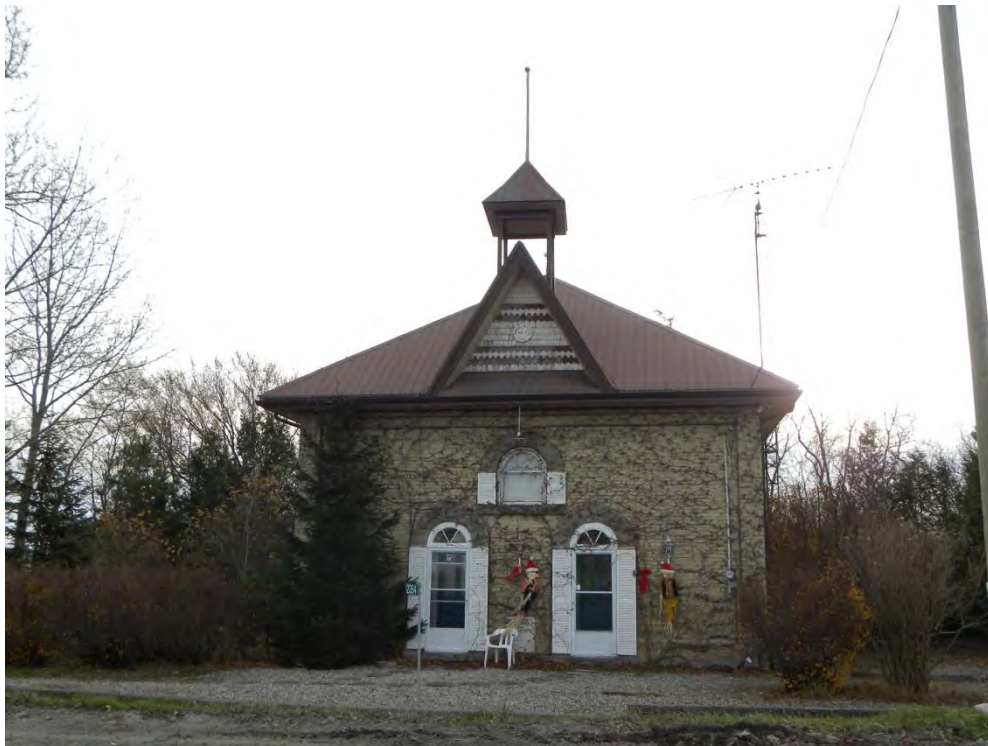
Plate 16: School House No. 5, Highway 21, Bruce Township, Ontario

This private residence, formerly School Section No. 5, is listed because it is a former township school house (Plate 16).

This listed structure is not located at, adjacent to, or abutting the Project Location (Figure 2).

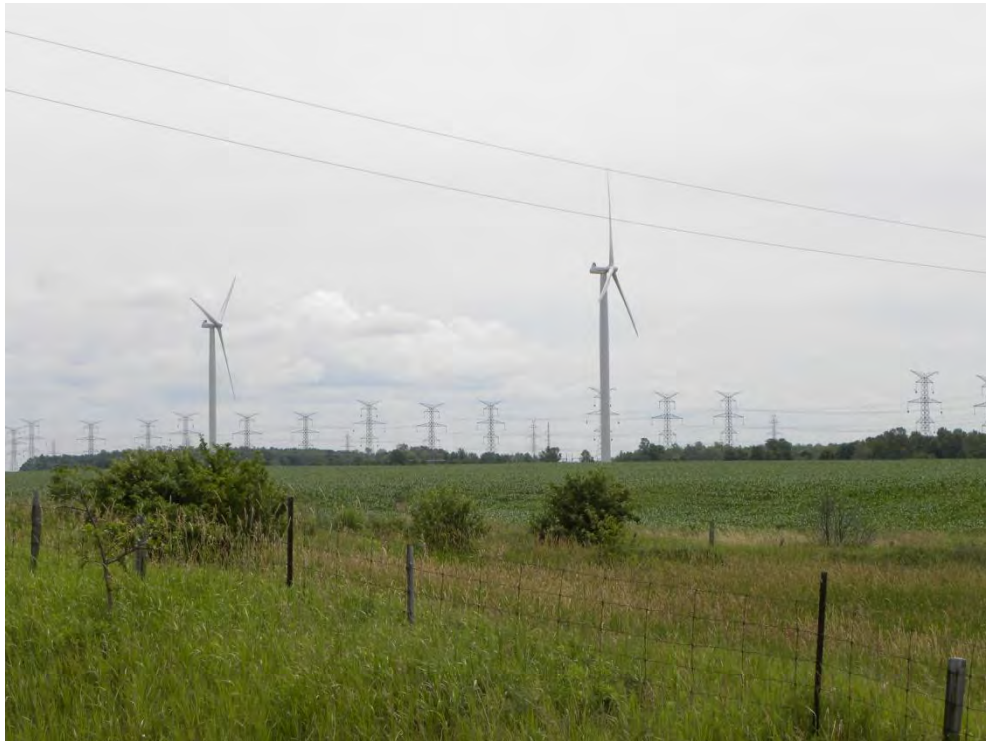
Spanning the northeast edge of the Study Area is a visually prominent hydro corridor which contains four rows of hydro towers and runs the length of the Study Area. Ten turbines are located at the western edge of this corridor, north of Concession Road 2 in between Sideroad 15 and Sideroad 10 (Plate 17).

The hydro corridor is characteristic of the expansive power generation which occurs at the Bruce Power Generating Station, located west of the Study Area. Although indicative of the large investment in power generation undertaken throughout Bruce County, this hydro corridor is one example of many throughout the region.

Plate 17: Hydro and Wind Turbine Corridor, looking south from County Road 20.

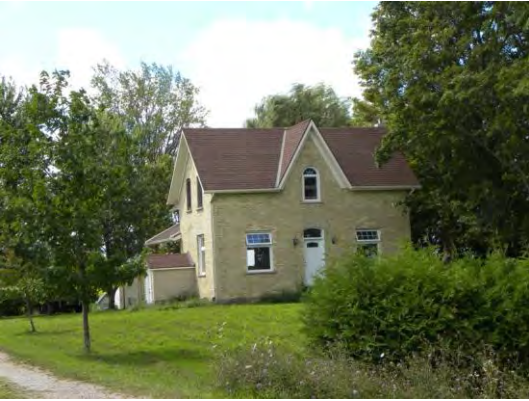
Site #1 – 497 Concession Road 7 (Municipality of Kincardine)	Lot: East part of Lot 23 Concession: 6

<p>Date: 1860s – 1890s</p> <p>Description: One and one half storey side gabled house with a steep roof pitch and centre gable, yellow brick exterior and undetermined foundation. Vernacular Gothic Revival design elements include symmetrical design, rounded central window extending into the steeply pitched centre gable, decorative rounded brick drip moulds over the gable window and central door, decorative quoin-like brickwork and open rake and eaves. Modern asphalt shingles, windows, doors and rear addition.</p> <p>Potential CHVI According to O. Reg. 9/06:</p> <p>1) Design or Physical Value: Representative of mid-19th century Vernacular Gothic Revival design, popular throughout southwestern Ontario.</p> <p>2) Historical or Associate Value: None identified.</p> <p>3) Contextual Value: None identified.</p> <p>Heritage Attributes: Symmetrical design; rounded central window extending into steeply pitched centre gable; decorative rounded brick drip moulds over gable window and central door; decorative quoin-like brickwork; open rake and eaves.</p>

<p>Potential Direct and Indirect Impacts to the Heritage Attributes: None anticipated.</p>	
<p>Mitigation of Negative Impacts: No negative impacts identified, therefore no further mitigation recommended.</p>

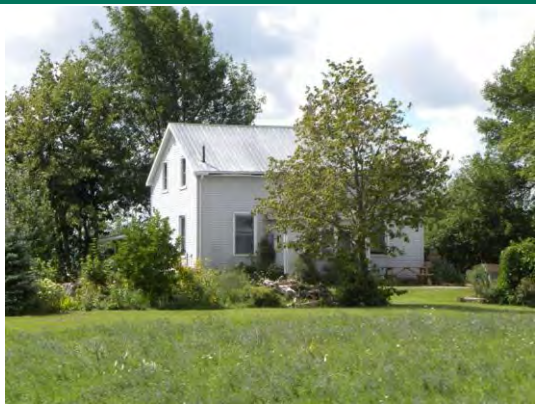
Site #2 – 1081 Bervie Side Road (Municipality of Kincardine)		Lot: Pt 25 Concession: 6

Date: 1860s – 1890s	Potential CHVI According to O. Reg. 9/06: 1) Design or Physical Value: None identified. 2) Historical or Associate Value: None identified. 3) Contextual Value: 19 th century construction supports the character of the surrounding vernacular rural landscape. Heritage Attributes: Relationship of structure to outbuilding and road.
	Description: One and one half storey side gabled house with a steep roof pitch, exterior clad in modern siding and stone foundation. Symmetrical in design with covered front entryway. Modern windows and metal roof.	
Potential Direct and Indirect Impacts to the Heritage Attributes: None anticipated.		
Mitigation of Negative Impacts: No negative impacts identified, therefore no further mitigation recommended.

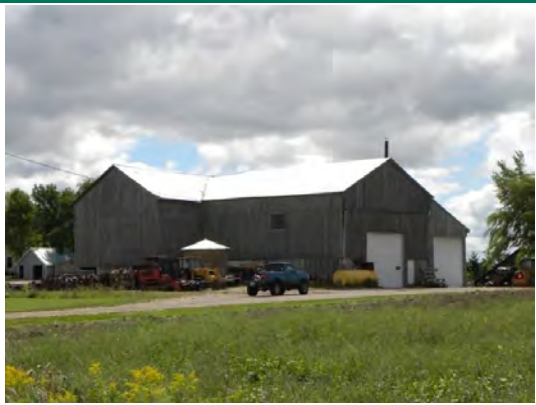
Date: 19 th – early 20 th century	Potential CHVI According to O. Reg. 9/06: 1) Design or Physical Value: 19 th – early 20 th century example of timber barn which, although common throughout the study area, is increasingly rare throughout the province. 2) Historical or Associate Value: None identified 3) Contextual Value: Supports the agricultural character of the surrounding vernacular rural landscape. Heritage Attributes: Timber frame construction. Relationship of structure to residence and road.

Description: Three-bay, gabled barn with metal roof, timber frame and stone foundation. Modern shed extension and implement storage entryway.	
Potential Direct and Indirect Impacts to the Heritage Attributes: None anticipated.		
Mitigation of Negative Impacts: No negative impacts identified, therefore no further mitigation recommended.

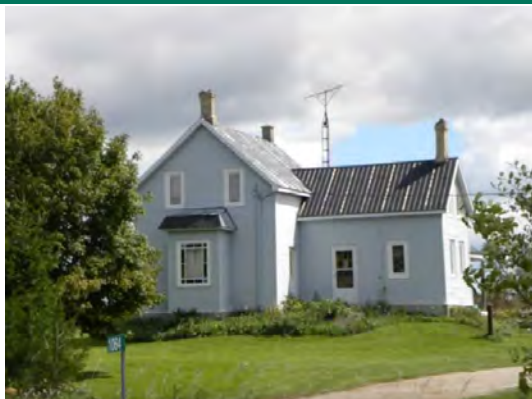
Site #3 – 1064 Bernie Side Road (Municipality of Kincardine)

Date: Undetermined (19th – early 20th century)

Description: One and one half storey L-shaped house with cross gabled roof with a medium pitch, exterior clad in modern siding over apparent brick exterior and concrete foundation. Front cross gable contains decorative stained glass and mansard roof. Modern metal roof with possible rear addition.

Mitigation of Negative Impacts: Impacts were not identified, therefore mitigation is not recommended or necessary.

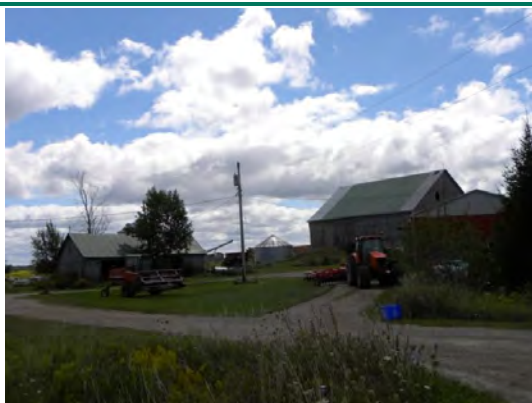
Date: Various (19th – 20th century)

Description: Primary barn is a raised three-bay barn with metal roof, timber frame and undetermined foundation. Additional buildings include a storage shed with metal roof, timber frame and undetermined foundation, metal bin and implement storage shed.

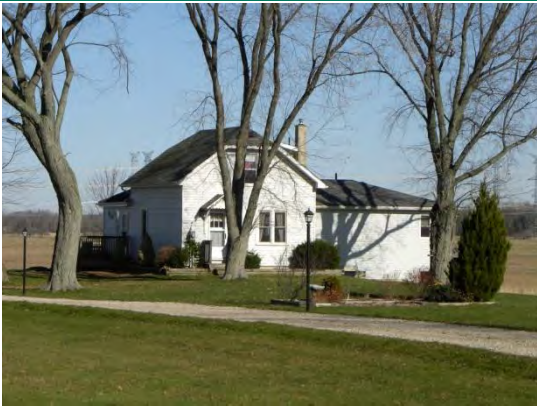
Site #4 – 544 Concession Road 2 (Municipality of Kincardine)		Lot: Pt 22 Concession: 3

Date: Undetermined (19 th – early 20 th century)	Potential CHVI According to O. Reg. 9/06: 1) Design or Physical Value: None identified. 2) Historical or Associate Value: None identified. 3) Contextual Value: None identified. Not determined to have cultural heritage value or interest.
	Description: One and one half storey pitched front hip-on-gable house with a medium roof pitch, exterior clad in modern siding and undetermined foundation. Vernacular design.	
Potential Direct and Indirect Impacts to the Heritage Attributes: CHVI was not identified, therefore impacts were not assessed.		
Mitigation of Negative Impacts: Impacts were not identified, therefore mitigation is not recommended or necessary.

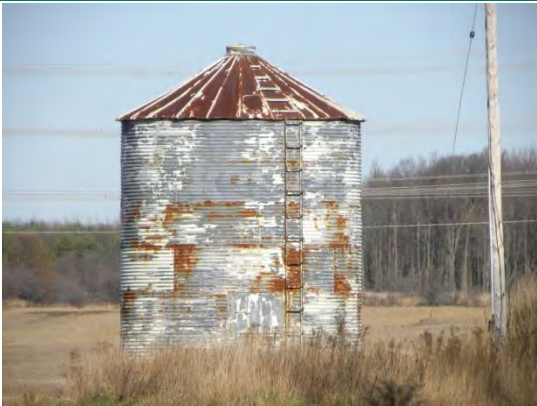
Date: 20 th century	Potential CHVI According to O. Reg. 9/06: 1) Design or Physical Value: None identified. 2) Historical or Associate Value: None identified. 3) Contextual Value: None identified. Not determined to have cultural heritage value or interest.

Description: Single corrugated metal bin.	
Potential Direct and Indirect Impacts to the Heritage Attributes: CHVI was not identified, therefore impacts were not assessed.		
Mitigation of Negative Impacts: Impacts were not identified, therefore mitigation is not recommended or necessary.

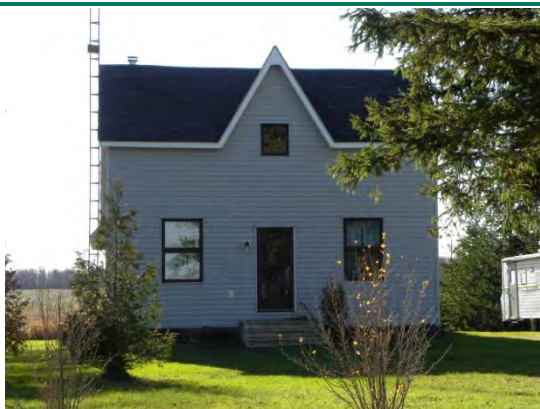
Lot: 31 Concession: 12

Date: 1860s – 1890s

Description: One and one half storey side gabled house with a steep roof pitch and centre gable, exterior clad in modern siding and undetermined concrete foundation. Vernacular Gothic Revival design elements include symmetrical design, central window extending into the steeply pitched centre gable. Modern windows and asphalt shingles.

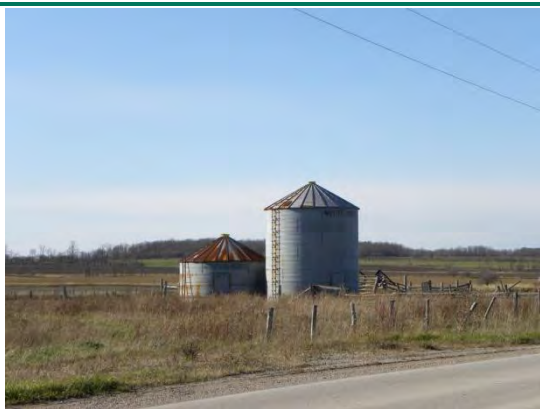
Date: 20th century

Description: Two corrugated metal bins of various sizes.

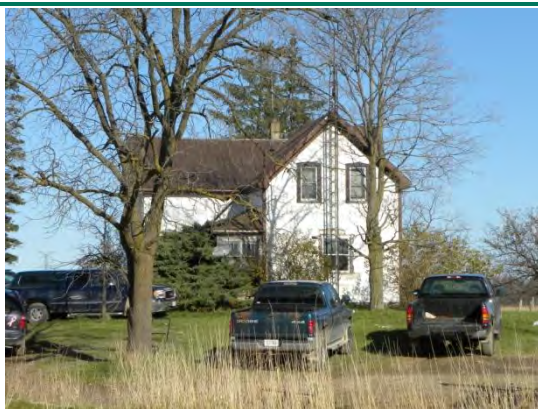
Lot: 30 Concession: 1

Date: 1890s – 1920s

Description: One and one half storey cross-gabled house with a medium roof pitch, exterior clad in modern siding and concrete block foundation. Asymmetrical in design with some modern windows, metal roof and small porch addition.

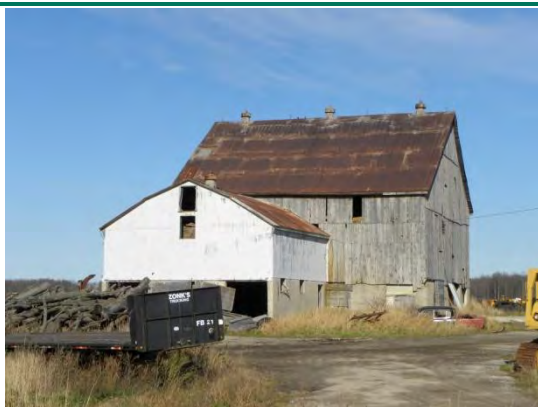
Date: Various (19th – 20th century)

Description: Raised three-bay barn with gambrel roof addition. Metal roofs on timber frames and mixed concrete foundations.

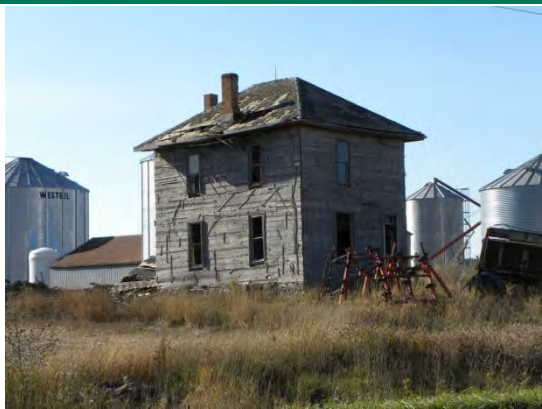
Site #7 – County Road 15 (Municipality of Kincardine)		Lot: 30 Concession: 12

Date: 1860s – 1890s	Potential CHVI According to O. Reg. 9/06:
	Description: Abandoned two storey hipped roof house with a low roof pitch, timber frame and exterior, and stone foundation. Vernacular four-square design with sash windows.	1) Design or Physical Value: Two storey construction with vernacular foursquare design relatively rare in the study area, although popular throughout southwestern Ontario. 2) Historical or Associate Value: None identified. 3) Contextual Value: None identified. Heritage Attributes: Two storey residence with vernacular foursquare design.
Potential Direct and Indirect Impacts to the Heritage Attributes: None anticipated.		
Mitigation of Negative Impacts: No negative impacts identified, therefore no further mitigation recommended.

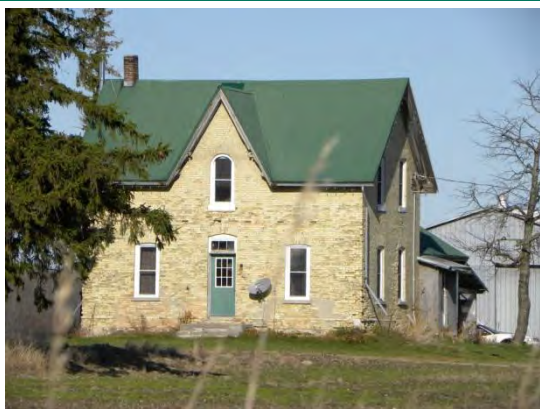
Lot: 26 Concession: 1

Date: 1860s – 1880s

Description: One and one half storey side gabled house with a steep roof pitch and prominent centre gable, yellow brick exterior and stone foundation. Vernacular Gothic Revival design elements include symmetrical design, central rounded window extending into the steeply pitched centre gable and remnants of decorative bargeboard. Rear addition, metal roof, and modern windows.

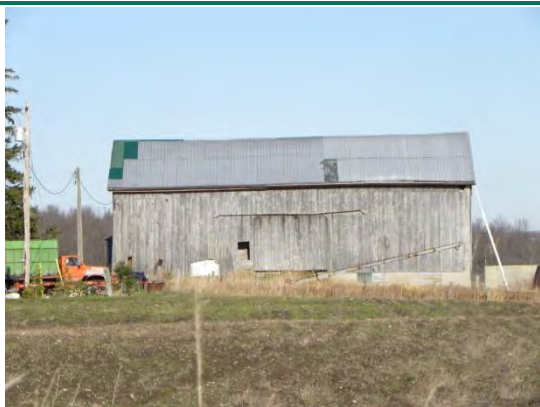
Date: 19th – early 20th century

Description: Raised three-bay barn with metal roof, timber frame and covered concrete foundation.

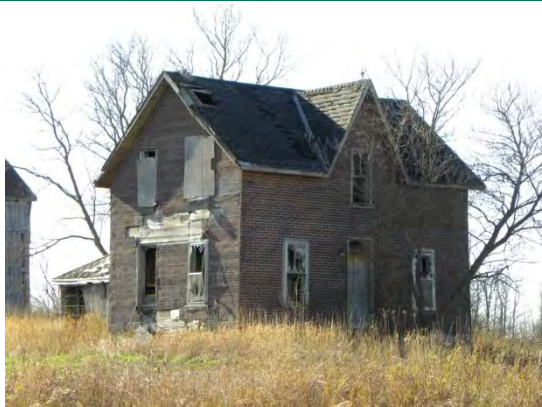
Site #9 – County Road 15 (Municipality of Kincardine)		Lot: 26 Concession: 12

Date: 1860s – 1880s	Potential CHVI According to O. Reg. 9/06: 1) Design or Physical Value: Representative of mid-19th century Vernacular Gothic Revival design, popular throughout southwestern Ontario. 2) Historical or Associate Value: None identified. 3) Contextual Value: Popular style of 19 th century construction supports the character of the surrounding vernacular rural landscape. Heritage Attributes: Symmetrical design; central window extending into steeply pitched centre gable; open rake. Relationship of structure to outbuilding and road.
	Description: Abandoned one and one half storey side gabled house with a steep roof pitch and prominent centre gable, asphalt brick siding exterior over timber frame and undetermined foundation. Vernacular Gothic Revival design elements include symmetrical design, central window extending into steeply pitched centre gable and open rake. Rear addition evident and asphalt shingle roof.

Potential Direct and Indirect Impacts to the Heritage Attributes: None anticipated.		
Mitigation of Negative Impacts: No negative impacts identified, therefore no further mitigation recommended.

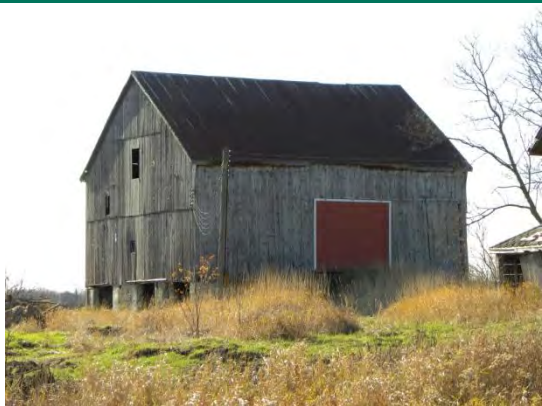
Date: 19 th – early 20 th century	Potential CHVI According to O. Reg. 9/06: 1) Design or Physical Value: 19 th century example of timber barn which, although common throughout the study area, is increasingly rare throughout the province. 2) Historical or Associate Value: None identified 3) Contextual Value: Supports the agricultural character of the surrounding vernacular rural landscape. Heritage Attributes: Timber frame construction. Relationship of structure to residence and road.
	Description: Raised three-bay barn with metal roof, timber frame and undetermined foundation.	
Potential Direct and Indirect Impacts to the Heritage Attributes: None anticipated.		
Mitigation of Negative Impacts: No negative impacts identified, therefore no further mitigation recommended.

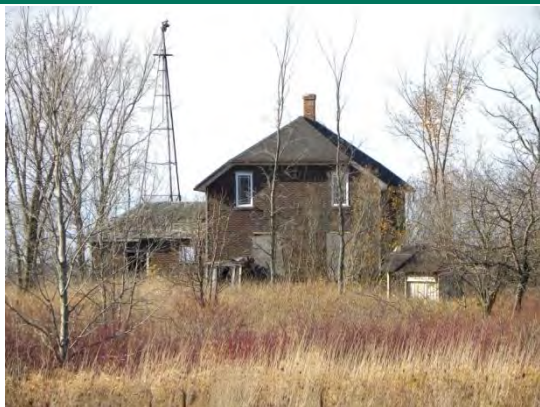
Site #10 – 1983 County Road 15 (Municipality of Kincardine)

Date: Undetermined (19th – early 20th century)

Description: Possibly abandoned, one and one half storey hip on gable house with a medium roof pitch, insulbrick siding over an apparent timber frame with an undetermined foundation. Some modern windows and asphalt shingles.

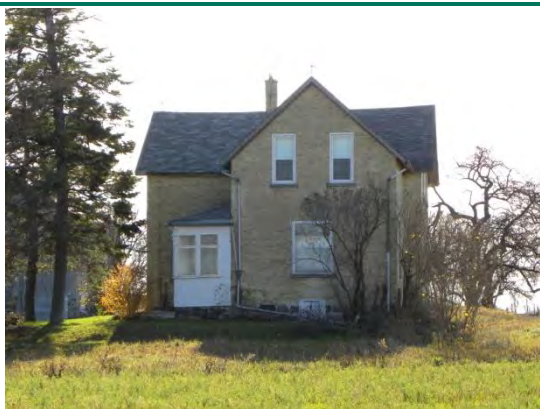
Site #11 – 1161 Concession Road 11 (Municipality of Kincardine)

Date: 1860s – 1890s

Description: Possibly abandoned one and one half storey cross-gabled house with a medium roof pitch, yellow brick exterior and stone foundation. Asymmetrical in design with minor Vernacular Gothic Revival design elements including remnants of brackets on porch. Modern windows, addition at rear and asphalt shingles.

Potential Direct and Indirect Impacts to the Heritage Attributes: None anticipated.

Mitigation of Negative Impacts: No negative impacts identified, therefore no further mitigation recommended.

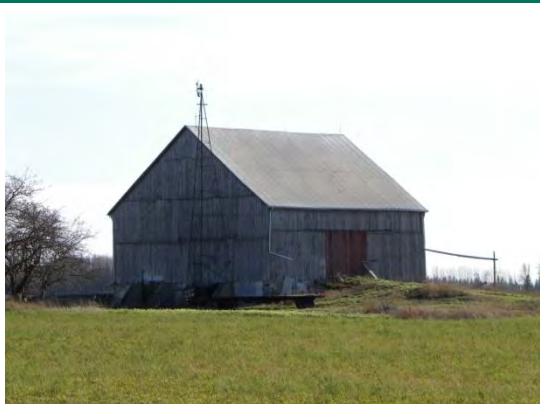
Date: 19th – early 20th century

Description: Raised three-bay barn with metal roof, timber frame and stone foundation.

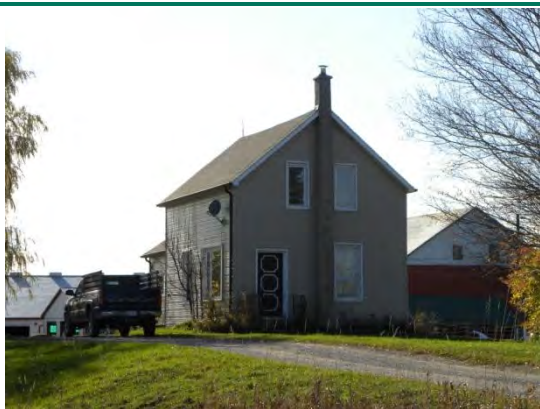
Site #12 – 873 Concession Road 11 (Municipality of Kincardine)

Date: Undetermined (19th – early 20th century)

Description: One and one half storey front gabled house with medium roof pitch, exterior clad in modern material and undetermined foundation. Addition at rear.

Potential Direct and Indirect Impacts to the Heritage Attributes: CHVI was not identified, therefore impacts were not assessed.

Mitigation of Negative Impacts: Impacts were not identified, therefore mitigation is not recommended or necessary.

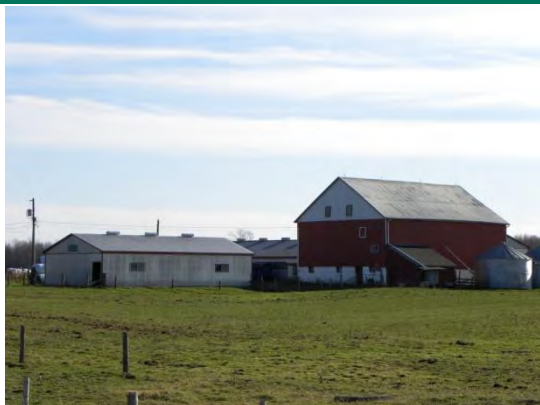
Date: Various (19th – 20th century)

Description: Barn complex with multiple structures. Primary building is a raised three-bay barn with side addition, metal roof, timber frame and likely concrete covered stone foundation.

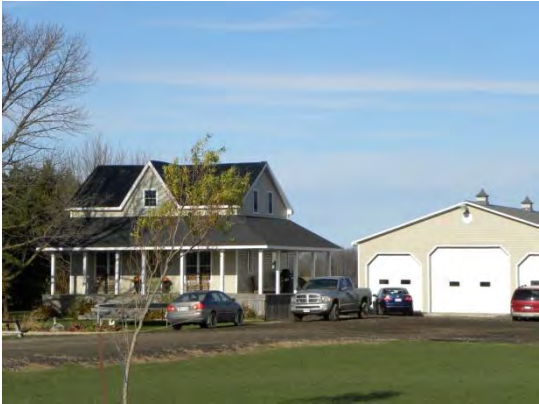
Site #13 – 554 Concession Road 11 (Municipality of Kincardine)	Lot: Pt 22 Concession: 11

<p>Date: 1860s – 1880s</p> <p>Description: One and one half storey side gabled house with a medium roof pitch and centre gable, exterior clad in modern siding and undetermined foundation. Vernacular Gothic Revival design elements include symmetrical design, central window originally extending into the steeply pitched centre gable. Modern windows, asphalt shingles and wrap-around porch.</p> <p>Potential CHVI According to O. Reg. 9/06: 1) Design or Physical Value: None identified. 2) Historical or Associate Value: None identified. 3) Contextual Value: None identified. Not determined to have cultural heritage value or interest.</p>
<p>Potential Direct and Indirect Impacts to the Heritage Attributes: CHVI was not identified, therefore impacts were not assessed.</p>	
<p>Mitigation of Negative Impacts: Impacts were not identified, therefore mitigation is not recommended or necessary.</p>

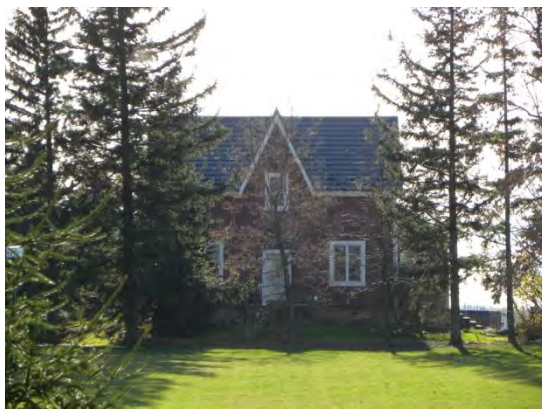
Site #14 – 425 Concession Road 11 (Municipality of Kincardine)	Lot: Pt 25 Concession:10

<p>Date: 1860s – 1880s</p> <p>Description: One and one half storey side gabled house with a steep roof pitch and prominent centre gable, undetermined siding exterior, possibly insulbrick, over timber frame and stone foundation. Vernacular Gothic Revival design elements include symmetrical design and central window extending into steeply pitched centre gable. Rear addition evident and modern metal or plastic shingle roof. Barn ruin at rear.</p> <p>Potential CHVI According to O. Reg. 9/06:</p> <p>1) Design or Physical Value: Representative of mid-19th century Vernacular Gothic Revival design, popular throughout southwestern Ontario.</p> <p>2) Historical or Associate Value: None identified.</p> <p>3) Contextual Value: None identified.</p> <p>Heritage Attributes: Symmetrical design and central window extending into steeply pitched centre gable.</p>

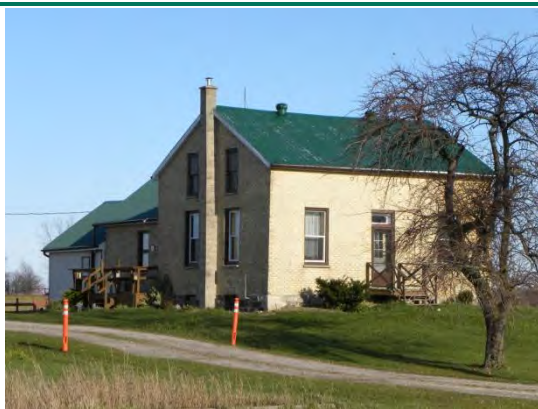
Site #15 – 336 Concession Road 11 (Municipality of Kincardine)

Date: 1860s – 1890s

Description: One and one half storey side gabled yellow brick house with low-medium roof pitch. Symmetrical in design with central doorway with transom flanked by single windows. Stone foundation. Modern addition at the rear as well as modern windows, doors, and metal roof.

Potential Direct and Indirect Impacts to the Heritage Attributes: None anticipated.

Mitigation of Negative Impacts: No negative impacts identified, therefore no further mitigation recommended.

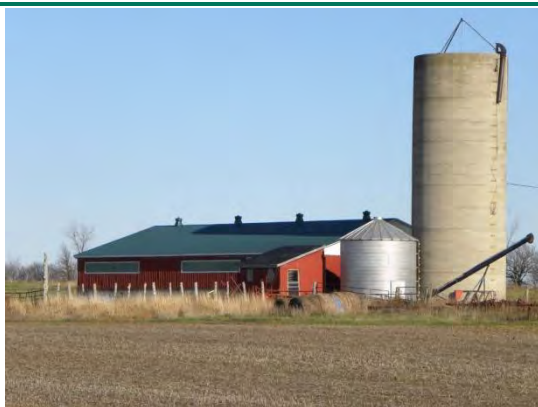
Date: 20th century

Description: Single storey barn with modern metal roof, timber frame with red painted siding and concrete foundation. One concrete silo and one metal bin on site.

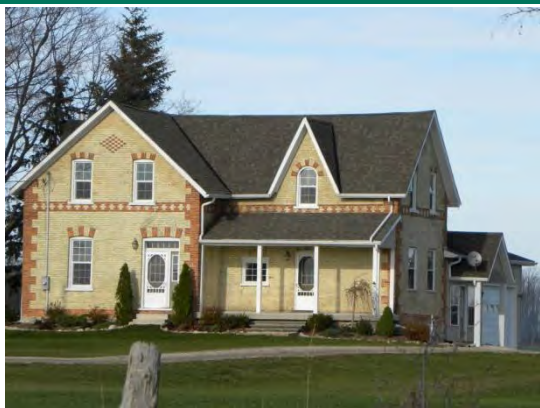
Site #16 – 108 Concession Road 11 (Municipality of Kincardine)

Date: 1860s – 1890s

Description: One and one half storey cross gabled yellow brick house with a steep roof pitch and multiple medium and steeply pitched cross gables. Stone foundation. Asymmetrical design appears to be a T-plan with Vernacular Gothic Revival influences including extensive polychromatic brick detailing. Modifications include extensive rear additions, modern windows, modern secondary doorway and asphalt shingles.

Potential Direct and Indirect Impacts to the Heritage Attributes: None anticipated.

Mitigation of Negative Impacts: No negative impacts identified, therefore no further mitigation recommended.

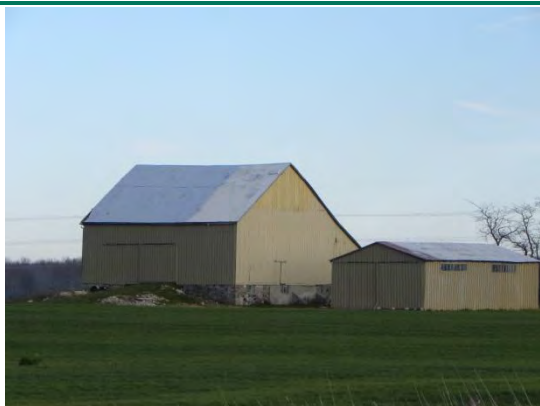
Date: 19th – early 20th century

Description: Raised three-bay barn with metal roof, a timber frame covered with modern metal siding, and stone foundation.

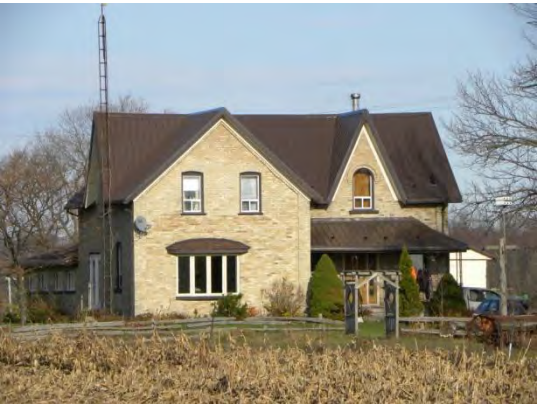
Site #17 – 64 Concession Road 11 (Municipality of Kincardine)	Lot: Pt 34 Concession: 11

<p>Date: 1860s – 1890s</p> <p>Description: One and one half storey cross gabled yellow brick house with a steep roof pitch and multiple medium and steeply pitched cross gables. Undetermined foundation. Asymmetrical design appears to be a T-plan with Vernacular Gothic Revival influences including central window with brick drip mould that extends into front gable and simple brick detailing along corners and cornices. Modifications include extensive rear addition, modern windows and addition of front bay window, metal roof and replacement chimney.</p> <p>Potential CHVI According to O. Reg. 9/06:</p> <p>1) Design or Physical Value: Representative of mid-19th century Vernacular Gothic Revival design, popular throughout southwestern Ontario.</p> <p>2) Historical or Associate Value: None identified.</p> <p>3) Contextual Value: None identified.</p> <p>Heritage Attributes: Asymmetrical design; central rounded window with brick drip mould that extends into steeply pitched front gable; simple brick detailing along corners and cornices.</p>

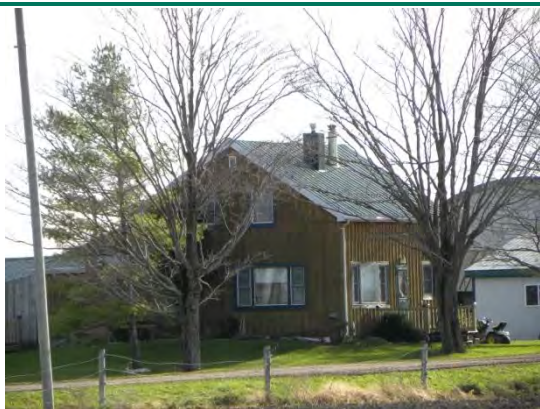
Site #18 – 345 Concession Road 9 (Municipality of Kincardine)

Date: Undetermined (19th – early 20th century)

Description: One and one half storey front gabled frame house with medium roof pitch, timber exterior and undetermined foundation. Addition at rear. Modern windows, exterior, and metal roof.

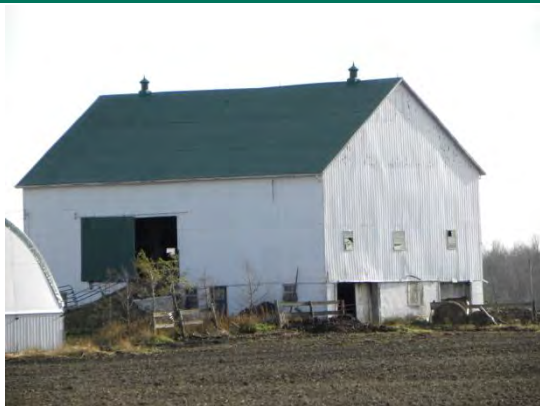
Date: 19th – early 20th century

Description: Raised three-bay barn with metal roof, timber frame clad in metal siding, concrete covered foundation.

Mitigation of Negative Impacts: No negative impacts identified, therefore no further mitigation recommended.

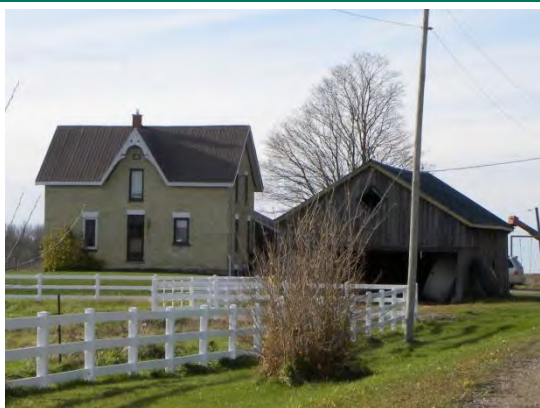
Site #19 – 3 Weber Sideroad (Municipality of Kincardine)

Date: c1900
(as indicated in centre gable)

Description: One and one half storey side gabled house with a steep roof pitch and prominent centre gable, yellow brick exterior and stone foundation. Vernacular Gothic Revival design elements include symmetrical design, central window extending into the steeply pitched centre gable, decorative bargeboard and open rake. Rear addition, metal roof, and modern windows.

Potential Direct and Indirect Impacts to the Heritage Attributes: None anticipated.

Mitigation of Negative Impacts: No negative impacts identified, therefore no further mitigation recommended.

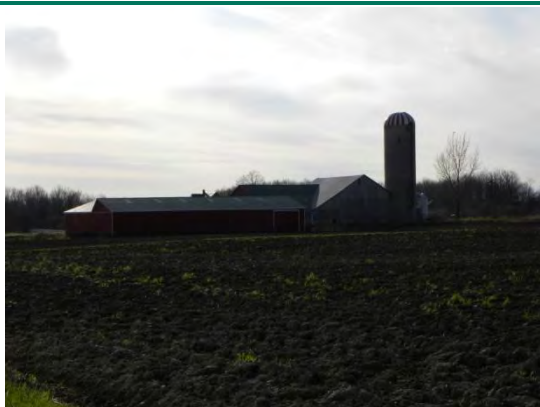
Date: Various (19th – 20th century)

Description: Two barn structures. Primary is three gable barn with mixed metal roof, timber frame and stone foundation. Secondary barn appears to be 20th construction with low pitch metal roof, undetermined siding and undetermined foundation. Concrete silos and metal bins present at rear.

Heritage Attributes: Timber frame construction on stone foundation. Relationship of structures to residence and road.

Mitigation of Negative Impacts: No negative impacts identified, therefore no further mitigation recommended.

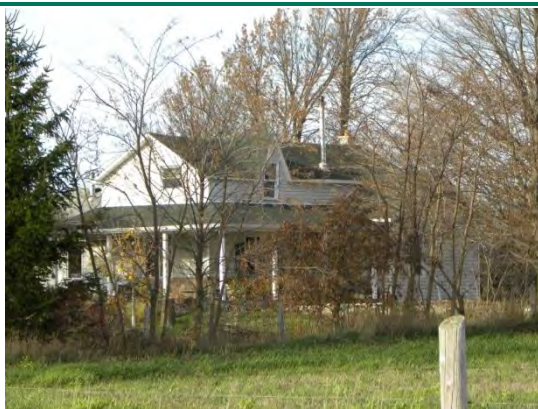
Site #20 – 874 Concession Road 9 (Municipality of Kincardine)

Date: Undetermined (Possibly 19th century)

Description: One and one half storey front gabled house with medium roof pitch and steep pitched side gable, exterior clad in modern material and undetermined foundation. Multiple additions, front wrap-around porch, modern windows and asphalt shingles.

Potential Direct and Indirect Impacts to the Heritage Attributes: CHVI was not identified, therefore impacts were not assessed.

Mitigation of Negative Impacts: Impacts were not identified, therefore mitigation is not recommended or necessary.

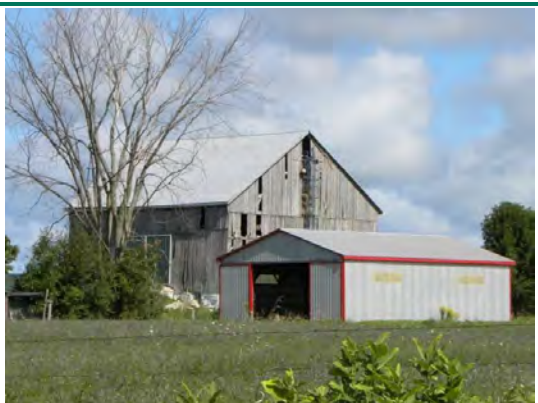
Date: Various (19th – 20th century)

Description: Raised three-bay barn with metal roof, timber frame and stone foundation.

Mitigation of Negative Impacts: No negative impacts identified, therefore no further mitigation recommended.

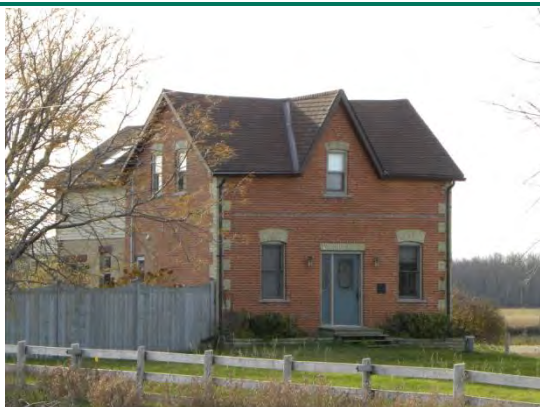
Site #21 – 911 Concession Road 9 (Municipality of Kincardine)

Date: 1860s – 1890s

Description: One and one half storey red brick side gabled house with a steep roof pitch, centre gable and undetermined foundation. Vernacular Gothic Revival design elements include symmetrical design, centre window extending into the steeply pitched centre gable and quoin like brick detailing. Modern windows, doors, extensive rear addition and asphalt shingles.

Mitigation of Negative Impacts: No negative impacts identified, therefore no further mitigation recommended.

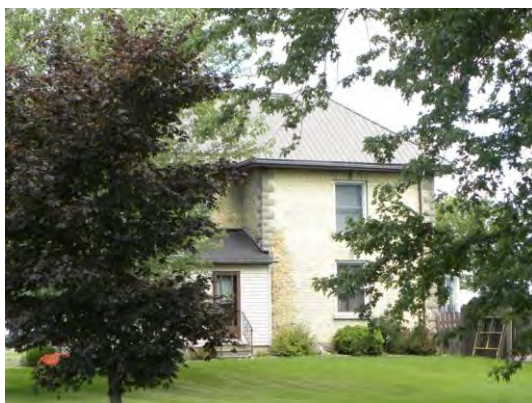
Site #22 – 658 North Line (Municipality of Kincardine)

Date: 1890s – 1920s

Description: Two storey hipped roof house with cross-hipped projection, medium pitch and yellow brick exterior on concrete foundation. Decorative brick work above windows with concrete keystone. Rusticated concrete block quoins. Modern front porch addition and metal roof.

Heritage Attributes: Two storey residence; rusticated concrete block quoins and window keystones. Relationship of structure to outbuildings and road.

Potential Direct and Indirect Impacts to the Heritage Attributes: None anticipated.

Mitigation of Negative Impacts: No negative impacts identified, therefore no further mitigation recommended.

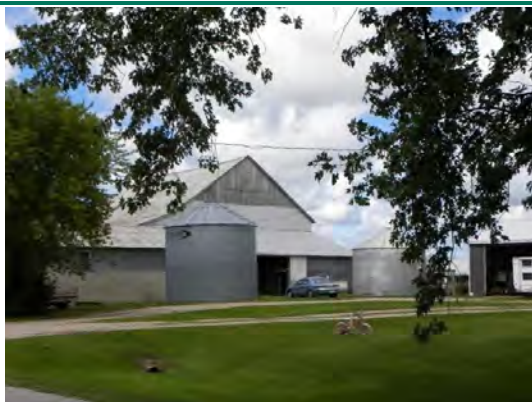
Date: Various (19th – 20th century)

Description: Barn complex with multiple structures. Primary structure appears to be a raised three-bay barn with multiple shed additions, a metal roof, timber frame and undetermined foundation.

Mitigation of Negative Impacts: No negative impacts identified, therefore no further mitigation recommended.
