Armow Wind Project

HERITAGE ASSESSMENT REPORT

SP Ontario Armow Wind Energy Project Various Communities, Municipality of Kincardine Bruce County, Ontario

Report Number: 11-1151-0247-4000-R01

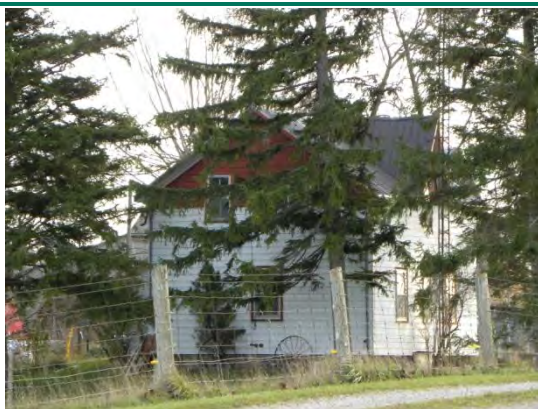
Site #24 – 323 Concession Road 7 (Municipality of Kincardine)

Date: 1880s – 1890s

Description: One and one half storey front gabled house with medium roof pitch, steep side gable, exterior clad in modern siding and a stone foundation.

Potential Direct and Indirect Impacts to the Heritage Attributes: None anticipated.

Mitigation of Negative Impacts: No negative impacts identified, therefore no further mitigation recommended.

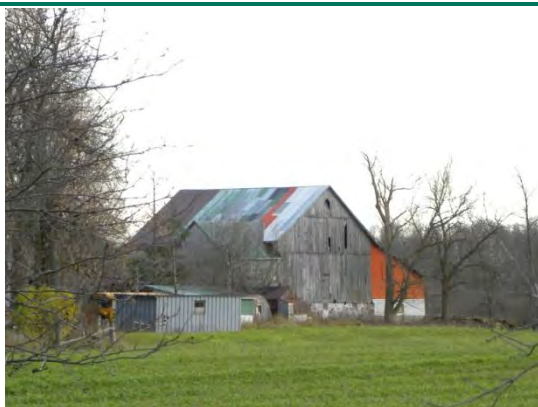
Date: 19th – early 20th century

Description: Raised three bay barn with front gable addition, metal roof, timber frame and stone foundation.

Mitigation of Negative Impacts: No negative impacts identified, therefore no further mitigation recommended.

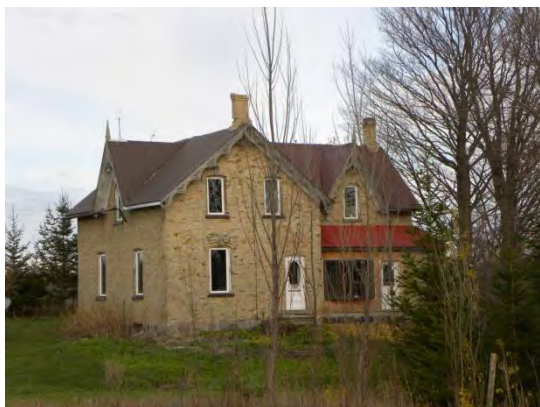
Site #25 – 324 Concession Road 7 (Municipality of Kincardine)

Date: 1860s – 1890s

Description: One and one half storey cross gabled yellow brick house with a steep roof pitch and multiple medium and steep pitched cross gables, stone foundation. Asymmetrical design appears to be a T-plan with Vernacular Gothic Revival influences including central window with brick drip mould containing decorative concrete keystone and decorative bargeboard featuring large finials. Modifications include small front porch addition, modern windows and metal roof.

Potential Direct and Indirect Impacts to the Heritage Attributes: None anticipated.

Mitigation of Negative Impacts: No negative impacts identified, therefore no further mitigation recommended.

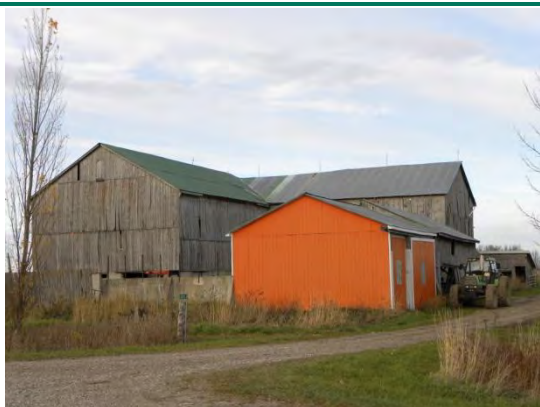
Date: Various (19th – 20th century)

Description: Three gable barn metal roof, timber frame and undetermined foundation. Apparent shed addition attached to primary barn and more modern implement storage shed with metal roof, metal siding on a timber frame and undetermined foundation.

Mitigation of Negative Impacts: No negative impacts identified, therefore no further mitigation recommended.

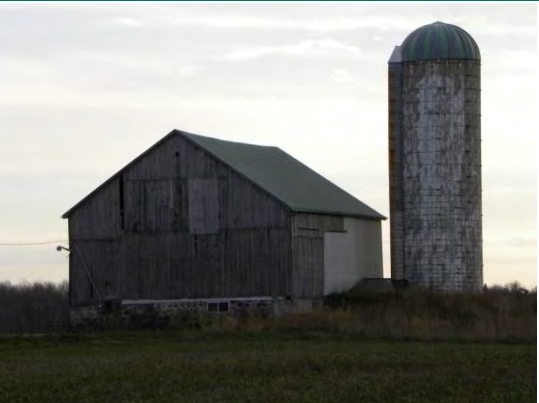
Site #26 – 217 Concession Road 7 (Municipality of Kincardine)		Lot: Pt 30 Concession: 6

Date: 19 th century	Potential CHVI According to O. Reg. 9/06: 1) Design or Physical Value: 19 th century example of timber barn which, although common throughout the study area, is increasingly rare throughout the province. 2) Historical or Associate Value: None identified 3) Contextual Value: Supports the agricultural character of the surrounding vernacular rural landscape. Heritage Attributes: Timber frame construction on a stone foundation. Relationship of structures to field patterns and road.
	Description: Raised three-bay barn with metal roof, timber frame and stone foundation with concrete silo at rear.	
Potential Direct and Indirect Impacts to the Heritage Attributes: None anticipated.		
Mitigation of Negative Impacts: No negative impacts identified, therefore no further mitigation recommended.

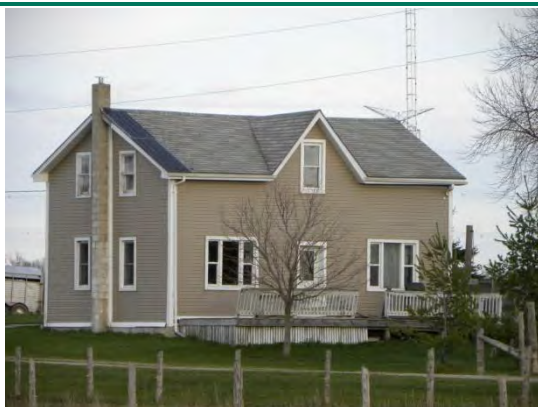
Site #27 – 104 Concession Road 7 (Municipality of Kincardine)

Date: 1860s – 1890s

Description: One and one half storey low pitch side gabled house with low pitched centre gable, exterior clad in modern siding and undermined foundation. Symmetrical in design. Modern windows, doors and asphalt shingles.

Potential Direct and Indirect Impacts to the Heritage Attributes: None anticipated.

Mitigation of Negative Impacts: No negative impacts identified, therefore no further mitigation recommended.

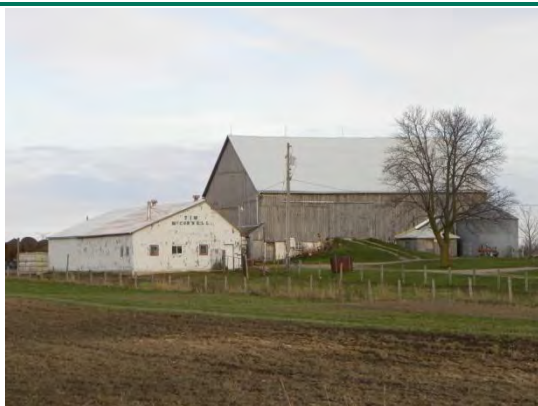
Date: Various (19th – 20th century)

Description: Raised barn with metal roof, timber frame and covered concrete foundation. One metal bin and one concrete bin apparent. Timber and additional outbuilding on site.

Mitigation of Negative Impacts: No negative impacts identified, therefore no further mitigation recommended.

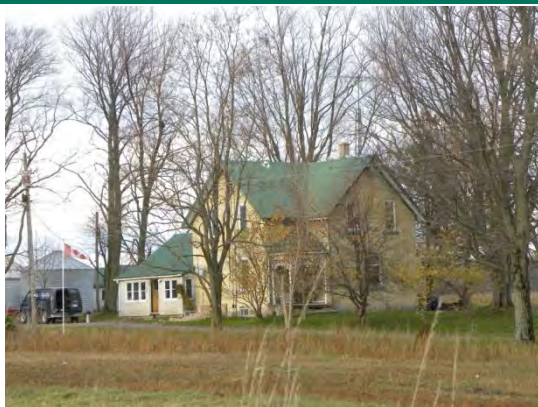
Site #28 – 1693 Sideroad 30 (Municipality of Kincardine)

Date: 1860s – 1890s

Description: One and one half storey cross gabled house with a medium roof pitch and L-shaped plan, yellow brick exterior and stone foundation. Corner porch with decorative bargeboard. Modern metal roof, window and rear addition exterior clad in modern siding. Prominent treed driveway.

Mitigation of Negative Impacts: No negative impacts identified, therefore no further mitigation recommended.

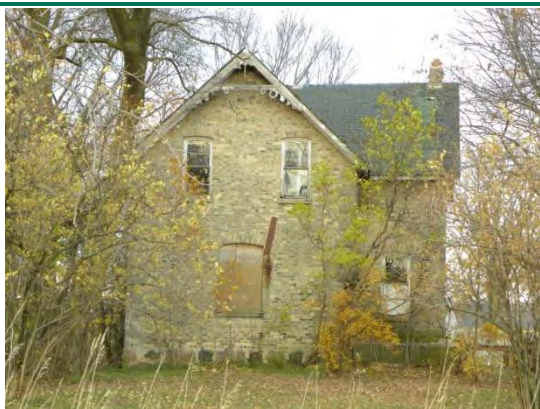
Site #29 – 272 Concession Road 5 (Municipality of Kincardine)

Date: 1860s – 1890s

Description: Abandoned one and one half storey cross gabled house with a steep roof pitch and medium front gable, yellow brick exterior on stone foundation. Vernacular Gothic Revival design elements include asymmetrical design and remnants of decorative bargeboard with crossbracing. Residence abuts a modern house.

Mitigation of Negative Impacts: No negative impacts identified, therefore no further mitigation recommended.

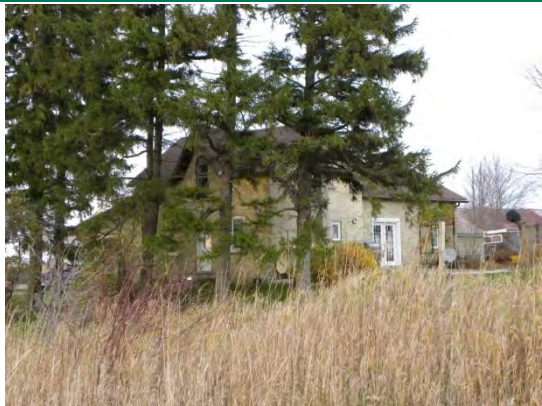
Site #30 – 356 Concession Road 5 (Municipality of Kincardine)		Lot: Pt 27 Concession: 5

Date: 1860s – 1890s	Potential CHVI According to O. Reg. 9/06:
	Description: One and one half storey side gabled house with a medium roof pitch and centre gabled, yellow brick exterior and stone foundation. Vernacular Gothic Revival design elements include symmetrical design, rounded central window extended into the centre gable with a steep pitch and open rake. Modern windows and side rear addition.	1) Design or Physical Value: Representative of mid-19 th century Vernacular Gothic Revival design, popular throughout southwestern Ontario. 2) Historical or Associate Value: None identified. 3) Contextual Value: None identified. Heritage Attributes: Symmetrical design; rounded central window extending into centre gable with steep pitch and open rake.
Potential Direct and Indirect Impacts to the Heritage Attributes: None anticipated.

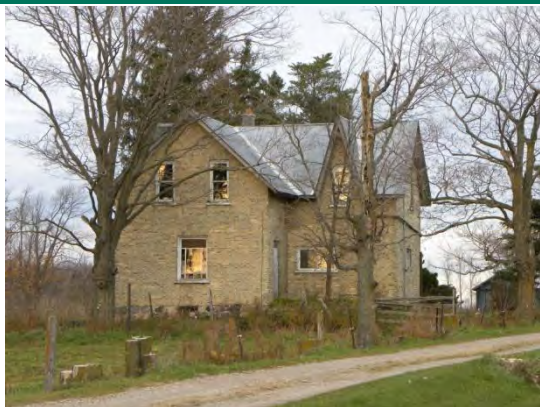
Site #31 – 568 Concession Road 5 (Municipality of Kincardine)

Date: 1860s – 1890s

Description: Possibly abandoned, one and one half storey cross gabled yellow brick house with a steep roof pitch and stone foundation. Asymmetrical design appears to be a T-plan with Vernacular Gothic Revival influences including rounded central window and steep pitched dormer. Modern metal and asphalt shingles.

Potential Direct and Indirect Impacts to the Heritage Attributes: None anticipated.

Mitigation of Negative Impacts: No negative impacts identified, therefore no further mitigation recommended.

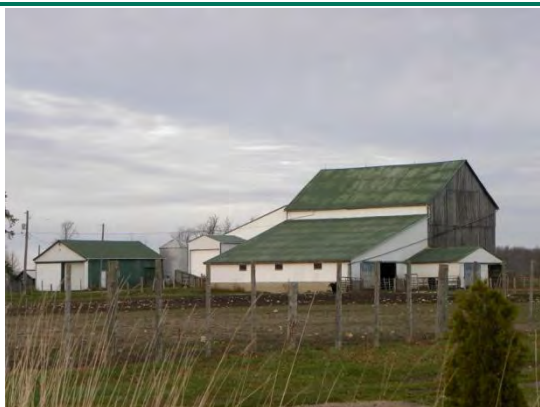
Date: Various (19th – 20th century)

Description: Multiple barns. Primary appears to be a raised three bay barn with metal roof, timber frame and undetermined foundation. 20th century shed addition with metal addition, timber frame clad in metal siding and concrete foundation.

Mitigation of Negative Impacts: No negative impacts identified, therefore no further mitigation recommended.

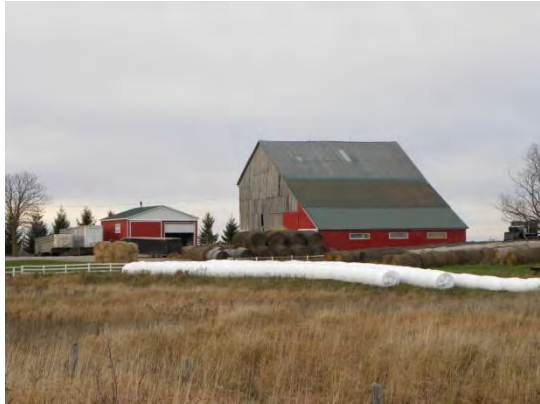
Site #32 – 598 Concession Road 5 (Municipality of Kincardine)	Lot: Pt 21 Concession: 5

<p>Date: Various (19th – 20th century)</p> <p>Description: Raised three-bay barn with metal roof, timber frame and undetermined foundation. 20th century shed addition with metal roof, red metal siding and undetermined foundation.</p> <p>Potential CHVI According to O. Reg. 9/06:</p> <p>1) Design or Physical Value: 19th – early 20th century example of timber barn which, although common throughout the study area, is increasingly rare throughout the province.</p> <p>2) Historical or Associate Value: None identified</p> <p>3) Contextual Value: Supports the agricultural character of the surrounding vernacular rural landscape.</p> <p>Heritage Attributes: Timber frame construction. Relationship of structures to field patterns and road.</p>
<p>Potential Direct and Indirect Impacts to the Heritage Attributes: None anticipated.</p>

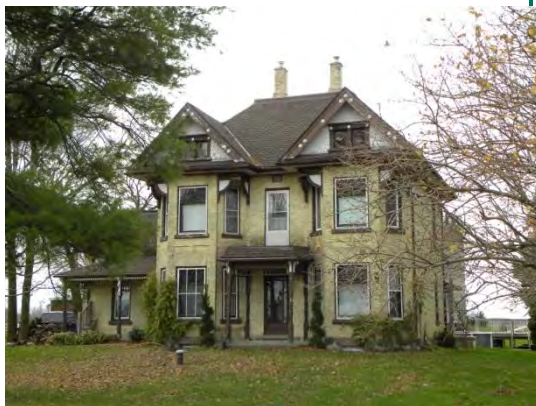
Site #33 – 735 Concession Road 5 (Municipality of Kincardine)

Date: c1902 (As indicated above door)

Description: Two storey hipped roof house with paired gables and medium roof pitch. Yellow brick exterior on a stone foundation. Vernacular Gothic Revival characteristics include symmetrical front facade, gables with fish scale detailing extend to create projecting wings, intricate brickwork throughout, bracketed window tops on second storey, open rake, simple decorative bargeboards, brackets along roof and front porch, paired chimneys. One and one half storey side gable addition.

Mitigation of Negative Impacts: No negative impacts identified, therefore no further mitigation recommended.

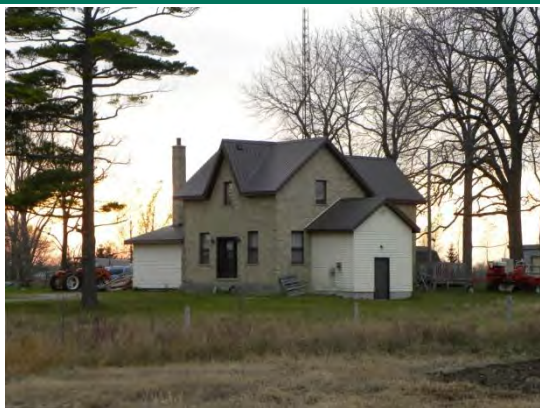
Site #34 – 339 Sideroad 15 (Municipality of Kincardine)

Date: 1860s – 1890s

Description: One and one half storey side gabled house with a medium roof pitch and centre gable, yellow brick exterior and concrete block foundation. Vernacular Gothic Revival design elements include symmetrical design, central window extending into the steeply pitched centre gable and quoin-like brick work. Modern windows, metal roof and multiple modern additions. Various outbuildings on site.

Mitigation of Negative Impacts: No negative impacts identified, therefore no further mitigation recommended.

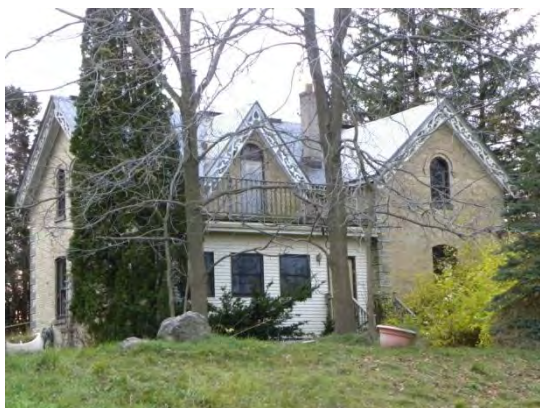
Site #35 – 919 Concession Road 5 (Municipality of Kincardine)

Date: 1860s – 1890s

Description: One and one half storey cross gabled house with steep roof pitch and prominent central gable, metal roof, yellow brick exterior and possible stone foundation. Vernacular Gothic Revival characteristics include asymmetrical design, decorated bargeboard, concrete block quoins and rounded windows with brick Italianate influenced hood moulds. Front porch likely original, but has been covered with modern siding. Modern metal roof and some windows.

Mitigation of Negative Impacts: No negative impacts identified, therefore no further mitigation recommended.

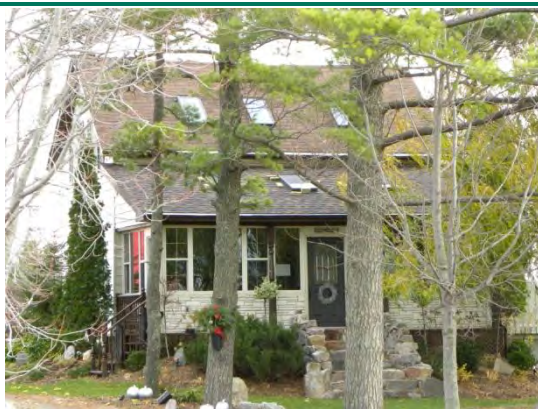
Site #36 – 432 Concession Road 9 (Municipality of Kincardine)

Date: 19th century

Description: One and one half storey side gabled house with medium to steep roof pitch, exterior clad in modern siding and undetermined foundation. Symmetrical in design. Extensive extension at rear and covered porch addition on the front facade.

Potential Direct and Indirect Impacts to the Heritage Attributes: None anticipated.

Mitigation of Negative Impacts: No negative impacts identified, therefore no further mitigation recommended.

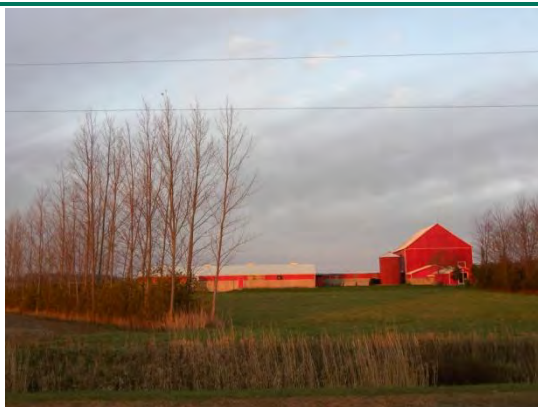
Date: Various (19th – 20th century)

Description: Multi-barn complex. Primary barn appears to be raised three-bay barn with metal roof, red painted siding on a timber frame and undetermined, possibly concrete, foundation. Single storey livestock barns at side and multiple small sheds at front. Single apparent metal bin on site.

Mitigation of Negative Impacts: No negative impacts identified, therefore no further mitigation recommended.

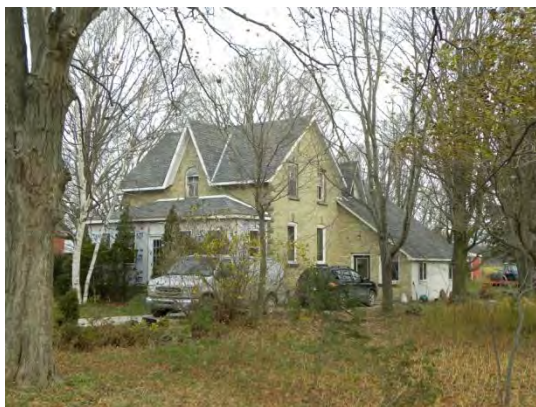
Site #37 – 546 North Line (Municipality of Kincardine)

Date: 1890s – 1920s

Description: One and one half storey side gabled house with a steep to medium roof pitch and centre gable, yellow brick exterior and mixed concrete and stone foundation. Vernacular Gothic Revival design elements include symmetrical design, rounded central window extending into the steeply pitched centre gable and rusticated concrete block quoins. Some modern windows, asphalt shingles, covered front porch and rear addition.

Heritage Attributes: Symmetrical design; rounded central window extending into steeply pitched centre gable; rusticated concrete block quoins. Relationship of structure to outbuildings and road.

Potential Direct and Indirect Impacts to the Heritage Attributes: None anticipated.

Mitigation of Negative Impacts: No negative impacts identified, therefore no further mitigation recommended.

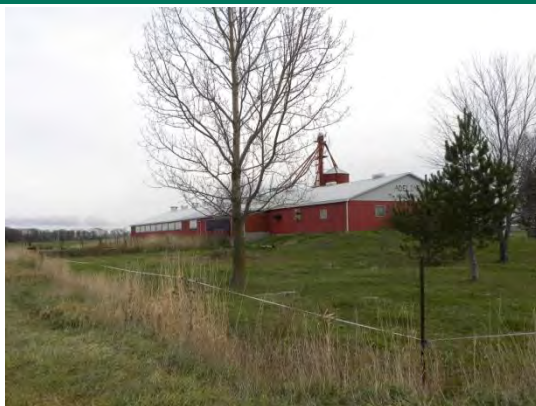
Date: 20th century

Description: Multiple barn complex. Apparent livestock operation with single storey barn structures with metal roofs, metal siding, and concrete foundations. Multiple metal bins on site.

Mitigation of Negative Impacts: No negative impacts identified, therefore no further mitigation recommended.

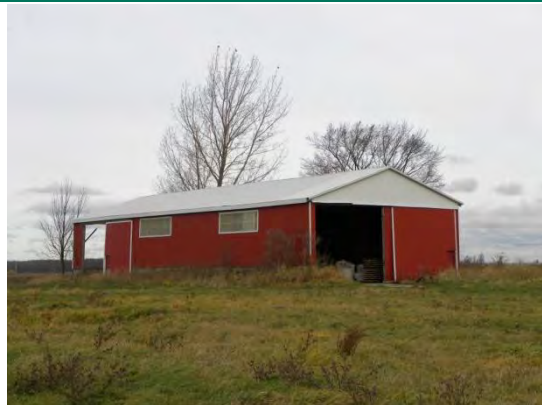
Site #38 – 547 North Line (Municipality of Kincardine)		Lot: Pt 53 and 54 Concession: 3 NDR

Date: 20 th century	Potential CHVI According to O. Reg. 9/06: 1) Design or Physical Value: None identified. 2) Historical or Associate Value: None identified. 3) Contextual Value: None identified. Not determined to have cultural heritage value or interest.
	Description: Implement storage shed with metal roof, metal siding and concrete foundation.	
Potential Direct and Indirect Impacts to the Heritage Attributes: CHVI was not identified, therefore impacts were not assessed.		
Mitigation of Negative Impacts: Impacts were not identified, therefore mitigation is not recommended or necessary.

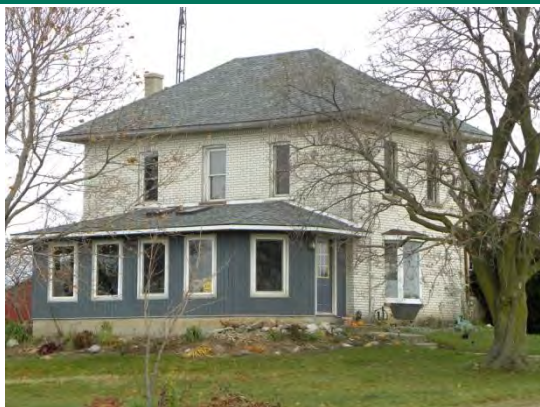
Site #39 – 604 North Line (Municipality of Kincardine)

Date: 1890s – 1920s

Description: Two storey hipped roof house with a medium pitch, unidentified brick frame and apparent concrete foundation. Symmetrical facade, rectangular design, full width front porch (although modified), and central window flanked by smaller single windows with rusticated concrete (possibly stone) block keystones.

Heritage Attributes: Symmetrical front facade; rectangular design; rusticated concrete (possibly stone) block keystones in smaller windows. Two storey construction.

Potential Direct and Indirect Impacts to the Heritage Attributes: None anticipated.

Mitigation of Negative Impacts: No negative impacts identified, therefore no further mitigation recommended.

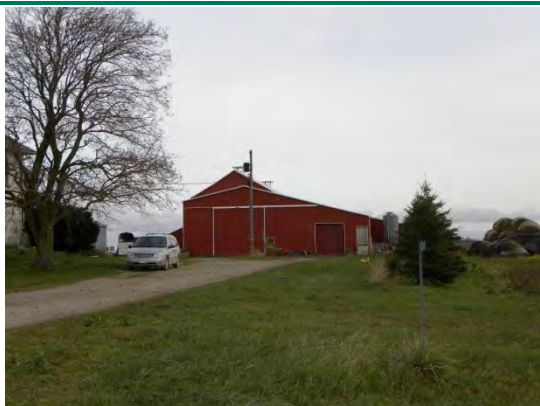
Date: 20th century

Description: Single storey shed with unidentified barn at rear. Both have metal roofs, apparent metal siding and undetermined foundations.

Mitigation of Negative Impacts: Impacts were not identified, therefore mitigation is not recommended or necessary.

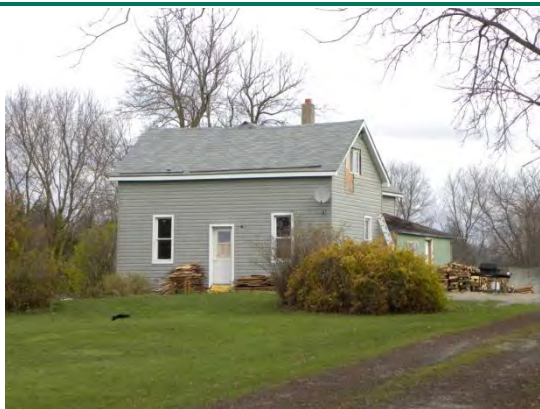
Site #40 – 860 North Line (Municipality of Kincardine)

Date: Undetermined (19th – early 20th century)

Description: One and one half storey side gabled house with a medium -steep roof pitch, exterior clad in modern siding and an undetermined foundation. Symmetrical in design with rear and side addition, modern windows, modern chimney and asphalt shingles.

Potential Direct and Indirect Impacts to the Heritage Attributes: CHVI was not identified, therefore impacts were not assessed.

Mitigation of Negative Impacts: Impacts were not identified, therefore mitigation is not recommended or necessary.

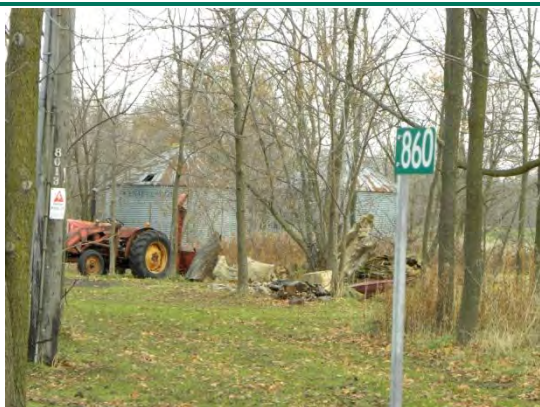
Date: 20th century

Description: Two metal bins on site and unidentified structure at rear, possibly barn ruin.

Mitigation of Negative Impacts: No negative impacts identified, therefore no further mitigation recommended.

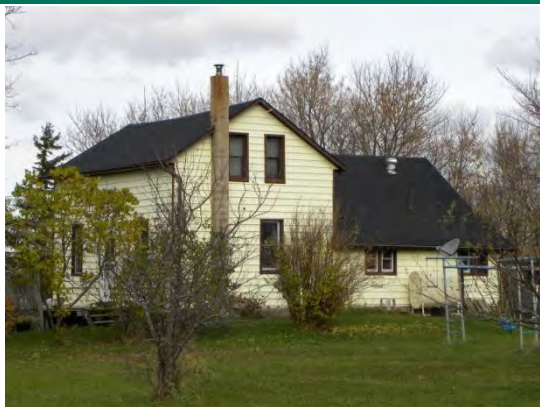
Site #41 – 900 North Line (Municipality of Kincardine)

Date: Undetermined (19th – early 20th century)

Description: One and one half storey side gabled house with medium roof pitch, exterior clad in modern siding and undetermined foundation. Symmetrical in design. Extensive addition at rear, modern windows, chimney and asphalt shingles.

Mitigation of Negative Impacts: Impacts were not identified, therefore mitigation is not recommended or necessary.

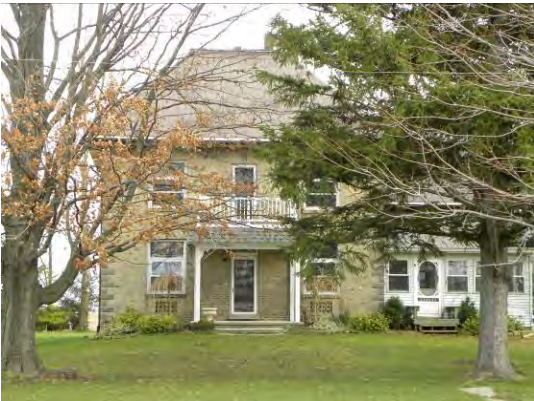
Site #42 – 982 North Line (Municipality of Kincardine)	Lot: Pt 33 Concession: 3 NDR

<p>Date: 1890s – 1920s</p> <p>Description: Two storey hipped roof house with side gable, steep roof pitch, yellow brick exterior and stone foundation. Symmetrical rectangular design, small entry porch, apparent decorative cornices and rusticated concrete block quoins. Other design elements include decorative brackets, window coverings featuring key stones and decorative brick work below the first storey windows. Rear and side porch addition.</p> <p>Potential CHVI According to O. Reg. 9/06:</p> <p>1) Design or Physical Value: Two storey construction relatively rare in the study area, although popular throughout southwestern Ontario.</p> <p>2) Historical or Associate Value: Suggestive of an era of rural prosperity.</p> <p>3) Contextual Value: None identified.</p> <p>Heritage Attributes: Two storey residence; symmetrical design; small entry porch; decorative cornices; rusticated concrete block quoins; decorative brackets; keystone window coverings; decorative brickwork below first storey windows.</p>

<p>Potential Direct and Indirect Impacts to the Heritage Attributes: None anticipated.</p>	
<p>Mitigation of Negative Impacts: No negative impacts identified, therefore no further mitigation recommended.</p>

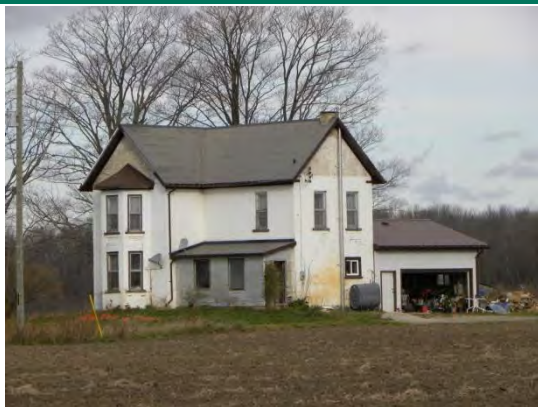
Site #43 – 728 North Line (Municipality of Kincardine)

Date: 1890s – 1920s

Description: Two storey cross gabled house with steep roof pitch, painted brick exterior and undetermined foundation. L-shaped plan with prominent two storey bay window in front gable. Modifications include modern siding, covered front porch, rear garage addition, some modern windows and metal roof.

Mitigation of Negative Impacts: No negative impacts identified, therefore no further mitigation recommended.

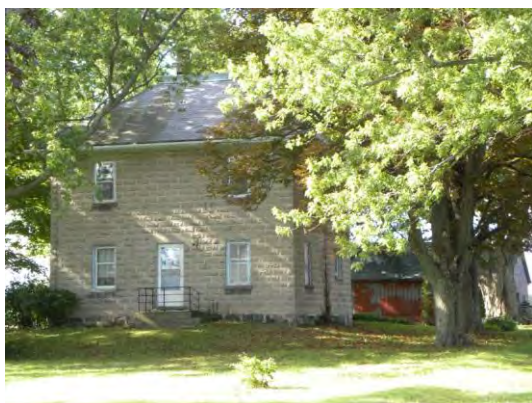
Site #44 – 2025 County Road 15 (Municipality of Kincardine)

Date: 1890s – 1920s

Description: Two storey, four square, hipped roof house with a medium pitch and asphalt shingles, rusticated concrete block exterior and stone foundation. Symmetrical in design with double hung windows, cement sills and drip-mould like cement work.

Heritage Attributes: Two storey residence; foursquare, symmetrical design; rusticated concrete block exterior; double hung windows; cement sills; drip-mould like cement work. Relationship of structure to outbuildings and road.

Mitigation of Negative Impacts: No negative impacts identified, therefore no further mitigation recommended.

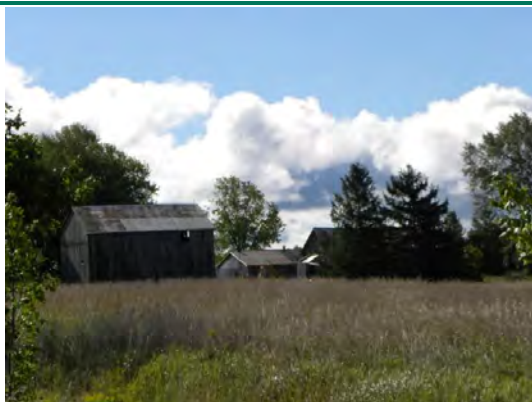
Date: 19th – early 20th century

Description: Two barns. Primary is a raised three-bay barn with metal roof on a timber frame and concrete (possibly over stone) foundation. Secondary appears to be an English barn with a metal roof on a timber frame and undetermined foundation with a third gable addition.

Mitigation of Negative Impacts: No negative impacts identified, therefore no further mitigation recommended.

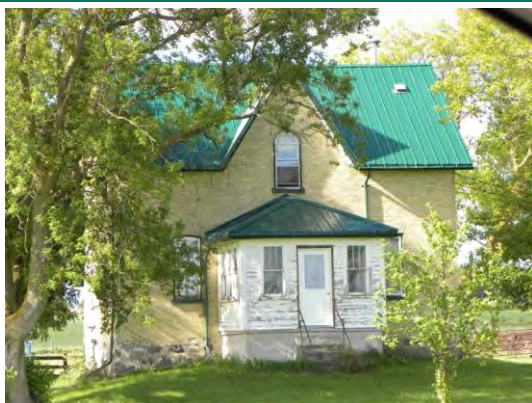
Site #45 – 1637 County Road 15 (Municipality of Kincardine)

Date: 1860s – 1890s

Description: One and one half storey side gabled house with a steep roof pitch and centre gable, yellow brick exterior and mixed concrete and stone foundation. Vernacular Gothic Revival design elements include symmetrical design, rounded central window extending into the steeply pitched centre gable and small central porch. Modern metal roof. Front porch likely contemporary addition.

Mitigation of Negative Impacts: No negative impacts identified, therefore no further mitigation recommended.

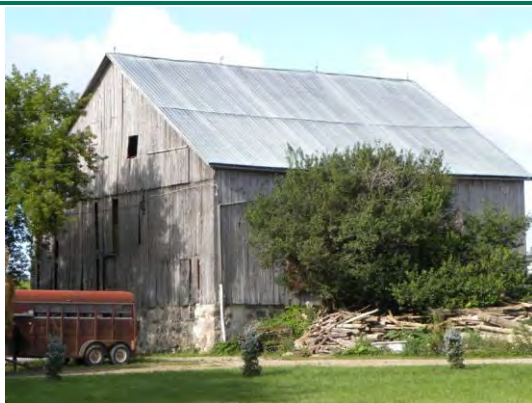
Date: 19th – early 20th century

Description: Raised three-bay barn with metal roof, timber frame and stone foundation.

Heritage Attributes: Timber frame construction on stone foundation. Relationship of structure to residence and road.

Mitigation of Negative Impacts: No negative impacts identified, therefore no further mitigation recommended.

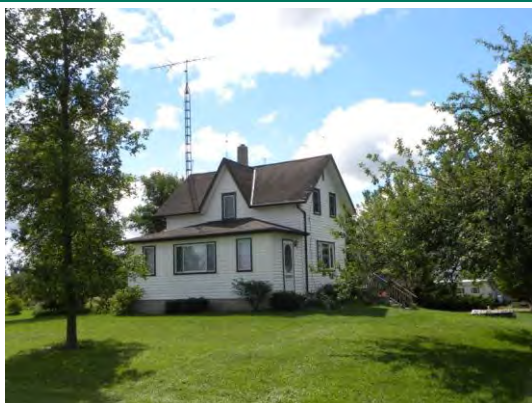
Site #46 – 341 Concession Road 7 (Municipality of Kincardine)

Date: 1860s – 1890s

Description: One and one half storey side gabled house with a steep roof pitch and centre gable, exterior clad in modern siding and concrete block foundation beneath front porch. Vernacular Gothic Revival design elements include symmetrical design, central window extending into the steeply pitched centre gable and full central porch. Modern asphalt shingles, rear addition and covered front porch.

Mitigation of Negative Impacts: No negative impacts identified, therefore no further mitigation recommended.

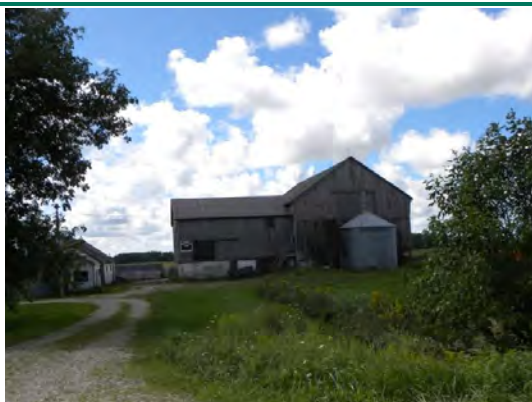
Date: 19th – early 20th century

Description: Three-gable barn with metal roof, timber frame and apparent concrete covered foundation. Metal silo located adjacent to barn.

Mitigation of Negative Impacts: No negative impacts identified, therefore no further mitigation recommended.

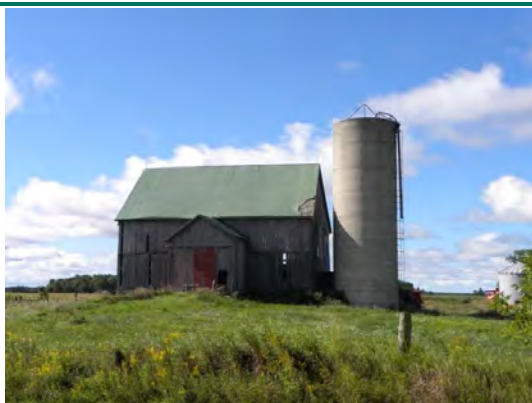
Site #47 – 271 Concession Road 11 (Municipality of Kincardine)

Date: 19th – early 20th century

Description: Raised three-gable barn with front gable roof entry. Barn has a metal roof on a timber frame and apparent stone foundation. Concrete silo is connected at the side.

Mitigation of Negative Impacts: No negative impacts identified, therefore no further mitigation recommended.

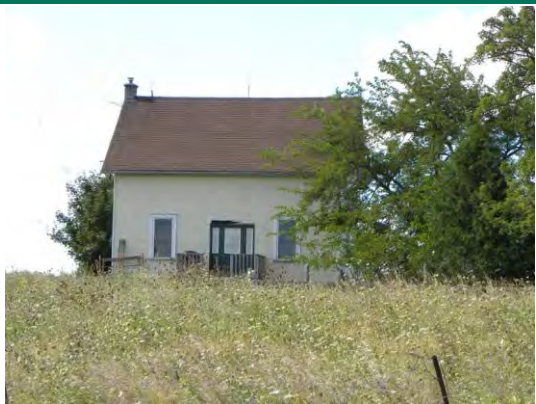
Site #48 – 55 Concession Road 9 (Municipality of Kincardine)		Lot: Pt 15 Concession: 10

Date: Undetermined (19 th – early 20 th century)	Potential CHVI According to O. Reg. 9/06:
	Description: One and one half storey side gabled house with a steep roof pitch, asphalt shingles, exterior clad in modern siding and undetermined foundation. Symmetrical in design with large front entryway.	1) Design or Physical Value: None identified. 2) Historical or Associate Value: None identified. 3) Contextual Value: None identified. Not determined to have cultural heritage value or interest.
Potential Direct and Indirect Impacts to the Heritage Attributes: CHVI was not identified, therefore impacts were not assessed.		
Mitigation of Negative Impacts: Impacts were not identified, therefore mitigation is not recommended or necessary.

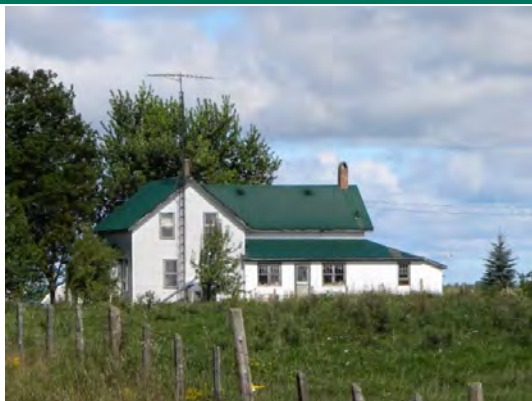
Site #49 – 234 Concession Road 9 (Municipality of Kincardine)

Date: Undetermined (19th – early 20th century)

Description: One and one half storey side gabled house with a medium roof pitch, exterior clad in modern siding and undetermined foundation. Symmetrical in design with rear extensive contemporary rear addition and covered front entryway.

Mitigation of Negative Impacts: Impacts were not identified, therefore mitigation is not recommended or necessary.

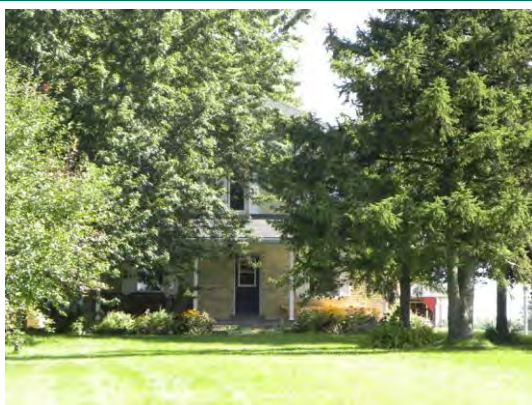
Site #50 – 302 Concession Road 9 (Municipality of Kincardine)

Date: Undetermined (19th – early 20th century)

Description: Two storey hipped roof house with medium roof pitch, asphalt shingles, yellow brick exterior and undetermined foundation. Appears symmetrical in design with rectangular design, full entry porch and apparent decorative cornices. Extensive rear addition clad in modern siding as well as modern windows and doors.

Mitigation of Negative Impacts: No negative impacts identified, therefore no further mitigation recommended.

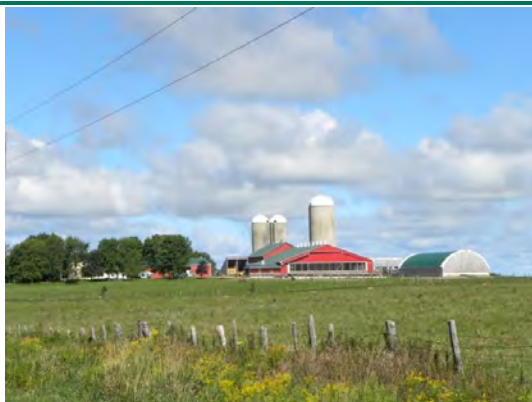
Date: Various (19th – 20th century)

Description: Extensive barn complex. One barn appears to be a raised three-bay design with a metal roof, painted timber exterior and undermined foundation. Three concrete silos and multiple modern structures on property.

Mitigation of Negative Impacts: No negative impacts identified, therefore no further mitigation recommended.

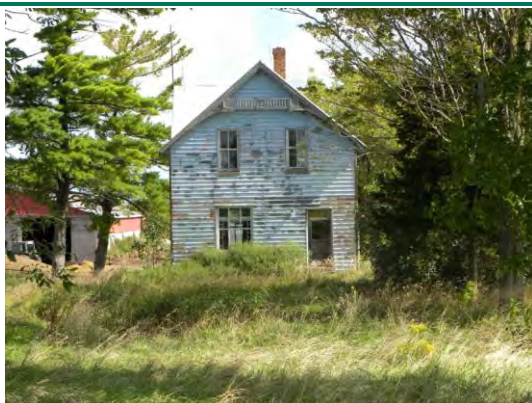
Site #51 – 514 Concession Road 9 (Municipality of Kincardine)

Date: 1860s – 1890s

Description: Abandoned one and one half storey front gabled house with a medium roof pitch, side gable, metal roof, metal siding and undetermined foundation. Vernacular Gothic Revival characteristics include remnants of decorative bargeboard with crossbracing and open eaves.

Mitigation of Negative Impacts: No negative impacts identified, therefore no further mitigation recommended.

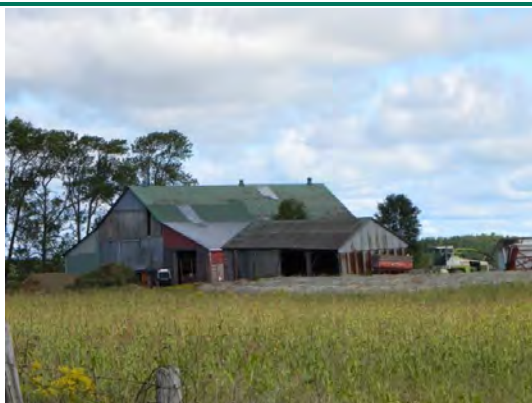
Date: Various (19th – 20th century)

Description: Appears to be raised three-bay barn with side shed additions, metal roof, timber frame and undetermined foundation. Secondary structure is an implement storage shed with metal roof, timber frame and undetermined foundation.

Mitigation of Negative Impacts: No negative impacts identified, therefore no further mitigation recommended.
