# Technical Memorandum

To	North Kent 1 LP	Page	1
CC	Mark Van der Woerd (AECOM), Jody Law, Joshua Vaidhyan		
Subject	<b>North Kent Wind 1 (Chatham-Kent, ON)</b> <b>Well Water Impact Complaint Investigation – UPDATED v.2</b> [REDACTED] - PIN 007460069, [REDACTED]		
From	Jason Murchison, P.Geo.		
Date	November 15 <sup>th</sup> , 2017	Project No.	60343599

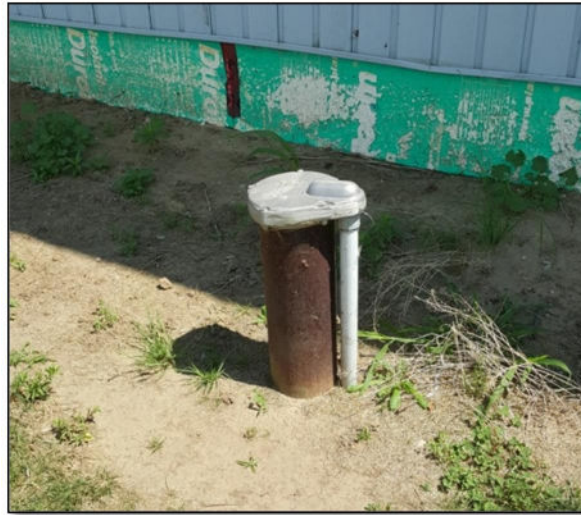
**PHOTO 1: Site Well (as on 2-August-2017)**

In review of the MOECC record for the on-site drilled water well, it is evident that it obtains its groundwater source from the upper weathered portion of the shale bedrock. In this regard, a 'water found' depth interval of 19.8 m to 20.7 mBGS (65' to 67') is reported by the Contractor on the record. Above the shale bedrock interface, a 0.75 m thick layer of gravel and 'shale stones' is reported (water-bearing) which is in turn overlain by an approximately 17.8 m dense clay unit that extends to within 1.8 m of the ground surface. Surficially, a mixture of sand and clay is reported to reside locally atop the clay to the existing surface grade.

Groundwater entry to the well is facilitated through the installation of a 0.9 m long stainless steel well screen with its base positioned at a depth of approximately 20.6 mBGS (67.5'). Geologic details contained on the well record indicate that the lower 0.15 m of the screen is located within hard black shale bedrock, while the upper 0.75 m is positioned within the overlying 'black gravel' and 'shale stones'. Comparing the details above with water found depths reported by the Contractor on the well record, the effective screen intake length is estimated to be approximately 0.75 m.

The top of the well screen reportedly is positioned at a depth of 19.7 mBGS (64.5') corresponding to the interface between the water-bearing black gravel / stones and overlying grey clay. Considering that a well screen slot size of 100 was selected by the Contractor for their installation of the well (correlating to an aperture opening width of 2.5 mm), and that an annular seal was not installed (common for a cable tool drilling method), it is interpreted that the well could be susceptible to sediment particle entry via the upper portion of the well screen, given that clay particles (generally <0.002 mm) are significantly smaller than the well screen openings. Over time, these sediments may accumulate within the well, resulting in a progressive loss of effective screen length and potential yield, as well as increased potential for sediment ingress during active pumping due to re-suspension of entrained sediment and/or increased turbulence across the well screen.

A copy of the well record is included as **Attachment C** and a photograph of the well is provided as **Photo 1**.

A recommended pump setting of 14.0 mBGS (46'), or about 5.6 m above the top of the well screen interval is provided on the MOECC record. The actual current pump intake setting within the well is unconfirmed however. Based on the age of the well (>25 years), it is likely that the well pump has been replaced on at least one occasion and thus the current installed position of the pump may differ from the original recommendation provided by the well Contractor. What is known, however, is that the well presently draws water using a submersible well pump (pump specifications are not known).

Depending on the size of the pump that presently is installed, there lies a potential for sediment to be drawn into the well as a result of pumping in excess of its sustainable capacity (either short or long-term).

Based on the foregoing discussion, including the selected installation methodology for the well screen, absence of an annular seal, and relatively low reported yield from the 'black gravel' and 'shale stones', it is our opinion that an inherent susceptibility would exist for the influx of sediment (hence increases in total suspended solids and inorganic turbidity) during the course of normal pump operation and variations in groundwater demand. Due to the absence of an annular seal, the well also could be inherently susceptible to impact(s) arising from surface drainage ingress along the well casing exterior. This is supported by the presence of a relatively poor baseline raw (untreated) groundwater quality at the well, as will be discussed further in the following section.

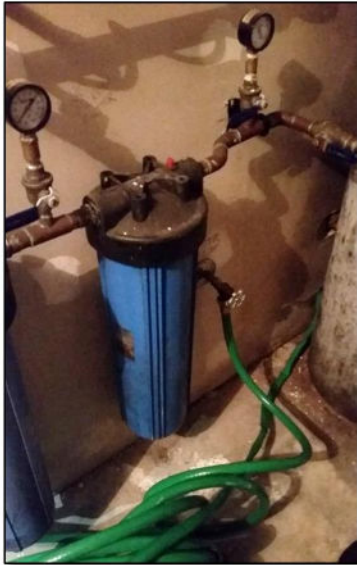
At the time of AECOM's baseline site visit on 2-February-2017, water treatment at the [REDACTED] residence comprised multi-stage particle filtration (filter cartridge pore sizes unconfirmed), water softening, and reverse osmosis (latter two being confirmed as per water well survey information), indicating that the water was known to be of degraded quality prior to the outset of construction. During AECOM's 2-August-2017 site visit, a multi-stage particle (cartridge) filtration system was observed in a room located adjacent to that which AECOM staff had previously attended during baseline sampling (**Photo 2**). The filtration system shown in **Photo 3** was not present at the time of our 2-February-2017 site visit and is of recent origin, having been installed at the recommendation of Water Wells First (WWF) as part of an ongoing particle/sediment quality study. Raw water quality sampling during the August 2<sup>nd</sup> site visit was completed using the gate valve on the white PVC pipe at the far left hand side of Photo 3 (blue handle).

**PHOTO 2: Particle Filter System (as on 2-February-2017).  
Opposing side of wall from recent photograph.  
(Presence unconfirmed during 2-August-2017 site visit)**

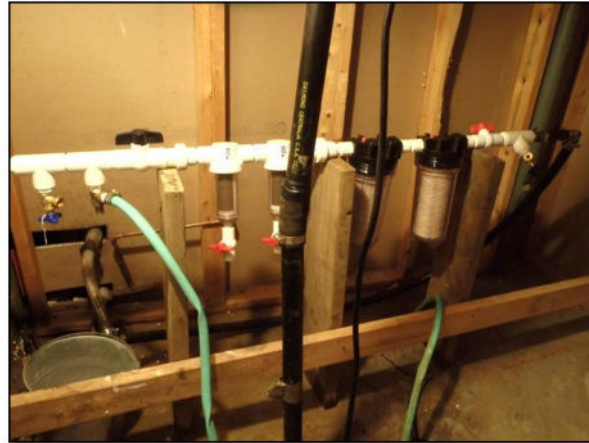
**PHOTO 3: Particle Filter System (as on 2-August-2017)**

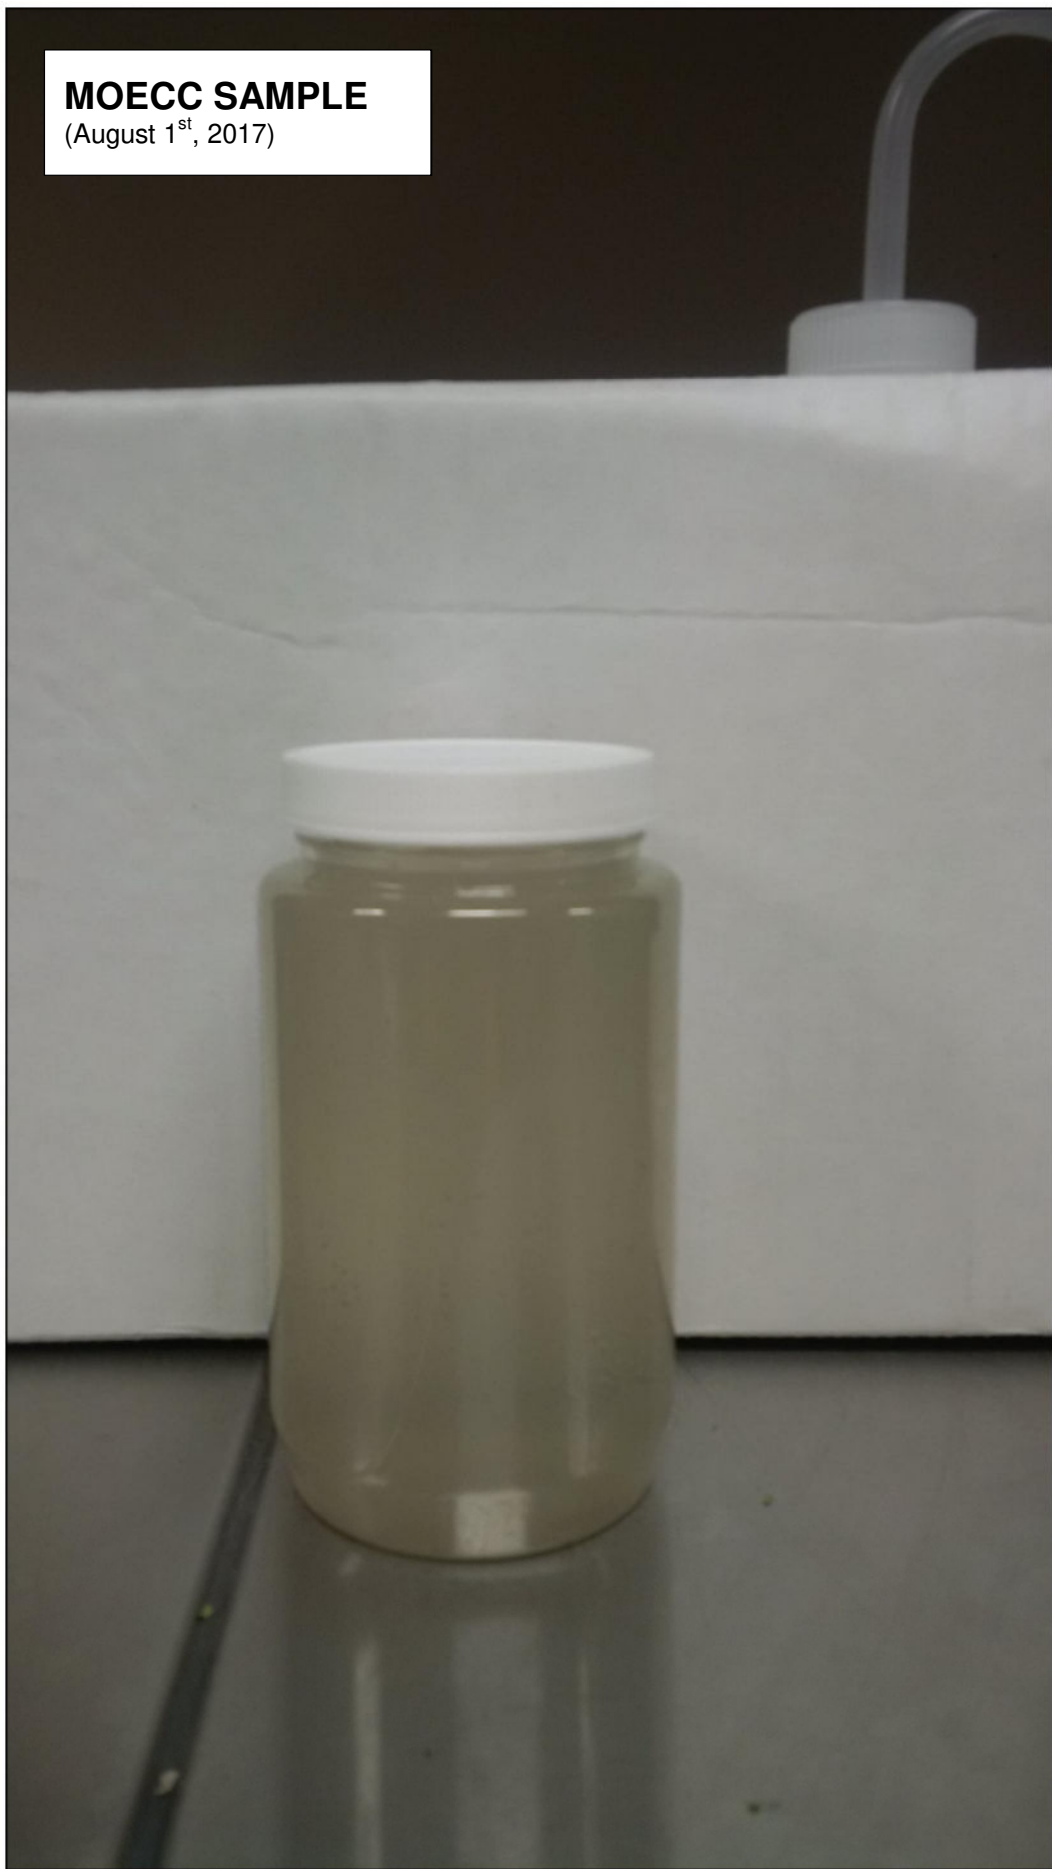
**MOECC SAMPLE**  
(August 1<sup>st</sup>, 2017)

I have also seen a photo provided by [REDACTED] via email to Jody Law the evening of Aug. 3. It purports to be a photo of the sample taken by AECOM during their Aug. 2 visit to the [REDACTED] residence. In that photo, the sampled water appears noticeably cloudy (see attached)

At the site well, turbidity levels in the samples fluctuate between a baseline (raw - AECOM) value of 6.2 NTU up to 86.8 NTU (raw - MOECC) on 1-August-2017. A raw water sample value of 57.3 NTU was determined on the subsequent day (2-August-2017). In considering this data, it should be noted that a turbidity variation of greater than 50 NTU would be readily visible to the naked eye, and thus present an adverse impact to the aesthetic quality of the groundwater source. Elevated turbidity levels of this magnitude may also lead to flow restrictions within the residence based on the capacity of the installed water treatment system and rate of sediment accumulation.

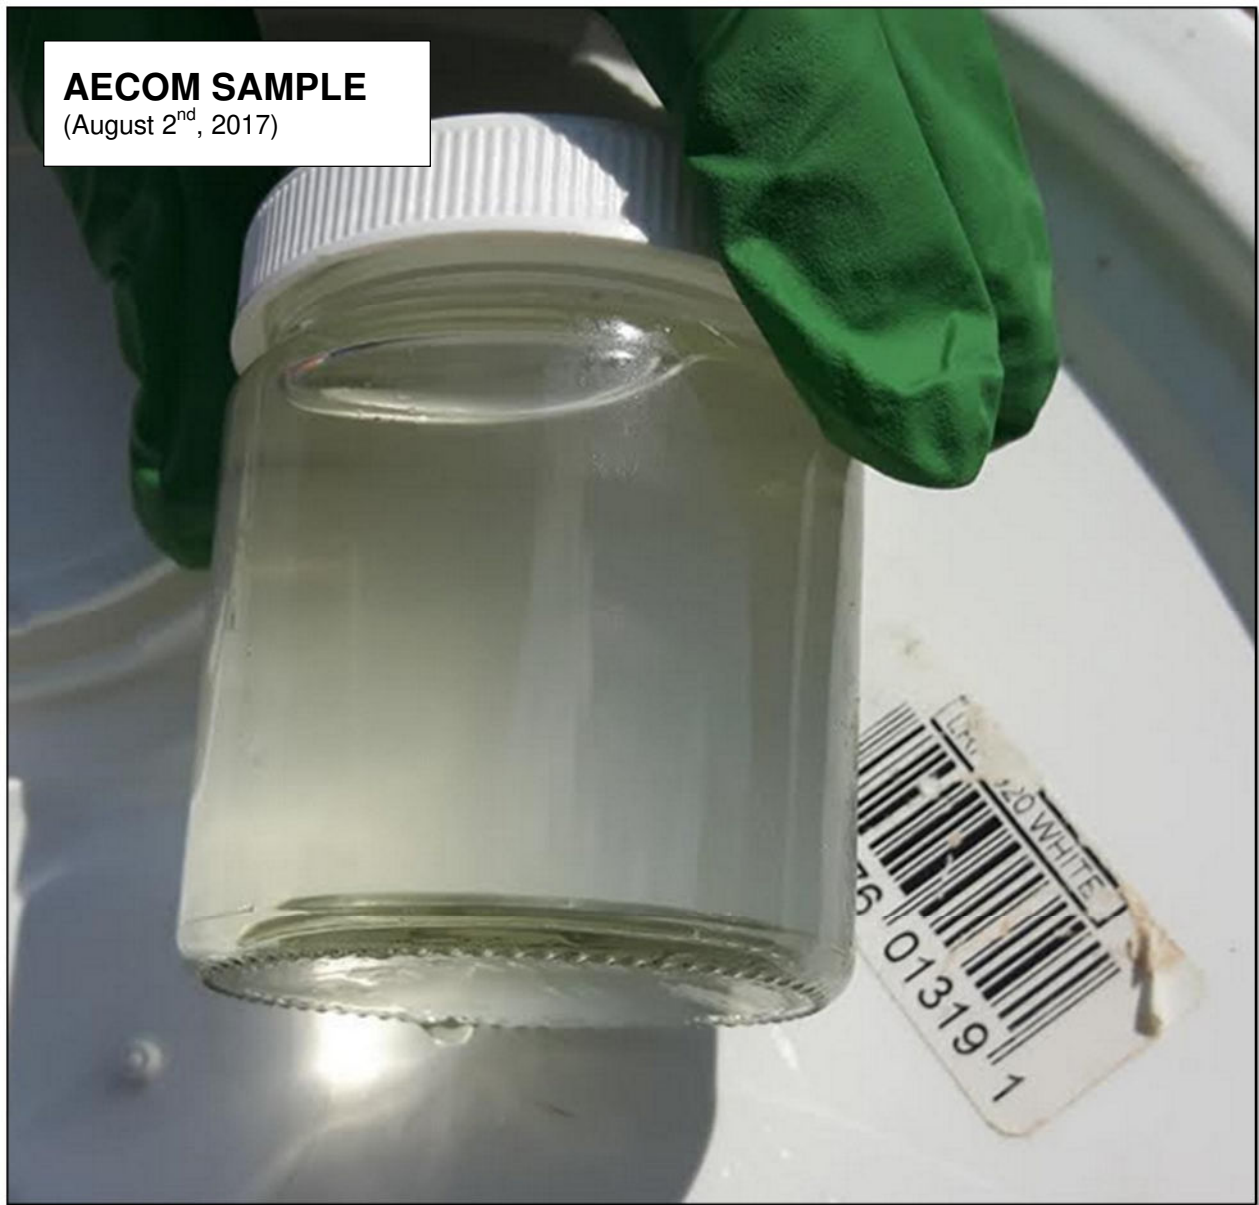
**AECOM SAMPLE**  
(August 2<sup>nd</sup>, 2017)

I am trying to reconcile this varying information. Is AECOM saying that the cloudy water collected and photographed during the Aug 2, 2017 visit is visually the same as the 6.2 NTU samples taken Feb. 2, 2017? Are there any photos of the Feb 2 sample? I am hoping that Aecom's report will address / answer these questions.

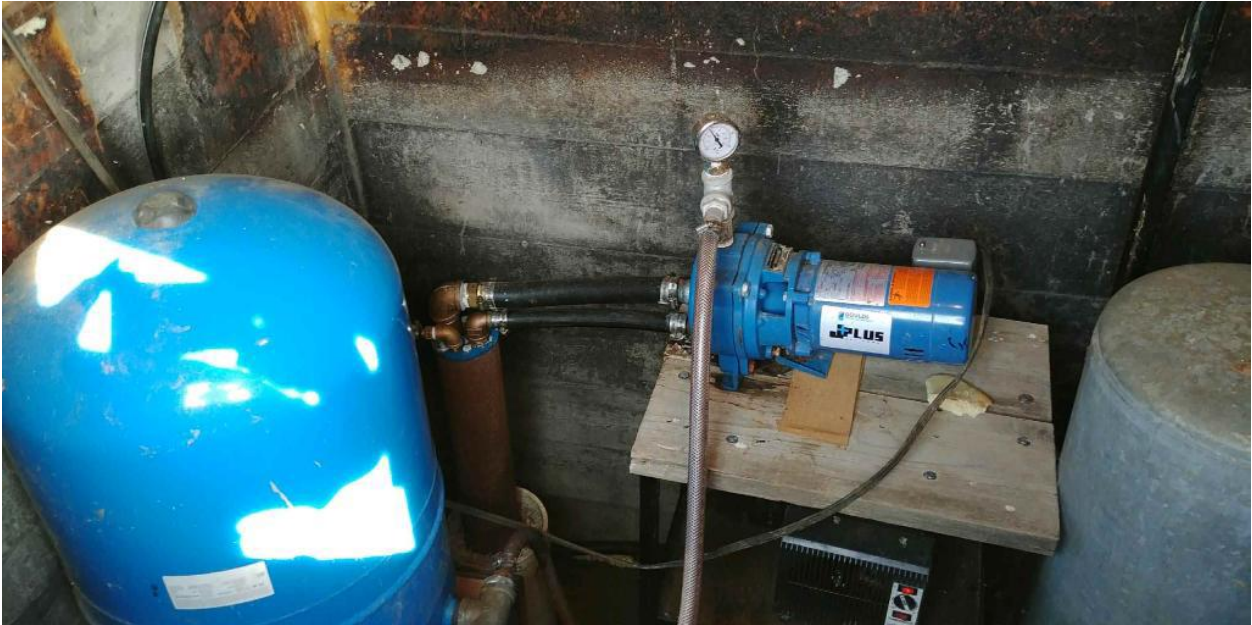
When reviewing Table 1, attached, it should be noted that during well monitoring of multiple wells in the area, well casing vibrations directly attributable to the well pumps were measured and these were as much as 2.4 millimetres per second (mm/s) with one well experiencing vibrations of almost 5 mm/s during installation, initial operation and adjustments. The Well 6 casing exhibited vibrations of as much as 0.44 mm/s directly attributable to the well pump operating. Vibration monitoring at Wells 7 and 8 undertaken outside of times during which pile driving was underway recorded maximum measured well casing vibrations of 0.370 mm/s, consistent with vibration magnitudes associated with other transient sources including nearby traffic and vehicles entering and leaving the properties.

Photograph 1: Well 6 illustrating proximity of pump, hoses and tank to well casing.

**Monitoring Notes:** Tractor was observed operating frequently near Well 6. Water pump was observed cycling on and off during pile driving operations and remaining on for periods of 2 to 4 minutes. When pump was operating, casing at Well 6 exhibited particle velocities in the range of 0.08 to 0.12 mm/s and this data dominated FFT analysis of data. Pile restrike events were of short duration with the following total number of hammer blows shown in parentheses: Pile 1 (20), Pile 10 (5 to 7), 13 (205), 14 (140), 16 (51), 15 (214). Pile 17 experienced 446 hammer blows over a period of 9 minutes. Data obtained during pile dynamic analyses is pending. Piles noted with "A" represent piles installed to replace similarly-numbered piles. After installation, selected piles were struck again with the hammer to demonstrate resistance performance and these are noted as "restrikes". Monitoring of deliberate pump operation at Well 6 on July 13, 2017, during a period when no pile driving was occurring, measured maximum particle velocities of 0.08 to 0.8 mm/s.
