Technical Memorandum

To	North Kent 1 LP	Page	1
CC	Mark Van der Woerd (AECOM), Jody Law (Pattern), Joshua Vaidhyan (Samsung)		
Subject	North Kent Wind 1 (Chatham-Kent, ON) Well Water Impact Complaint Investigation – UPDATED v.3 [REDACTED] - PIN 007490086, [REDACTED]		
From	Jason Murchison, P.Geo.		
Date	December 14 th , 2017	Project No.	60343599

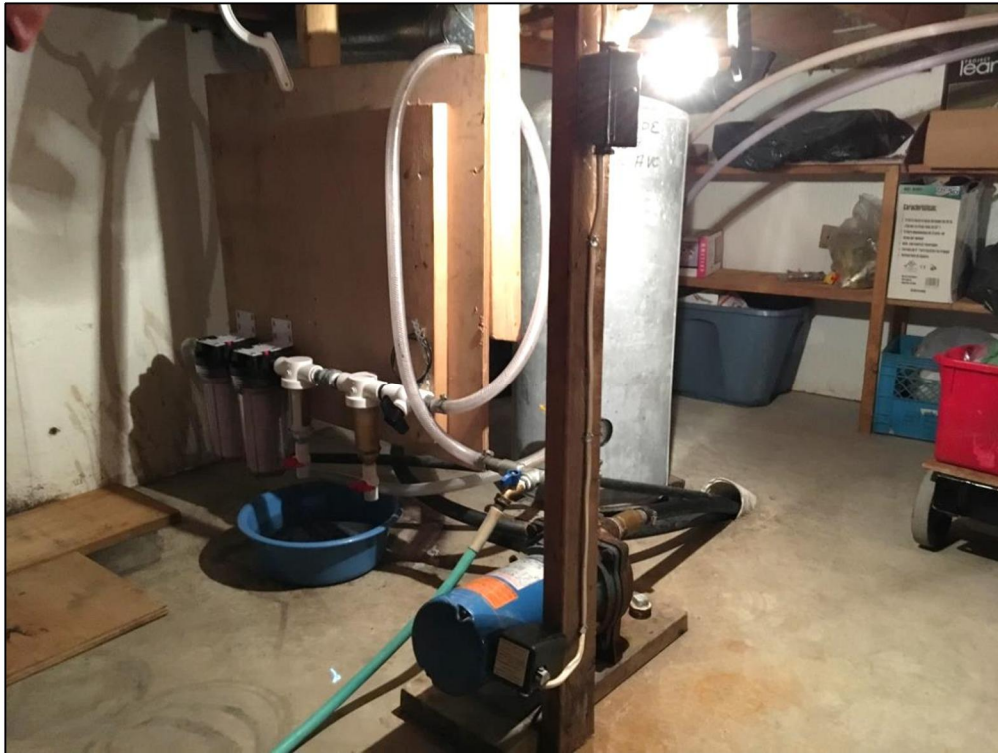
PHOTO 1: Well Pump & Particle Filter System (as observed by AECOM on 18-September-2017)

The location of the recently-installed filtration system represents a concern based on observations made during our 18-September-2017 site visit. As can be observed in **Photo 1**, the filtration system is installed intermediate to the well (jet) pump / pressure switch and pressure tank. This configuration is not recommended, as the presence of the filter array would result in the generation of additional backpressure on the discharge side of the pump. The amount of backpressure generated is cumulative based on the pore diameter and number of filters that are installed and will progressively increase over time as the capacity of the filters becomes used. This backpressure will result in the cut-out (upper) setting in the pressure switch to be reached rapidly causing on/off cycling of the pump with very little water being produced during each pumping event. This frequent cycling can lead to possible pump damage or failure and can also result in the generation of turbulence within the well which can suspend sediment existing at its base and draw it into the water system. This effect may be exacerbated should the pump inlet within the well be aged and/or positioned in close proximity to the well bottom. To alleviate these issues, water filtration systems for a well supply typically are installed downstream of the primary pumping and pressure systems (ie. on the distribution side of the water system), inclusive of such components as the well pump, pressure switch and pressure tank.

It is recommended that the property owner contact an MOECC-licensed well pump contractor (Class 1 / Class 4) to assess their well, pump and filtration systems (including downhole components), and to make any necessary replacement, repairs or re-arrangements, as necessary. The information detailed herein appears to be related to the property's pumping / filtration systems and not associated with changes in groundwater flow / quality.

reported by the property owner appear to be more related to local water system issues versus an area-wide impact to the local groundwater system. As noted within this report, assessment by a qualified professional of the current condition of the on-site well supply, pumping system, and current installed location of the particle filtration system is recommended.

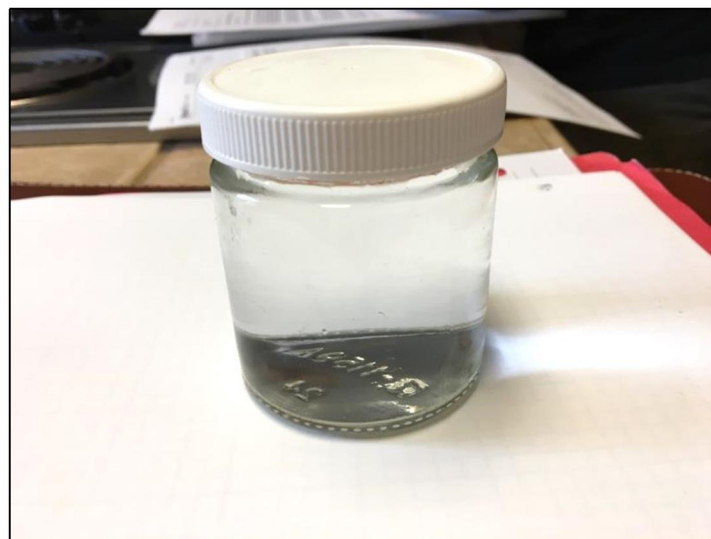
Sample collection during our 18-September-2017 site visit was completed using a valve installed immediately downstream of the well pump and upstream of the water treatment system in the basement of the [REDACTED] residence (blue handle faucet above well pump in **Photo 1**). Prior to sampling, the faucet was permitted to flush for a period of approximately five (5) minutes with the pumped water being directed into a calibrated pail (the well pump also was found to be running at the time of our arrival, as per **Section 4.1**). Prior to sample collection, the pre-existing garden hose was disconnected and the faucet orifice disinfected. As noted previously, no detectable changes in the water discharge stream (eg. colour, odour, sediment, etc.) were identified either during flow rate testing or water quality sample collection activities. A detectable amount of dissolved gas in the water discharge stream was observed during flow rate testing and sample collection. A photograph of the raw water appearance at the time of sample collection is included below as **Photo 2**.

PHOTO 2: Raw Water Appearance (as sampled by AECOM on 18-September-2017)

No exceedances of health-related parameters analyzed, including *Escherichia coli* and Total Coliform bacteria, Nitrate (as N), Nitrite (as N), and Fluoride, were detected either in the baseline or complaint investigation raw (untreated) groundwater samples collected from the existing on-site well supply.
