Technical Memorandum

To	North Kent 1 LP	Page	1
CC	Mark Van der Woerd (AECOM), Jody Law (Pattern), Joshua Vaidhyan (Samsung)		
Subject	North Kent Wind 1 (Chatham-Kent, ON) Well Water Impact Complaint Investigation [REDACTED] - PIN 007530054, [REDACTED] (Tupperville, ON)		
From	Jason Murchison, P.Geo.		
Date	December 6 th , 2017	Project No.	60343599

1. Introduction and Background

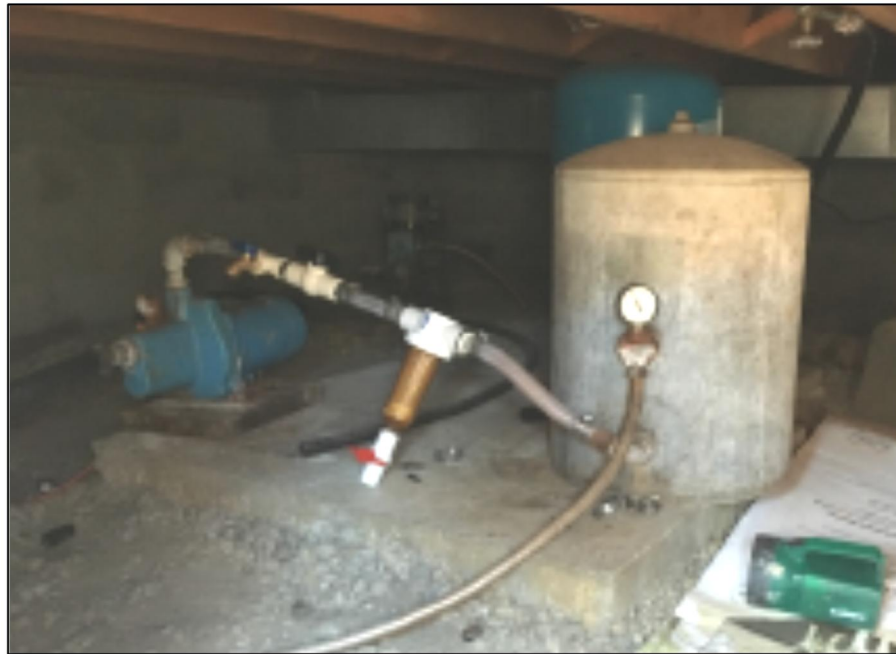
PHOTO 1: Well Pump & Particle Filter System (as observed on 20-October-2017)

The location of the recently-installed filtration system represents a concern based on observations made during our 20-October-2017 site visit. As can be observed in **Photo 1**, the filtration system is installed intermediate to the well (jet) pump / pressure switch and pressure tanks (x2). This configuration is not recommended, as the presence of the filter unit would result in the generation of additional backpressure on the discharge side of the pump. The amount of backpressure generated will progressively increase over time as the capacity of the filter becomes used. This backpressure will result in the cut-out (upper) setting in the pressure switch to be reached rapidly causing on/off cycling of the pump with very little water being produced during each pumping event. This frequent cycling can lead to possible pump damage and/or failure and can also result in the generation of turbulence within the well which can suspend sediment existing at its base and subsequently draw it into the water system. This effect may be exacerbated should the pump inlet within the well be aged and/or positioned in close proximity to the well bottom. To alleviate these issues, water filtration systems for a well supply typically are installed downstream of the primary pumping and pressure systems (ie. on the distribution side of the water system), inclusive of such components as the well pump, pressure switch and pressure tank(s).

It is recommended that the property owner contact an MOECC-licenced well pump contractor (Class 1 / Class 4) to assess their well, pump and filtration system (including downhole components), and to make any necessary replacement, repairs or re-arrangements, as necessary. The information detailed herein appears to be related to the property's pumping / filtration systems and not associated with changes in groundwater flow / quality.

The water quantity issues reported by the property owner appear to be related to local water system issues versus an area-wide impact to the local groundwater system. As noted within this report, assessment by a qualified professional of the current condition of the on-site well supply, pumping system and current installed location of the particle filtration system is recommended.

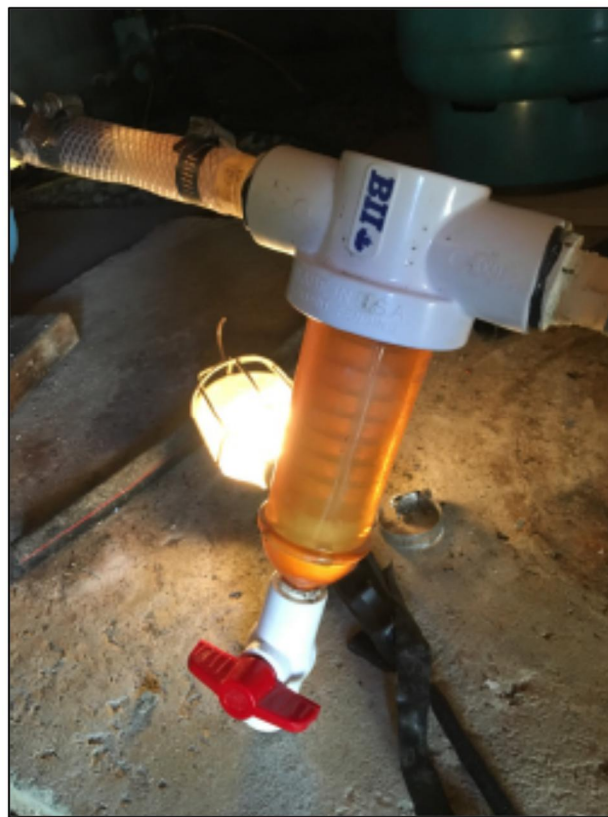
PHOTO 2: Visible iron fouling within sediment filter (as on 20-October-2017)

At the time of AECOM's baseline site visit on 19-January-2017, no water treatment devices reportedly were present within the residence. During AECOM's 20-October-2017 site visit however, a particle filter (in-line T-Standard sand separator, see **Photo 2**) was observed to have been installed within the crawlspace beneath the residence at a location intermediate to the water system's jet pump and pressure tanks. The filter unit reportedly was installed on August 1st, 2017 at the recommendation of WSC Consulting as a preventative measure to ensure that sediment would not enter the residence's plumbing system. The mesh size of the filter element is unconfirmed. As is shown in **Photo 2**, evidence of iron fouling (iron-related bacteria) is readily visible as an orange discolouration and bacterial floc within the translucent filter housing.

Iron concentrations were determined to be in excess of its AO limit of 0.3 mg/L in both the baseline (0.426 mg/L) and complaint investigation (0.398 mg/L) raw groundwater samples collected by AECOM from the site well. Elevated concentrations of iron can impart a brownish discolouration to water (including staining of fixtures and laundry) and can also provide an astringent taste during consumption.

Where elevated iron concentrations occur in well water, the presence of iron-related bacteria (IRB) is not uncommon. IRB combine iron (as well as manganese, where present) with oxygen as part of their metabolic processes to form visible 'rust' deposits / stains (eg. yellow, orange, red or brown) that are typically associated with a greasy or slimy texture. Various foul odours may also be associated with the presence of IRB within a well water system (eg. rotten egg, swampy, sewage-like, etc.). The 'slime' will tend stick to fixtures and water system components, including filter elements, pump foot valve assemblies, and well screens, which can result in flow restrictions over time. The orange discolouration and visible bacterial floc shown in **Photo 2** is characteristic of IRB and is surmised to likely be source of marginally higher turbidity that was observed in the most recent raw water sample collected from the well. Although being a nuisance, there is no documented health risk associated with IRB. It is recommended that the property owner seek the guidance of an MOECC-licensed well pump contractor (Class 1 / Class 4) and/or water treatment specialist to address the elevated levels of iron and associated IRB within the well.

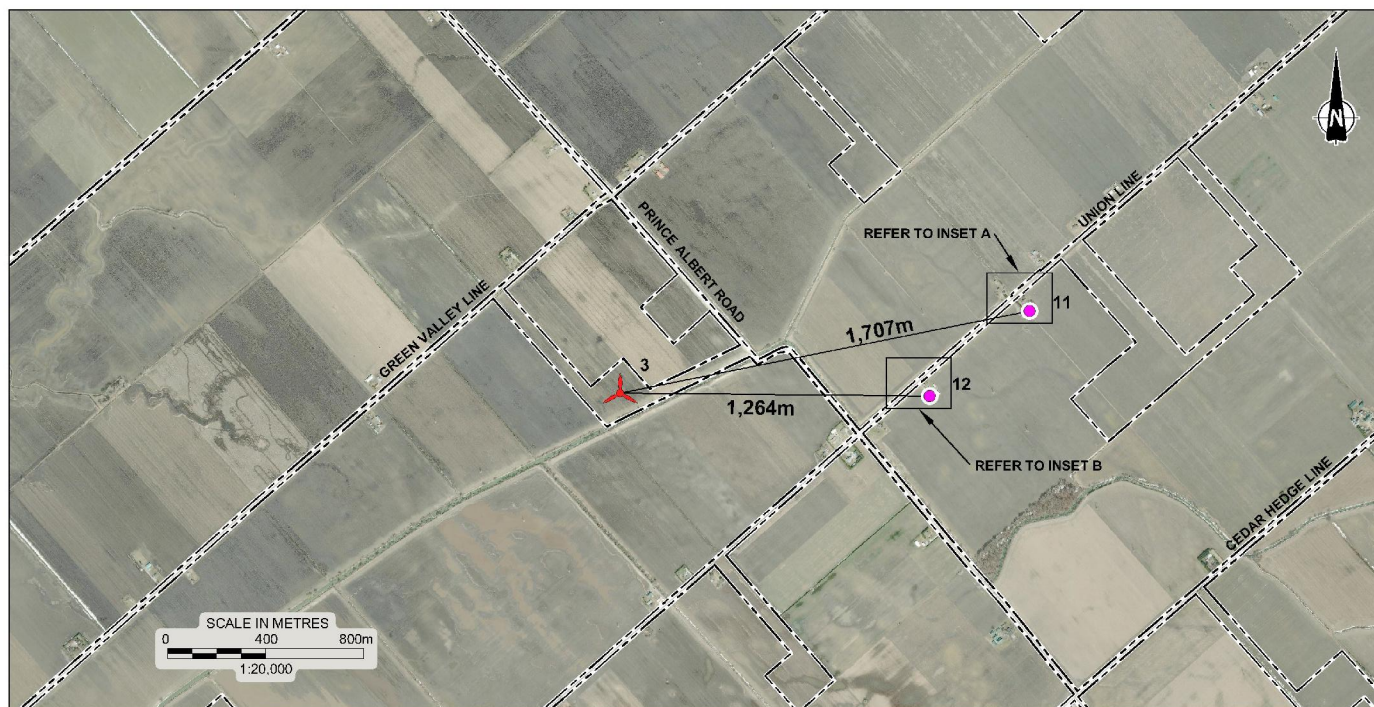
SITE PLAN

PROJECT			
NORTH KENT 1 VIBRATION MONITORING			
TITLE			
TURBINE PILES AND WATER WELL LOCATION PLAN, T6			
	PROJECT NO.	16686031	FILE NO. 16686031-2000-RC2016
	DATE	09/18/17	SCALE AS SHOWN
	DESIGNED BY	DCI/ZLR	REV.
FIGURE T6

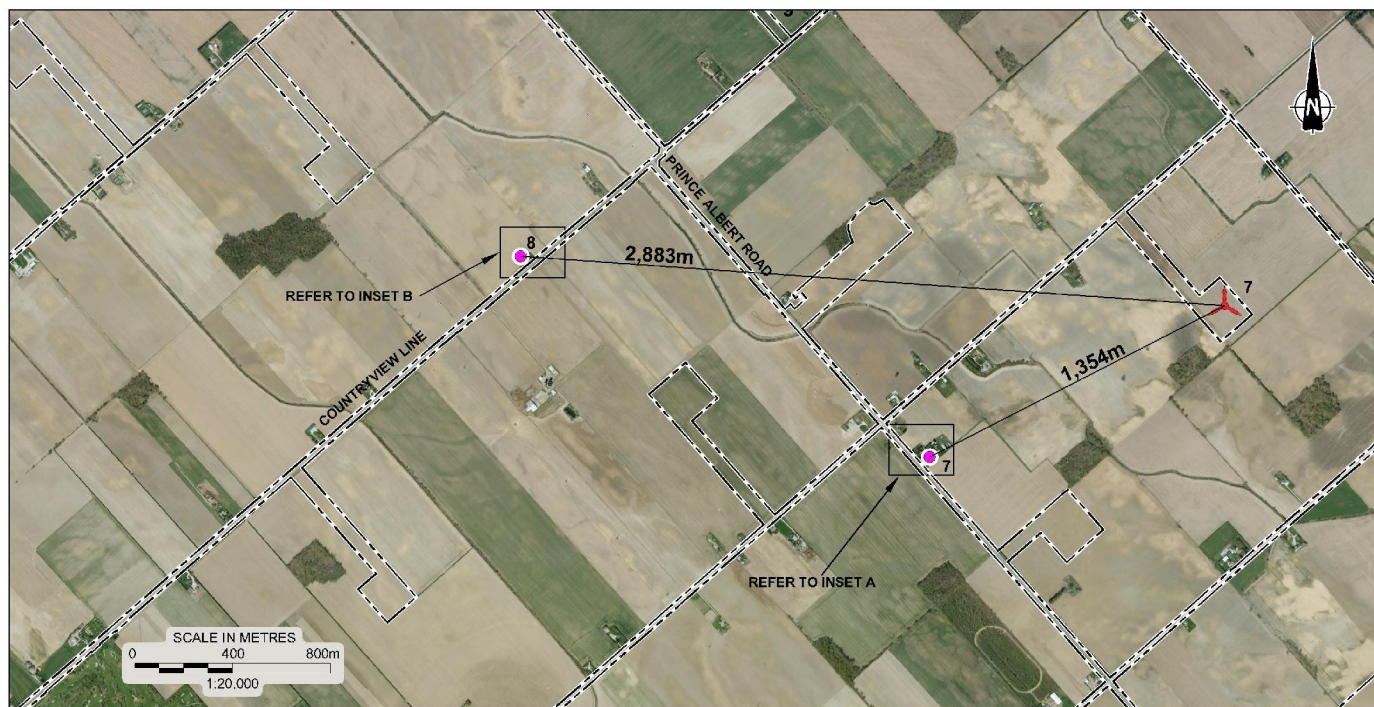
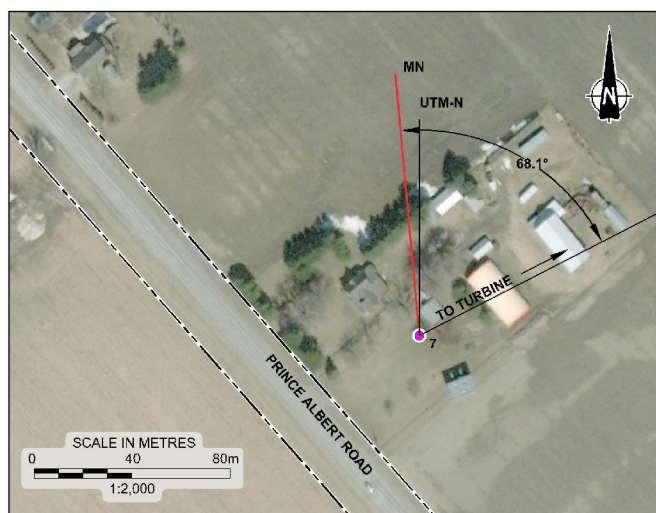
SITE PLAN

INSET A (WELL #7)

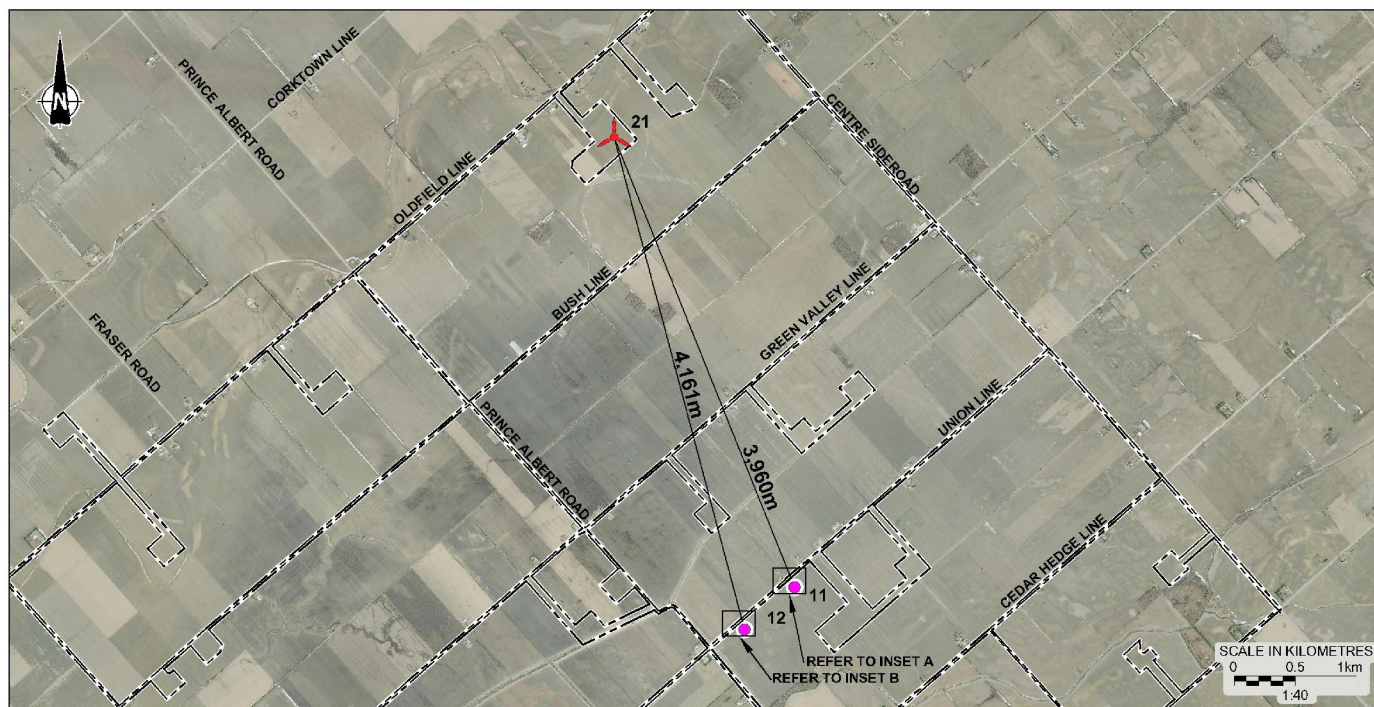
SITE PLAN

PROJECT			
NORTH KENT 1 VIBRATION MONITORING			
TITLE			
TURBINE PILES AND WATER WELL LOCATION PLAN, T20			
	PROJECT NO.	16686031	FILE NO. 16686031-2000-RC2120
	DATE	DCH/ZLB Sept. 18/17	SCALE AS SHOWN
	CHECKED		REV.
			FIGURE T20

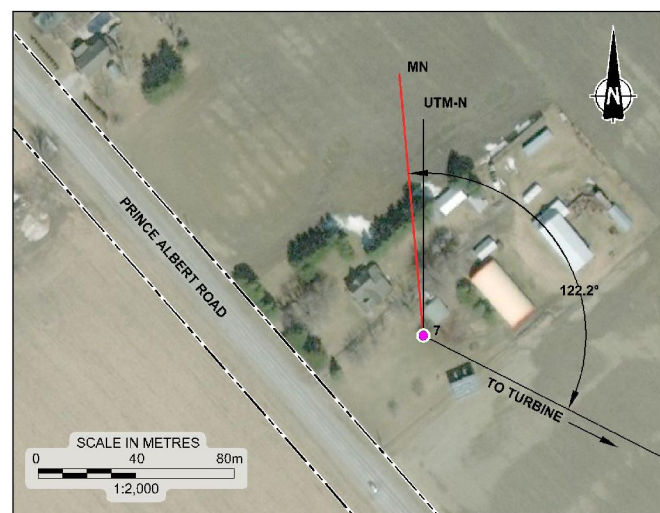
INSET A (WELL #7)

PROJECT		NORTH KENT 1 VIBRATION MONITORING	
TITLE		TURBINE PILES AND WATER WELL LOCATION PLAN, T31	
PROJECT No.	1088031	FILE No.	1088031-2000-RC2131
DATE	DOH/ZLB Sept. 18/17	SCALE	AS SHOWN
CHECKED			
		FIGURE T31

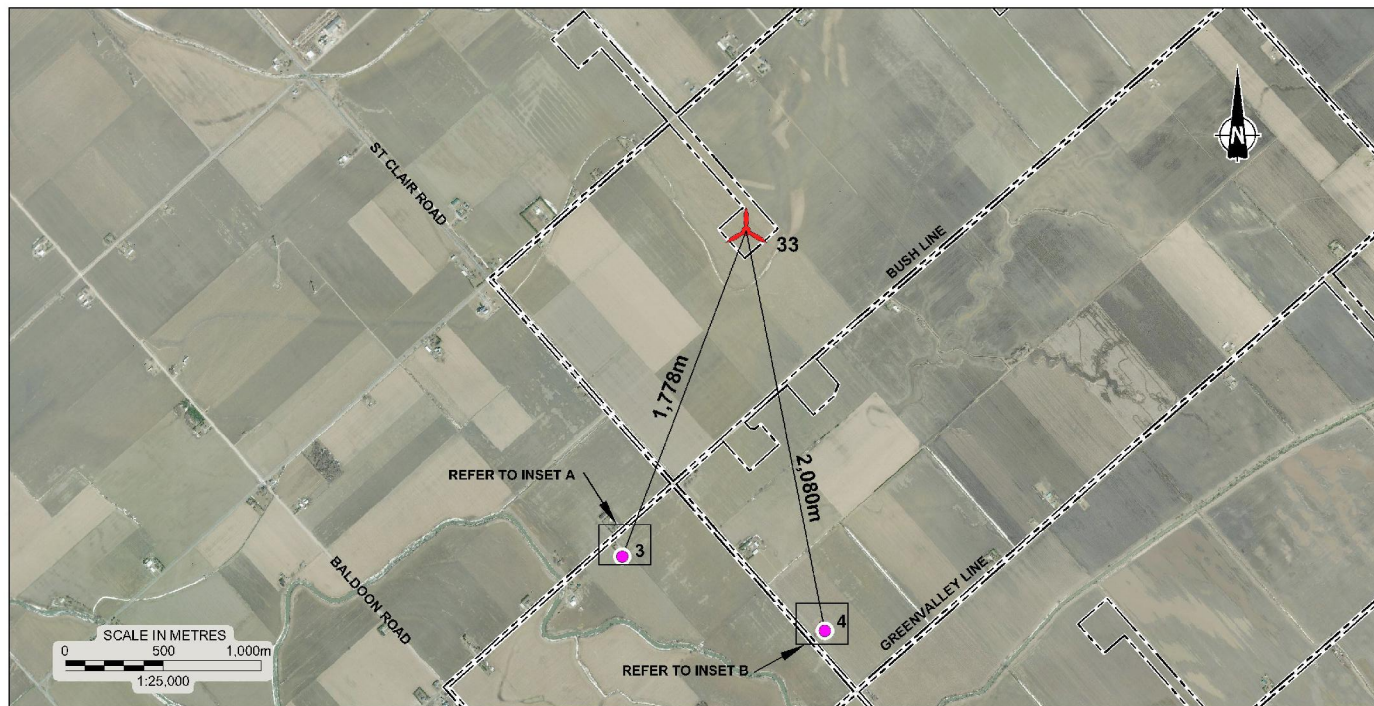
SITE PLAN

PROJECT			
NORTH KENT 1 VIBRATION MONITORING			
TITLE			
TURBINE PILES AND WATER WELL LOCATION PLAN, T35			
	PROJECT No.	1098031	FILE NO. 1098031-2000-R02T35
	DATE	09/28/17	SCALE AS SHOWN
	DRAWN BY	18/17	
			FIGURE T35

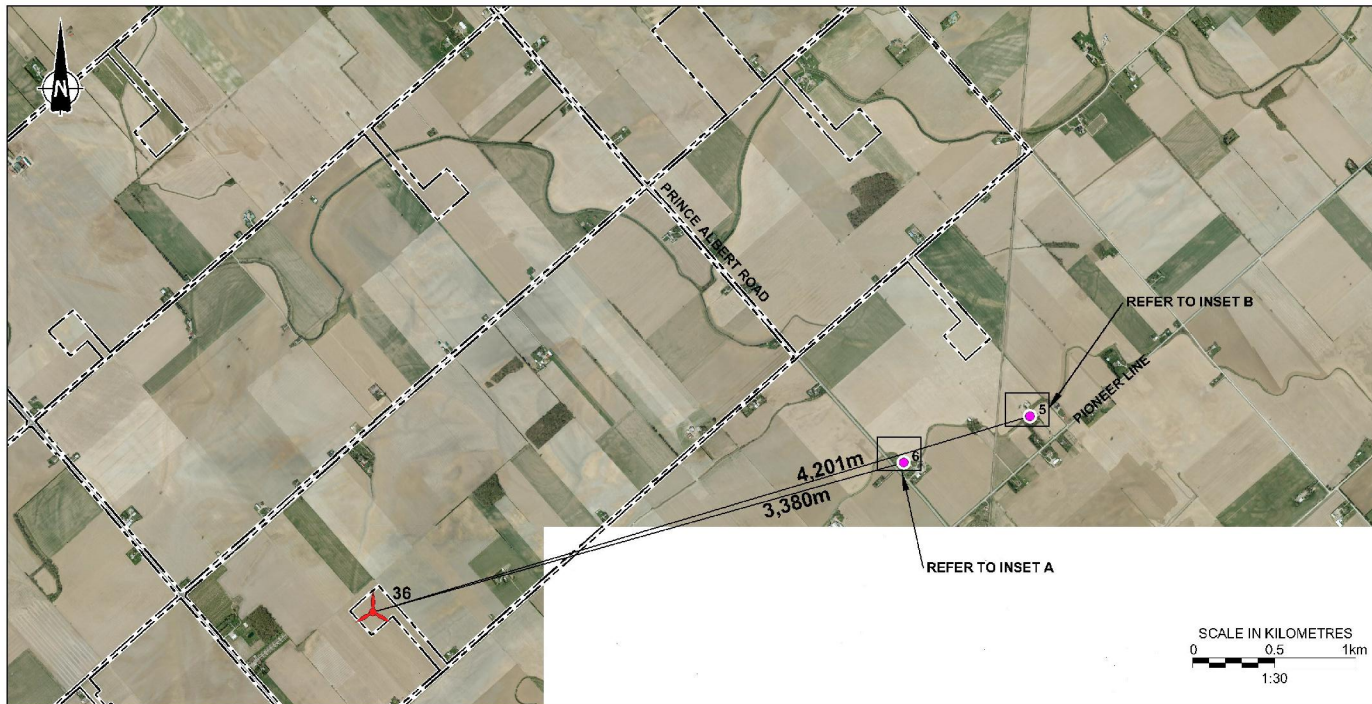
SITE PLAN

PROJECT			
NORTH KENT 1 VIBRATION MONITORING			
TITLE			
TURBINE PILES AND WATER WELL LOCATION PLAN, T36			
	PROJECT No.	16686031	FILE No. 16686031-2000-R02T36
	SCALE	AS SHOWN	REV.
	DATE	DCH/ZLB	Sep. 20/17
	CHECK		
			FIGURE T36
