# Technical Memorandum

To	North Kent 1 LP	Page	1
CC	Mark Van der Woerd (AECOM), Jody Law (Pattern), Joshua Vaidhyan (Samsung)		
Subject	<b>North Kent Wind 1 (Chatham-Kent, ON)</b> <b>Well Water Impact Complaint Investigation – REVISED</b> [REDACTED] - PIN 007530036, [REDACTED] (Dresden, ON)		
From	Jason Murchison, P.Geo.		
Date	January 23 <sup>rd</sup> , 2017	Project No.	60343599

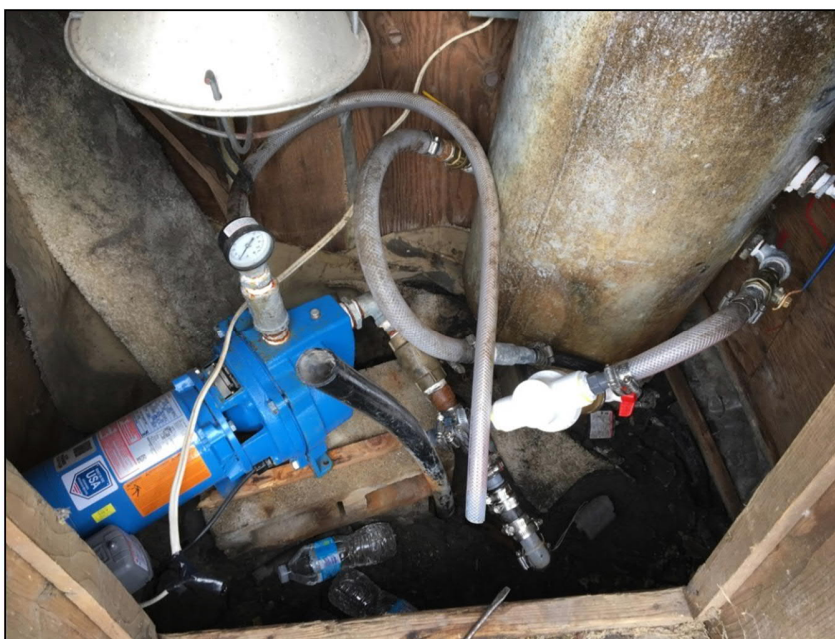
**PHOTO 1: Well Pump & Particle Filter System (as observed on 4-October-2017)**

During AECOM's well interference complaint visit to the [REDACTED] property on 4-October-2017, a limited flow rate test was completed to assess the current capacity of the ½ hp jet pump (Goulds® Model: J5SH) that is connected to the well. This testing was facilitated through disconnection (by the property owner) of a 19 mm (¾") braided hose on the inlet side of a sediment filter installed a short distance downstream of the well pump (see **Photo 1**).

The location of a recently-installed particle filtration system represents a concern based on observations made during our 4-October-2017 site visit. As can be observed in **Photo 1**, the filtration system is installed intermediate to the well (jet) pump / pressure switch and the pressure tank. This configuration is not recommended, as the presence of the filter unit would result in the generation of additional backpressure on the discharge side of the pump. The amount of backpressure generated will progressively increase over time as the capacity of the filter becomes used. This backpressure will result in the cut-out (upper) setting in the pressure switch to be reached rapidly causing on/off cycling of the pump with very little water being produced during each pumping event. Frequent cycling can lead to possible pump damage and/or failure and can also result in the generation of turbulence within the well which can suspend sediment existing at its base and subsequently draw it into the water system. This effect may be exacerbated should the pump inlet within the well be aged and/or positioned in close proximity to the well bottom. To alleviate these issues, water filtration systems for a well supply typically are installed downstream of the primary pumping and pressure systems (ie. on the distribution side of the water system), inclusive of such components as the well pump, pressure switch and pressure tank(s).

Based on the well's reported age (ie. >70 years), and fact that the wellhead is buried (not in accordance with O.Reg. 903); the current condition of the casing / screen (if present) and downhole components (including cap type / water-tightness and pump foot valve assembly) is considered questionable.

It is recommended that the property owner contact an MOECC-licenced well pump contractor (Class 1 / Class 4) to assess the current condition of the well casing / screen (if present), cap, pump (including downhole components) and filtration system, and to make any necessary replacement, repairs or re-arrangements, as necessary.

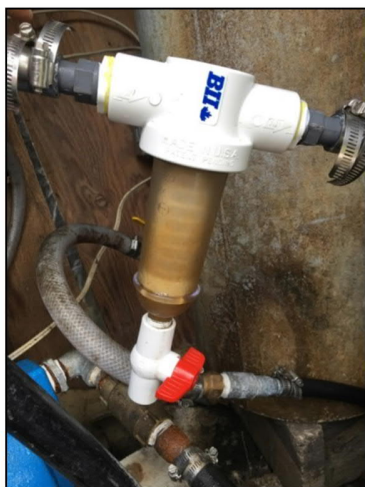
**PHOTO 2: Particle Filter (as on 4-October-2017)**

At the time of AECOM's baseline site visit on 25-January-2017, no water treatment devices reportedly were present. During AECOM's 4-October-2017 site visit however, a particle filter (in-line T-Standard sand separator, see **Photo 2**) was observed to have been installed within a well pumphouse in the front yard at a location intermediate to the water system's jet pump/pressure switch and pressure tank. According to Mr. Simmons, the filter unit was installed in March 2017 at the recommendation of WSC Consulting for the purposes of collecting sediment samples for analysis. The mesh size of the filter element is unconfirmed.

Iron and manganese concentrations were determined to be in excess of their respective AO limits in the complaint investigation raw groundwater sample collected by AECOM from the site well. Elevated concentrations of iron and manganese can impart a brownish to black discolouration to water (including staining of fixtures and laundry) and can also result in an undesirable taste during consumption. Discolouration attributed to elevated concentrations of these metals (iron in particular) is evident in **Photo 2** as an orange-brown discolouration on the interior of the translucent filter housing.

Where elevated iron concentrations occur in well water, the presence of iron-related bacteria (IRB) is not uncommon. IRB combine iron (as well as manganese, where present) with oxygen as part of their metabolic processes to form visible 'rust' deposits / stains (eg. yellow, orange, red or brown) that are typically associated with a greasy or slimy texture. Various foul odours may also be associated with the presence of IRB within a well water system (eg. rotten egg, swampy, sewage-like, etc.). The 'slime' will tend stick to fixtures and water system components, including filter elements, pump foot valve assemblies, and well screens, which can result in flow restrictions over time. While not assessed as part of this investigation, IRB may potentially be present within the well which could affect the functionality of the installed filter system (via clogging) as well as impact water quality sample results, most notably turbidity. Although being a nuisance, there is no documented health risk associated with IRB, if present, and can be managed through treatment combined with regular maintenance disinfection of the well supply.
