Technical Memorandum

To	North Kent 1 LP	Page	1
CC	Mark Van der Woerd (AECOM), Jody Law (Pattern), Joshua Vaidhyan (Samsung)		
Subject	North Kent Wind 1 (Chatham-Kent, ON) Well Water Impact Complaint Investigation [REDACTED] - PIN 007420011, [REDACTED] (Dresden, ON)		
From	Jason Murchison, P.Geo.		
Date	January 25 th , 2017	Project No.	60343599

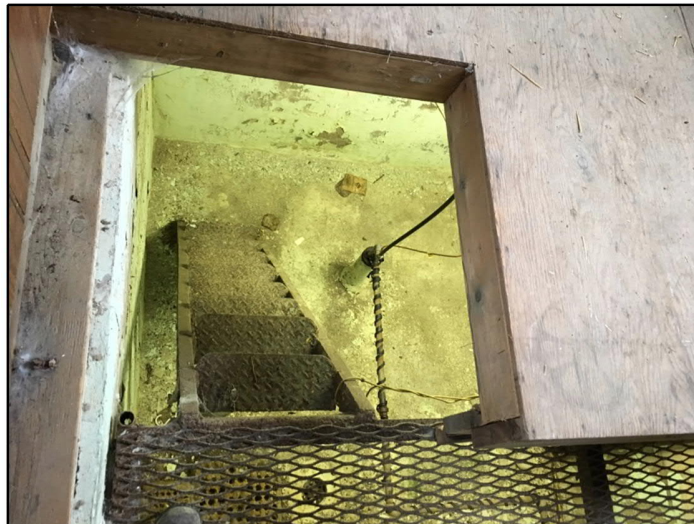
PHOTO 1: Site Well (Installed through basement floor in shed at rear of property)

Visual condition assessment and measurement of well details (eg. type, total depth, water level, etc.) was unable to be completed by AECOM during our 30-October-2017 site visit due to the wellhead being sealed and installed through the concrete floor of a small shed to the rear of the residence.

A photograph of the well, as observed during our 30-October-2017 site visit is provided as **Photo 1**.

It is recommended that the property owner contact an MOECC-licenced well pump contractor (Class 1 / Class 4) to assess the current condition of the well, pump (including downhole components) and filtration system, and to make any necessary replacements, repairs or re-arrangements, as necessary.

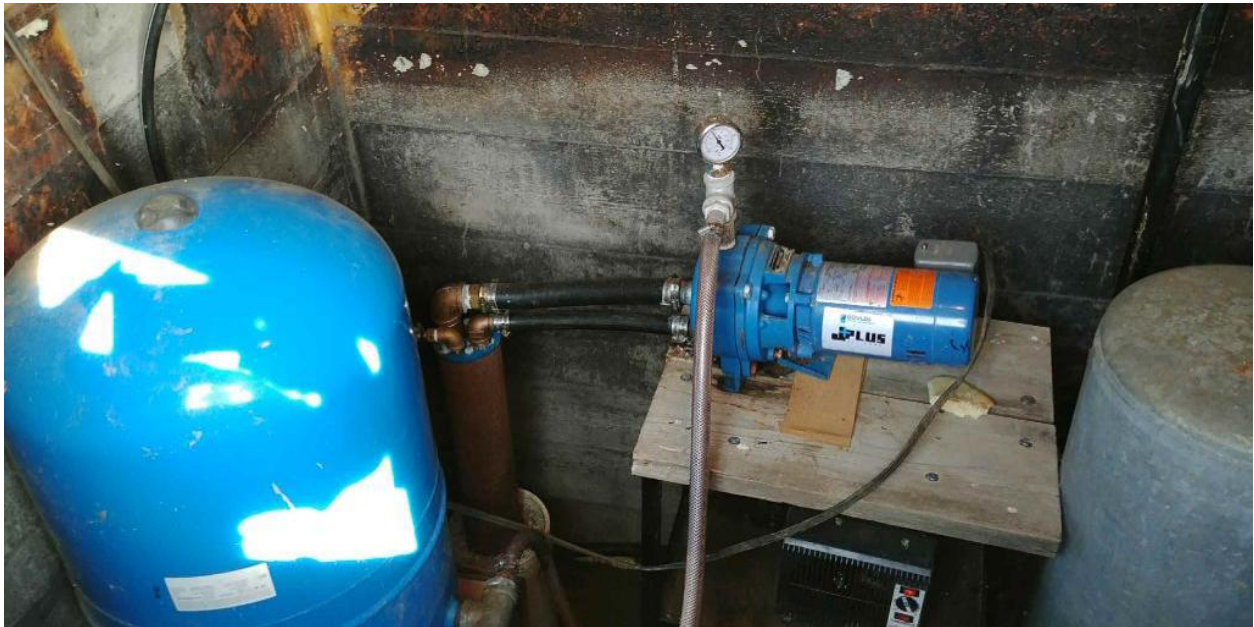
Photograph 1: Well 6 illustrating proximity of pump, hoses and tank to well casing.

When reviewing Table 1, attached, it should be noted that during well monitoring of multiple wells in the area, well casing vibrations directly attributable to the well pumps were measured and these were as much as 2.4 millimetres per second (mm/s). Activities at the Well 3 property included crop harvesting, movement of farm vehicles and loading of haul trucks in relatively close proximity to Well 3. Peak well casing vibration velocities for Well 4 of nearly 5 mm/s were recorded on September 6, 2017 when a well pump was connected, operated and adjusted and the owner made frequent return visits to the well shed. Crop harvesting was also carried out as close as about 25 m from the well casing on the previous day and vehicles travelled and parked on the site in close proximity to the well on September 5 and 6, 2017. Access to Well 4 was unavailable for monitoring after September 10, 2017. Data from monitoring Well 5 exhibited intermittent vibration characteristics similar to pump operations (i.e., constant, relatively high frequency vibrations). These vibrations were independent of pile driving times and were not consistent with traffic-induced transient vibrations. It is suspected that the pump for this well may have been located within the adjacent garage/shed, the plumbing between the pump and casing may be relatively rigid and coupled to the casing or a separate piece of machinery may have been operating from time to time within the garage/shed. The pump for Well 6 is mounted in close proximity to the well casing. Peak particle velocities of as much as 0.8 mm/s were obtained from monitoring data collected at Well 6 on July 13, 2017 when the well pump was operating during a time period without pile driving. The influences of the pump were readily discernable in the monitoring data. Approximately 1 minute after driving of Pile 1 for turbine T12 concluded, a loaded tractor-trailer dump truck drove by on the road near Well 6 and, at the same time, the resident was hammering in a nearby shed. Vibrations associated with the loaded dump truck were also perceptible by our well monitoring staff and registered at about
