Technical Memorandum

To	North Kent 1 LP	Page	1
CC	Mark Van der Woerd (AECOM), Jonathan Miranda (Pattern), Joshua Vaidhyan (Samsung)		
Subject	North Kent Wind 1 (Chatham-Kent, ON) Well Water Impact Complaint Investigation #2 – UPDATED [REDACTED] – PIN 007420039, [REDACTED]		
From	Jason Murchison, P.Geo.		
Date	June 5 th , 2018	Project No.	60343599

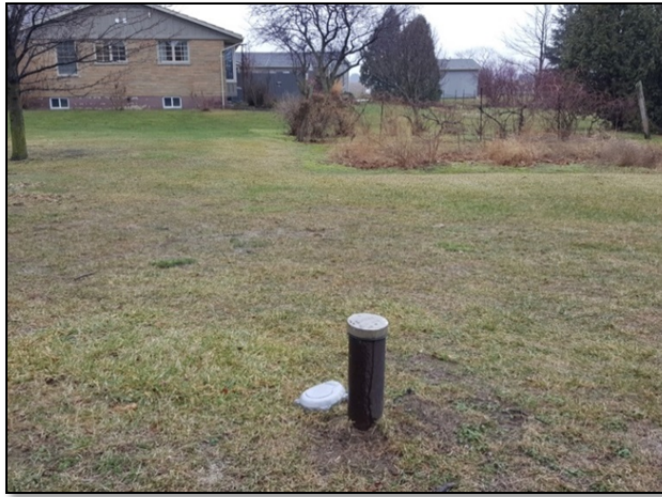
PHOTO 1: Drilled Water Well (as on 20-January-2017)

Visual assessment of the water well at surface did not reveal any apparent concerns regarding its condition. A photograph of the well is provided as **Photo 1**.

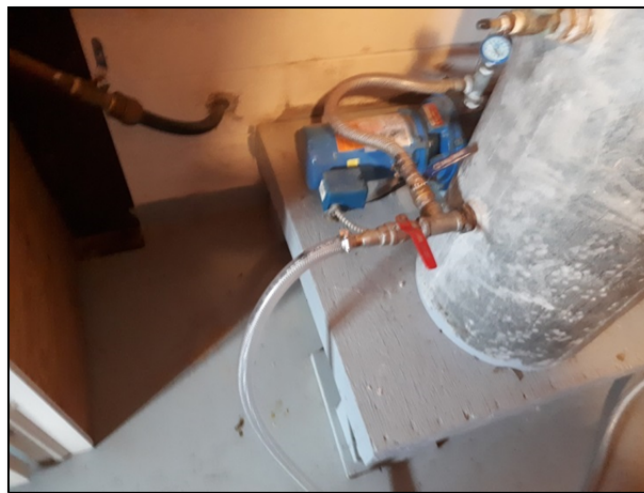
PHOTO 2: Sampling and Flow Rate Testing Location in Basement (as on 16-January-2018)

During AECOM's recent well interference complaint investigation site visit on 16-January-2018, a limited flow rate test was completed to assess the current pumping capacity of the jet pump ($\frac{1}{2}$ hp) connected to the well. Testing was completed using a ball valve and braided hose assembly installed at the outlet side of the water system pressure tank within the basement portion of the residence (**Photo 2**).

For the test, the water system was permitted to flush continuously for a period of approximately eleven (11) minutes. During pumping, the discharge rate was assessed by AECOM on four (4) separate occasions; three (3) with the valve opened half way and one (1) with the valve opened completely. Flow rate measurement was completed by timing the collection of 12 L of water into a calibrated pail. Discharge from the hose was directed to a sump pit within the basement of the residence.

Test results indicated an average flow rate of approximately 15 L/min (4.0 USgpm) with the valve opened half way, and 72 L/min (19 USgpm) with the valve fully open. Comparatively, the MOECC

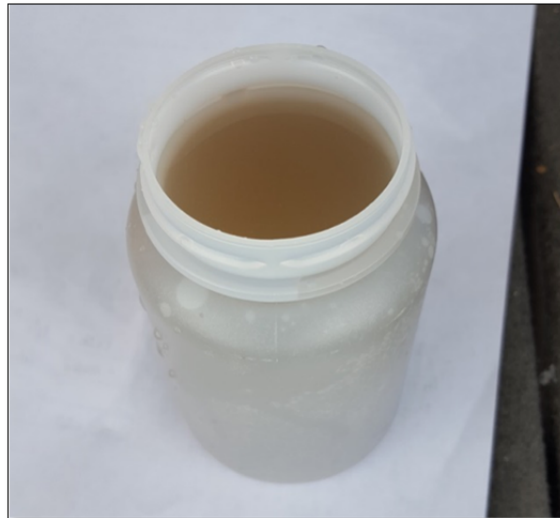
PHOTO 3a: Water Quality Sample Clarity (as on 16-January-2018)

At the time of sampling on 16-January-2018, the raw (untreated) groundwater pumped from the well was observed to be turbid, brown in colour and contain an appreciable amount of sand-textured sediment. The sediment content appeared to increase relative to pumping rate and duration. No apparent odour(s) were detected.

A photograph of the water quality sample collected by AECOM for laboratory testing on 16-January-2018 is shown in **Photo 3a**, whereas a zoomed-in perspective of settled sediment (sand) is shown in **Photo 3b**.
