Technical Memorandum

To	North Kent 1 LP	Page	1
CC	Mark Van der Woerd (AECOM), Jonathan Miranda (Pattern), Joshua Vaidhyan (Samsung)		
Subject	North Kent Wind 1 (Chatham-Kent, ON) Well Water Impact Complaint Investigation [REDACTED] – PIN 007460088, [REDACTED] (Dresden, ON)		
From	Jason Murchison, P.Geo.		
Date	May 24 th , 2018	Project No.	60343599

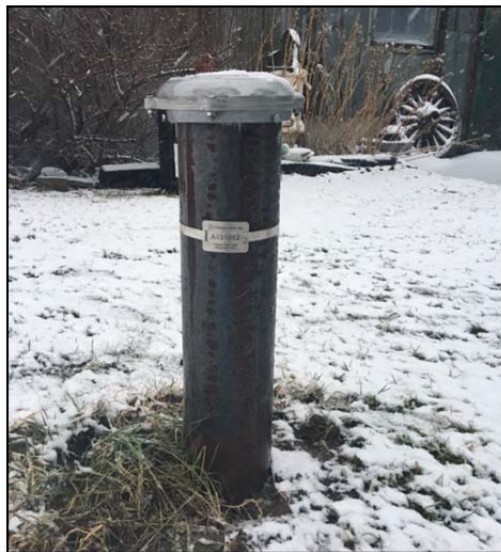
Visual assessment of the water well at surface did not reveal any apparent concerns regarding its condition. A photograph of the well is provided as **Photo 1**.

PHOTO 1: Drilled Water Well (as on 1-March-2018)

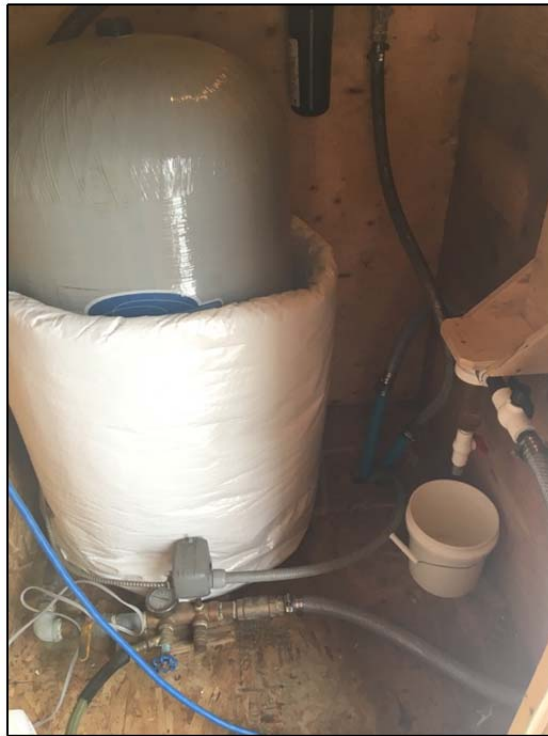
During AECOM's well interference complaint investigation site visit on 13-March-2018, a limited flow rate test was completed to assess the current pumping capacity of the submersible pump (½ hp) connected to the subject well. Testing was completed using garden hose (supplied by the property owner) connected to a cleanout faucet installed on a tank tee at the base of the water system pressure tank within a small pumphouse located to the rear of the residence (**Photo 2**).

For the test, the water system was permitted to flush continuously for a period of approximately twenty (20) minutes. During pumping, the discharge rate was assessed by AECOM on three (3) separate occasions. Flow rate measurement was completed by timing the collection of 12 L of water into a calibrated pail. Discharge from the hose was directed to the ground outside of the pumphouse.

Test results indicated an average flow rate of approximately 4.1 L/min (1.1 USgpm) with the cleanout valve fully open. Comparatively, the MOECC record for the well denotes a recommended pumping rate of approximately 5.7 L/min (1.5 USgpm) with a pump inlet depth positioned at the "bottom" of the well. Based on the foregoing, it would appear that the current pumping rate for the well pump is within the recommended yield for the site well, as indicated on the WWR.

PHOTO 2: Sampling and Flow Rate Testing Location (as on 13-March-2018)

At the time of AECOM's baseline site visit on 30-January-2017, an in-line cartridge filter assembly was observed to be installed a short distance downstream of the pressure tank within the pumphouse (ref. **Photo 2**). This same filter housing was observed to be present during our 1-March-2018 and 13-March-2018 site visits. The filter housing was observed to not contain a cartridge at the time of our most recent site visits.

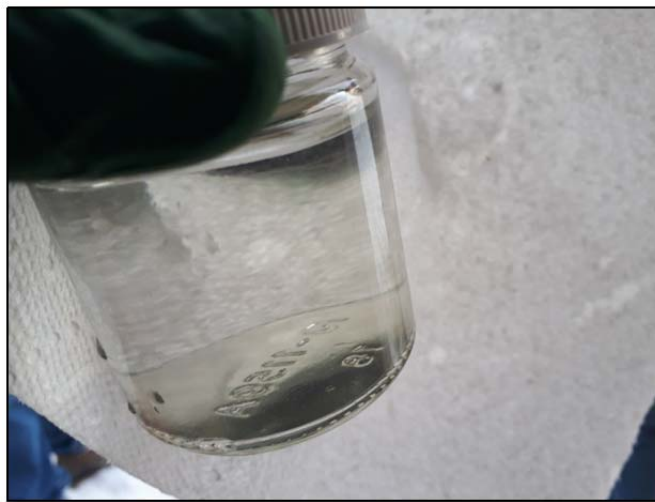
At the time of sampling on 13-March-2018, the raw (untreated) groundwater was observed to be colourless and appear to possess a slight amount of turbidity (cloudiness). Upon closer inspection of the sample bottles, the cloudiness was observed to be the result of tiny gas bubbles within the water. The water possessed a 'rotten egg' odour and contained no detectable amount of sediment. A photograph of the water quality sample collected by AECOM for laboratory testing on 13-March-2018 is shown in **Photo 3**.

PHOTO 3: Water Quality Sample Clarity (as on 13-March-2018)

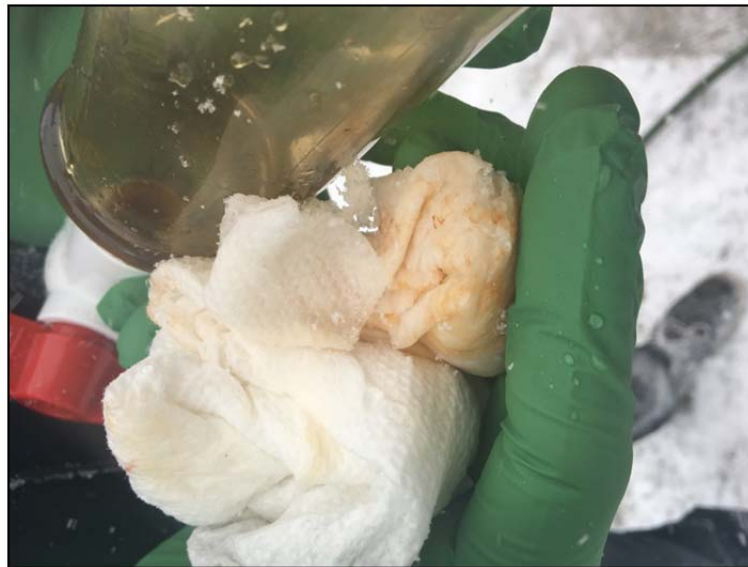
Iron concentrations were determined to be in excess of its AO limit in both the baseline and complaint investigation raw (untreated) groundwater samples collected by AECOM from the site well. Elevated concentrations of iron can impart a brownish discolouration to water (including staining of fixtures and laundry) and can also result in an undesirable taste during consumption. Discolouration attributed to elevated concentrations of this metal is evident in **Photo 4** as an orange-brown discolouration on the interior of the translucent filter housing. It is surmised that the elevated concentrations of iron in the samples is of a natural (non-anthropogenic) source.

PHOTO 4: Discolouration from Wiping of Filter Housing Interior (as on 13-March-2018)

Where elevated iron concentrations occur in well water, the presence of iron-related bacteria (IRB) is not uncommon. IRB combine iron (as well as manganese, where present) with oxygen as part of their metabolic processes to form visible 'rust' deposits / stains (eg. yellow, orange, red or brown) that are typically associated with a greasy or slimy texture. Various foul odours may also be associated with the presence of IRB within a well water system (eg. rotten egg, swampy, sewage-like, etc.). The 'slime' will tend to stick to fixtures and water system components, including filter elements, pump foot valve assemblies, and well screens, which can result in flow restrictions over time. While not assessed quantitatively (ie., via laboratory analysis) as part of this investigation, IRB is interpreted to be present within the well which could affect the functionality of the well pump and installed filter system (via clogging). During AECOM's 1-March-2018 site visit, the property owners provided samples of water that reportedly were obtained from their well on the date of outset of impact (25-February-2018). A photograph of one of the samples was obtained by AECOM and is included below (**Photo 5**). A review of the samples presented and photographs obtained indicates the presence of bacteriological floc versus inorganic sediment. Although being a nuisance, there is no documented health risk associated with IRB, and can be managed through treatment combined with regular maintenance disinfection of the well supply.

The water well impact(s) reported by the property owners appear to be related to local water system issue (biofouling) versus an area-wide impact to the local groundwater system. It is recommended that the property owners consult with a qualified water well contractor regarding the current condition of their on-site well supply, pumping and treatment systems.

It is further recommended that the property owner seek the guidance of MOECC, their local Public Health Unit, and/or an experienced water treatment specialist to address the elevated levels of biofouling within their well.
