Technical Memorandum

To	North Kent 1 LP	Page	1
CC	Mark Van der Woerd (AECOM), Jonathan Miranda (Pattern), Joshua Vaidhyan (Samsung)		
Subject	North Kent Wind 1 (Chatham-Kent, ON) Well Water Impact Complaint Investigation [REDACTED] – [REDACTED] (Chatham, ON)		
From	Jason Murchison, P.Geo.		
Date	May 28 th , 2018	Project No.	60343599

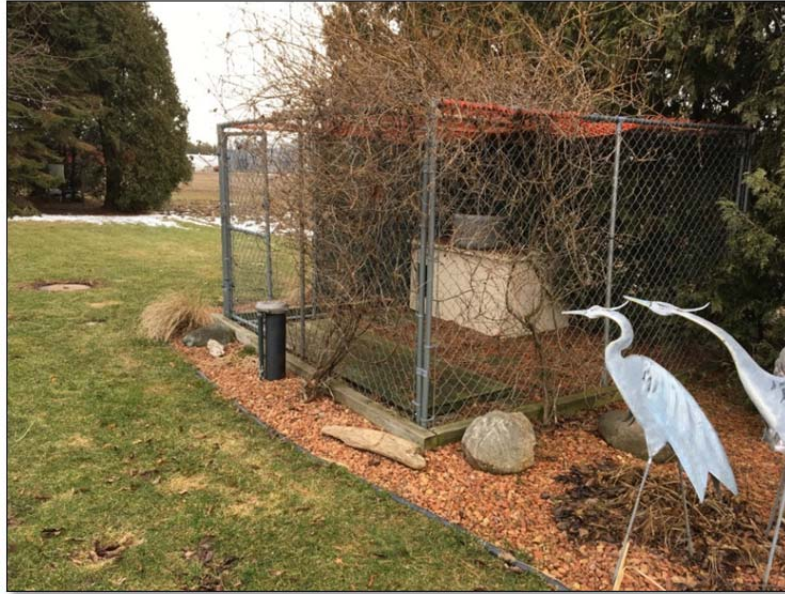
PHOTO 1: Water Well (as on 7-March-2018)

Visual assessment of the water well at surface did not reveal any apparent concerns regarding its condition. A photograph of the well is provided as **Photo 1**.

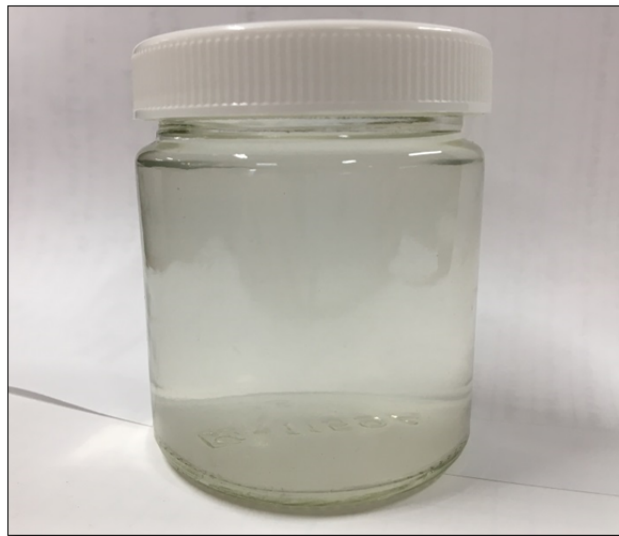
PHOTO 3: Water Quality Sample Clarity (as on 7-March-2018)

At the time of sampling on 7-March-2018, the raw (untreated) groundwater was observed to be slightly turbid (cloudy) and possessed a faint brown / tan discolouration. Upon closer inspection of the sample bottles, the cloudiness was observed to be the result, in part, of tiny gas bubbles. This observation is consistent with a cautionary note made by the drilling contractor on the MOECC record for the well wherein a *small amount of natural gas in waterbearing formation* was identified. The groundwater did not possess any apparent odour and contained a trace amount of sediment. A photograph of the water quality sample collected by AECOM for laboratory testing on 7-March-2018 is shown in **Photo 3**.
