# Technical Memorandum

To	North Kent 1 LP	Page	1
CC	Mark Van der Woerd (AECOM), Jody Law (Pattern), Joshua Vaidhyan (Samsung)		
Subject	<b>North Kent Wind 1 (Chatham-Kent, ON)</b> <b>Well Water Impact Complaint Investigation – UPDATED</b> <b>[REDACTED] - PIN 007500008, [REDACTED]</b>		
From	Jason Murchison, P.Geo.		
Date	October 31 <sup>st</sup> , 2017	Project No.	60343599

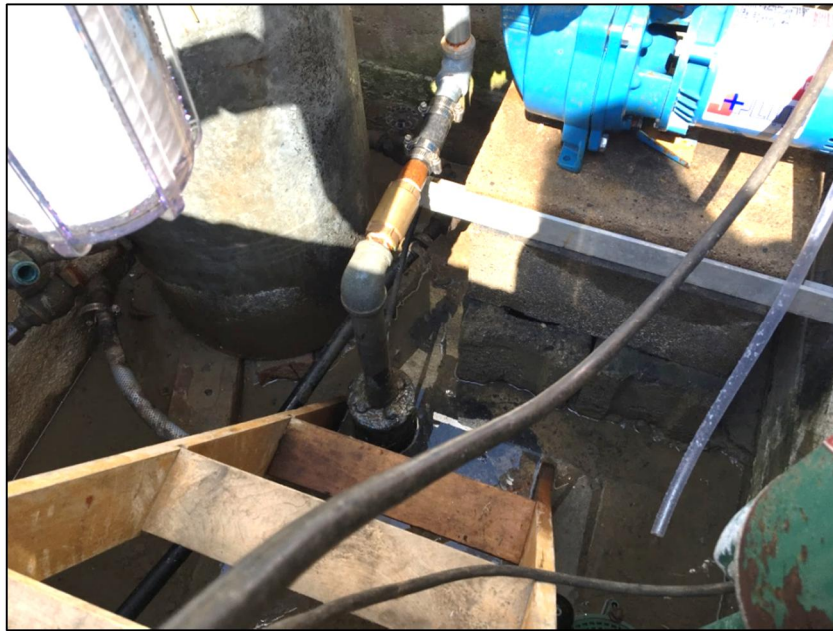
**PHOTO 1: Site Well (as Observed by AECOM on 14-August-2017)**

A copy of the technical brochure for the well pump was obtained from the manufacturer (Goulds) to provide a basis of comparison against the testing results (**Attachment C**). According to the property owner ([REDACTED]), the water system operates in a set cut in/out pressure range of 30/50 PSI (206.8 to 344.7 kPa). Based on this information, a median pressure value of 40 PSI (275.8 kPa) was considered in our review of projected flow rate specifications for the well pump. According to manufacturer specifications, a discharge range of between 19.7 L/min and 41.7 L/min (5.2 to 11.0 USgpm) has been determined for the pump, depending on the required level of suction lift (and being in as-new condition).

Assuming a static groundwater level of between approximately 3 m and 5 mBGS (based on a review of local WWR's) and considering friction losses within the plumbing system upstream of the pump (ie. riser pipe [steel and polyethylene], insert adaptors [x3], 90° elbows [x3], and check valve), a total suction lift in excess of 6.1 m (20') has been estimated. Thus, it is projected that the capacity of the pump (not withstanding age and/or other system condition limitations) would likely be in the range of about 19.7 L/min to 24.6 L/min (5.2 to 6.5 USgpm). When compared to the results of AECOM's flow rate test on 14-August-2017, the results fall within the estimated range of flows based on manufacturer specifications, and age / condition of the pump (manufactured in 2006 based on motor-end model number) and downhole suction piping / foot valve assembly (appears older than pump based on material type and visible condition).

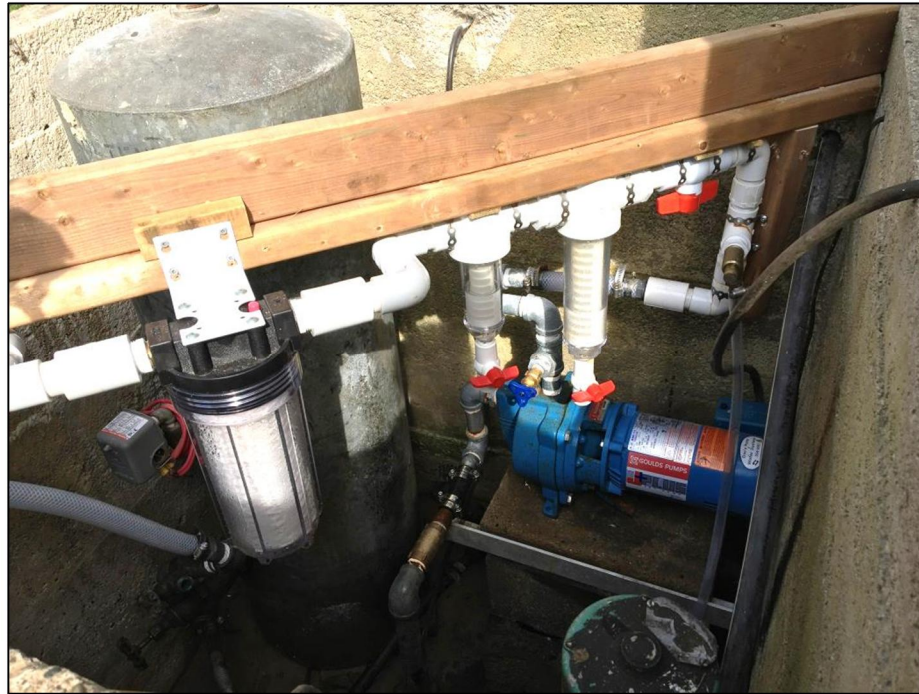
**PHOTO 2: Particle Filter System (as observed by AECOM on 14-August-2017 & 28-August-2017)**

The location of recently-installed filtration system represents a potential concern based on observations made during our 14-August-2017 site visit. As can be observed in **Photo 2**, the filtration system is installed intermediate to the pump / pressure switch and pressure tank. This configuration

is not recommended, as the presence of the filter array would result in additional backpressure on the discharge side of the pump that will progressively increase over time as the capacity of the filters becomes used. With the pressure tank being located on the opposing side of the filtration array, the water system (via the pressure tank) may be calling for water for prolonged periods of time, resulting in significant additional effort for the pump. This can lead to possible pump damage or failure due to prolonged operation and/or repetitive cycling. Water filtration systems for a well supply typically are installed downstream of the primary pumping and pressure systems, inclusive of such components as the well pump, pressure switch and pressure tank.

The collection of a raw (untreated) groundwater quality sample during our 14-August-2017 site visit was facilitated using a hose faucet installed just above the pump discharge within the upper component of the well pit at a location upstream of the particle filtration array (see **Photo 2**). As noted previously, prior to sampling, the system was permitted to flush for a period of 25 minutes using a sanitized hose assembly (provided by AECOM) attached to the faucet orifice. During flushing an appreciable amount of entrained air / gas was observed in the discharge stream.

- Age / condition of the well pump and/or downhole components (including possible loss of prime);
- Presence of the filtration system (as noted above) resulting in damage to the pump system.

In either case above, it is recommended that the property owner contact an MOECC-licensed well pump contractor (Class 4) to assess the system components and to make any necessary replacement, repairs or re-arrangements, as necessary. The information detailed herein appears to be related to the property's pumping / filtration systems and not associated with changes in groundwater flow / quality within the shale bedrock associated with construction of the NKW1 project.

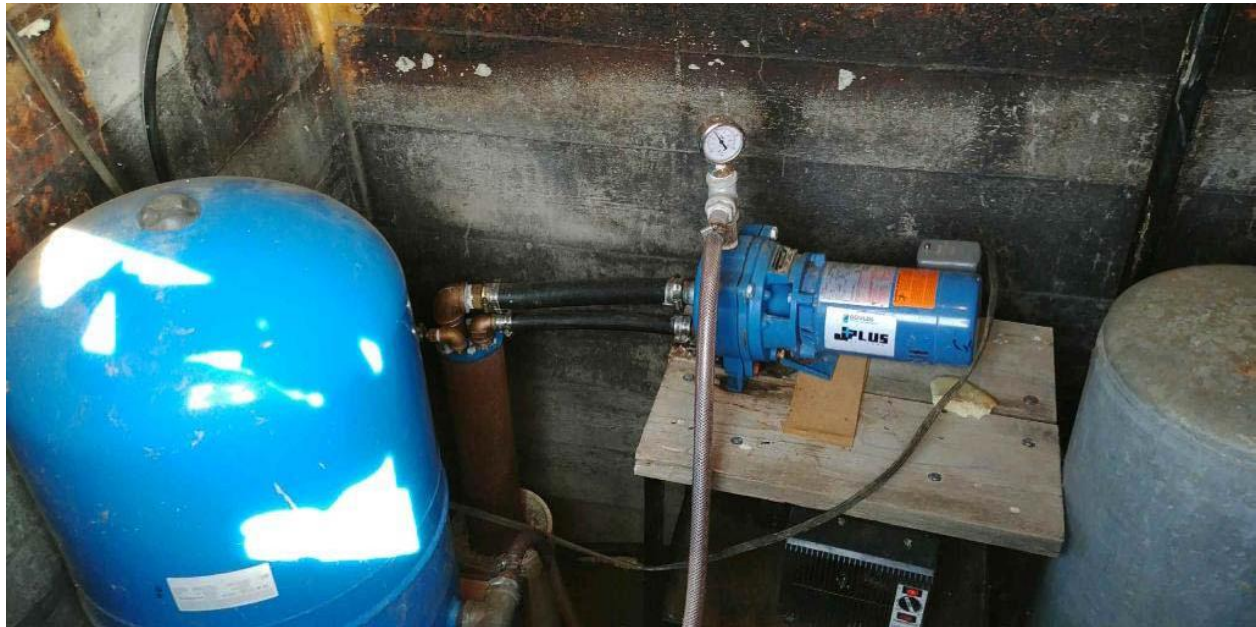
Photograph 1: Well 6 illustrating proximity of pump, hoses and tank to well casing.

The pumps at Wells 6, 10 and 12 were noted to influence well casing vibrations. Maximum particle velocities of as much as 0.8 mm/s were obtained from monitoring data collected at Well 6 on July 13, 2017 when the well pump was operating during a time period without pile driving. Similar conditions were observed for Wells 10 and 12. At the Well 10 site, maximum well casing particle velocities associated with pump operation during the known pumping time period were significantly greater than any measurements made during pile driving within the turbine cluster associated with Well 10. Well 10 exhibited maximum vibrations of about 1.25 mm/s during pump operation. Vibrations of the casings at Wells 11 and 12 were measured during water quality sampling events on August 17, 2017 in the absence of pile driving at any location. During the well sampling, when the pumps turned on, maximum vibration magnitudes of 0.016 and 0.896 mm/s were measured at these wells, respectively. During pile driving, Well 12 operated on a number of clearly definable occasions. Maximum vibration measurements of pump-induced well casing vibrations were as much as 2.4 mm/s at Well 12. The pump for Well 12 is a piston pump mounted directly on top of the well casing. Of note, a piston pump for Well 9 is located within the barn immediately adjacent to the Well 9 casing location. Golder has planned to conduct a separate monitoring event at this well to measure the influence of the pump on well casing vibrations in the absence of pile driving. Photographs of Wells 6, 10 and 12 are attached to this letter illustrating the proximity of the well pump to the casing.

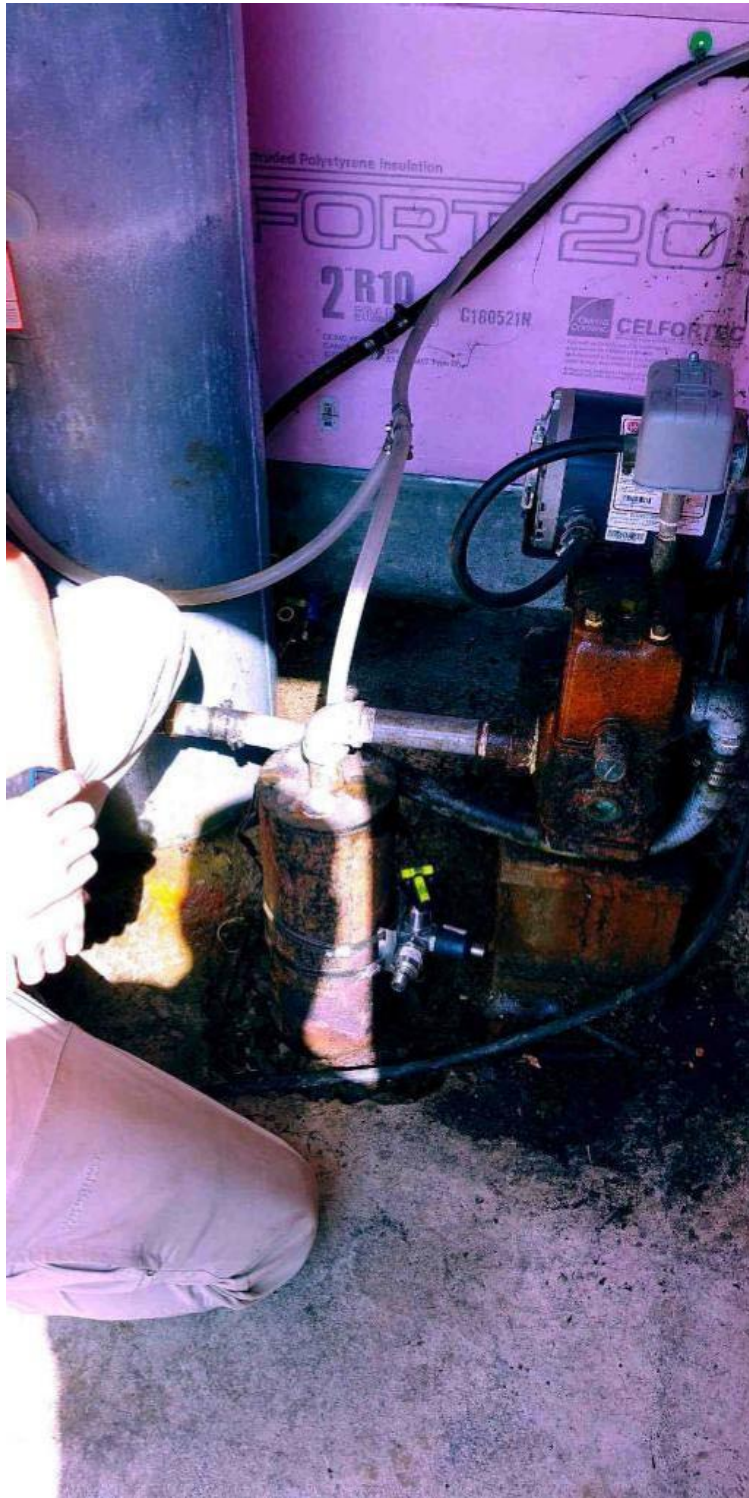
Photograph 2: Well 10 illustrating proximity of pump, hoses and tank to well casing.

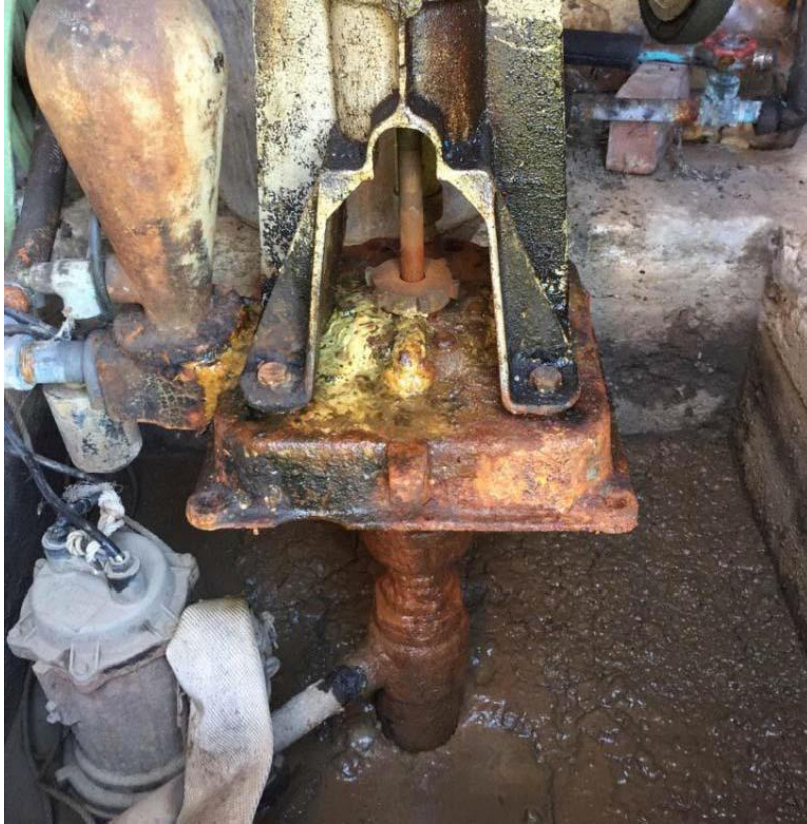
Photograph 3: Well 12 illustrating pump mounted directly on well casing.
