# Technical Memorandum

To	North Kent 1 LP	Page	1
CC	Mark Van der Woerd (AECOM), Jody Law (Pattern), Joshua Vaidhyan (Samsung)		
Subject	<b>North Kent Wind 1 (Chatham-Kent, ON)</b> <b>Well Water Impact Complaint Investigation – UPDATED</b> [REDACTED] - PIN 007500008, [REDACTED]		
From	Jason Murchison, P.Geo.		
Date	October 31 <sup>st</sup> , 2017	Project No.	60343599

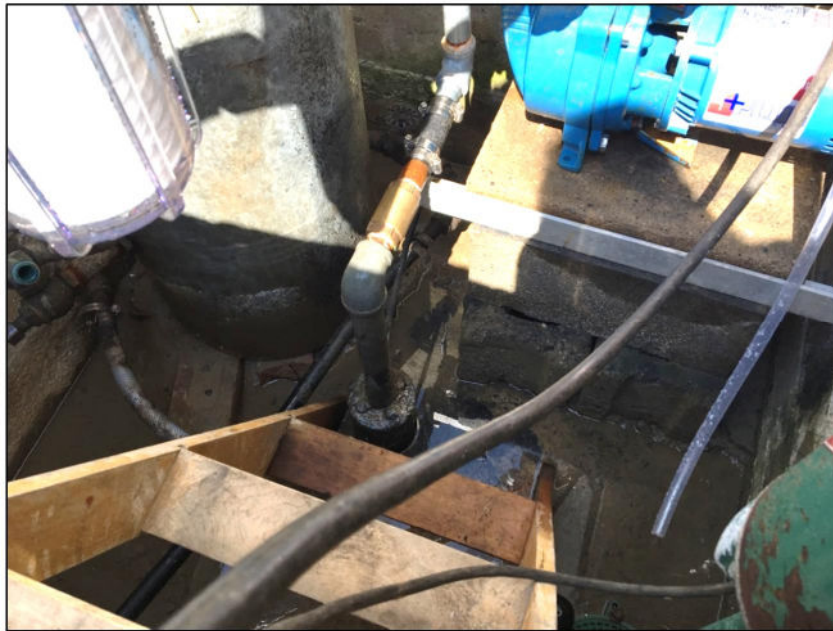
**PHOTO 1: Site Well (as Observed by AECOM on 14-August-2017)**

A copy of the technical brochure for the well pump was obtained from the manufacturer (Goulds) to provide a basis of comparison against the testing results (**Attachment C**). According to the property owner ([REDACTED]), the water system operates in a set cut in/out pressure range of 30/50 PSI (206.8 to 344.7 kPa). Based on this information, a median pressure value of 40 PSI (275.8 kPa) was considered in our review of projected flow rate specifications for the well pump. According to manufacturer specifications, a discharge range of between 19.7 L/min and 41.7 L/min (5.2 to 11.0 USgpm) has been determined for the pump, depending on the required level of suction lift (and being in as-new condition).

Assuming a static groundwater level of between approximately 3 m and 5 mBGS (based on a review of local WWR's) and considering friction losses within the plumbing system upstream of the pump (ie. riser pipe [steel and polyethylene], insert adaptors [x3], 90° elbows [x3], and check valve), a total suction lift in excess of 6.1 m (20') has been estimated. Thus, it is projected that the capacity of the pump (not withstanding age and/or other system condition limitations) would likely be in the range of about 19.7 L/min to 24.6 L/min (5.2 to 6.5 USgpm). When compared to the results of AECOM's flow rate test on 14-August-2017, the results fall within the estimated range of flows based on manufacturer specifications, and age / condition of the pump (manufactured in 2006 based on motor-end model number) and downhole suction piping / foot valve assembly (appears older than pump based on material type and visible condition).

In either case above, it is recommended that the property owner contact an MOECC-licensed well pump contractor (Class 4) to assess the system components and to make any necessary replacement, repairs or re-arrangements, as necessary. The information detailed herein appears to be related to the property's pumping / filtration systems and not associated with changes in groundwater flow / quality within the shale bedrock associated with construction of the NKW1 project.

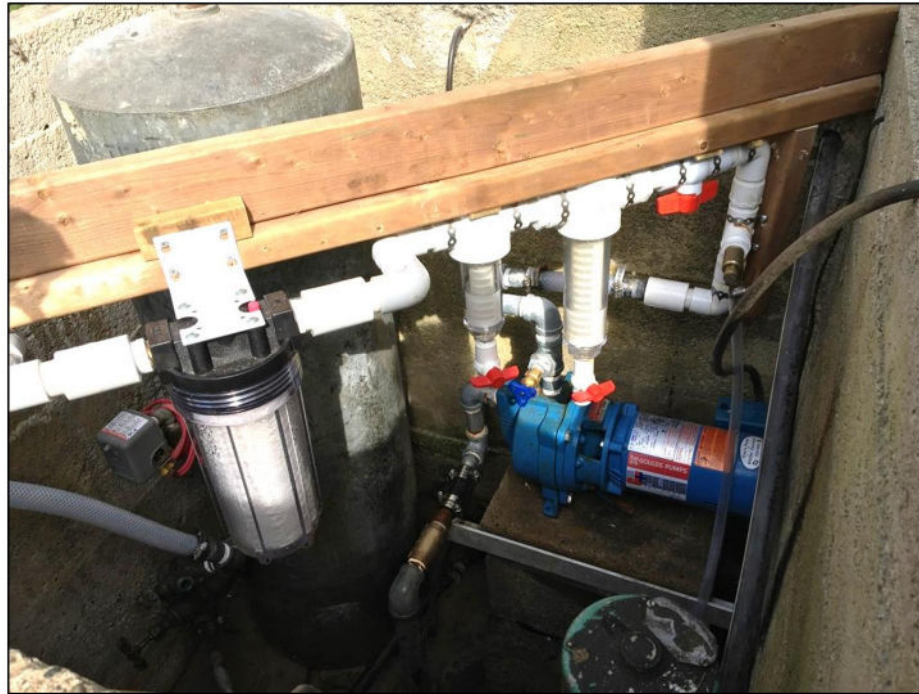
**PHOTO 2: Particle Filter System (as observed by AECOM on 14-August-2017 & 28-August-2017)**

The location of recently-installed filtration system represents a potential concern based on observations made during our 14-August-2017 site visit. As can be observed in **Photo 2**, the filtration system is installed intermediate to the pump / pressure switch and pressure tank. This configuration

is not recommended, as the presence of the filter array would result in additional backpressure on the discharge side of the pump that will progressively increase over time as the capacity of the filters becomes used. With the pressure tank being located on the opposing side of the filtration array, the water system (via the pressure tank) may be calling for water for prolonged periods of time, resulting in significant additional effort for the pump. This can lead to possible pump damage or failure due to prolonged operation and/or repetitive cycling. Water filtration systems for a well supply typically are installed downstream of the primary pumping and pressure systems, inclusive of such components as the well pump, pressure switch and pressure tank.

- Age / condition of the well pump and/or downhole components (including possible loss of prime);
- Presence of the filtration system (as noted above) resulting in damage to the pump system.

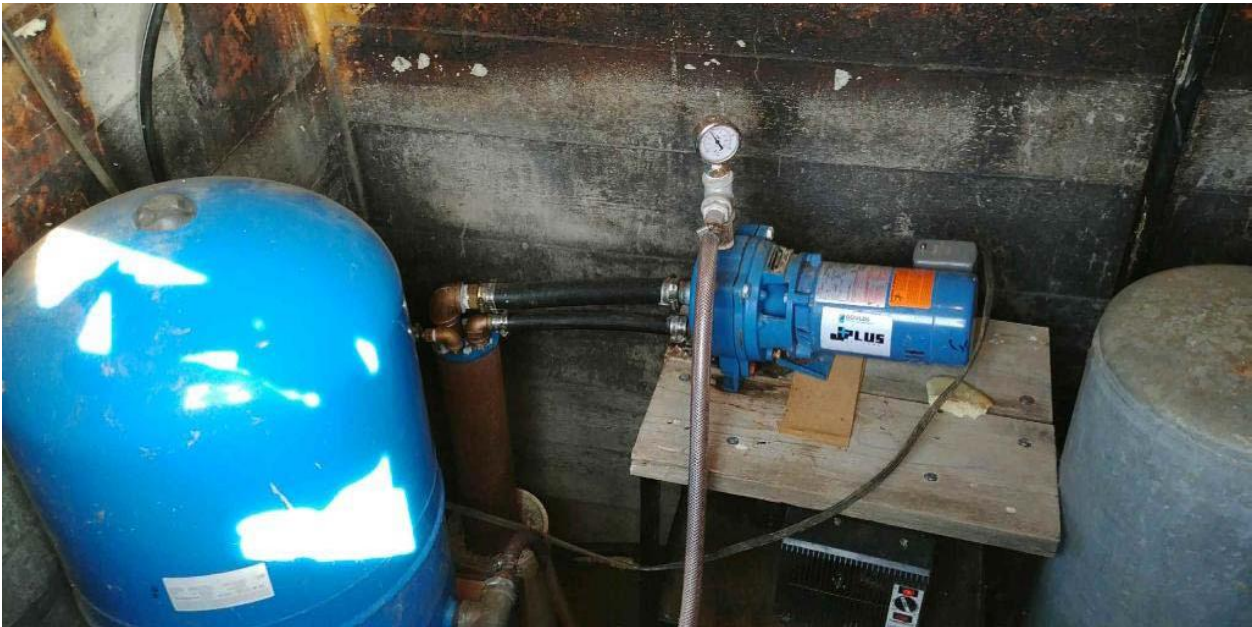
Photograph 1: Well 6 illustrating proximity of pump, hoses and tank to well casing.

The pumps at Wells 6, 10 and 12 were noted to influence well casing vibrations. Maximum particle velocities of as much as 0.8 mm/s were obtained from monitoring data collected at Well 6 on July 13, 2017 when the well pump was operating during a time period without pile driving. Similar conditions were observed for Wells 10 and 12. At the Well 10 site, maximum well casing particle velocities associated with pump operation during the known pumping time period were significantly greater than any measurements made during pile driving within the turbine cluster associated with Well 10. Well 10 exhibited maximum vibrations of about 1.25 mm/s during pump operation. Vibrations of the casings at Wells 11 and 12 were measured during water quality sampling events on August 17, 2017 in the absence of pile driving at any location. During the well sampling, when the pumps turned on, maximum vibration magnitudes of 0.016 and 0.896 mm/s were measured at these wells, respectively. During pile driving, Well 12 operated on a number of clearly definable occasions. Maximum vibration measurements of pump-induced well casing vibrations were as much as 2.4 mm/s at Well 12. The pump for Well 12 is a piston pump mounted directly on top of the well casing. Of note, a piston pump for Well 9 is located within the barn immediately adjacent to the Well 9 casing location. Golder has planned to conduct a separate monitoring event at this well to measure the influence of the pump on well casing vibrations in the absence of pile driving. Photographs of Wells 6, 10 and 12 are attached to this letter illustrating the proximity of the well pump to the casing.
