Technical Memorandum

To	North Kent 1 LP	Page	1
CC	Mark Van der Woerd (AECOM), Jody Law (Pattern), Joshua Vaidhyan (Samsung)		
Subject	North Kent Wind 1 (Chatham-Kent, ON) Well Water Impact Complaint Investigation – UPDATED v.2 [REDACTED] - PIN 007500065, [REDACTED]		
From	Jason Murchison, P.Geo.		
Date	November 22 nd , 2017	Project No.	60343599

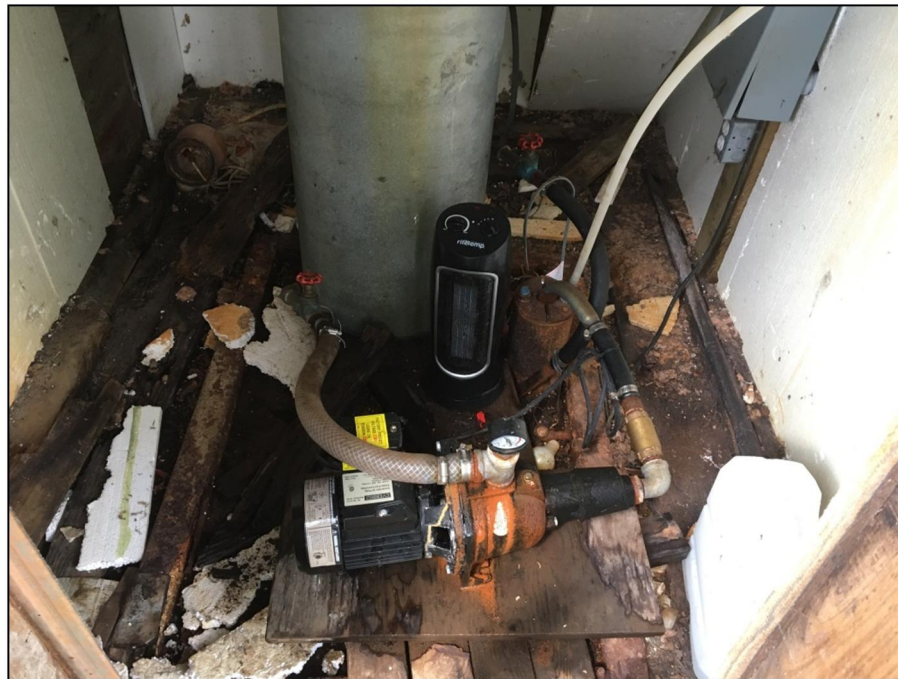
PHOTO 1: Site Well (as Observed by AECOM on 25-August-2017)

DETAILS	[REDACTED] (PIN 007500065)
Well Screen Interval	Not applicable (open bottom)
Well Cover Type	Metal/rubber sanitary well cap
Pump Intake Depth (as on WWR)	9.1 mBGS / 30'
Pumping Rate (as on WWR)	19 L/min / 5 USgpm
Pumping Rate (as meas. by AECOM)	6 L/min / 1.6 USgpm
Well Pump Type	Jet Pump (as observed by AECOM)
Well Pump Size	Unknown
Static Level (as on WWR)	4.6 mBGS / 15'
Pumping Level (as on WWR)	4.9 mBGS / 16'

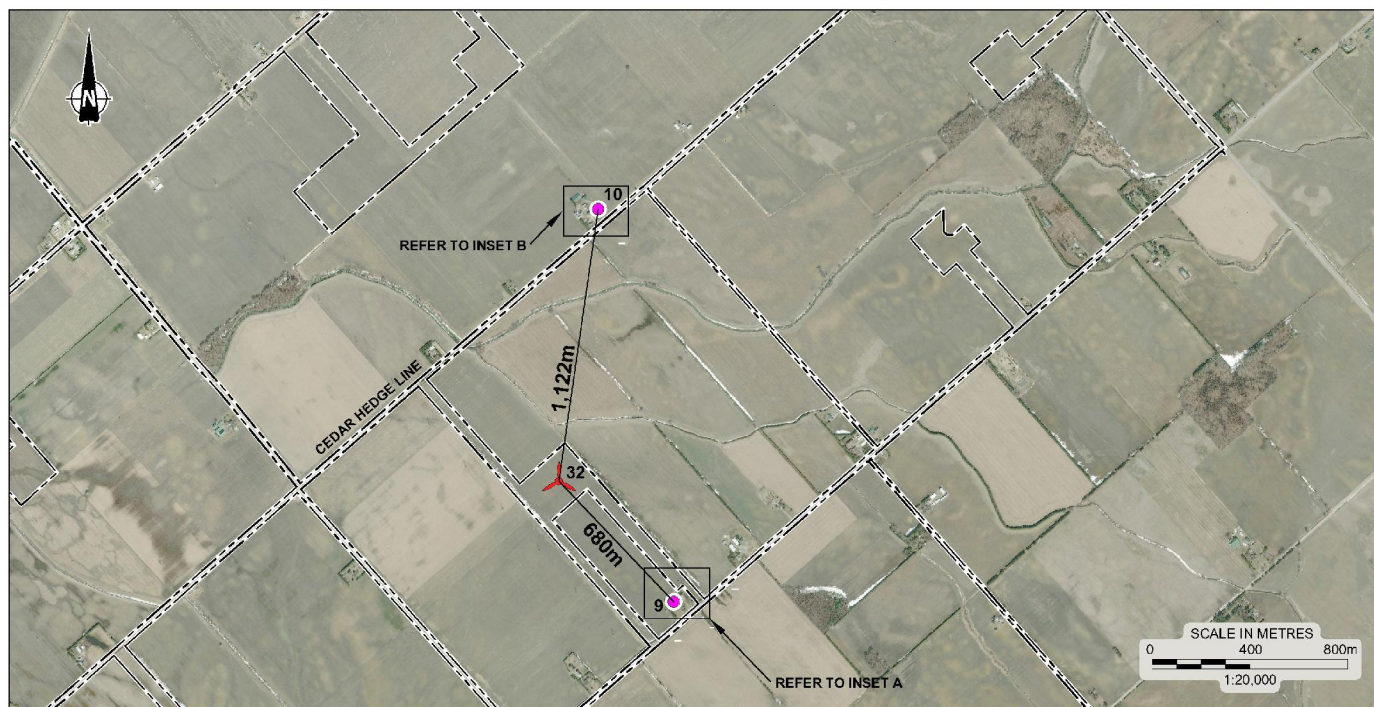
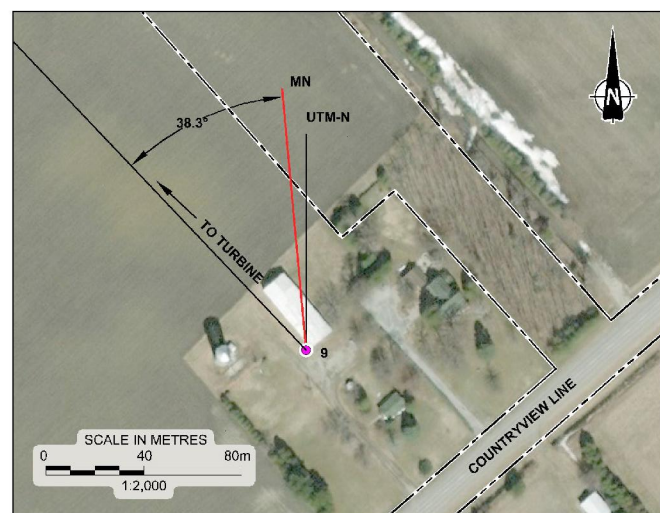
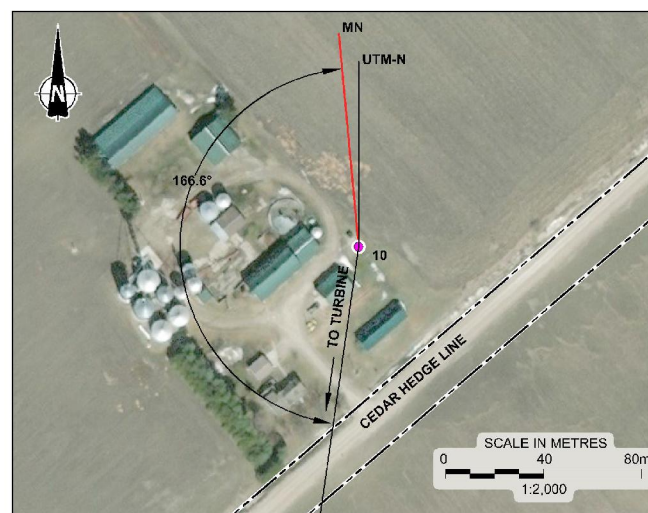
PROJECT			
NORTH KENT 1 VIBRATION MONITORING			
TITLE			
TURBINE PILES AND WATER WELL LOCATION PLAN, T32			
	PROJECT No.	1698031	FILE No. 1698031-2000-R02132
	DATE	DOH/ZLB	Sept. 18/17
	CHECKED		
SCALE			AS SHOWN
FIGURE T32

Vibration monitoring completed by GAL in the immediate vicinity of T32 ranged in offset distance from a minimum of 9.5 m at Pile #8 to a maximum of 26.4 m at Pile #17 (average of 18.9 m). During this monitoring, reported daily PPV values for work completed on 11-August-2017 were consistent at 3.43 mm/s, and on 14-August-2017 at 4.83 mm/s. No apparent correlation (increase / decrease) is observed in PPV values reported by GAL in response to pile driving activities on either day.
