# Technical Memorandum

To	North Kent 1 LP	Page	1
CC	Mark Van der Woerd (AECOM), Jody Law (Pattern), Joshua Vaidhyan (Samsung)		
Subject	<b>North Kent Wind 1 (Chatham-Kent, ON)</b> <b>Well Water Impact Complaint Investigation – UPDATED v.2</b> [REDACTED] & [REDACTED] - PIN 007530115, [REDACTED]		
From	Jason Murchison, P.Geo.		
Date	November 22 <sup>nd</sup> , 2017	Project No.	60343599

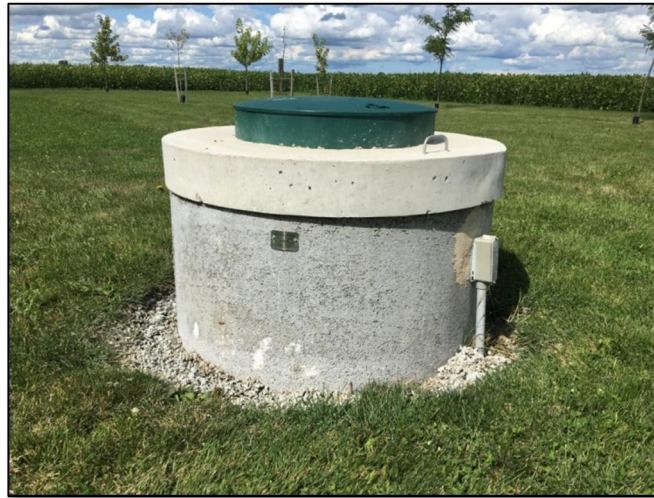
PHOTO 1: Site Well (as Observed by AECOM on 6-September-2017)

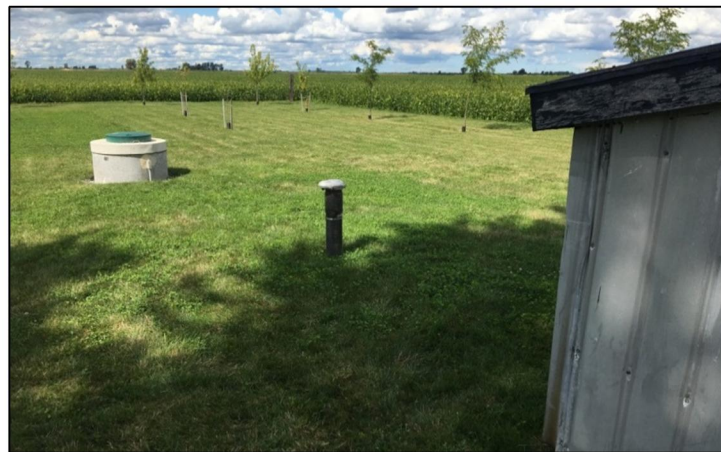
PHOTO 2: Bored Well with Unused Drilled Well in Foreground (as Observed by AECOM on 6-September-2017)

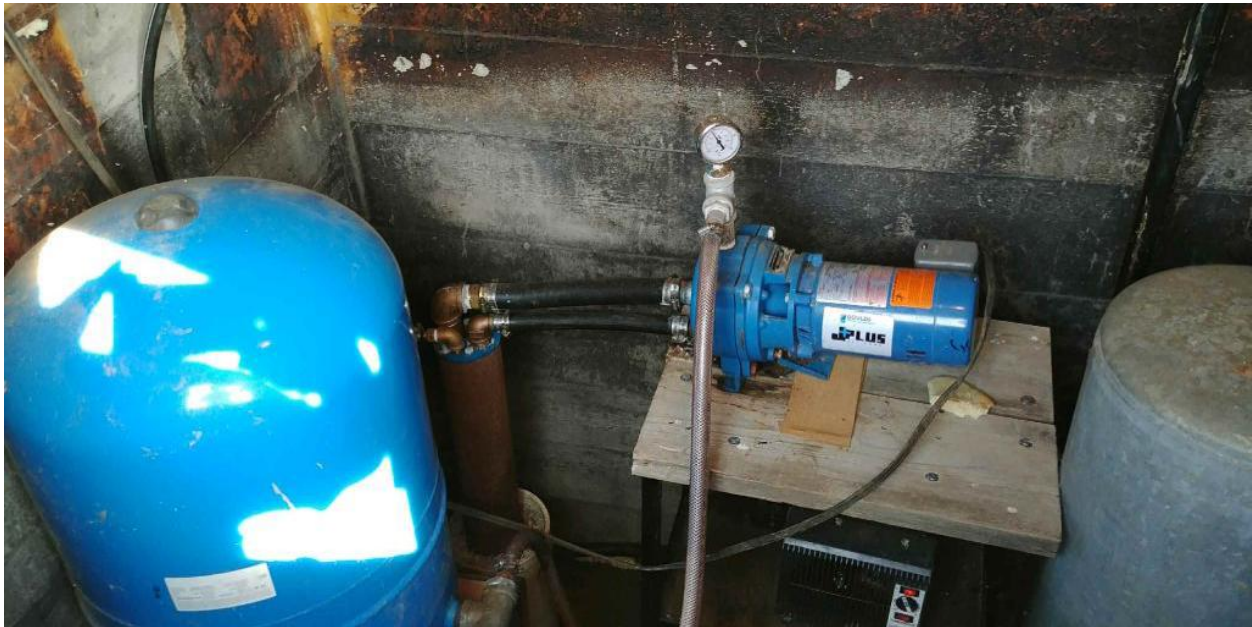
Photograph 1: Well 6 illustrating proximity of pump, hoses and tank to well casing.

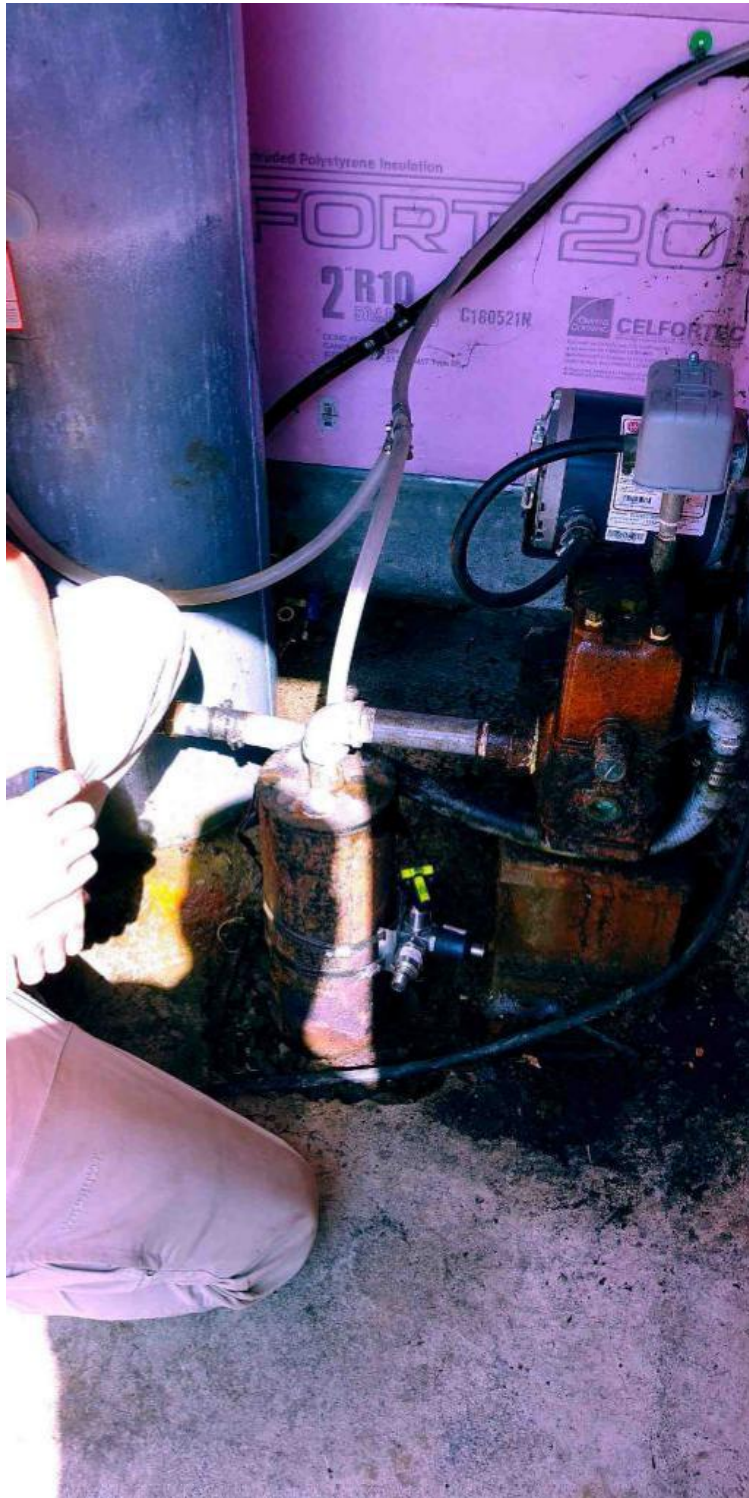
Photograph 2: Well 10 illustrating proximity of pump, hoses and tank to well casing.

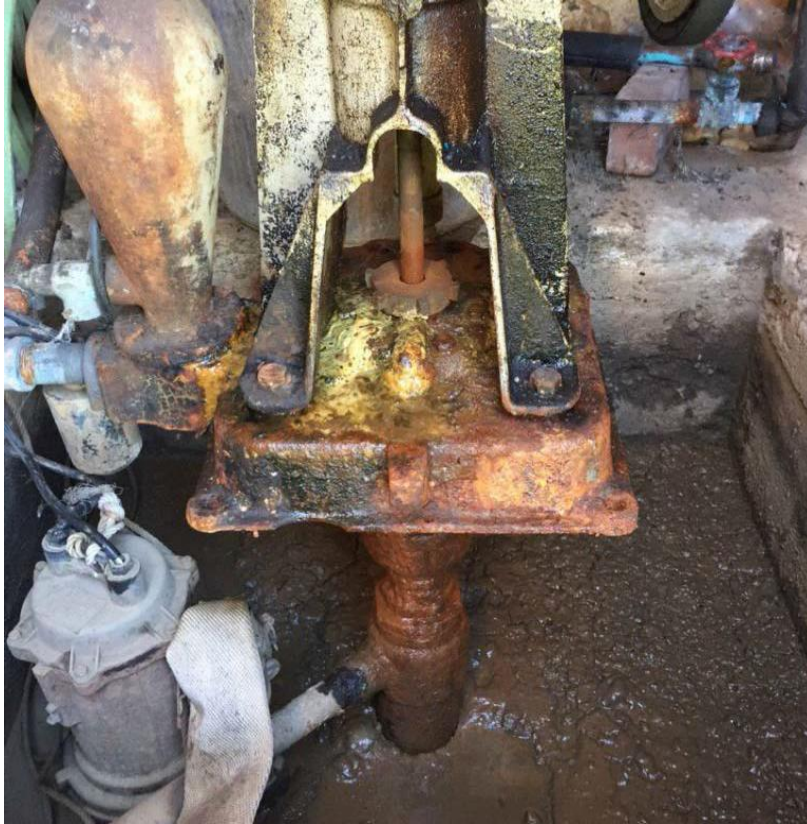
Photograph 3: Well 12 illustrating pump mounted directly on well casing.
