Technical Memorandum

То	North Kent 1 LP	Page 1				
CC	Mark Van der Woerd (AECOM), Jody Law (Pattern), Joshua Vaidhyan (Samsung)					
Subject	North Kent Wind 1 (Chatham-Kent, ON) Well Water Impact Complaint Investigation – UPDATED v.2 - PIN 007490092,					
From	Jason Murchison, P.Geo.					
Date	November 22 ^{na} , 2017	Project No.	60343599

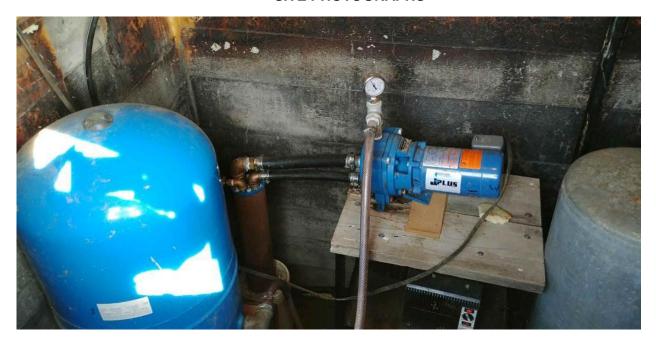
Photograph 1: Well 6 illustrating proximity of pump, hoses and tank to well casing.

Monitoring Notes: Tractor was observed operating frequently near Well 6. Water pump was observed cycling on and off during pile driving operations and remaining on for periods of 2 to 4 minutes. When pump was operating, casing at Well 6 exhibited particle velocities in the range of 0.08 to 0.12 mm/s and dominated analysis of data. Pile restrike events were of short duration with the following total number of hammer blows shown in parentheses: Pile 1 (20), Pile 10 (5 to 7), 13 (205), 14 (140), 16 (51), 15 (214). Pile 17 experienced 446 hammer blows over a period of 9 minutes. Piles noted with PDA indicate restrike events during which pile dynamics analyzer monitoring was completed. Piles noted with "A" represent piles installed to replace similarly-numbered piles. After installation, selected piles were struck again with the hammer to demonstrate resistance performance and these are noted as "restrikes". Monitoring of deliberate pump operation at Well 6 on July 13, 2017, during a period when no pile driving was occuring, measured maximum particle velocities of 0.08 to 0.8 mm/s. Where total driving duration between till/rock start and end times noted above is not representative, actual driving duration is shown in parentheses in minutes and seconds: 13A(10:00), 15A(6:24), 17 restrike (14:00), 13PDA(6:20). Total pile driving durations derived from start and end times noted above includes labour breaks, equipment work, splicing, welding and other standby time.

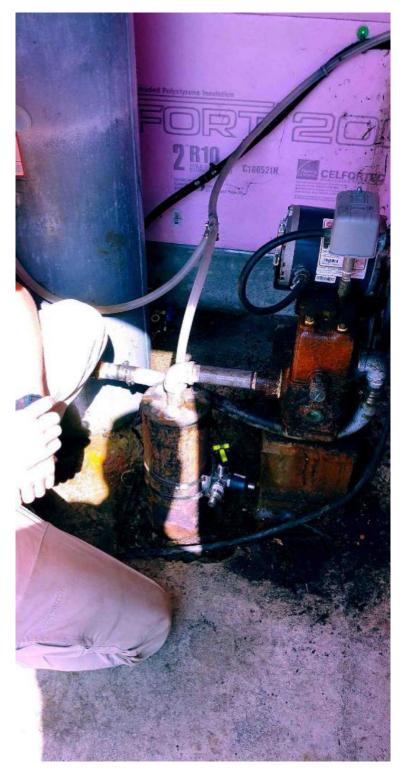
Photograph 2: Well 10 illustrating proximity of pump, hoses and tank to well casing.

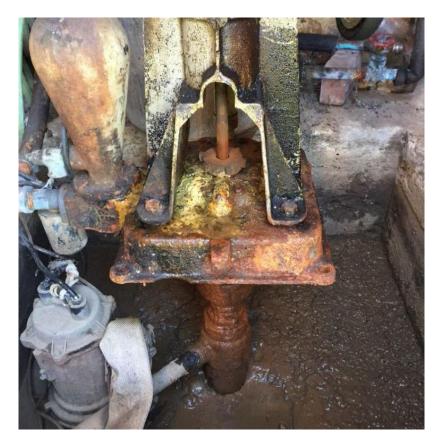
Photograph 3: Well 12 illustrating pump mounted directly on well casing.

For context when reviewing Table 1, attached, it should be noted that during well monitoring of multiple wells in the area, well casing vibrations directly attributable to the well pumps were measured and these were as much as 2.4 millimetres per second (mm/s) at Well 12.
