# Technical Memorandum

To	North Kent 1 LP	Page	1
CC	Mark Van der Woerd (AECOM), Jody Law (Pattern), Joshua Vaidhyan (Samsung)		
Subject	<b>North Kent Wind 1 (Chatham-Kent, ON)</b> <b>Well Water Impact Complaint Investigation – UPDATED v.2</b> [REDACTED] - PIN 007530061, [REDACTED]		
From	Jason Murchison, P.Geo.		
Date	November 22 <sup>nd</sup> , 2017	Project No.	60343599

**SUMMARY OF VIBRATION MONITORING  
FOUNDATION PILE DRIVING – MULTIPLE TURBINES  
NORTH KENT WIND 1 PROJECT  
CHATHAM-KENT, ONTARIO**

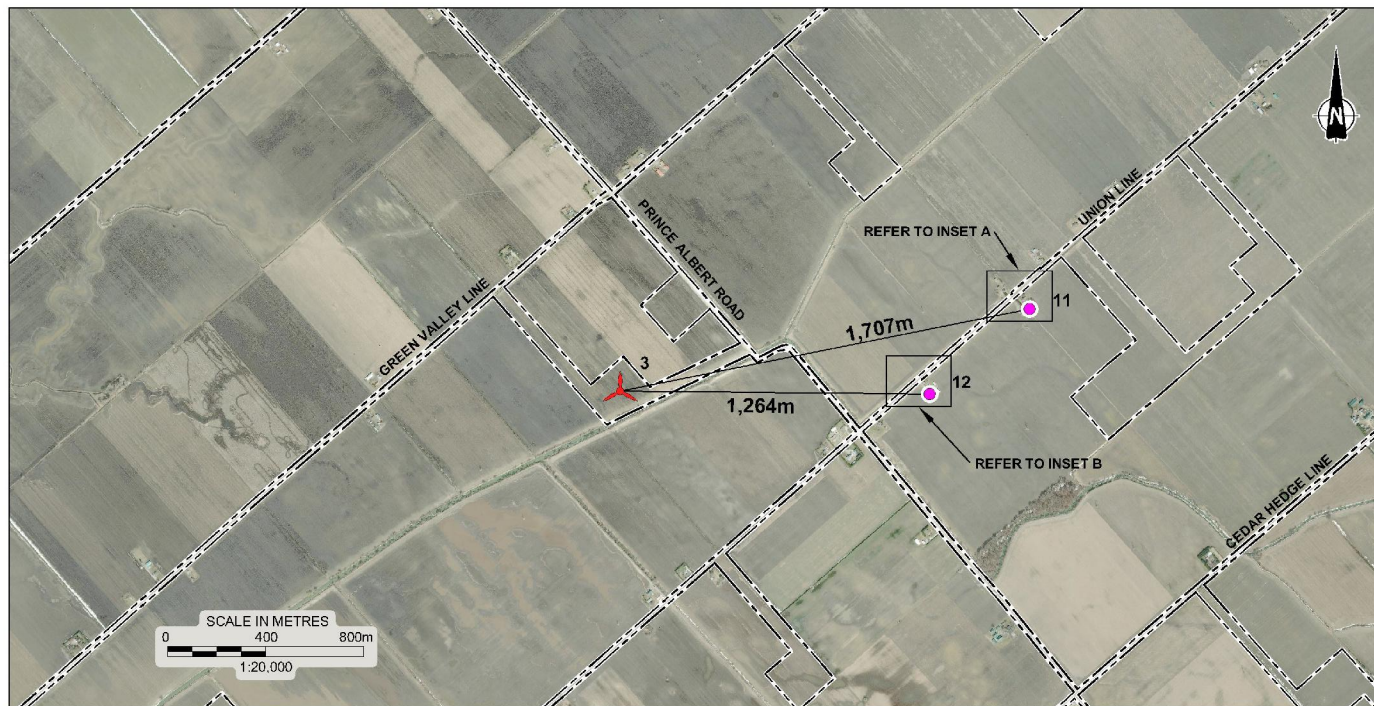
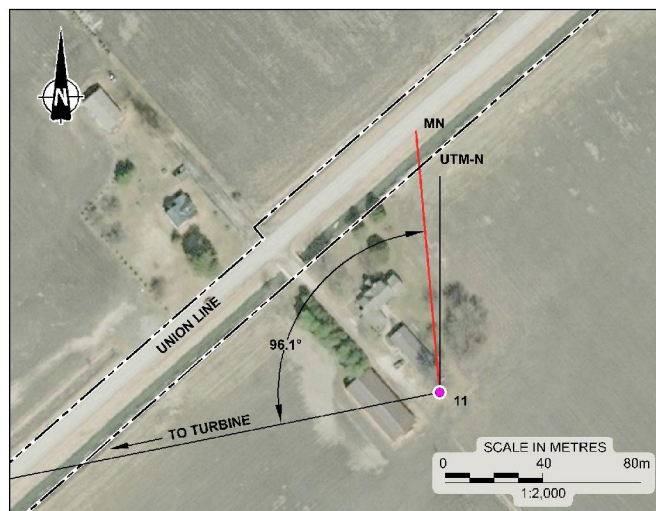
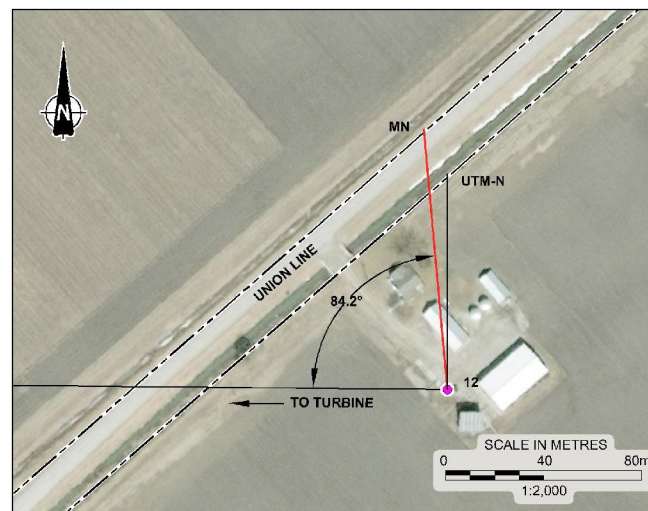
PROJECT			
NORTH KENT 1 VIBRATION MONITORING			
TITLE			
TURBINE PILES AND WATER WELL LOCATION PLAN, T3			
	PROJECT NO.	16686031	FILE NO. 16686031-2000-RC2013
	DATE	DCH/ZLB Sept. 18/17	SCALE AS SHOWN REV.
	CHECKED		
FIGURE T3

Pile driving activities for foundation construction at Turbine Location #3 (T3) commenced in the area of Pile #7 at 12:16pm on 22-August-2017. Following the initial pile installation, an additional ten (10) piles at the T3 site were driven on that same day, with work concluding at the location of Pile #8 at approximately 6:54pm. Seven (7) additional piles at the T3 site were installed on the subsequent day, with the final installation at Pile #3 having been completed at 12:41pm. Restrikes (to demonstrate resistance performance) also were completed at nine (9) pile locations this same day. A replacement Pile #7A was completed on 6-September-2017, albeit approximately one (1) week following the reported outset of well interference. As noted above, the pile driving work at T3 was undertaken at a distance of approximately 690 m (south-southeast) from the property owner's water well.

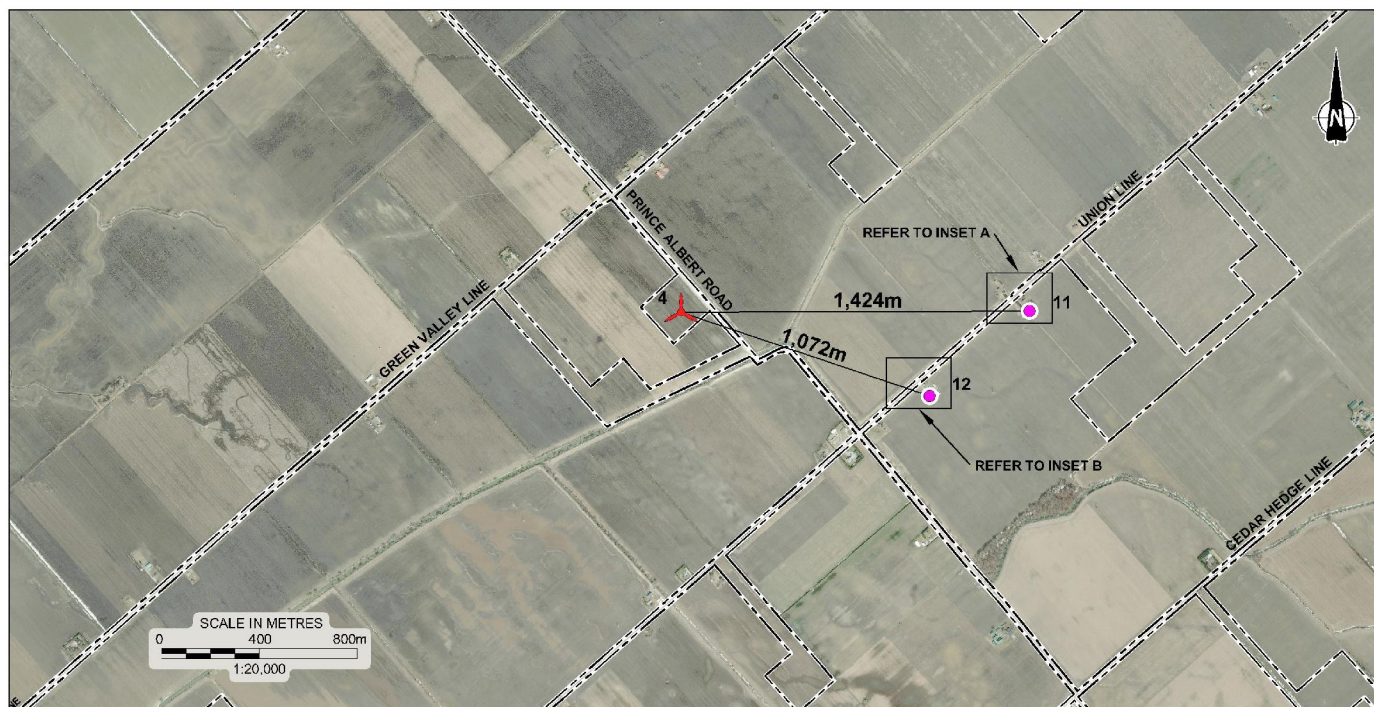
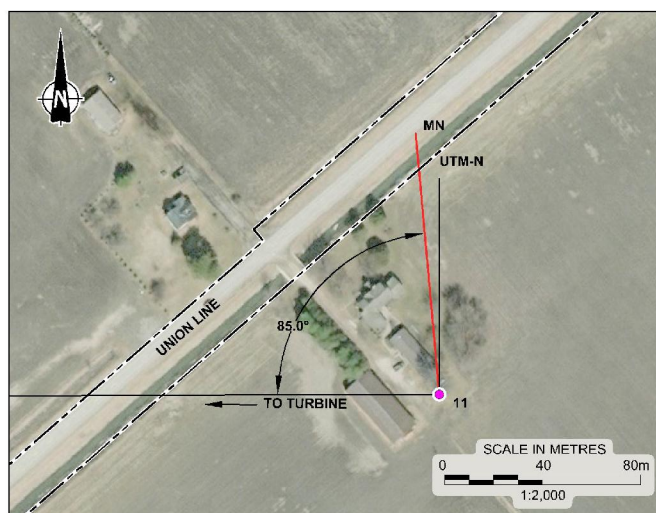
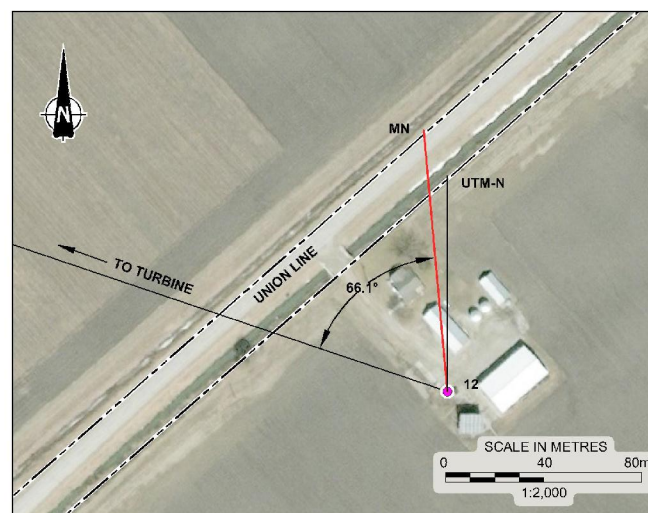
PROJECT			
NORTH KENT 1 VIBRATION MONITORING			
TITLE			
TURBINE PILES AND WATER WELL LOCATION PLAN, T4			
PROJECT No.	1698031	FILE No.	1698031-2000-R020T4
DRAWN BY	DOH/ZLB	DATE	Sept 18/17
CHECKED		SCALE	AS SHOWN
			FIGURE T4

Pile driving activities for foundation construction at Turbine Location #4 (T4) commenced in the area of Pile #7 at 9:56am on 24-August-2017. Following the initial pile installation, an additional twelve (12) piles at the T4 site were driven on that same day, with work concluding at the location of Pile #8 at approximately 3:14pm. Five (5) additional piles at the T4 site were installed on the subsequent day, with the final installation at Pile #2 having been completed at 9:16am. As noted above, the pile driving work at T4 was undertaken at a distance of about 720 m (southeast) from the property owner's water well.
