Technical Memorandum

To	North Kent 1 LP	Page	1
CC	Mark Van der Woerd (AECOM), Jody Law (Pattern), Joshua Vaidhyan (Samsung)		
Subject	North Kent Wind 1 (Chatham-Kent, ON) Well Water Impact Complaint Investigation - UPDATED [REDACTED] - PIN 007530004, [REDACTED]		
From	Jason Murchison, P.Geo.		
Date	November 30 th , 2017	Project No.	60343599

1. Introduction and Background

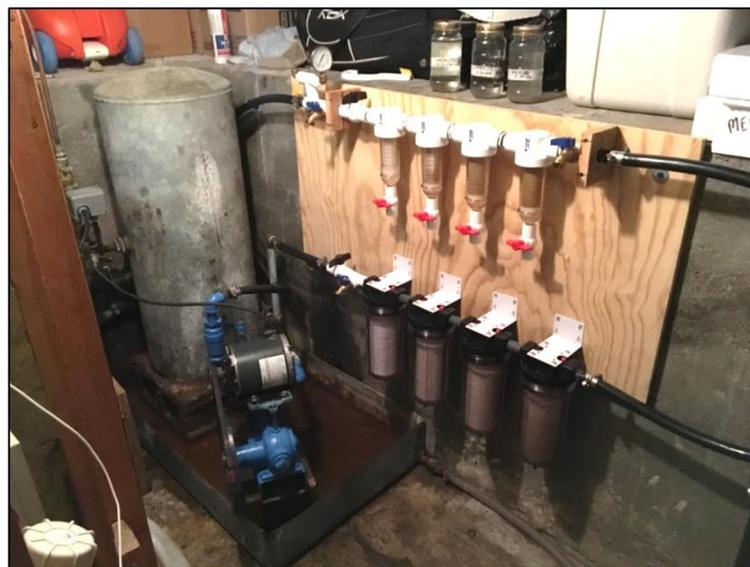
PHOTO 1: Particle Filter System (as observed by AECOM on 14-September-2017)

The location of recently-installed filtration system represents a concern based on observations made during our 14-September-2017 site visit. As can be observed in **Photo 1**, the filtration system is installed intermediate to the well (piston) pump and pressure tank / pressure switch. This configuration is not recommended, as the presence of the filter array would result in the generation of additional backpressure on the discharge side of the pump (as observed during our site visit). The amount of backpressure generated is cumulative based on the number and pore diameter of filters that are installed and will progressively increase over time as the capacity of the filters becomes used. With the pressure tank and pressure switch being located on the opposing side of the filtration array, the water system (via the pressure tank and switch) may be calling for water for prolonged periods of time, resulting in significant additional effort for the pump. This can lead to possible pump damage or failure due to prolonged operation under a significant backpressure condition and/or repetitive cycling. Labouring and/or repetitive cycling of a well pump can also result in the generation of turbulence within the well which can suspend sediment existing at its base and draw it into the water system. This effect may be exacerbated should the pump inlet within the well be located in close proximity to the well bottom. To alleviate these issues, water filtration systems for a well supply typically are installed downstream of the primary pumping and pressure systems (ie. on the distribution side of the water system), inclusive of such components as the well pump, pressure switch and pressure tank.

The pump labouing and lack of water observed during pump and water treatment system in operation on 14-September-2017 is interpreted to likely be a result of one or both of the potential mechanisms below.

- Age / condition of the well pump and/or downhole components (including the well itself);
- Presence of the filtration system (as noted above) resulting in a restriction and/or damage to the pumping system.

In either case above, it is recommended that the property owner contact an MOECC-licenced well pump contractor (Class 1 / Class 4) to assess the system components and to make any necessary replacement, repairs or re-arrangements, as necessary. The information detailed herein appears to be related to the property's pumping / filtration systems and not associated with changes in groundwater flow / quality.

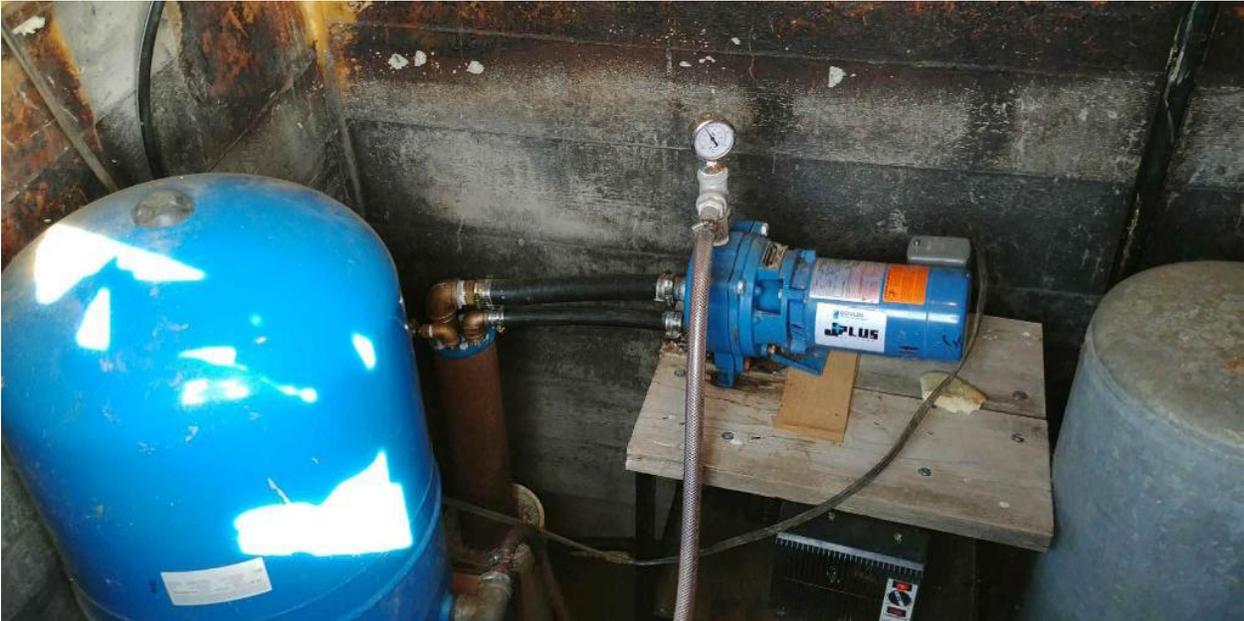
Photograph 1: Well 6 illustrating proximity of pump, hoses and tank to well casing.

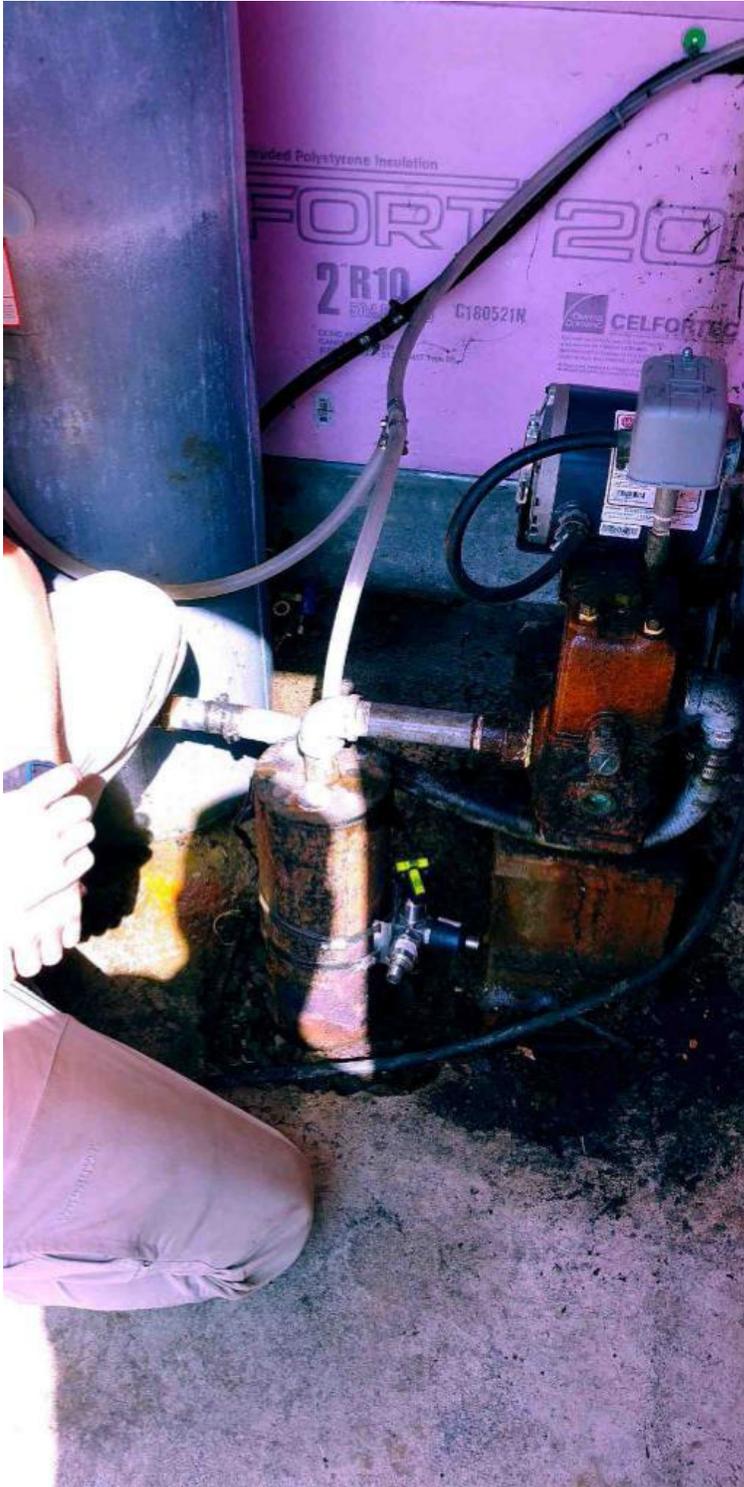
Photograph 2: Well 10 illustrating proximity of pump, hoses and tank to well casing.

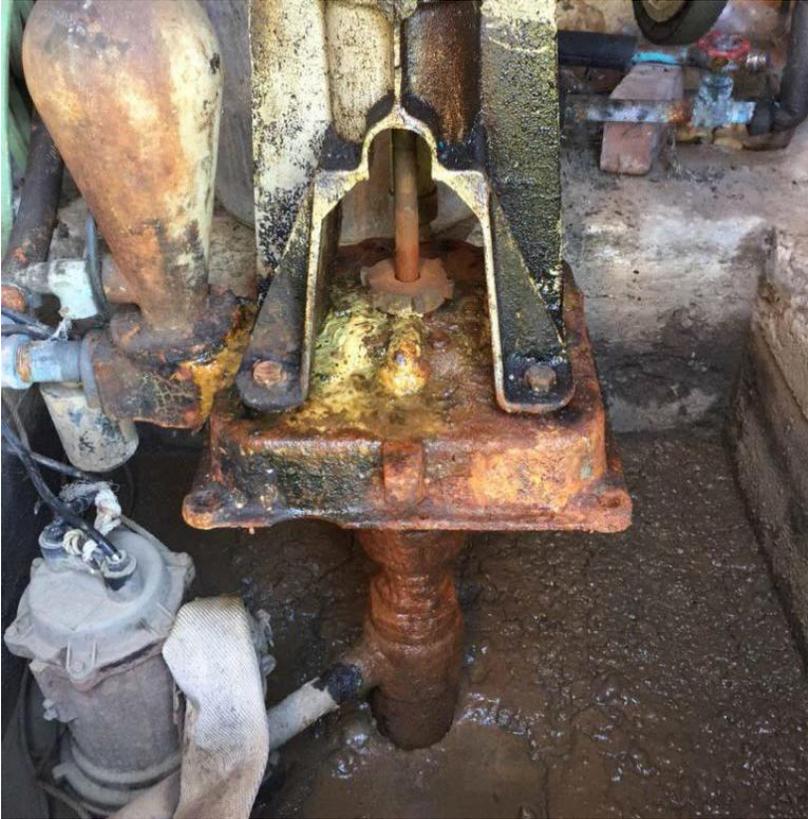
Photograph 3: Well 12 illustrating pump mounted directly on well casing.
