Technical Memorandum

To	North Kent 1 LP	Page	1
CC	Mark Van der Woerd (AECOM), Jody Law (Pattern), Joshua Vaidhyan (Samsung)		
Subject	**North Kent Wind 1 (Chatham-Kent, ON)** **Well Water Impact Complaint Investigation** [redacted] **– PIN 007530030,** [redacted] **(Dresden, ON)**		
From	Jason Murchison, P.Geo.		
Date	January 25th, 2017	Project No.	60343599

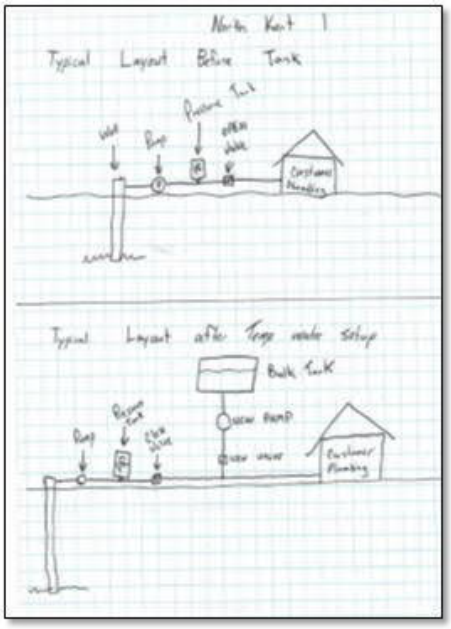
- NKW1 forwarded an email from JM Controls & Electric Ltd., (JMCE) dated 22-November-2017 which provided a summary of their inspection of the plumbing system within the [redacted] residence. Specifically, it is stated, "*We attended the site and none of the existing plumbing to the well was modified. We simply "t'd" in after the customers pressure tank,*

shut off the valve between the customer well and the house. If the customer was to turn on both valves, I can imagine that our system would pump water back down though the pressure tank, though the pump and into the well head (which may have been what happened). I realize the simple solution for this is to physically isolate (by disconnecting the pipe) between the well and customers house, however, most customers insist we keep it connected so they can continue to sample water from the well. See piping diagram attached on how we are typically connecting the systems. Sorry for its crudeness!".
