6B Water Body Site Investigation
Report

For
South Kent Wind Project

SOUTH KENT WIND PROJECT **Water Body Site Investigation Report**

Date: May 2012

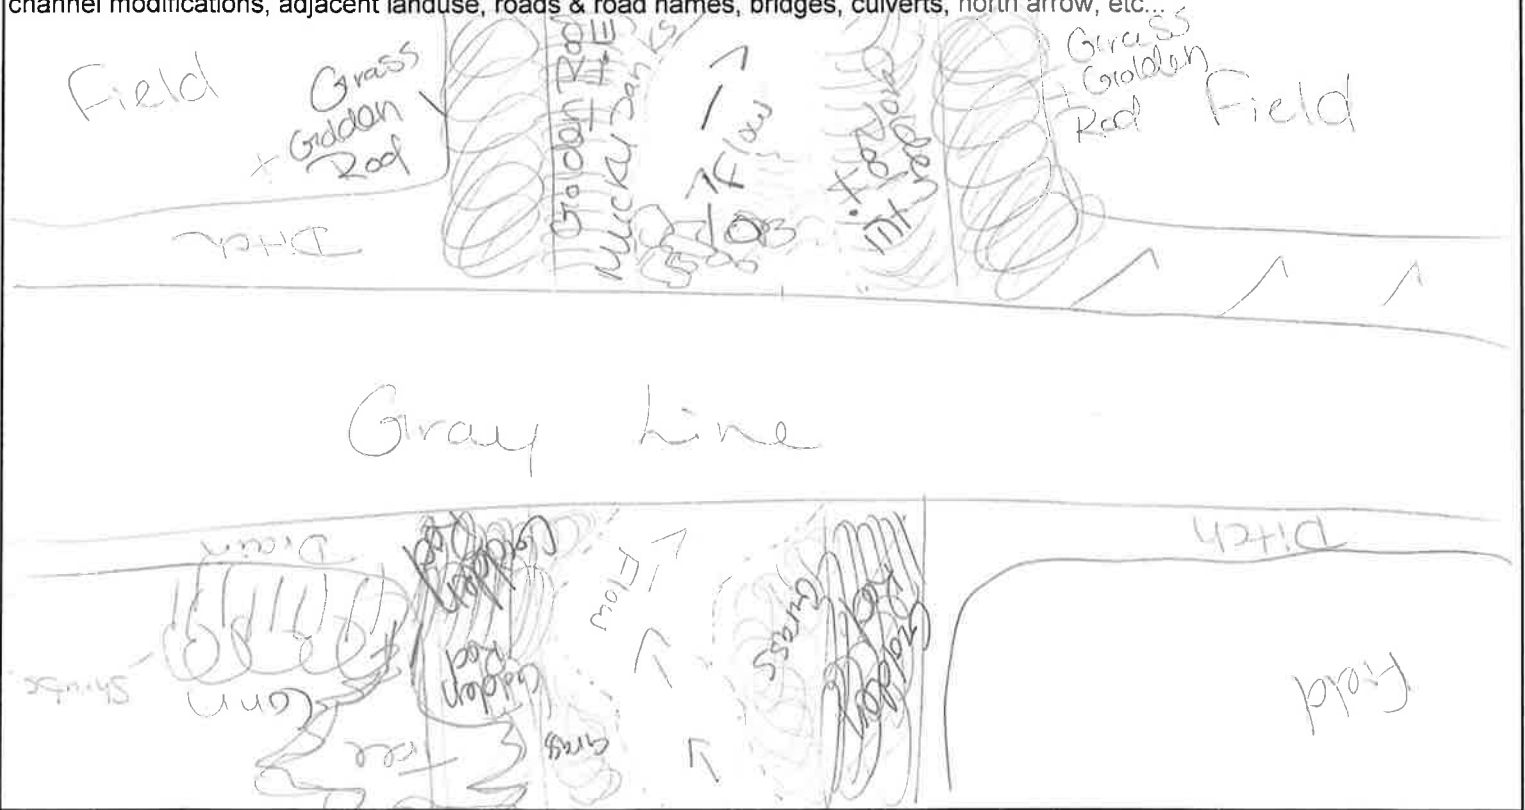
SITE DRAWING

Include: watercourse and name, flow direction, riffle/pool/run habitat, side tributaries, station location, approx. reach length, channel modifications, adjacent landuse, roads & road names, bridges, culverts, north arrow, etc.

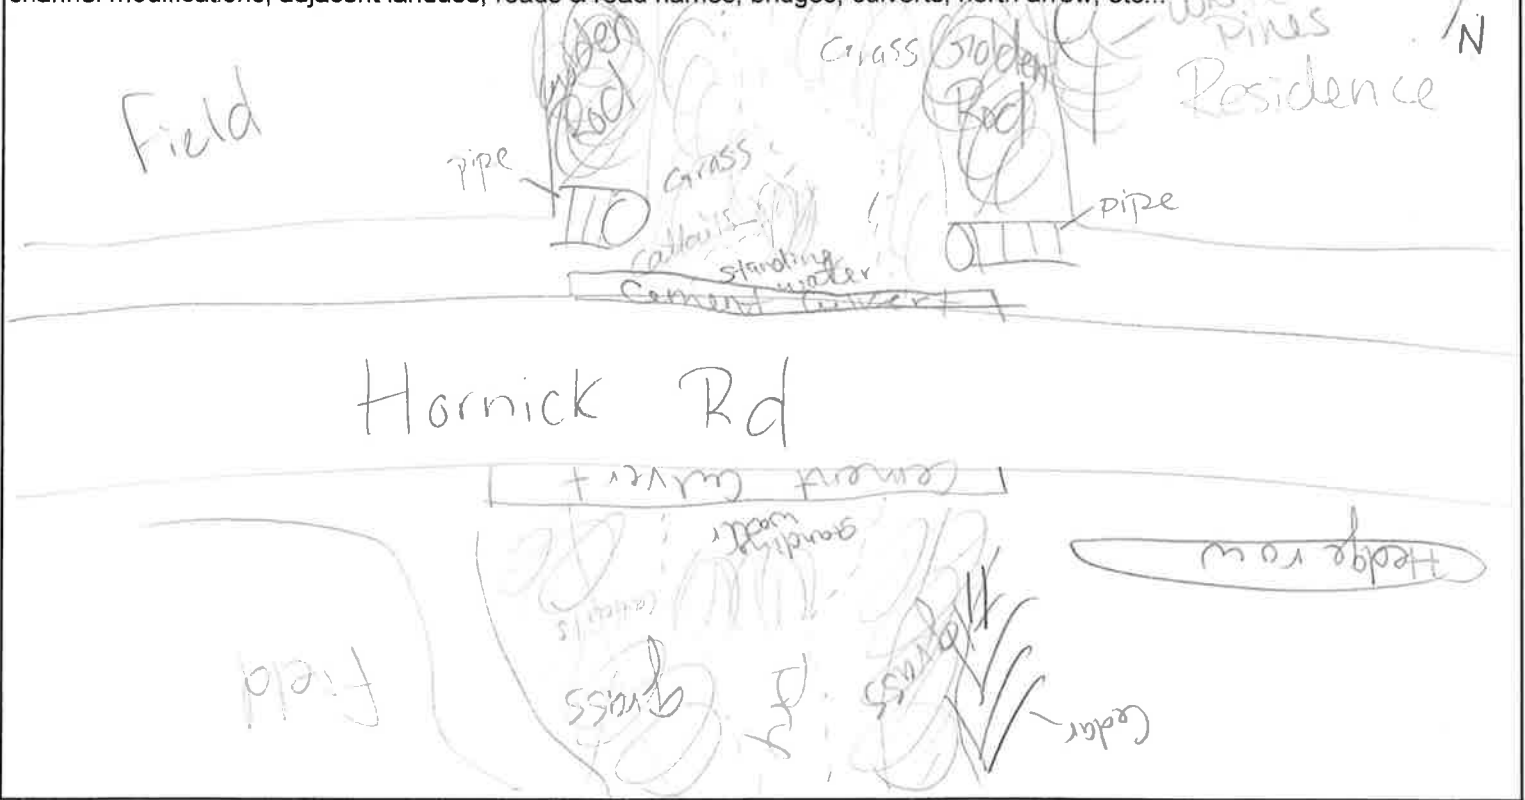
SITE DRAWING

Include: watercourse and name, flow direction, riffle/pool/run habitat, side tributaries, station location, approx. reach length, channel modifications, adjacent land use, roads & road names, bridges, culverts, north arrow, etc...

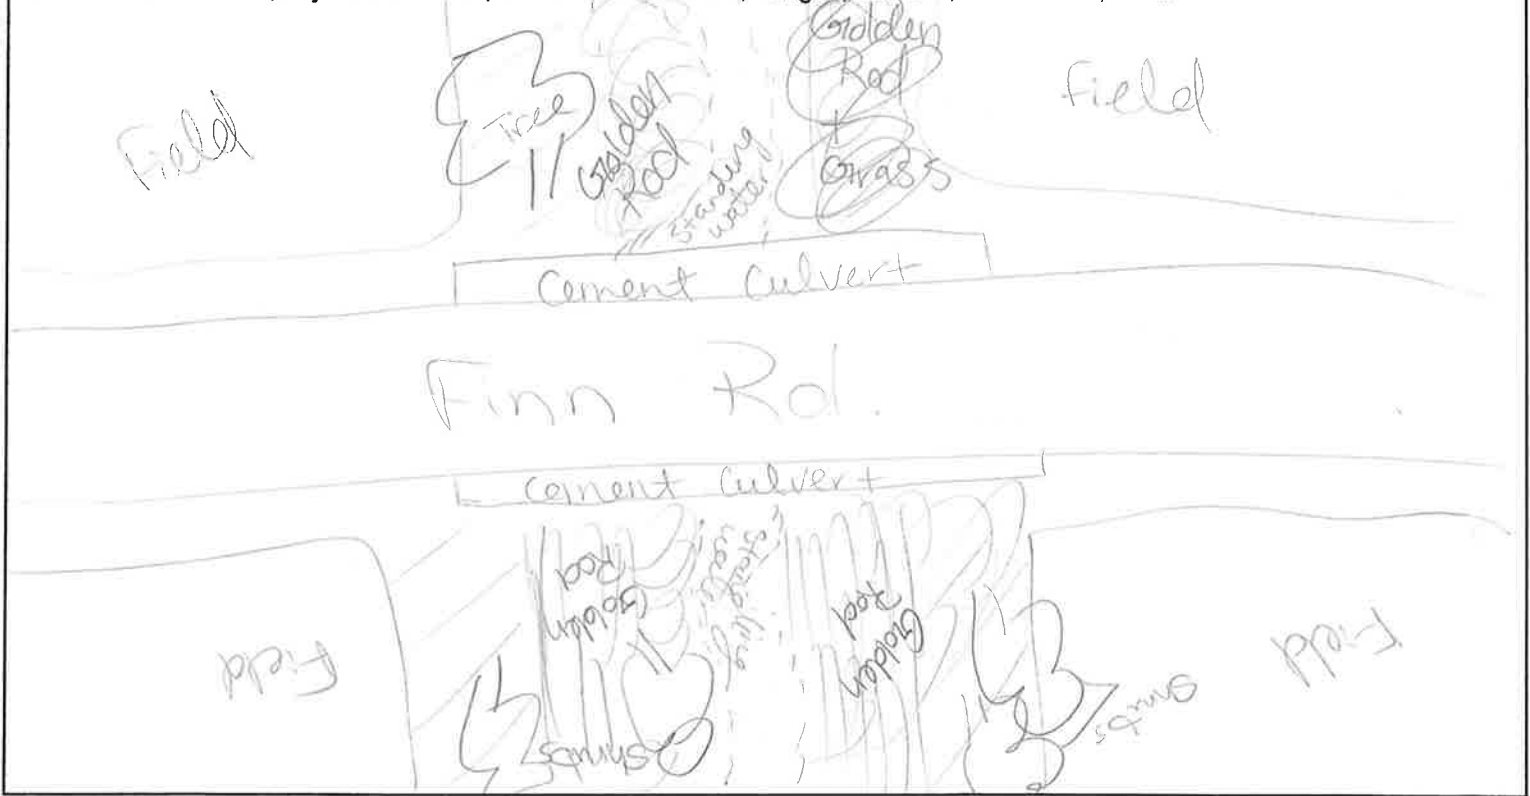
SITE DRAWING

Include: watercourse and name, flow direction, riffle/pool/run habitat, side tributaries, station location, approx. reach length, channel modifications, adjacent landuse, roads & road names, bridges, culverts, north arrow, etc...

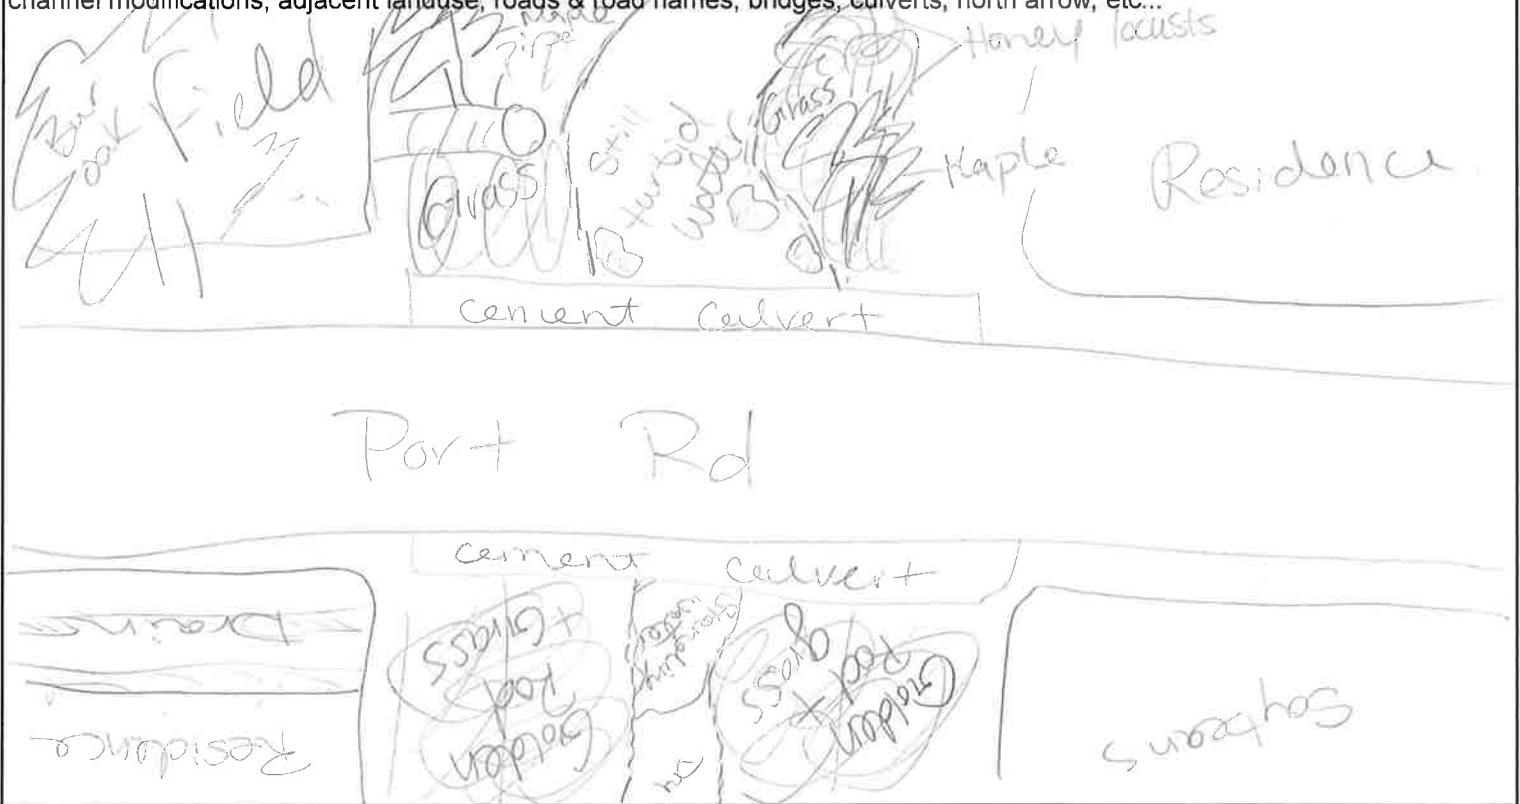
SITE DRAWING

Include: watercourse and name, flow direction, riffle/pool/run habitat, side tributaries, station location, approx. reach length, channel modifications, adjacent land use, roads & road names, bridges, culverts, north arrow, etc...

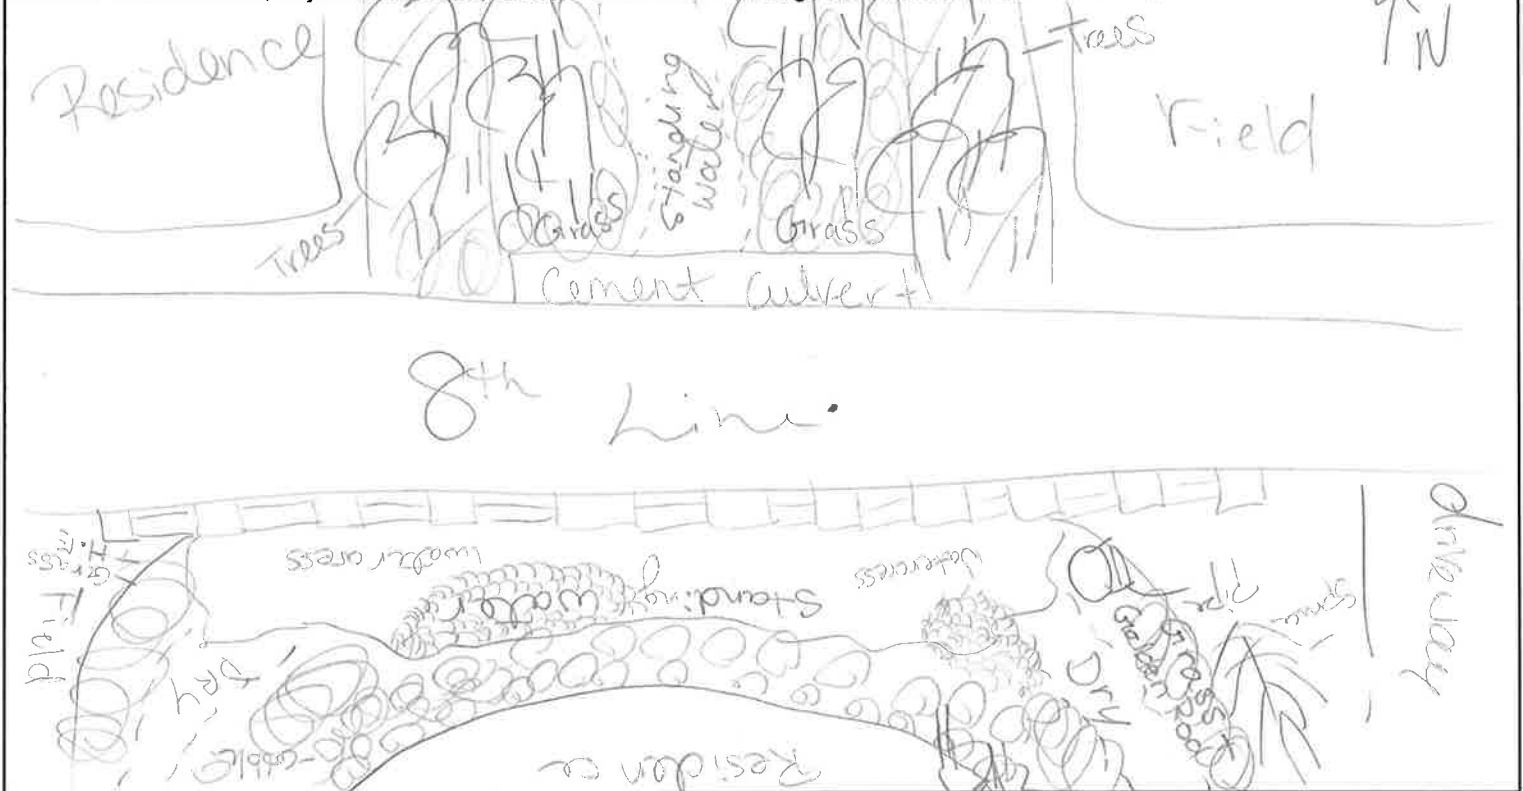
SITE DRAWING

Include: watercourse and name, flow direction, riffle/pool/run habitat, side tributaries, station location, approx. reach length, channel modifications, adjacent land use, roads & road names, bridges, culverts, north arrow, etc...

- channel breaks into 2 channels on south side
- watercress & filamentous algae only present on south side
- raccoon tracks & frogs observed.

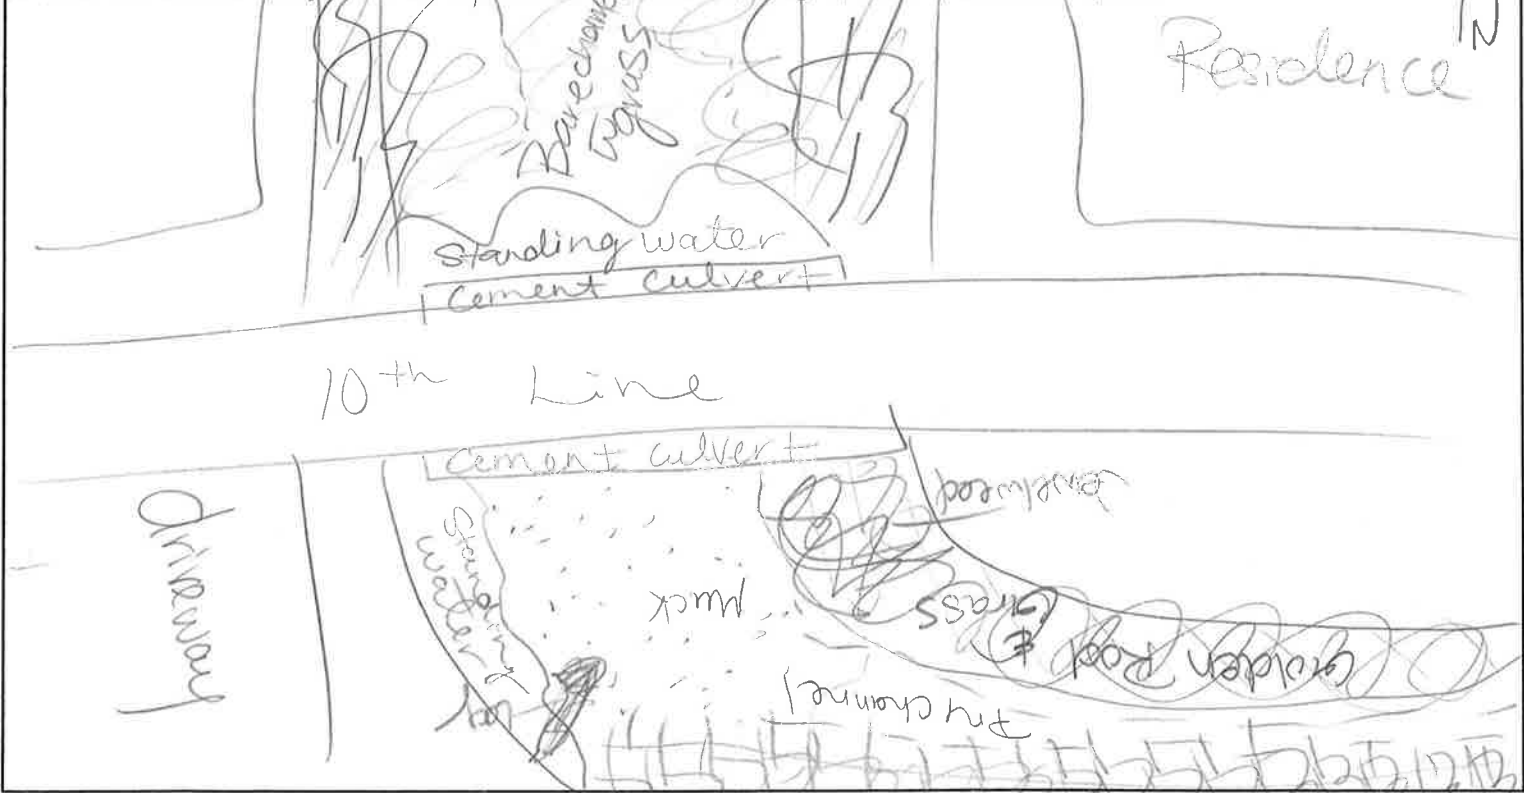
SITE DRAWING

Include: watercourse and name, flow direction, riffle/pool/run habitat, side tributaries, station location, approx. reach length, channel modifications, adjacent land use, roads & road names, bridges, culverts, north arrow, etc...

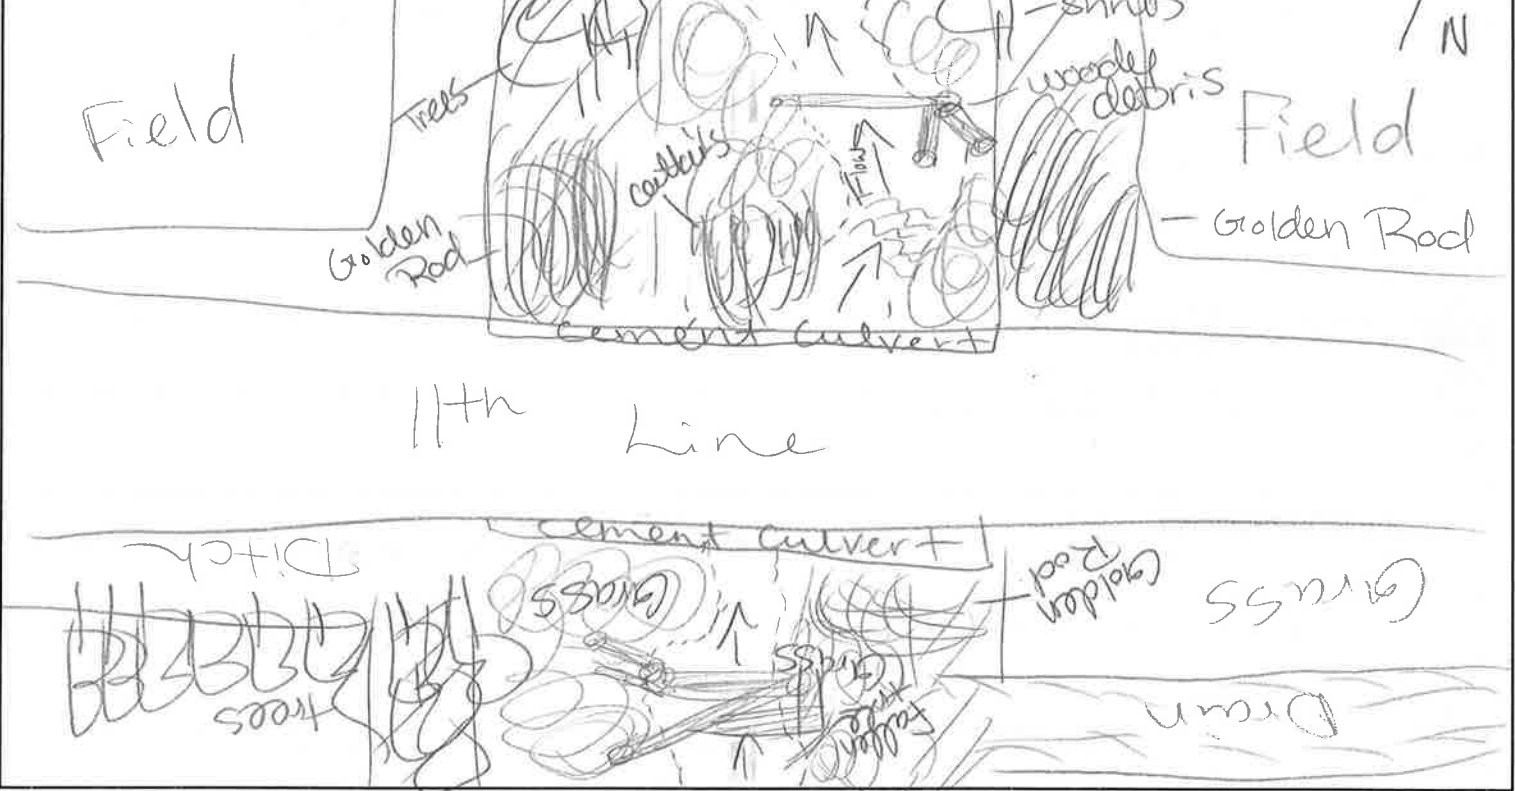
SITE DRAWING

Include: watercourse and name, flow direction, riffle/pool/run habitat, side tributaries, station location, approx. reach length, channel modifications, adjacent land use, roads & road names, bridges, culverts, north arrow, etc.

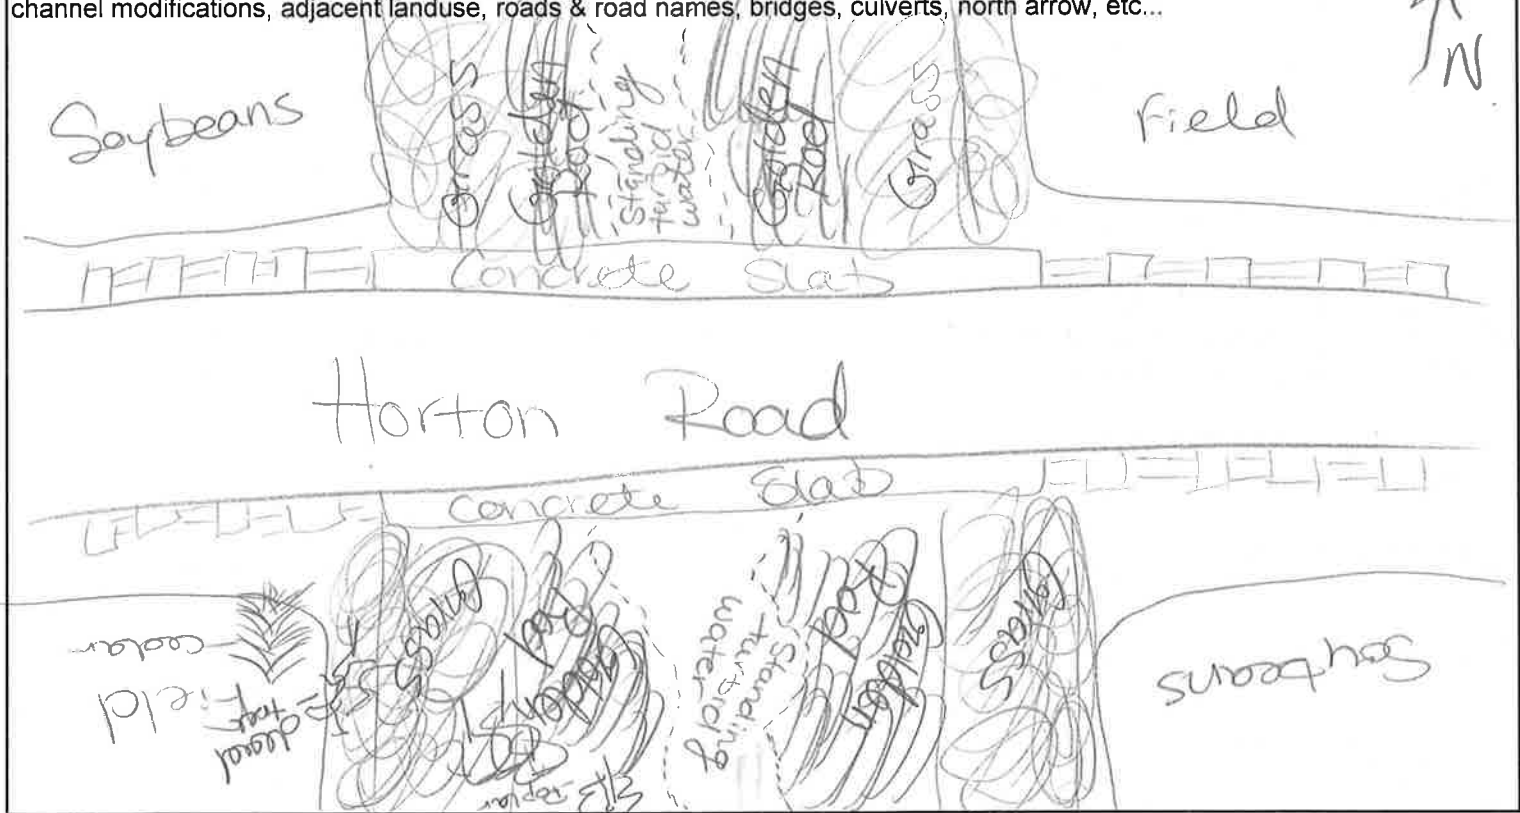
SITE DRAWING

Include: watercourse and name, flow direction, riffle/pool/run habitat, side tributaries, station location, approx. reach length, channel modifications, adjacent landuse, roads & road names, bridges, culverts, north arrow, etc...

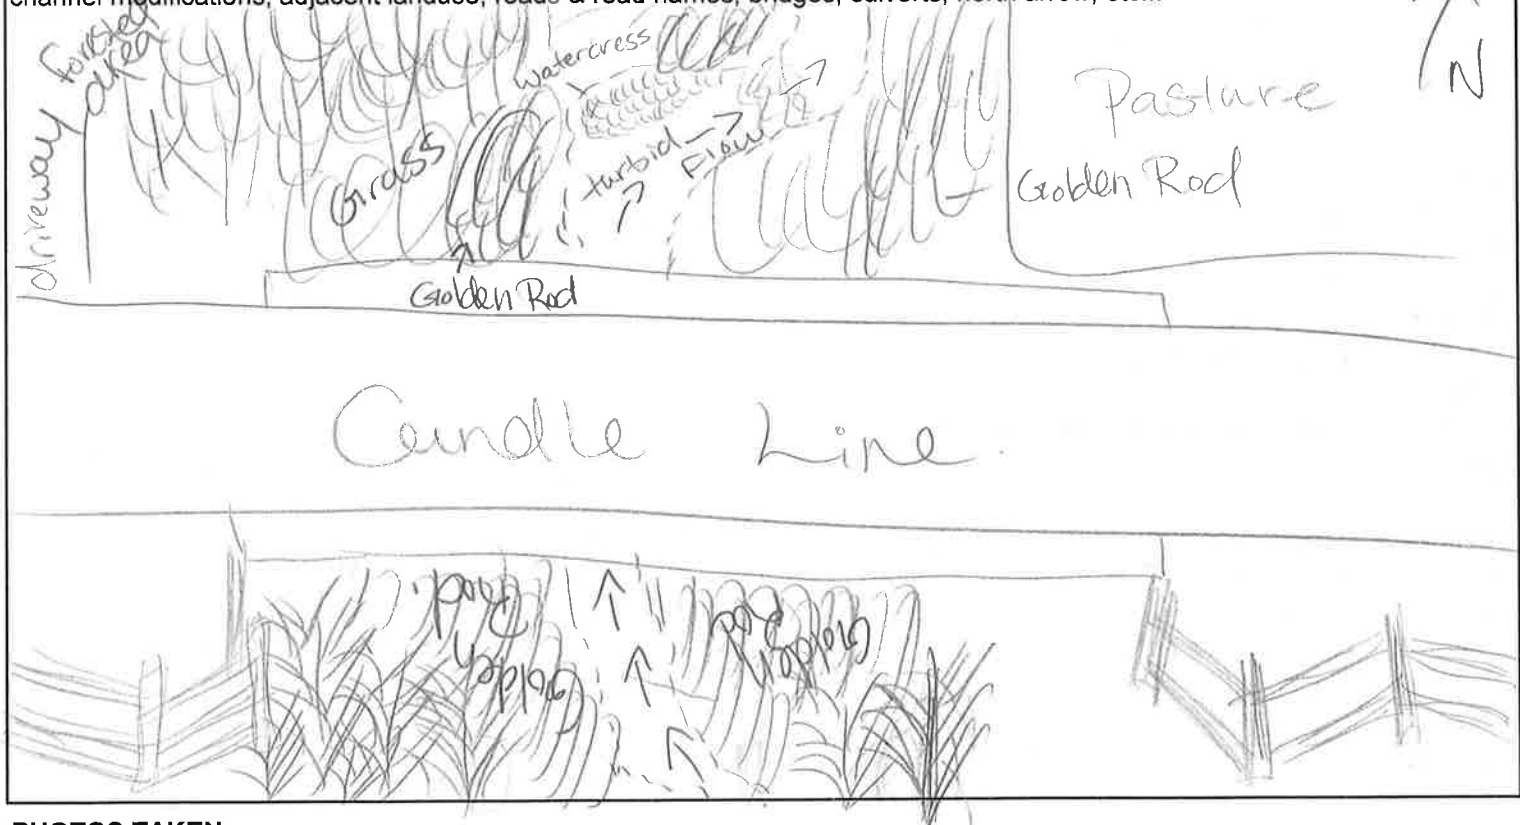
SITE DRAWING

Include: watercourse and name, flow direction, riffle/pool/run habitat, side tributaries, station location, approx. reach length, channel modifications, adjacent landuse, roads & road names, bridges, culverts, north arrow, etc...

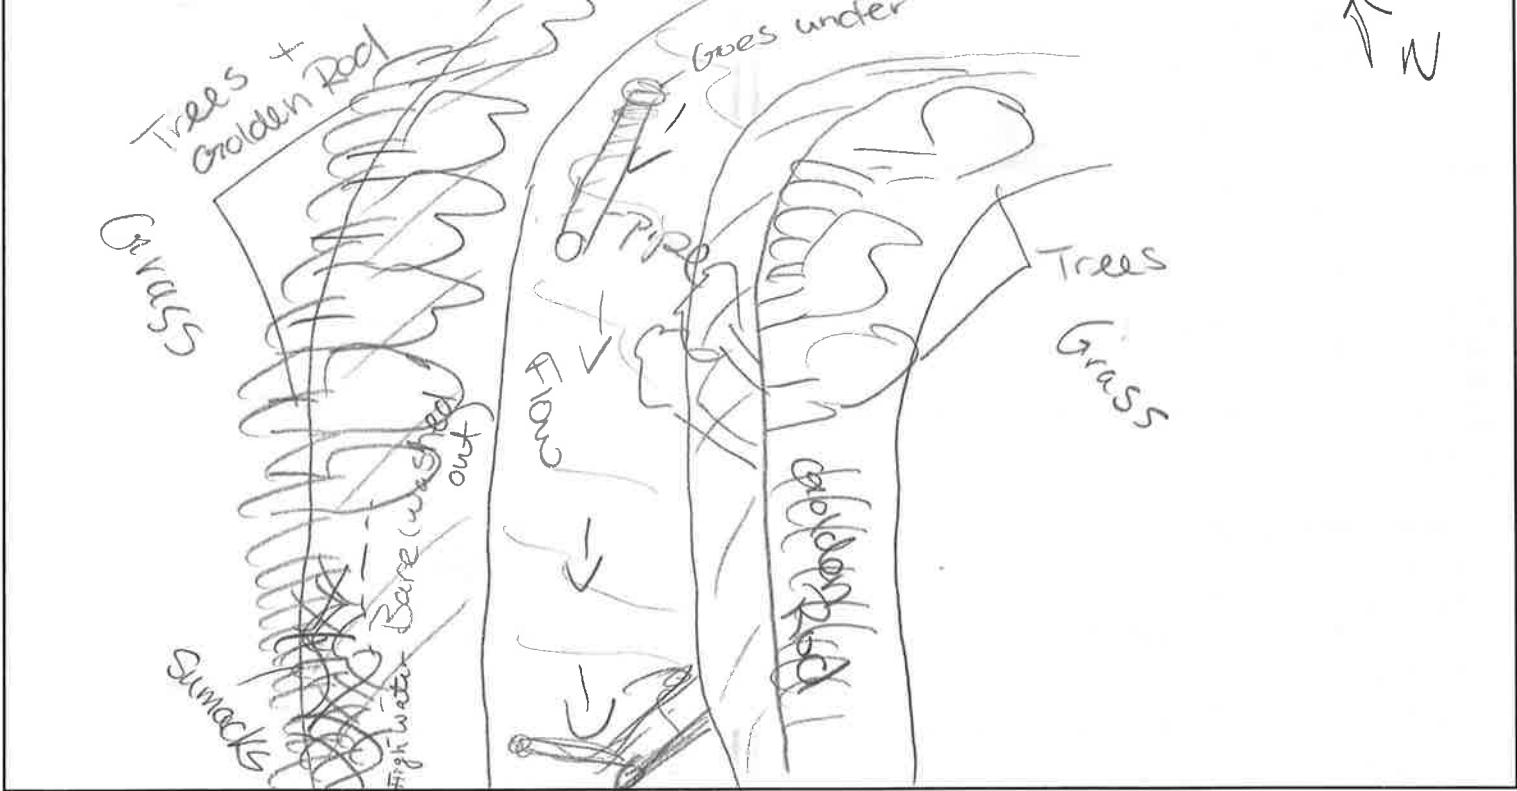
SITE DRAWING

Include: watercourse and name, flow direction, riffle/pool/run habitat, side tributaries, station location, approx. reach length, channel modifications, adjacent landuse, roads & road names, bridges, culverts, north arrow, etc...

- * agriculture surrounding area (soybeans)
- * no fish, frogs or inverts observed, but has lots of aquatic habitat (undercut banks, woody debris, lots of shade)
- * water slightly turbid (maybe from rain)

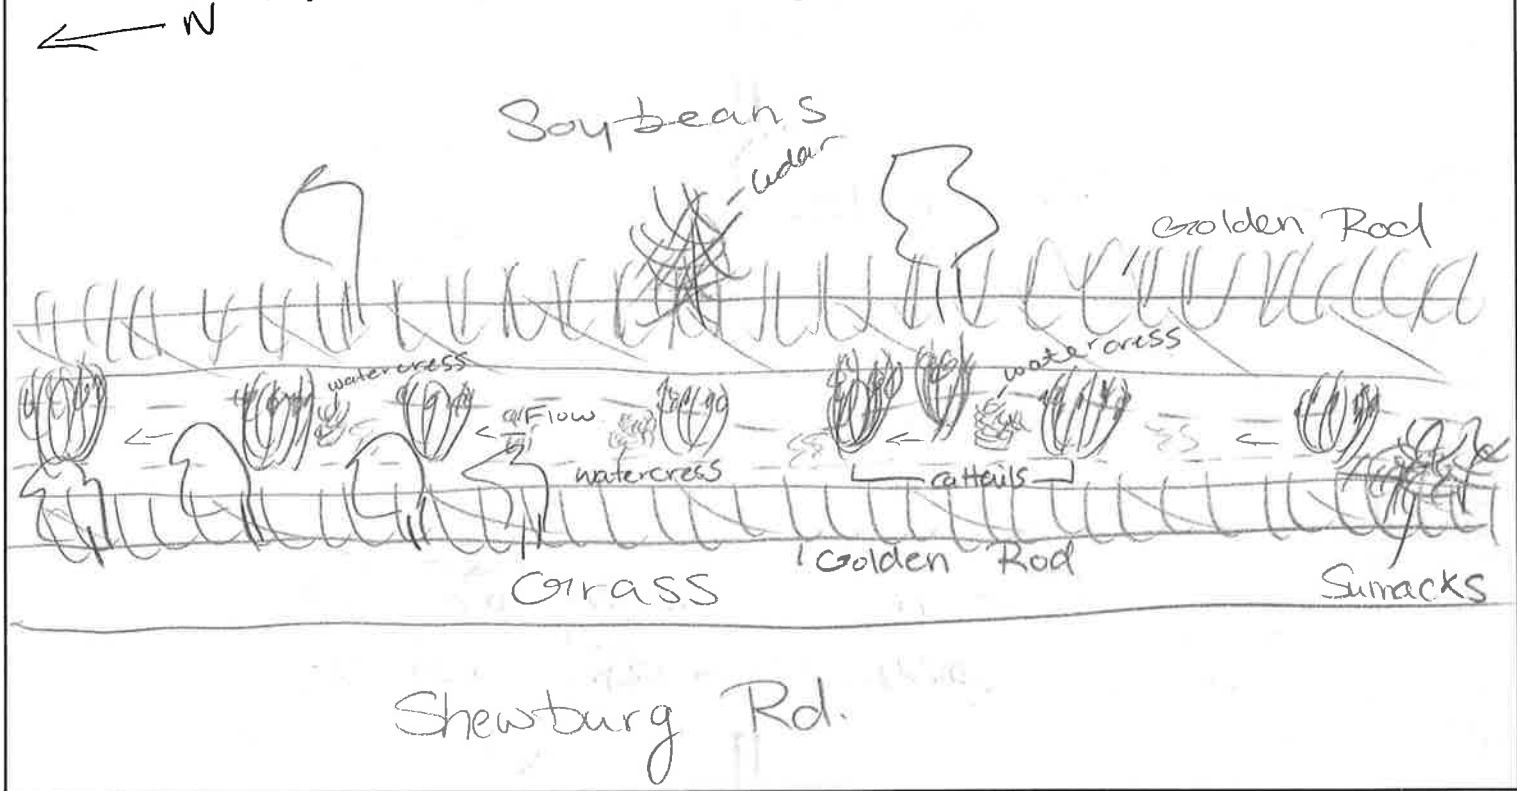
SITE DRAWING

Include: watercourse and name, flow direction, riffle/pool/run habitat, side tributaries, station location, approx. reach length, channel modifications, adjacent land use, roads & road names, bridges, culverts, north arrow, etc...

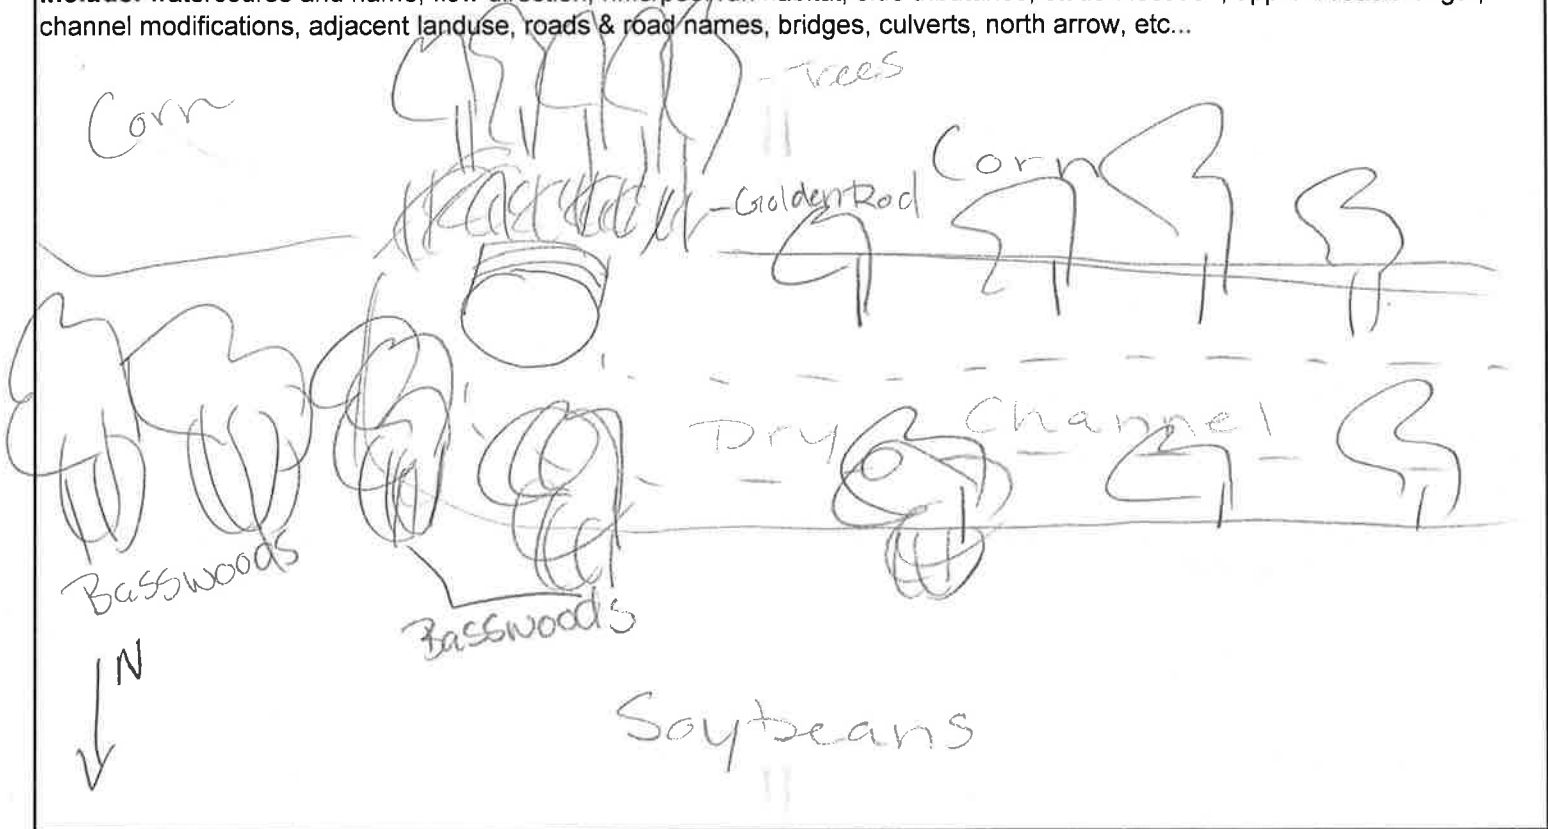
SITE DRAWING

Include: watercourse and name, flow direction, riffle/pool/run habitat, side tributaries, station location, approx. reach length, channel modifications, adjacent landuse, roads & road names, bridges, culverts, north arrow, etc...

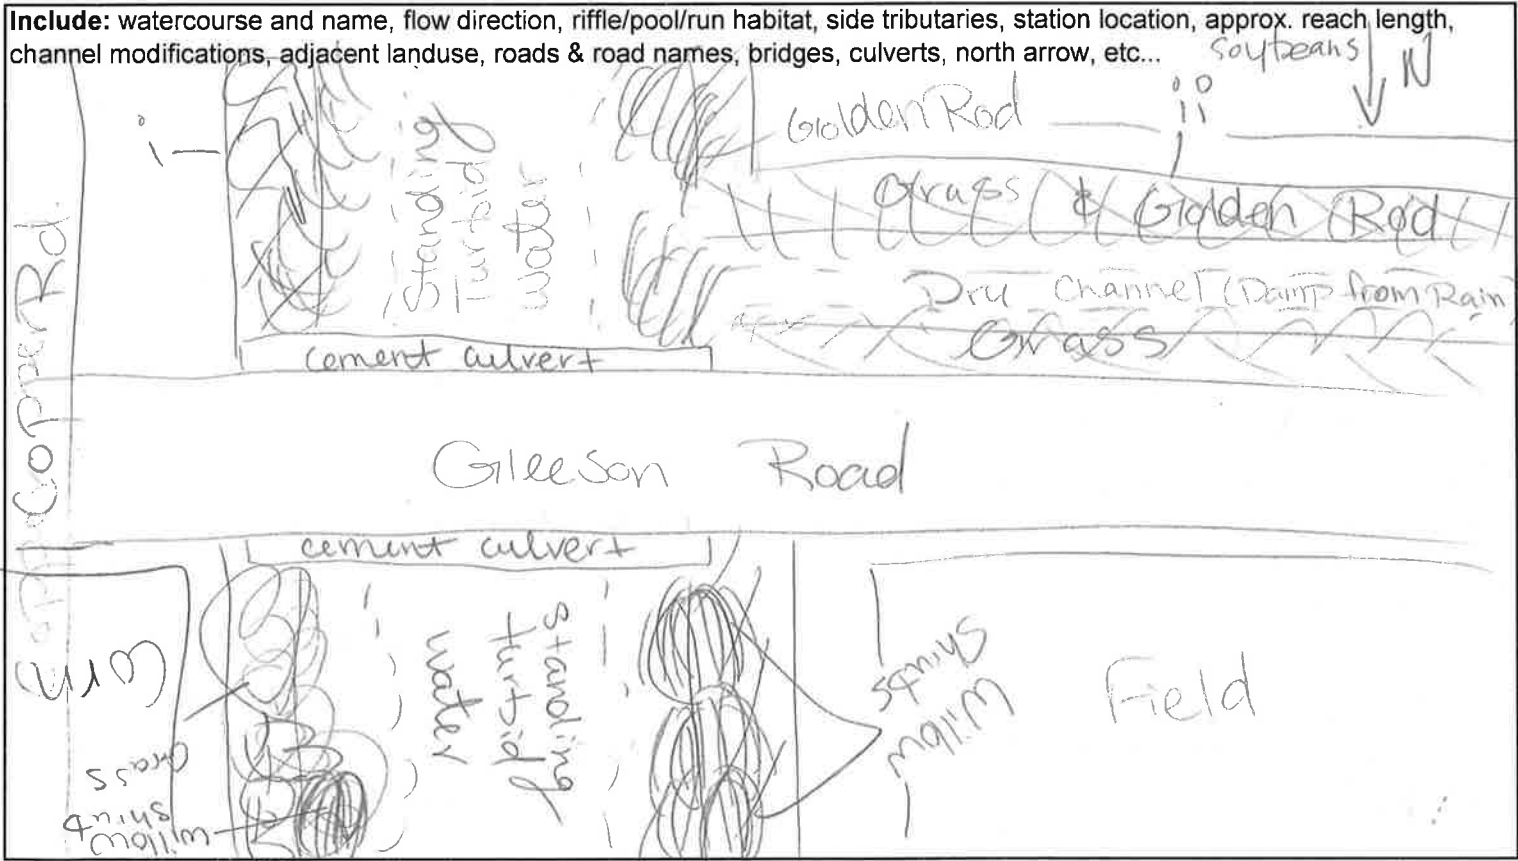
SITE DRAWING

Water Temp. (°C): 11°C	D.O. (ppm):	pH:	Visible Characteristics/Other Parameters: Standing turbid water
Air Temp. (°C): 10°C	D.O. (%):	TDS (ppm):	
Time Taken: 8:35	Conductivity (µs/cm):		
Location Taken: In Stream / roadside

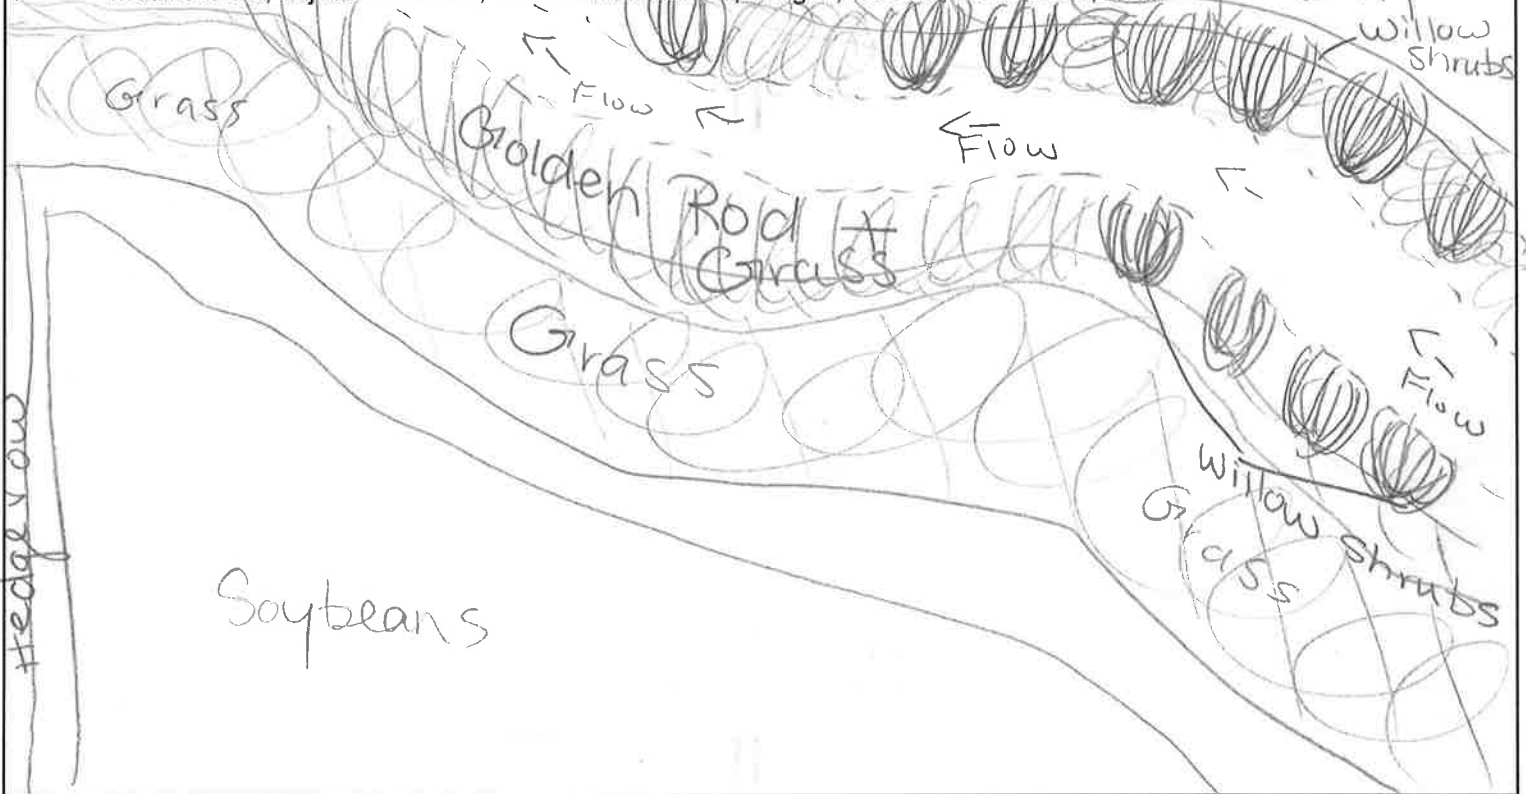
SITE DRAWING

Include: watercourse and name, flow direction, riffle/pool/run habitat, side tributaries, station location, approx. reach length, channel modifications, adjacent land use, roads & road names, bridges, culverts, north arrow, etc...

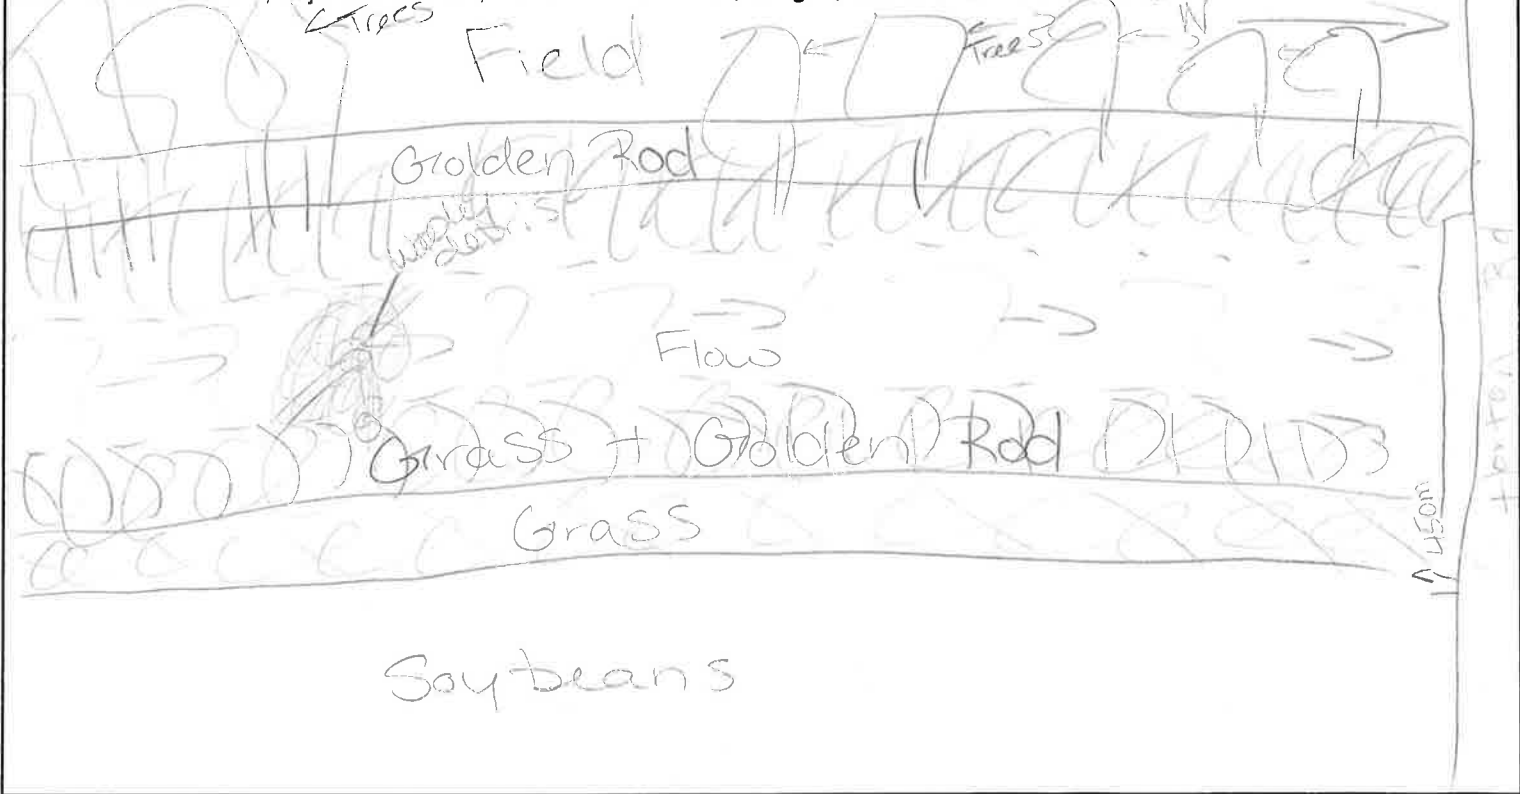
SITE DRAWING

Include: watercourse and name, flow direction, riffle/pool/run habitat, side tributaries, station location, approx. reach length, channel modifications, adjacent landuse, roads & road names, bridges, culverts, north arrow, etc...

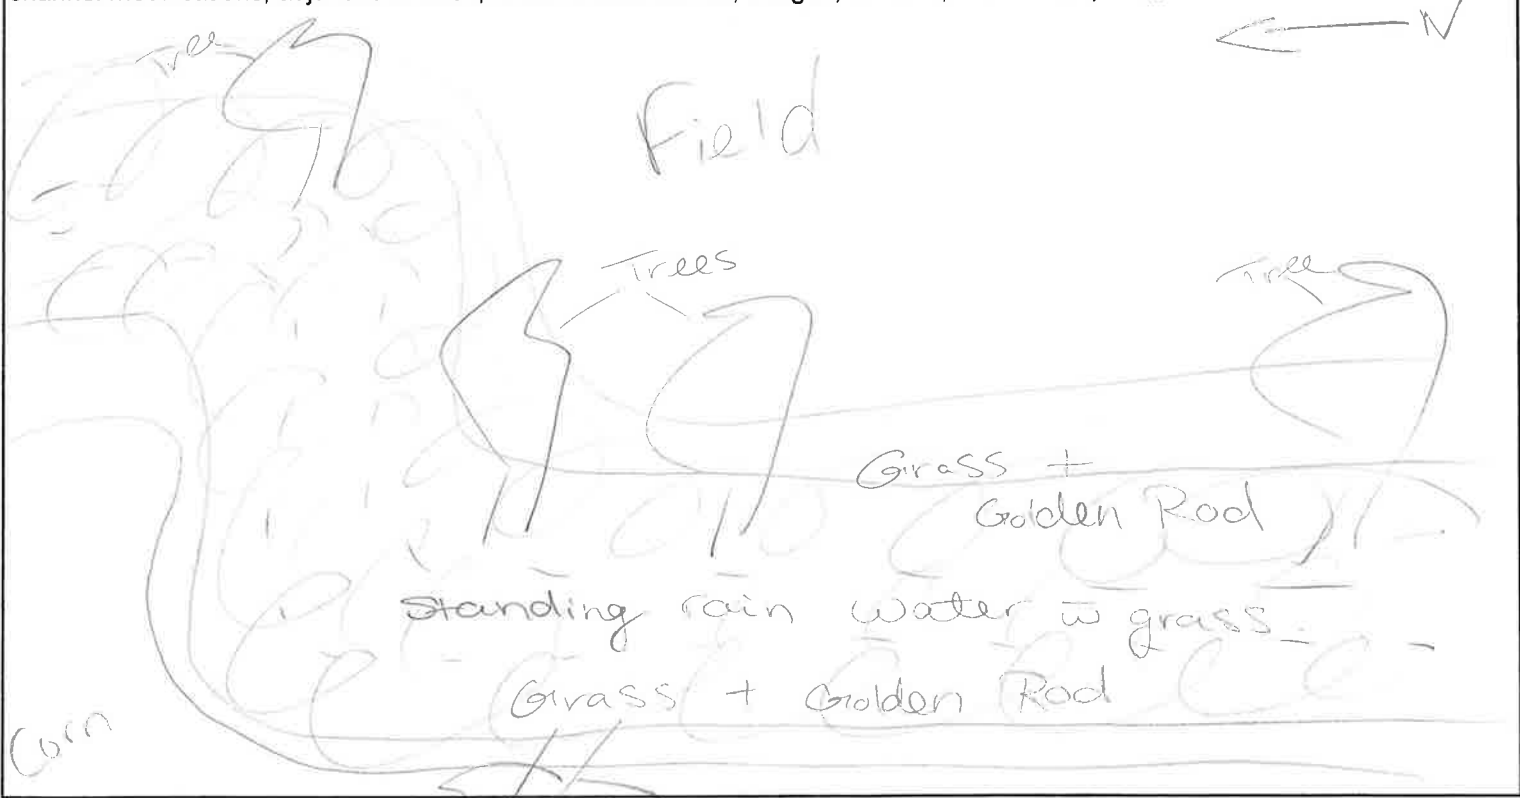
SITE DRAWING

Include: watercourse and name, flow direction, riffle/pool/run habitat, side tributaries, station location, approx. reach length, channel modifications, adjacent land use, roads & road names, bridges, culverts, north arrow, etc...

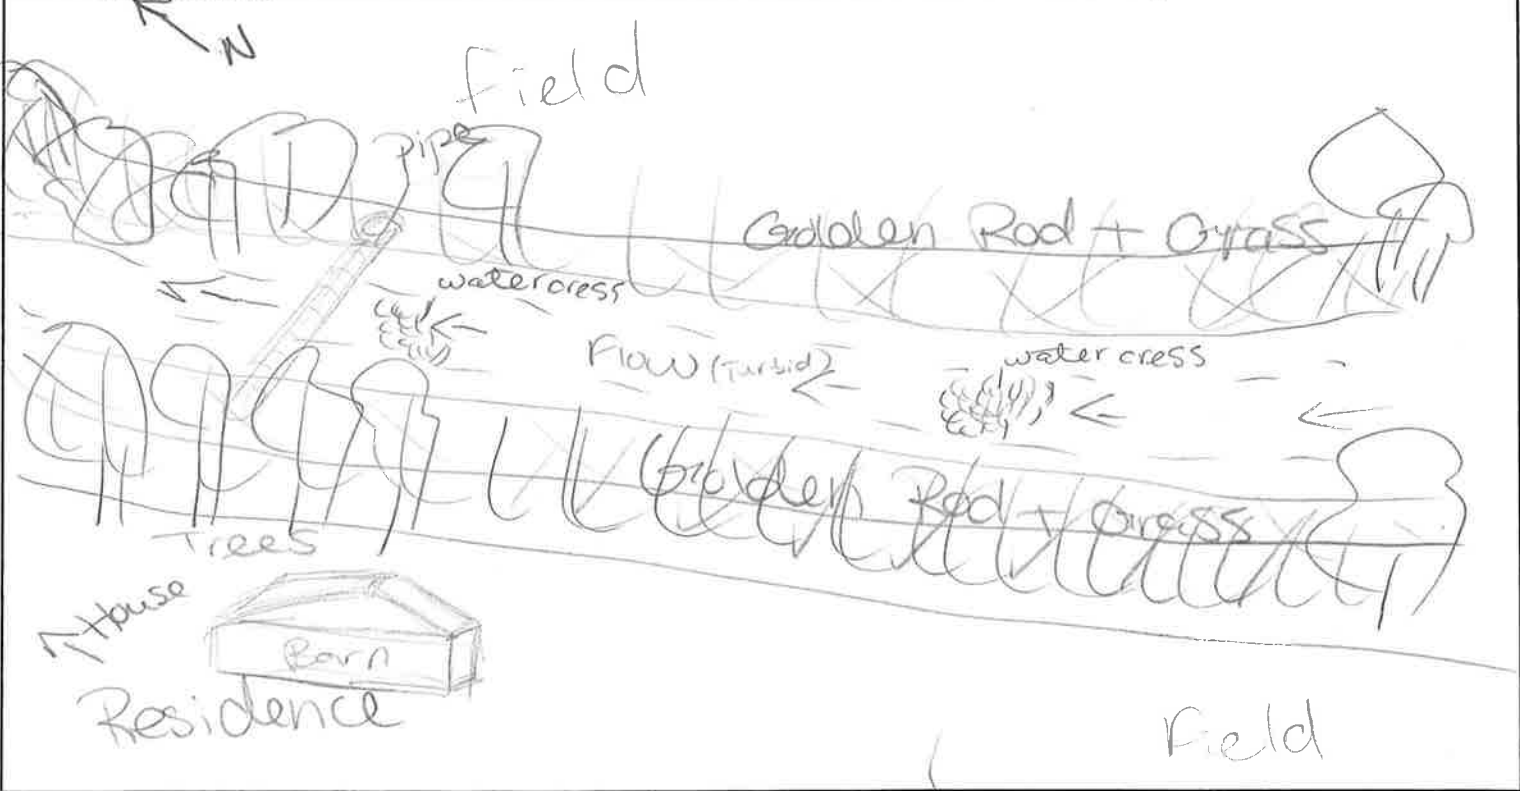
SITE DRAWING

Include: watercourse and name, flow direction, riffle/pool/run habitat, side tributaries, station location, approx. reach length, channel modifications, adjacent landuse, roads & road names, bridges, culverts, north arrow, etc...
