6B Water Body Site Investigation
Report

For
South Kent Wind Project

SOUTH KENT WIND PROJECT **Water Body Site Investigation Report**

Date: May 2012

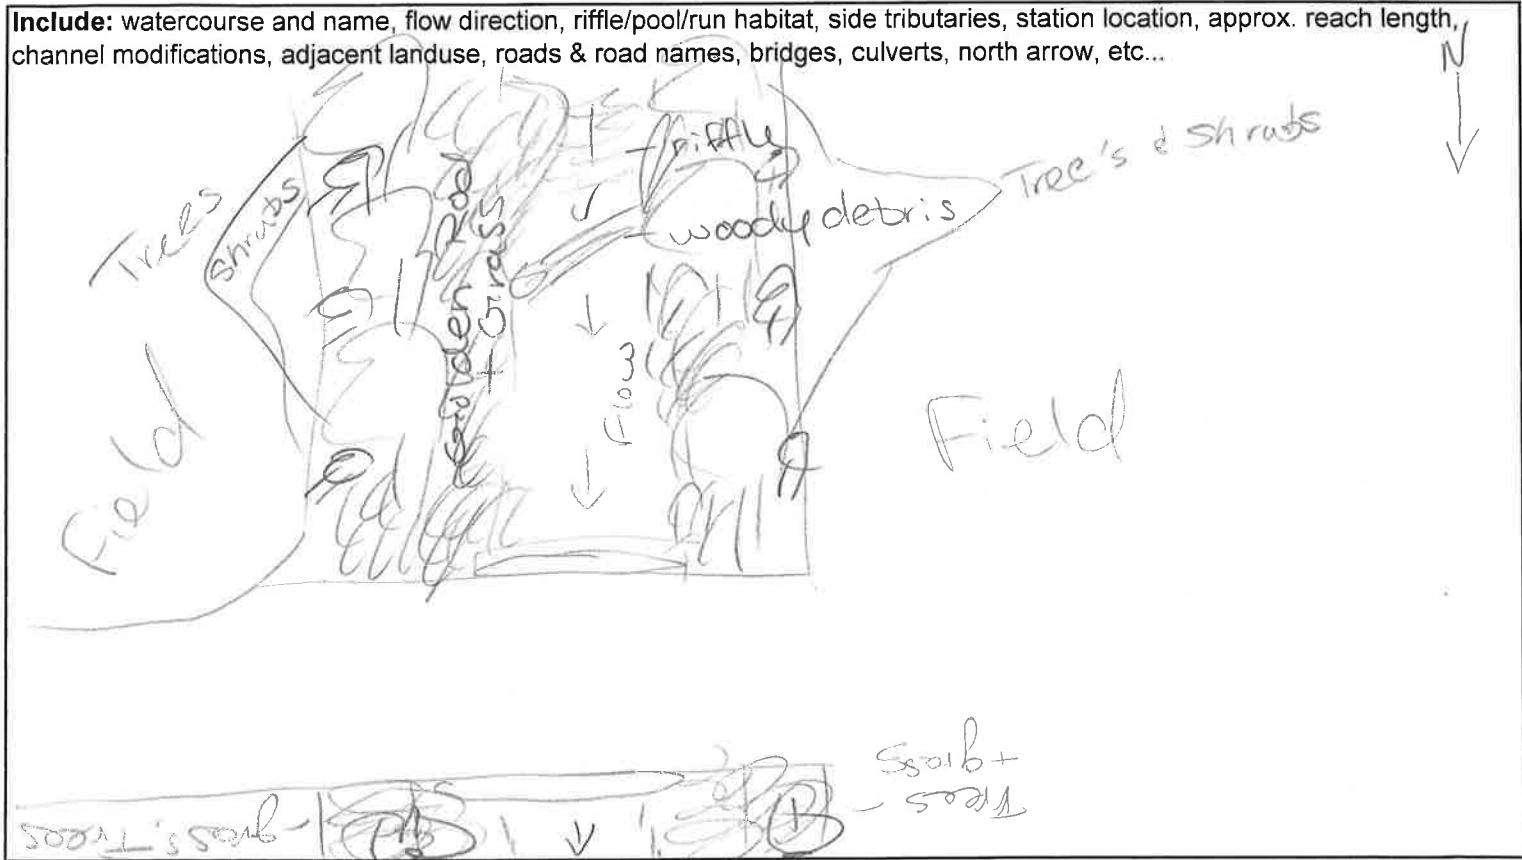
SITE DRAWING

Include: watercourse and name, flow direction, riffle/pool/run habitat, side tributaries, station location, approx. reach length, channel modifications, adjacent landuse, roads & road names, bridges, culverts, north arrow, etc...

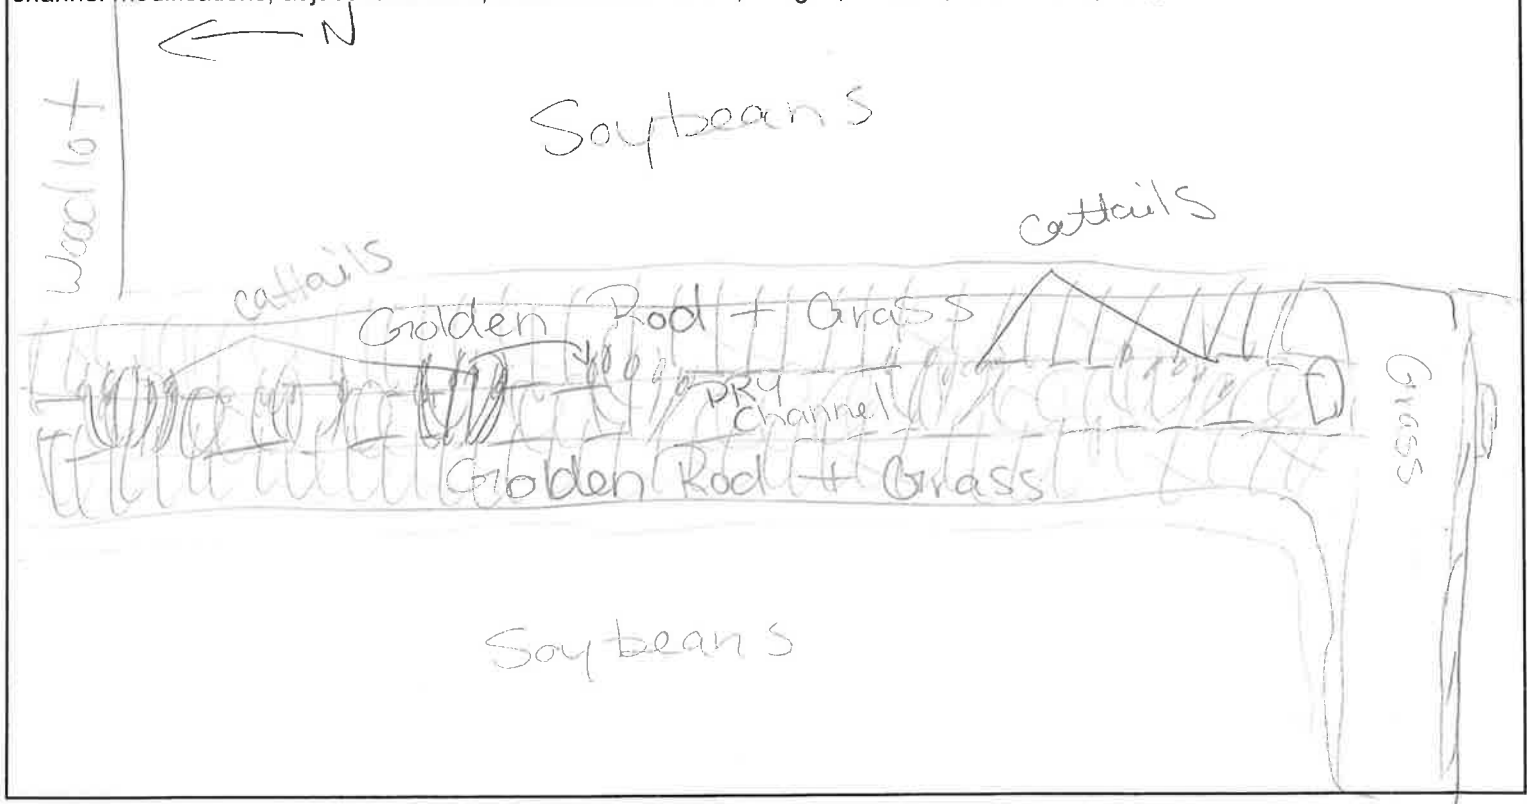
SITE DRAWING

Include: watercourse and name, flow direction, riffle/pool/run habitat, side tributaries, station location, approx. reach length, channel modifications, adjacent land use, roads & road names, bridges, culverts, north arrow, etc...

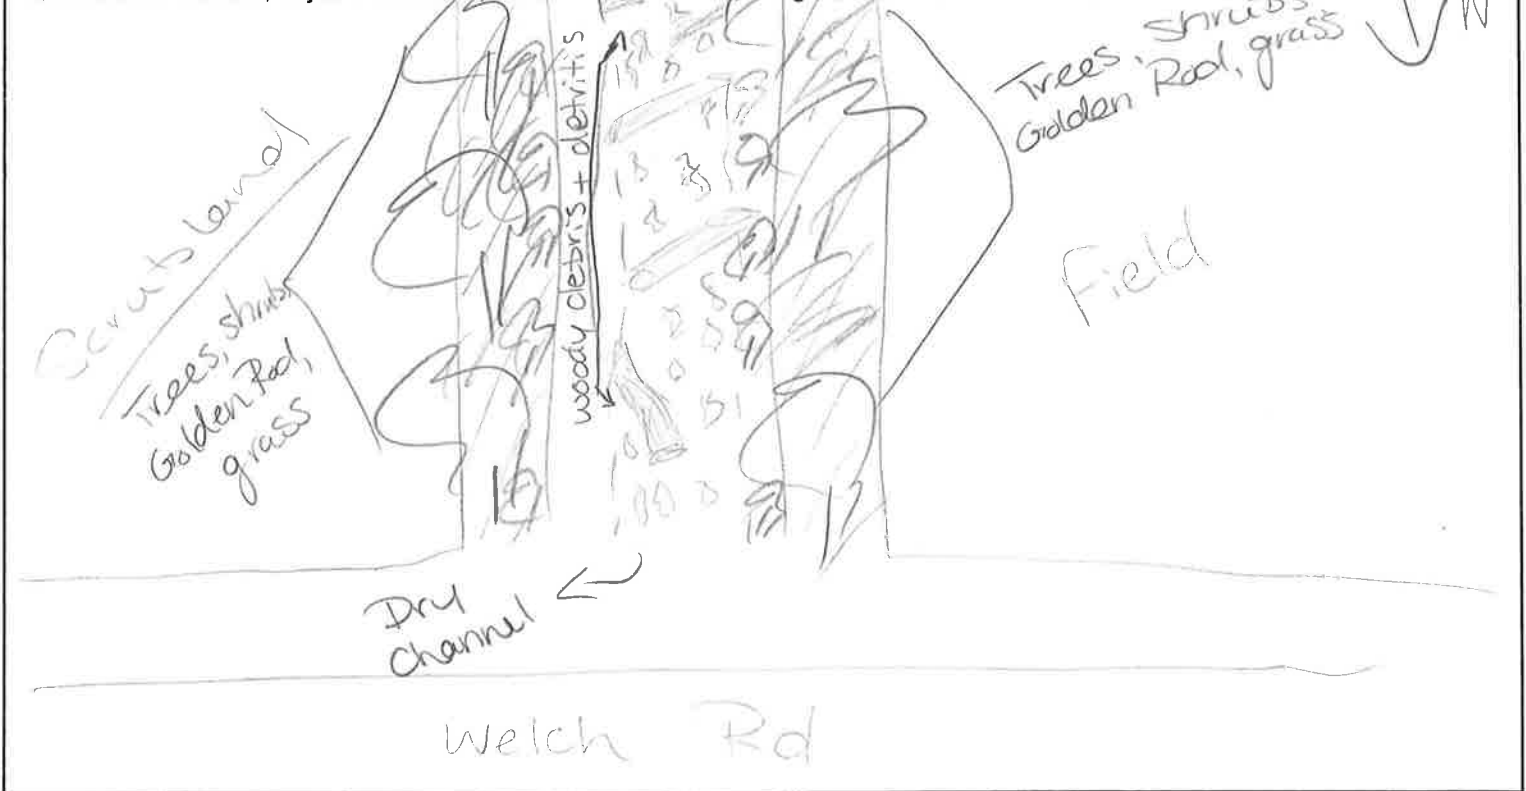
SITE DRAWING

Include: watercourse and name, flow direction, riffle/pool/run habitat, side tributaries, station location, approx. reach length, channel modifications, adjacent landuse, roads & road names, bridges, culverts, north arrow, etc...

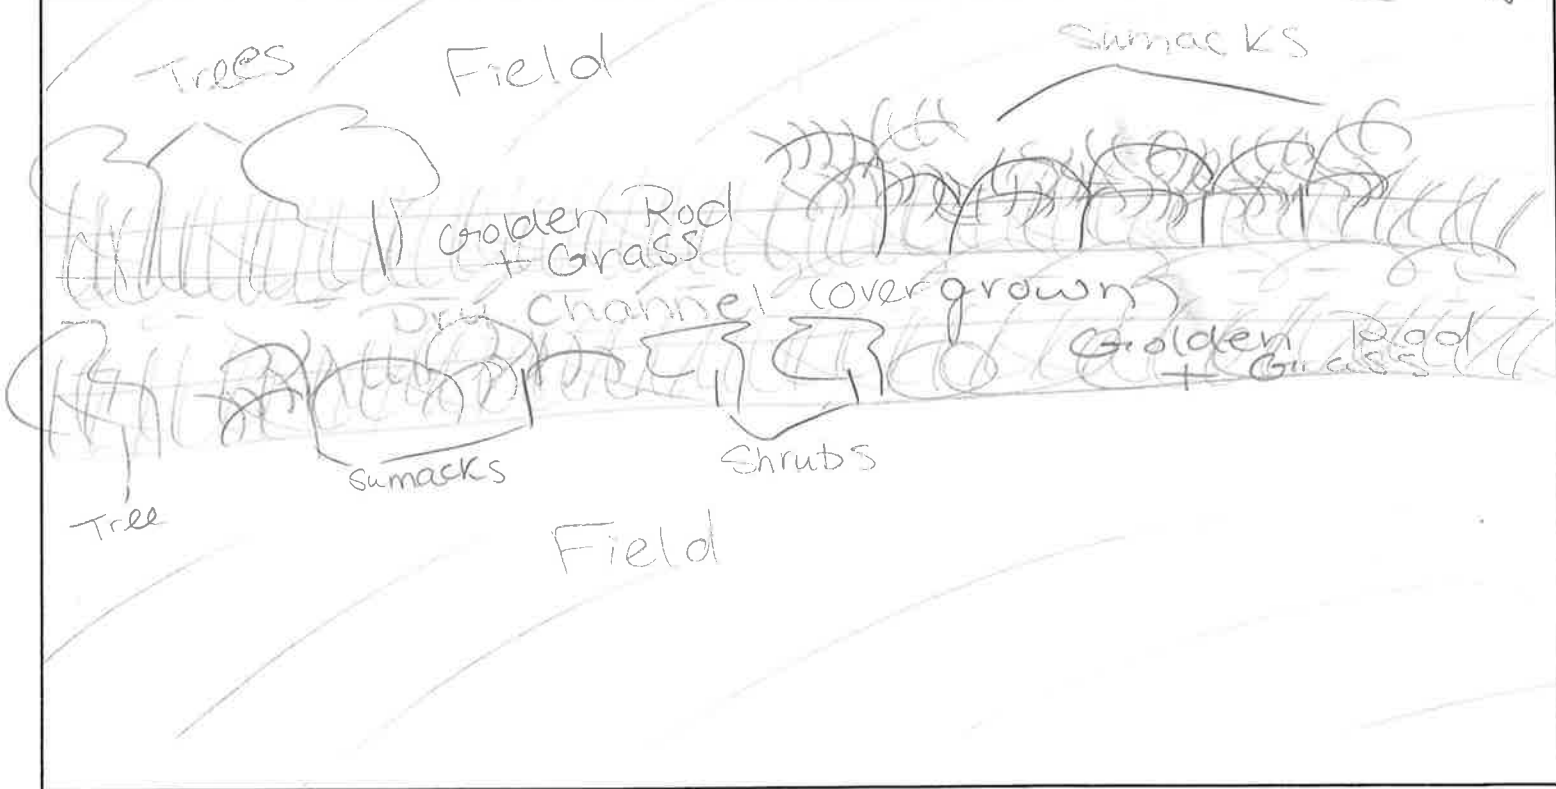
SITE DRAWING

Include: watercourse and name, flow direction, riffle/pool/run habitat, side tributaries, station location, approx. reach length, channel modifications, adjacent landuse, roads & road names, bridges, culverts, north arrow, etc...

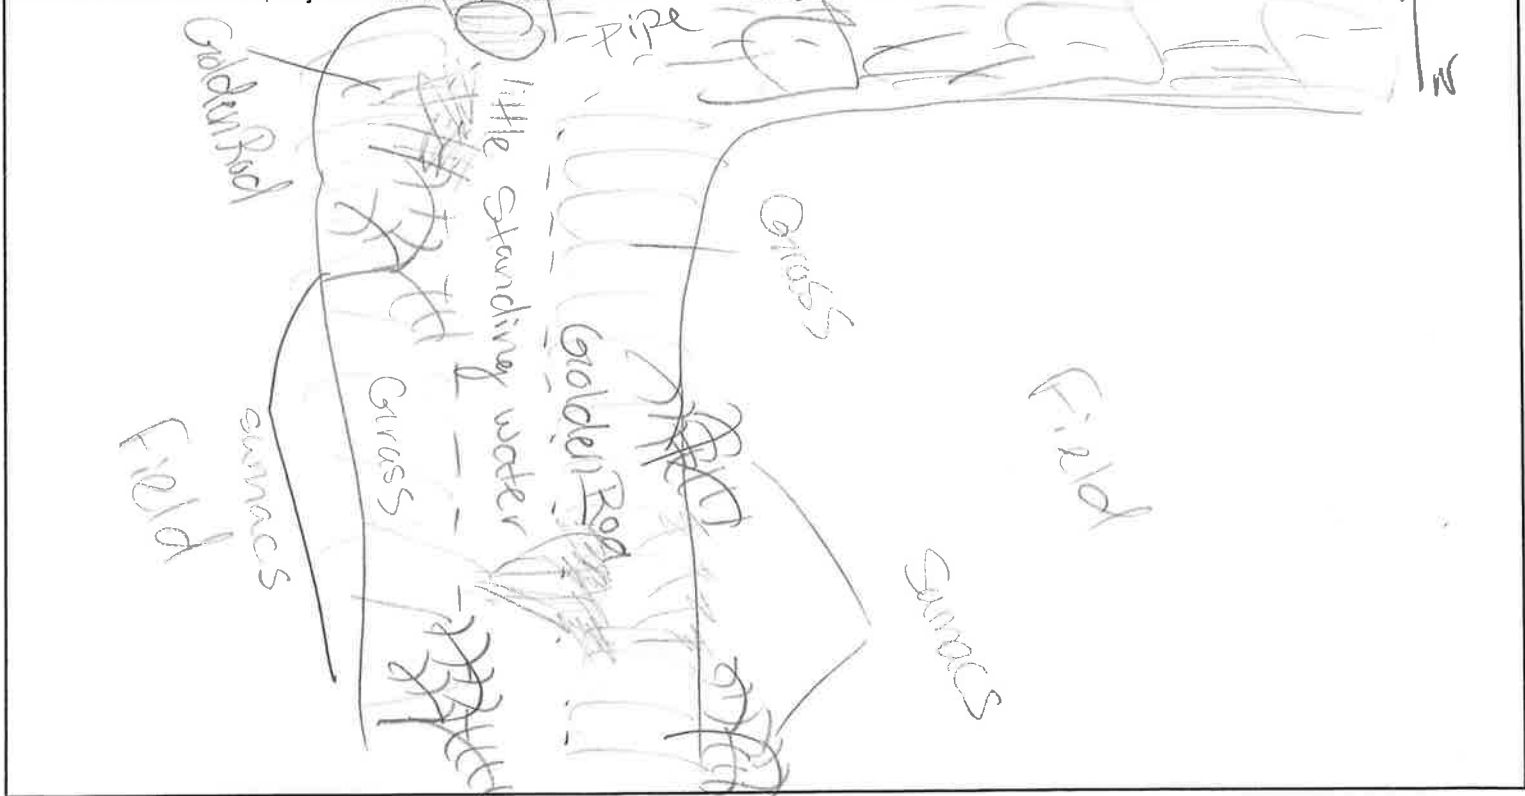
SITE DRAWING

Include: watercourse and name, flow direction, riffle/pool/run habitat, side tributaries, station location, approx. reach length, channel modifications, adjacent landuse, roads & road names, bridges, culverts, north arrow, etc...

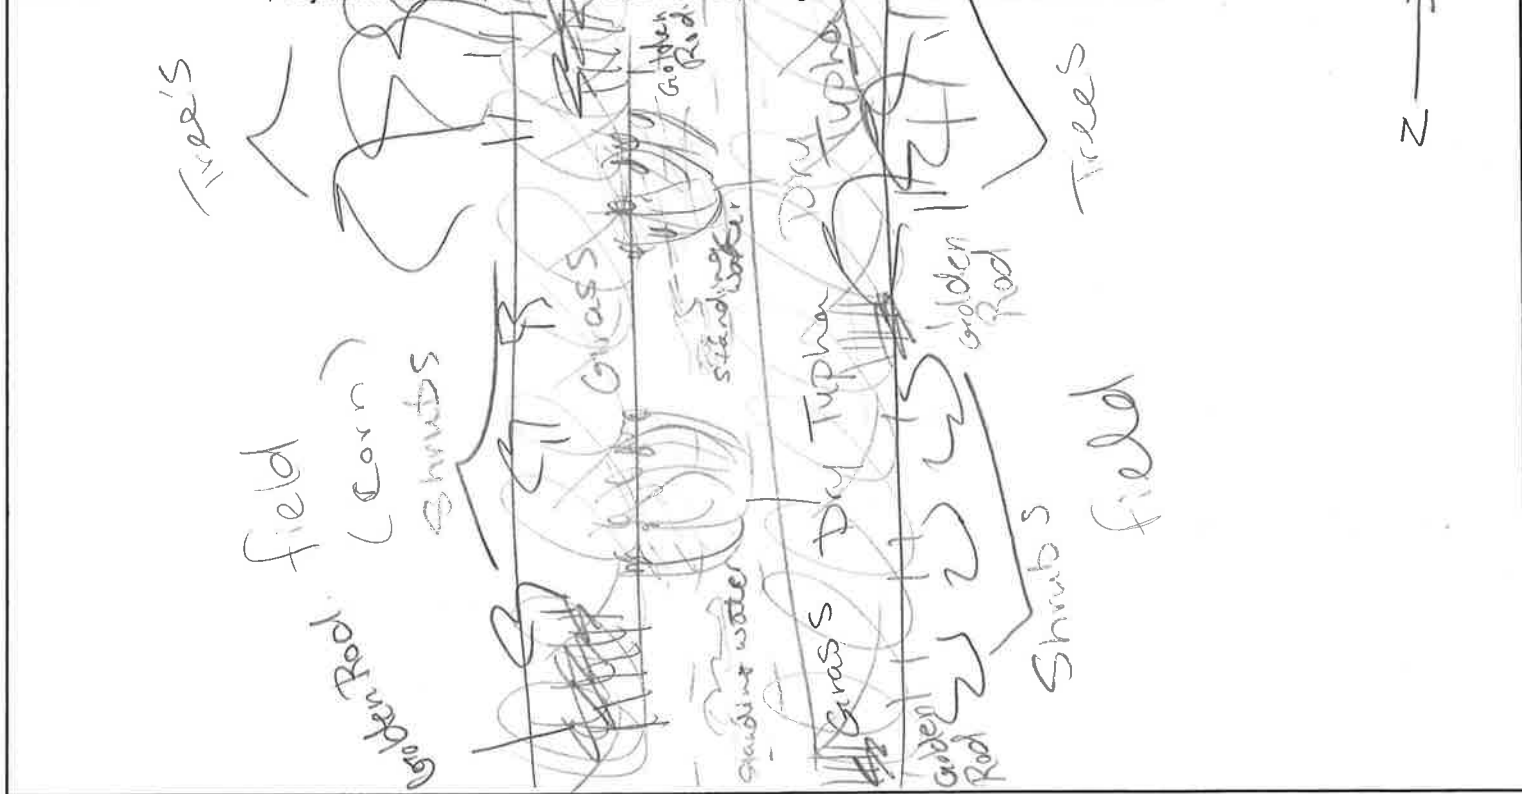
SITE DRAWING

Include: watercourse and name, flow direction, riffle/pool/run habitat, side tributaries, station location, approx. reach length, channel modifications, adjacent land use, roads & road names, bridges/culverts, north arrow, etc...

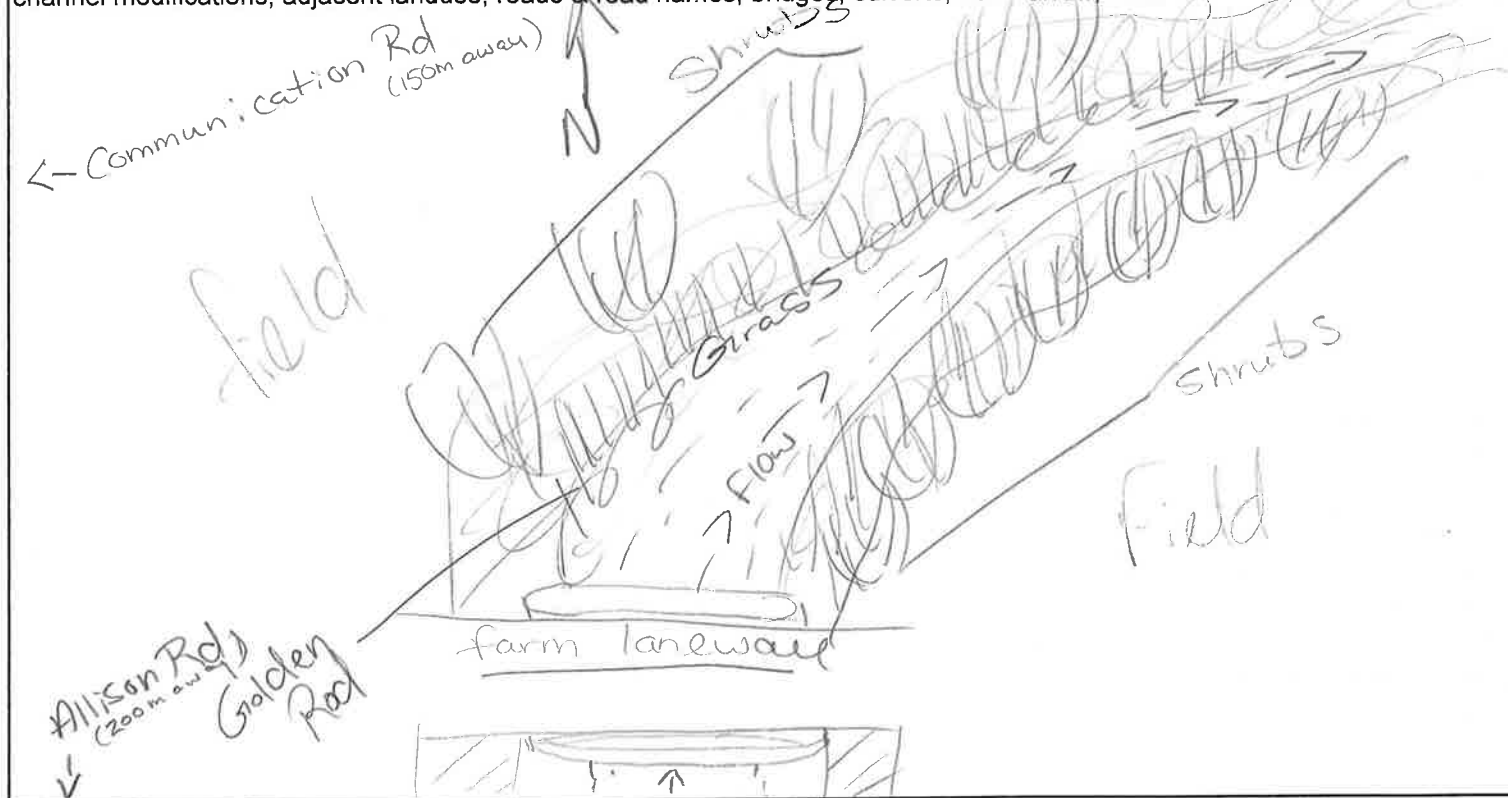
SITE DRAWING

Include: watercourse and name, flow direction, riffle/pool/run habitat, side tributaries, station location, approx. reach length, channel modifications, adjacent land use, roads & road names, bridges, culverts, north arrow, etc...

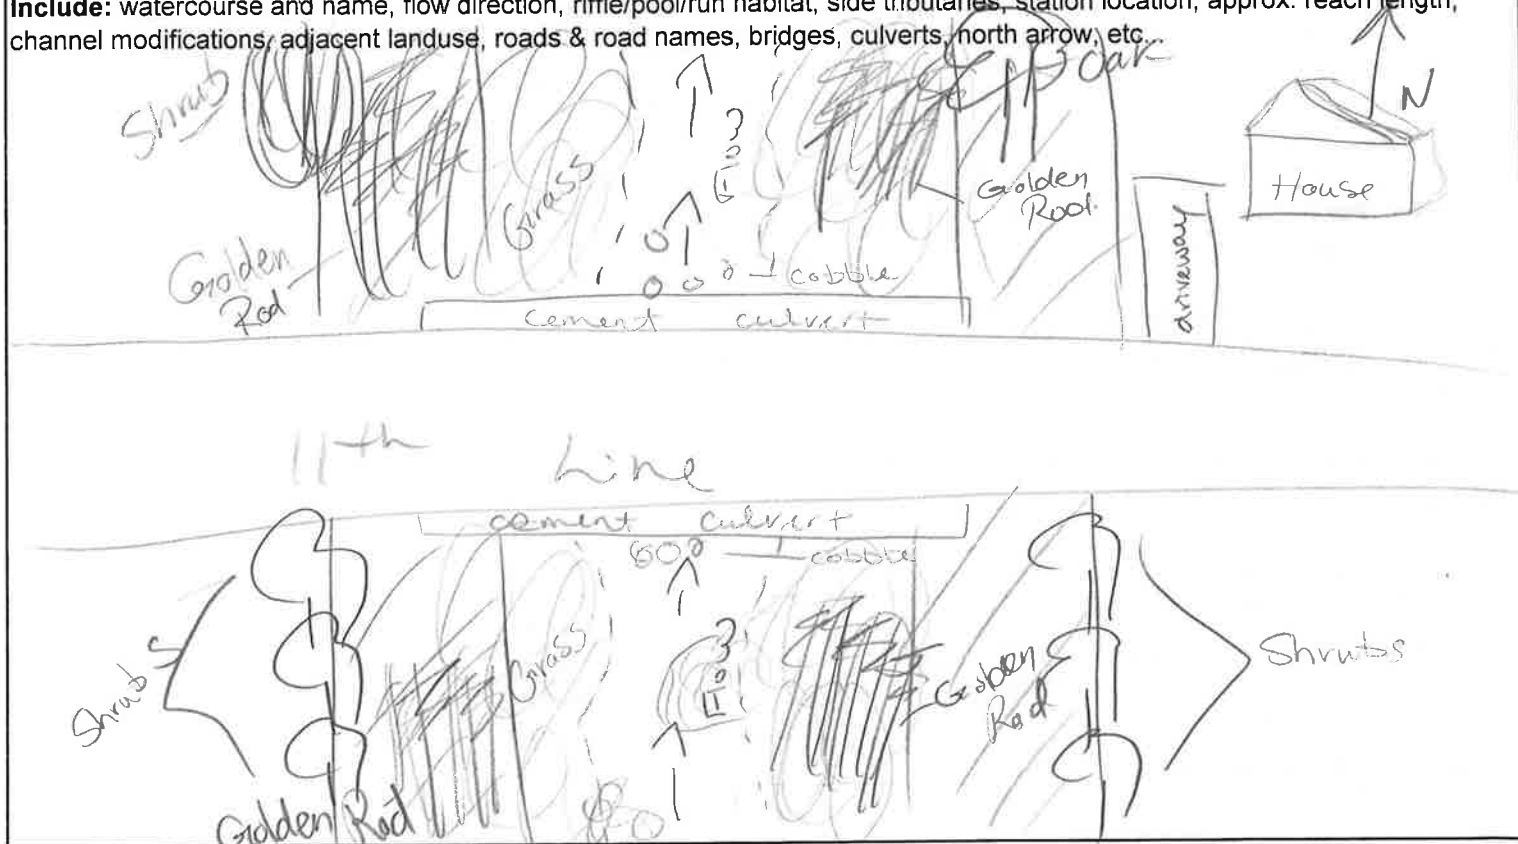
SITE DRAWING

Include: watercourse and name, flow direction, riffle/pool/run habitat, side tributaries, station location, approx. reach length, channel modifications, adjacent landuse, roads & road names, bridges, culverts, north arrow, etc.

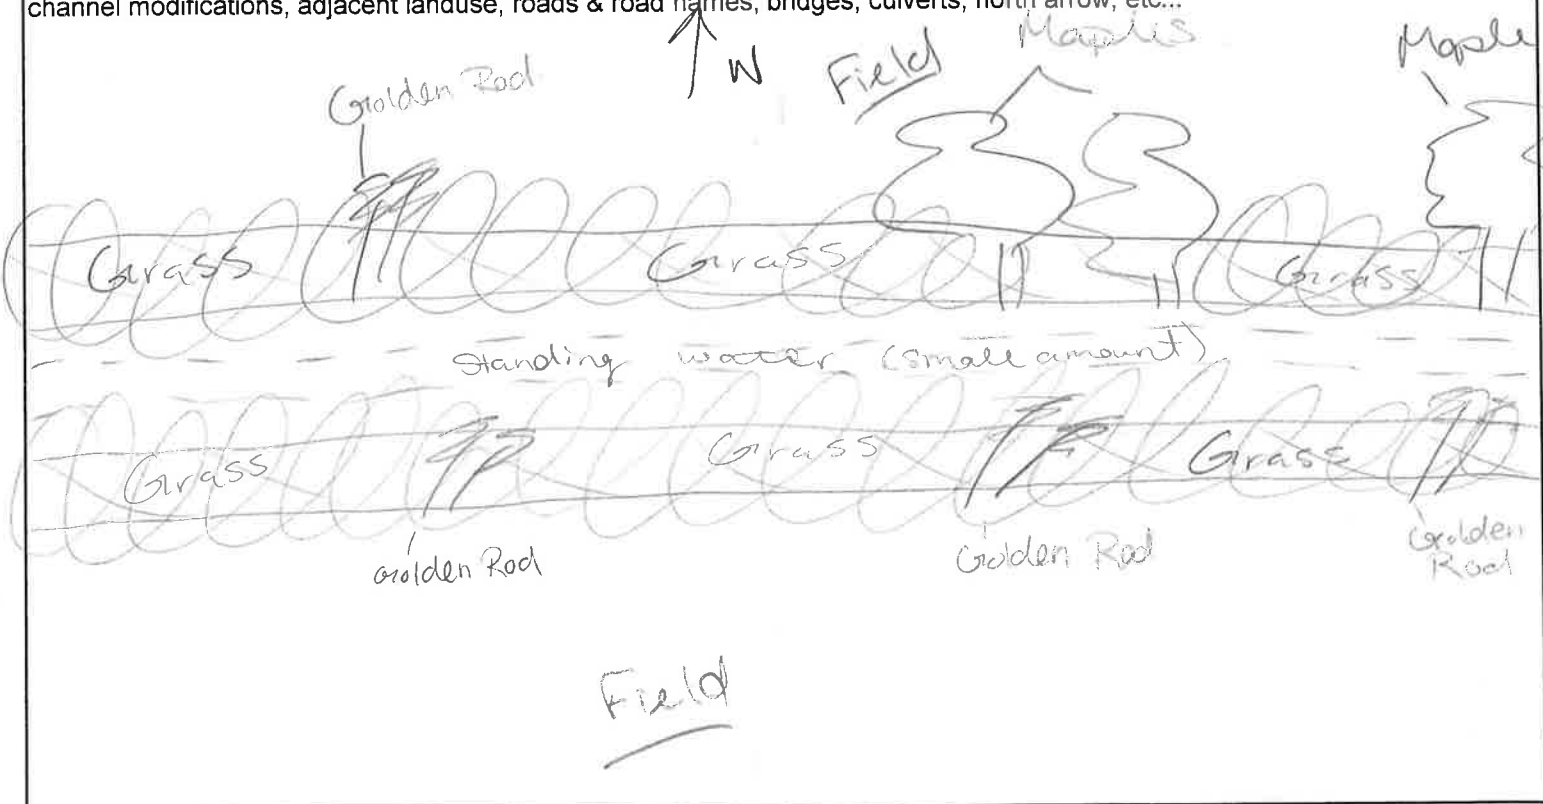
SITE DRAWING

Include: watercourse and name, flow direction, riffle/pool/run habitat, side tributaries, station location, approx. reach length, channel modifications, adjacent land use, roads & road names, bridges, culverts, north arrow, etc...

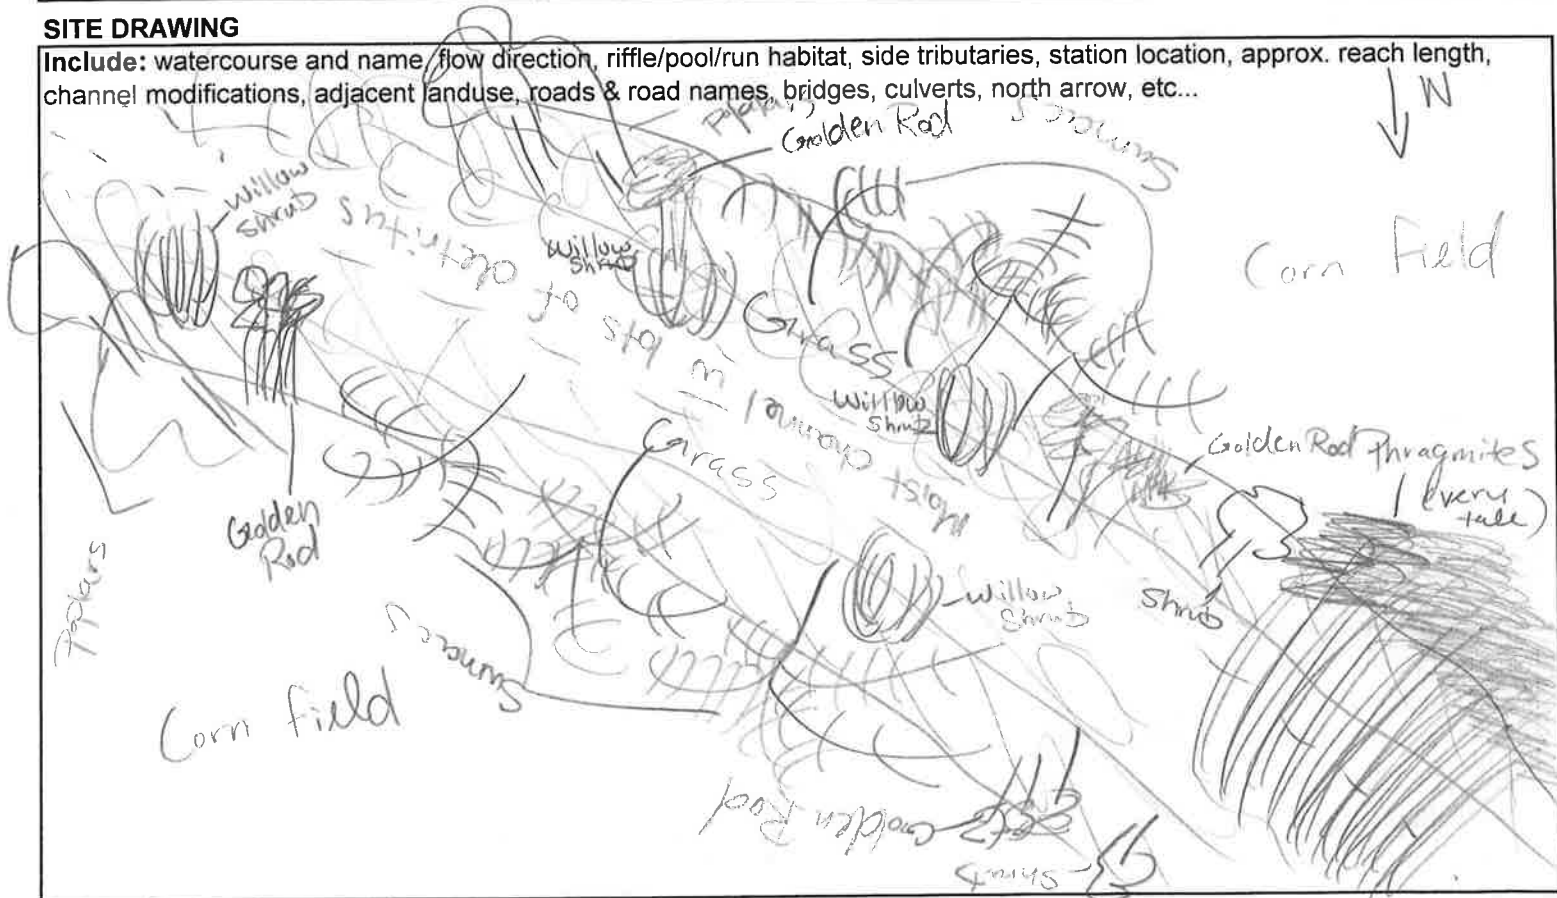
SITE DRAWING

Include: watercourse and name, flow direction, riffle/pool/run habitat, side tributaries, station location, approx. reach length, channel modifications, adjacent land use, roads & road names, bridges, culverts, north arrow, etc...

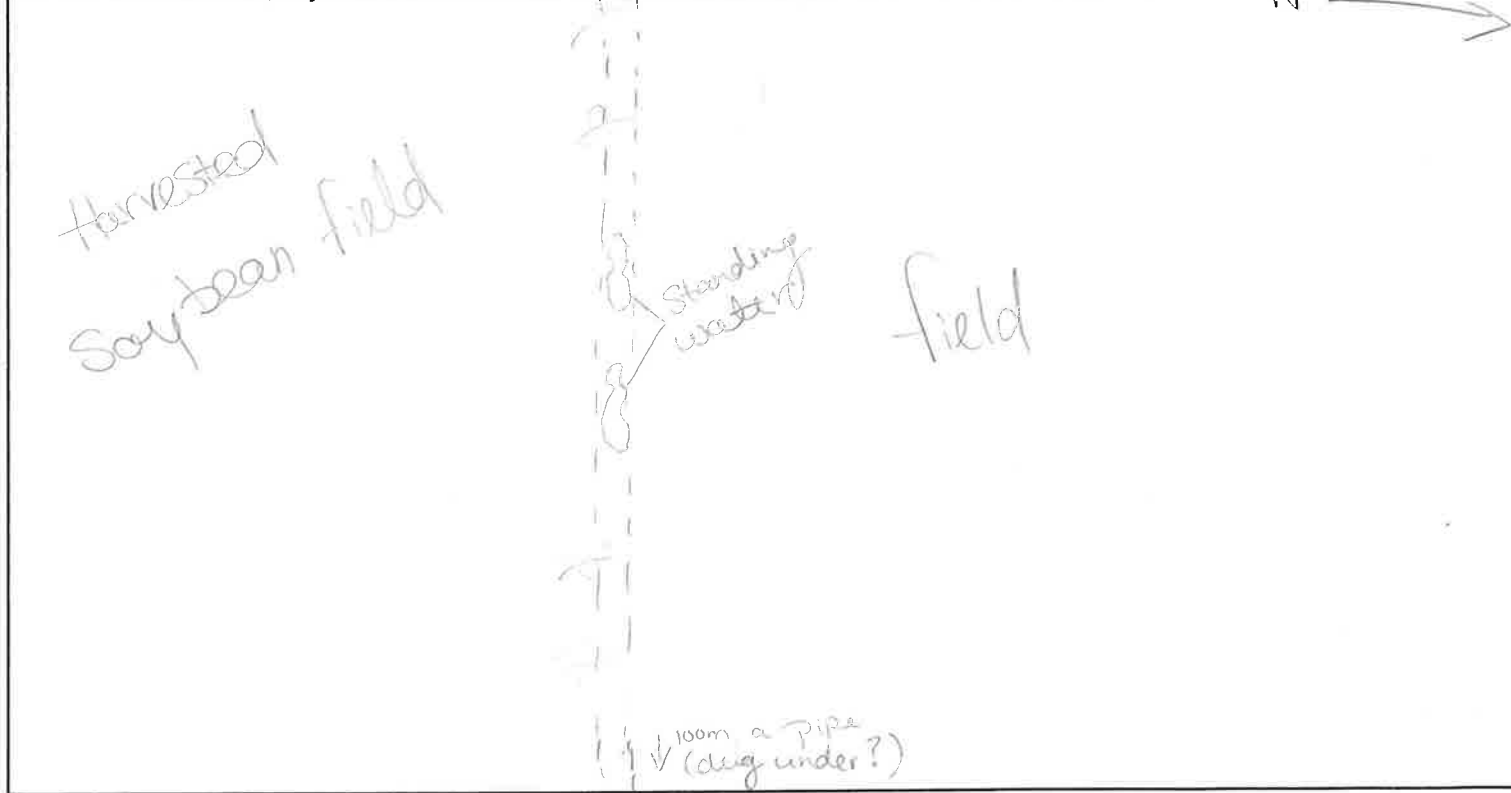
SITE DRAWING

Include: watercourse and name, flow direction, riffle/pool/run habitat, side tributaries, station location, approx. reach length, channel modifications, adjacent landuse, roads & road names, bridges, culverts, north arrow, etc...

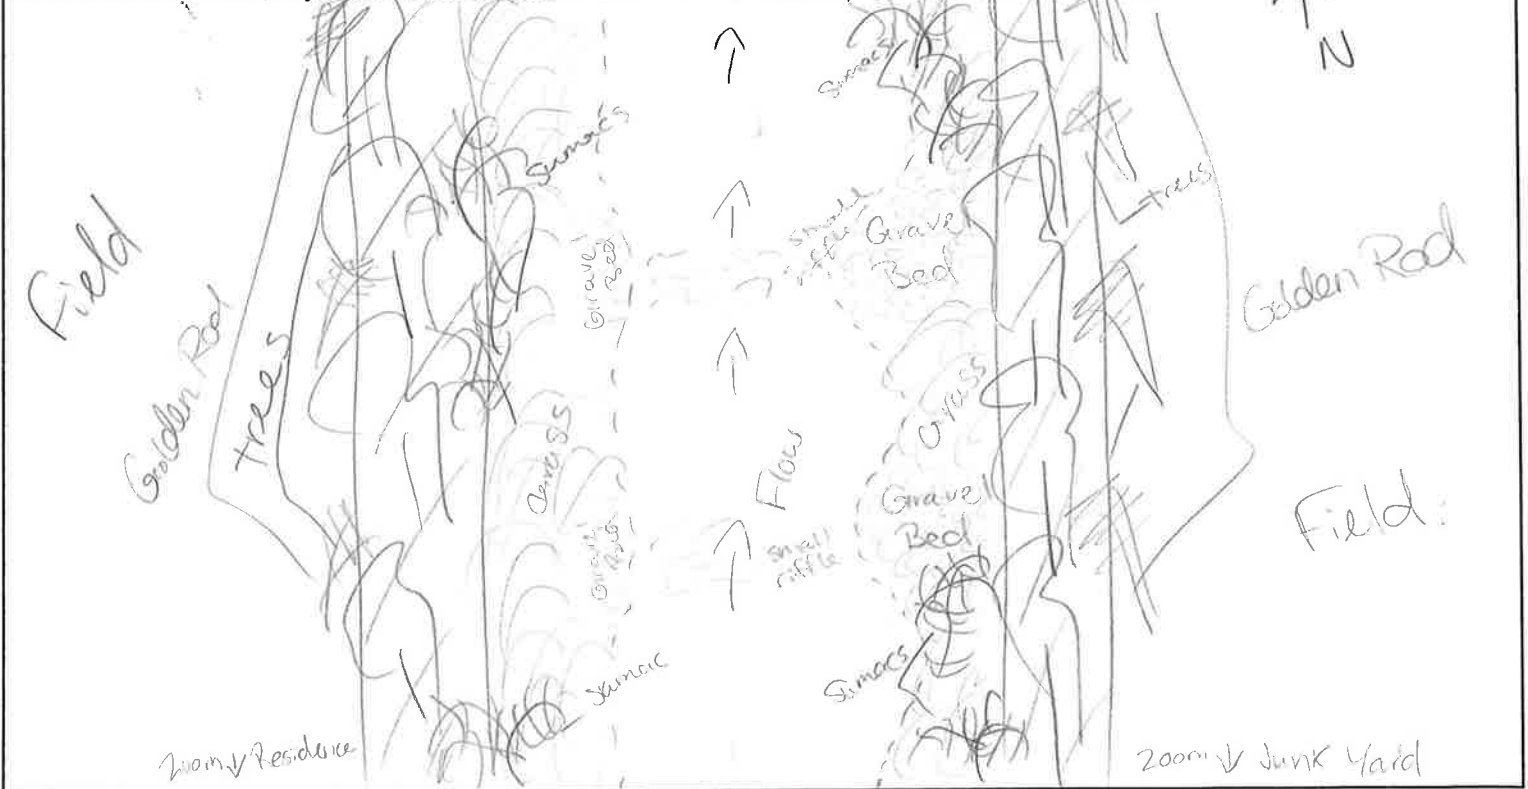
SITE DRAWING

Include: watercourse and name, flow direction, riffle/pool/run habitat, side tributaries, station location, approx. reach length, channel modifications, adjacent land use, roads & road names, bridges, culverts, north arrow, etc...

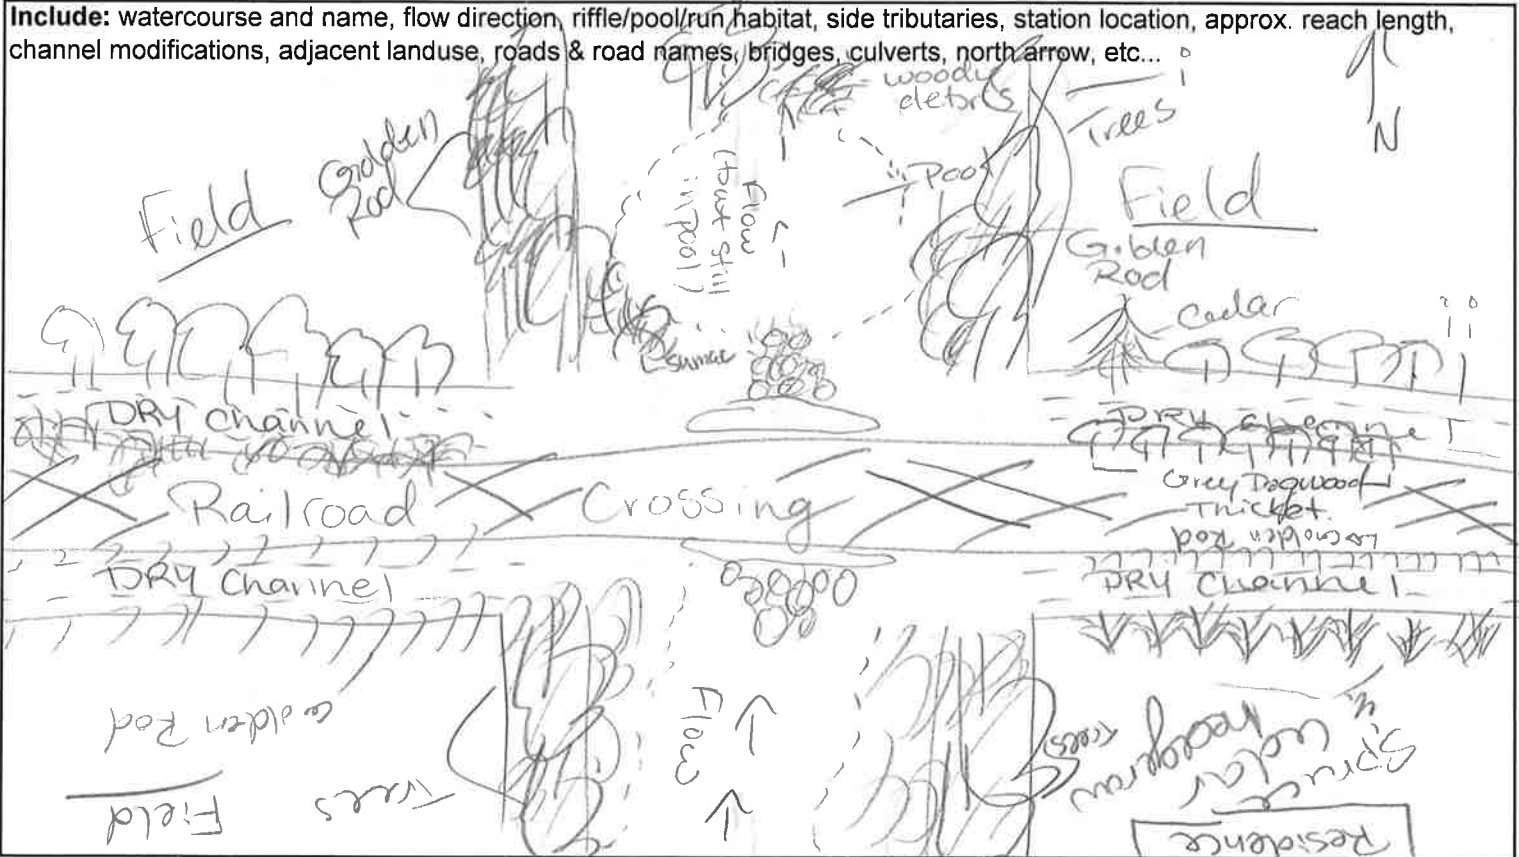
SITE DRAWING

Water Temp. (°C): 11°C	D.O. (ppm):	pH:	Visible Characteristics/Other Parameters: Slow flow north @ culvert, standing water north of culvert +
Air Temp. (°C): 11°C	D.O. (%):	TDS (ppm):	
Time Taken: 8:25	Conductivity (µs/cm):		
Location Taken:

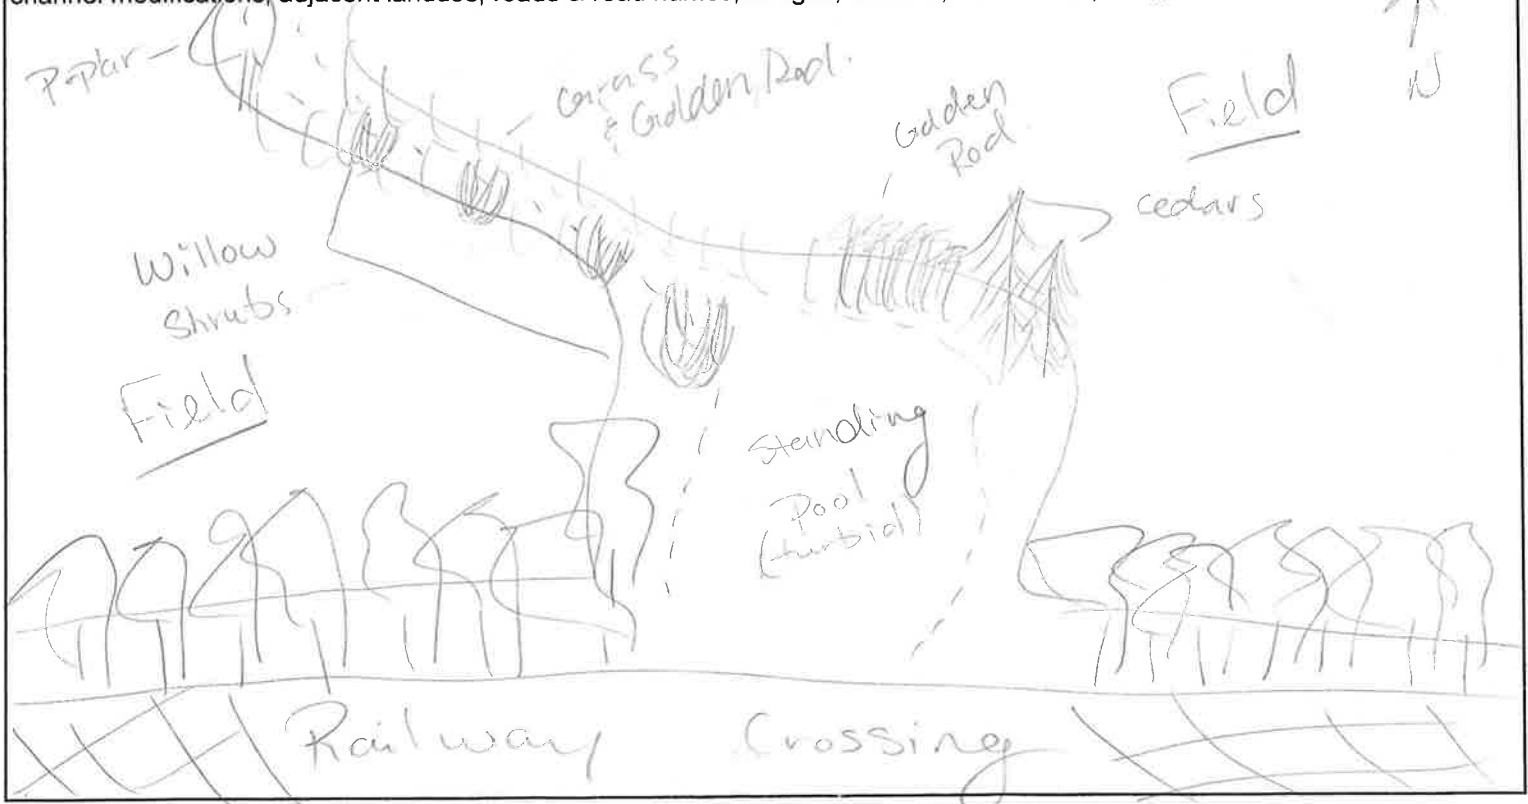
SITE DRAWING

Include: watercourse and name, flow direction, riffle/pool/run habitat, side tributaries, station location, approx. reach length, channel modifications, adjacent landuse, roads & road names, bridges, culverts, north arrow, etc...

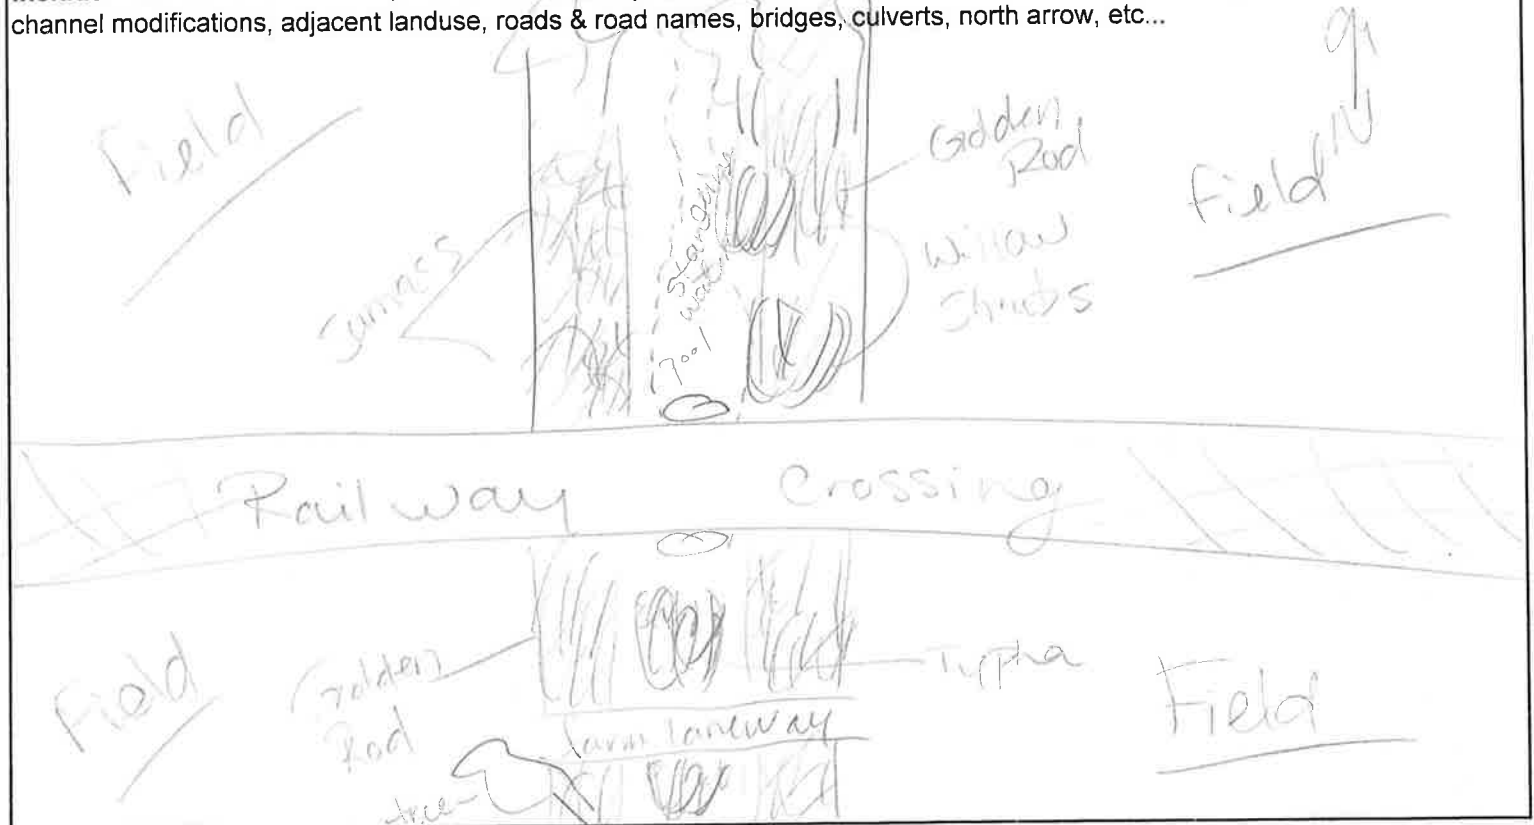
SITE DRAWING

Include: watercourse and name, flow direction, riffle/pool/run habitat, side tributaries, station location, approx. reach length, channel modifications, adjacent landuse, roads & road names, bridges, culverts, north arrow, etc...

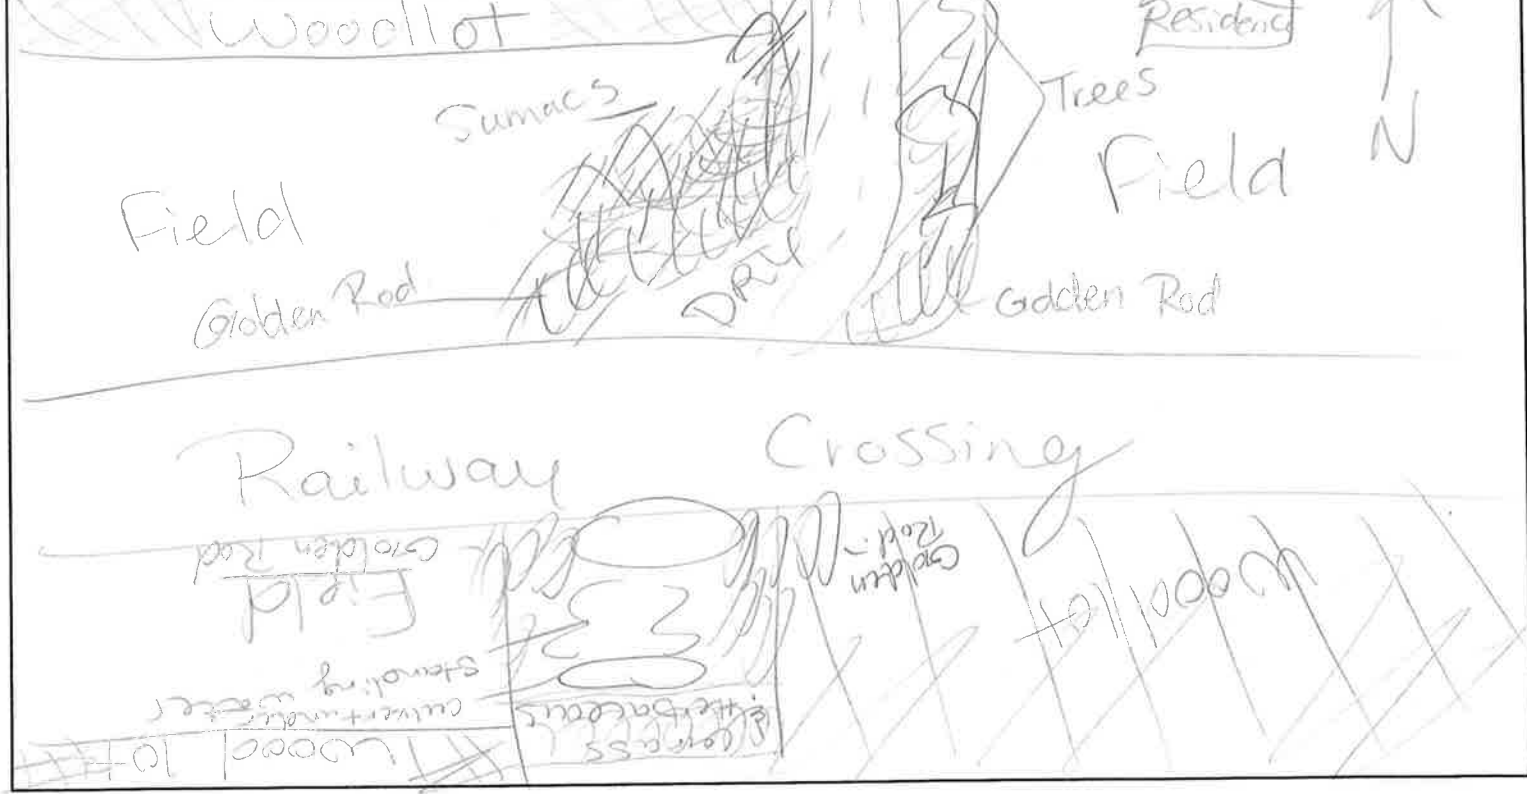
SITE DRAWING

Fish observed, unusual conditions, differences from previous site visit, landowner comments, topography, general land use and vegetation, etc.:
*channel had standing water on the south side only.

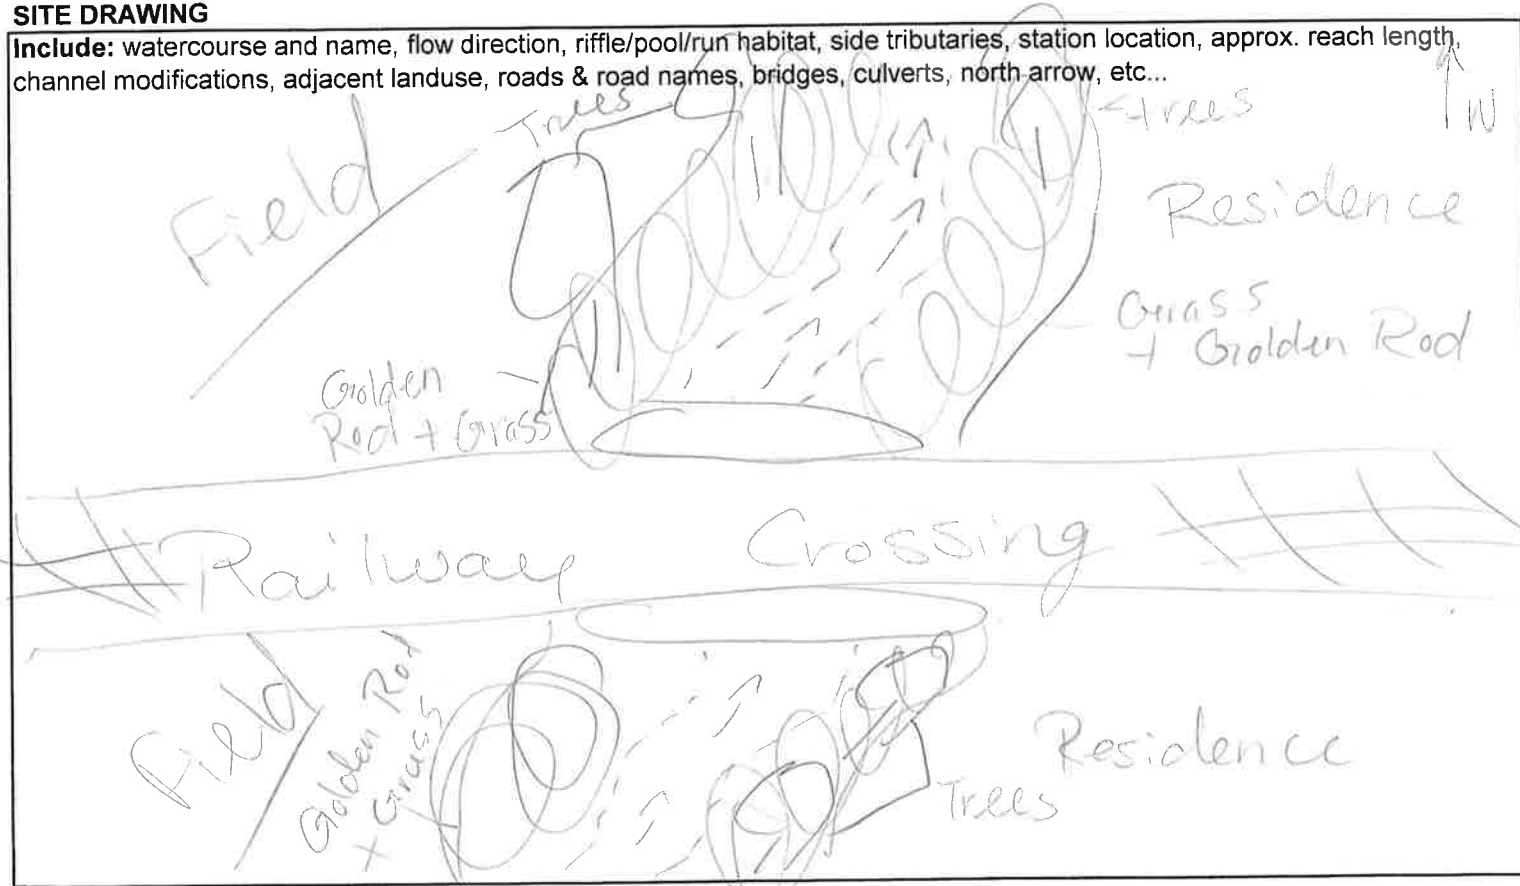
SITE DRAWING

* green frogs seen
* raccoon tracks observed.
