6B Water Body Site Investigation
Report

For
South Kent Wind Project

SOUTH KENT WIND PROJECT **Water Body Site Investigation Report**

Date: May 2012

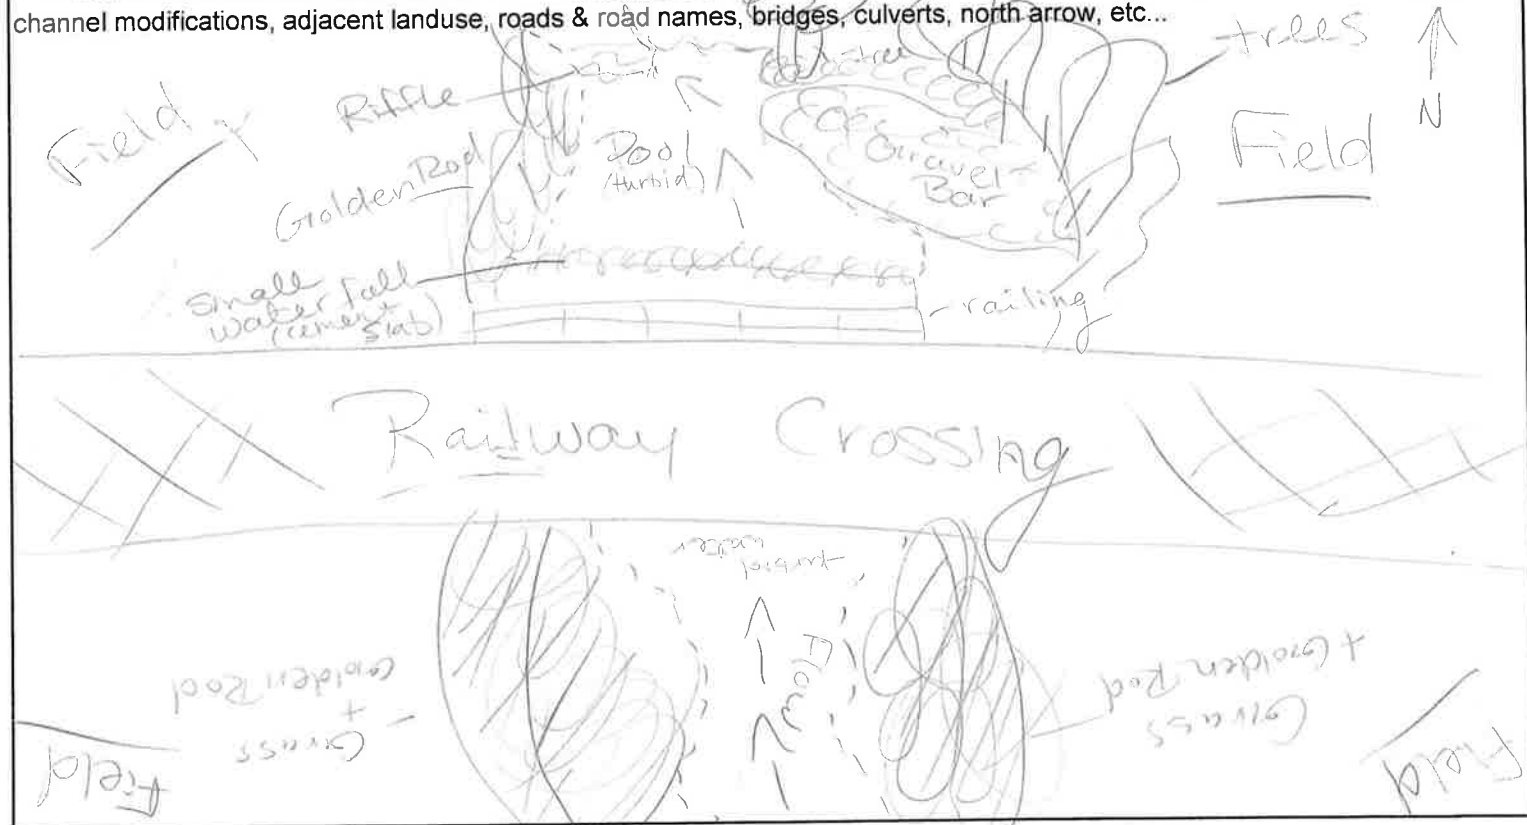
SITE DRAWING

- * cyprinids seen
- * raccoon tracks observed

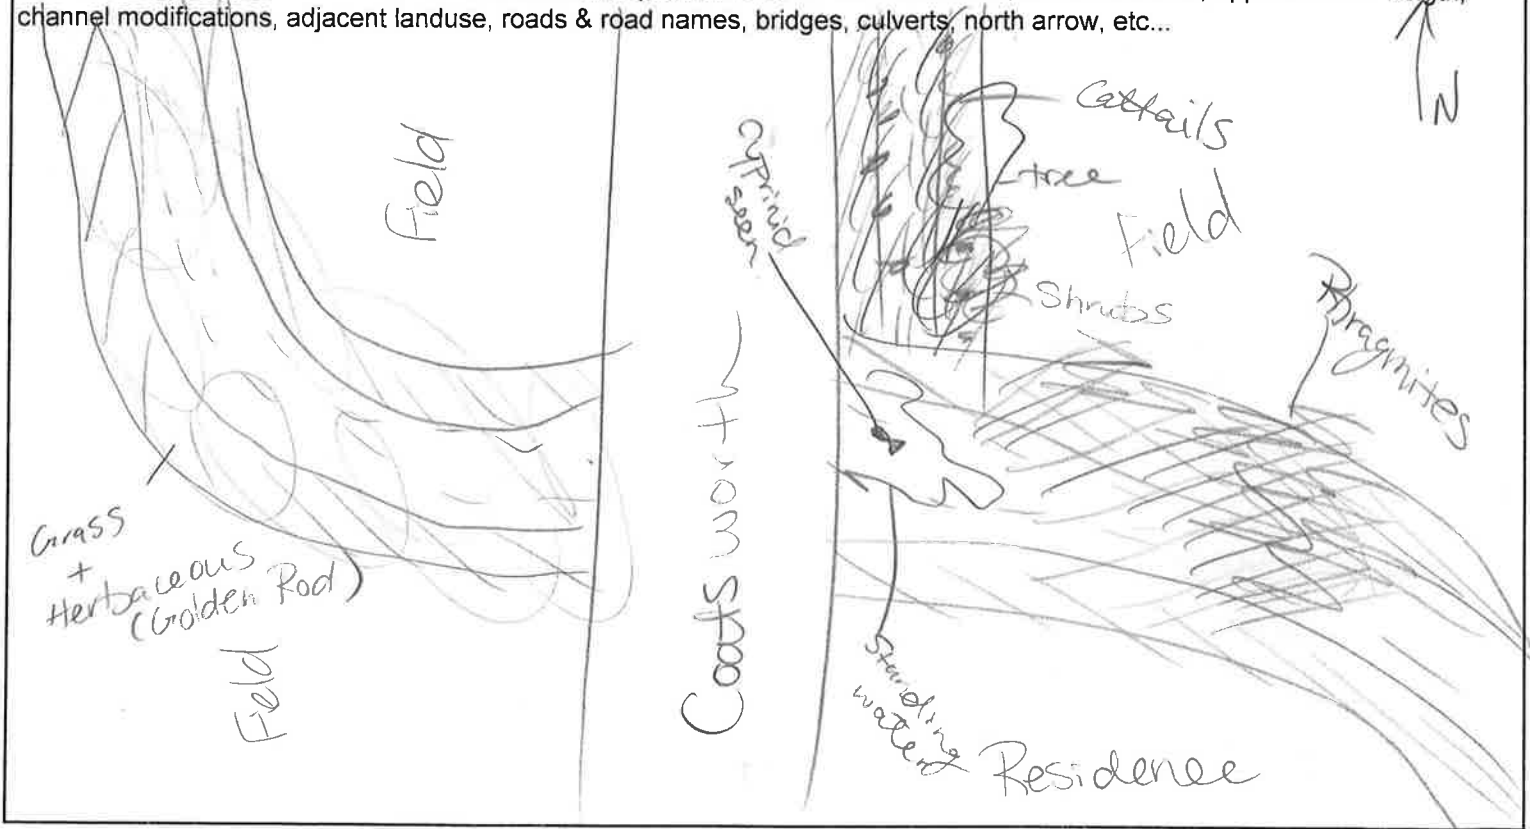
SITE DRAWING

- * cyprinid seen
- * raccoon tracks observed

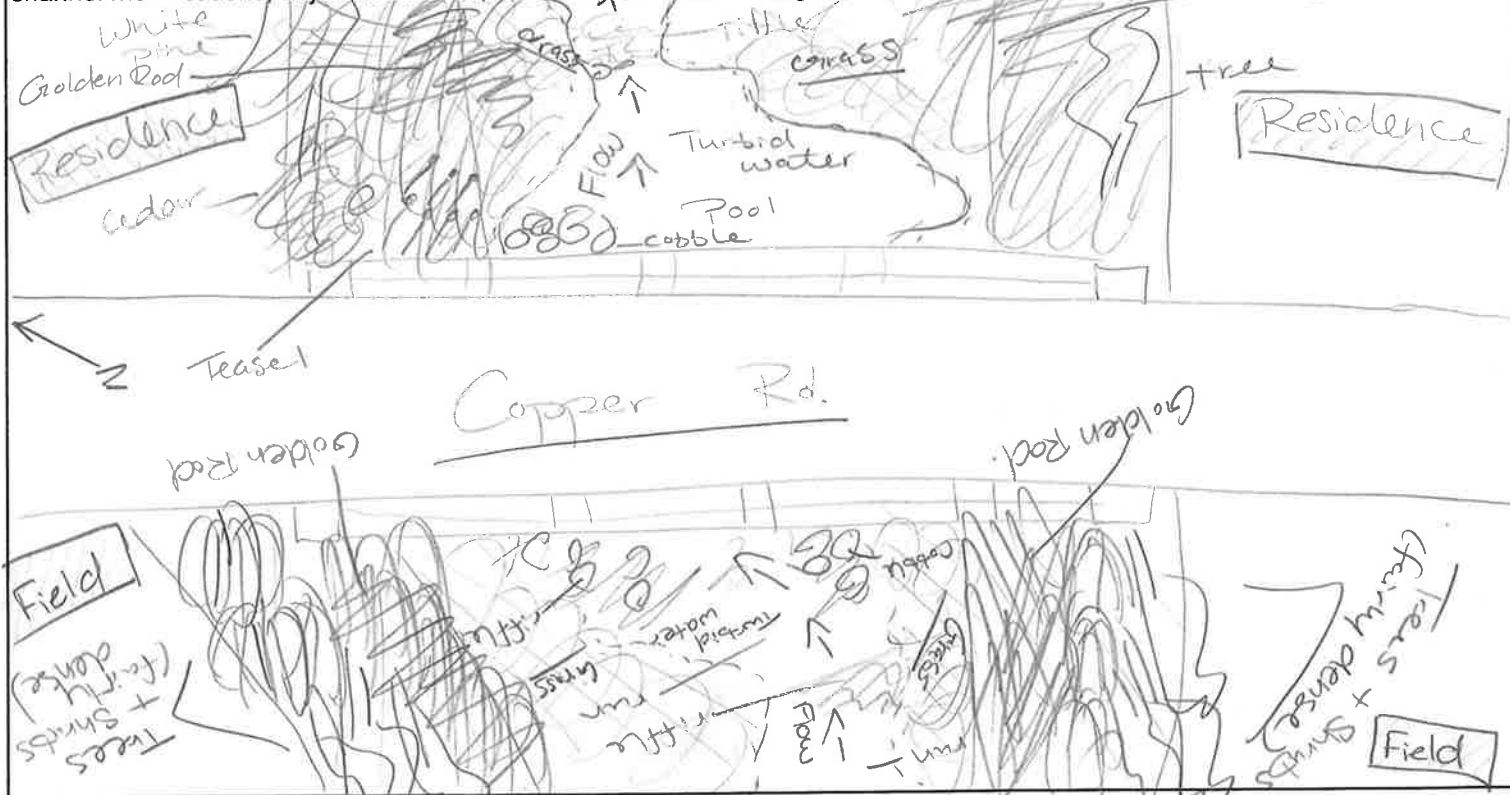
SITE DRAWING

- * Kestrel observed up the road from site.
- * no cyprinids observed, but looks like good fish habitat
- * water is turbid (could have had cyprinids but couldn't see because of turbid water)
- * raccoon tracks observed.

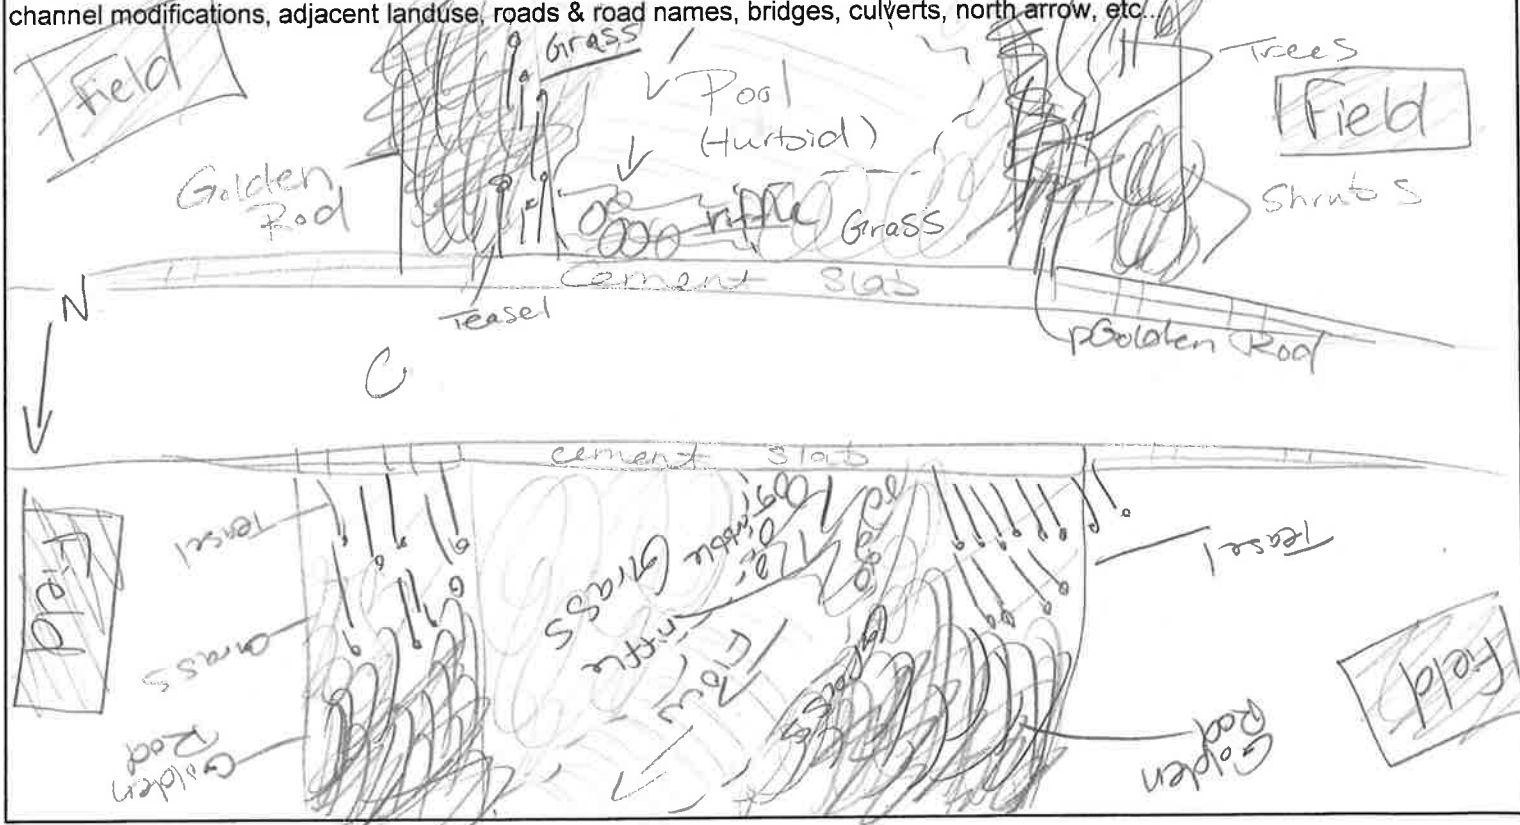
SITE DRAWING

* cyprinids observed
 * raccoon ; great blue heron tracks seen
 (drew picture facing south)

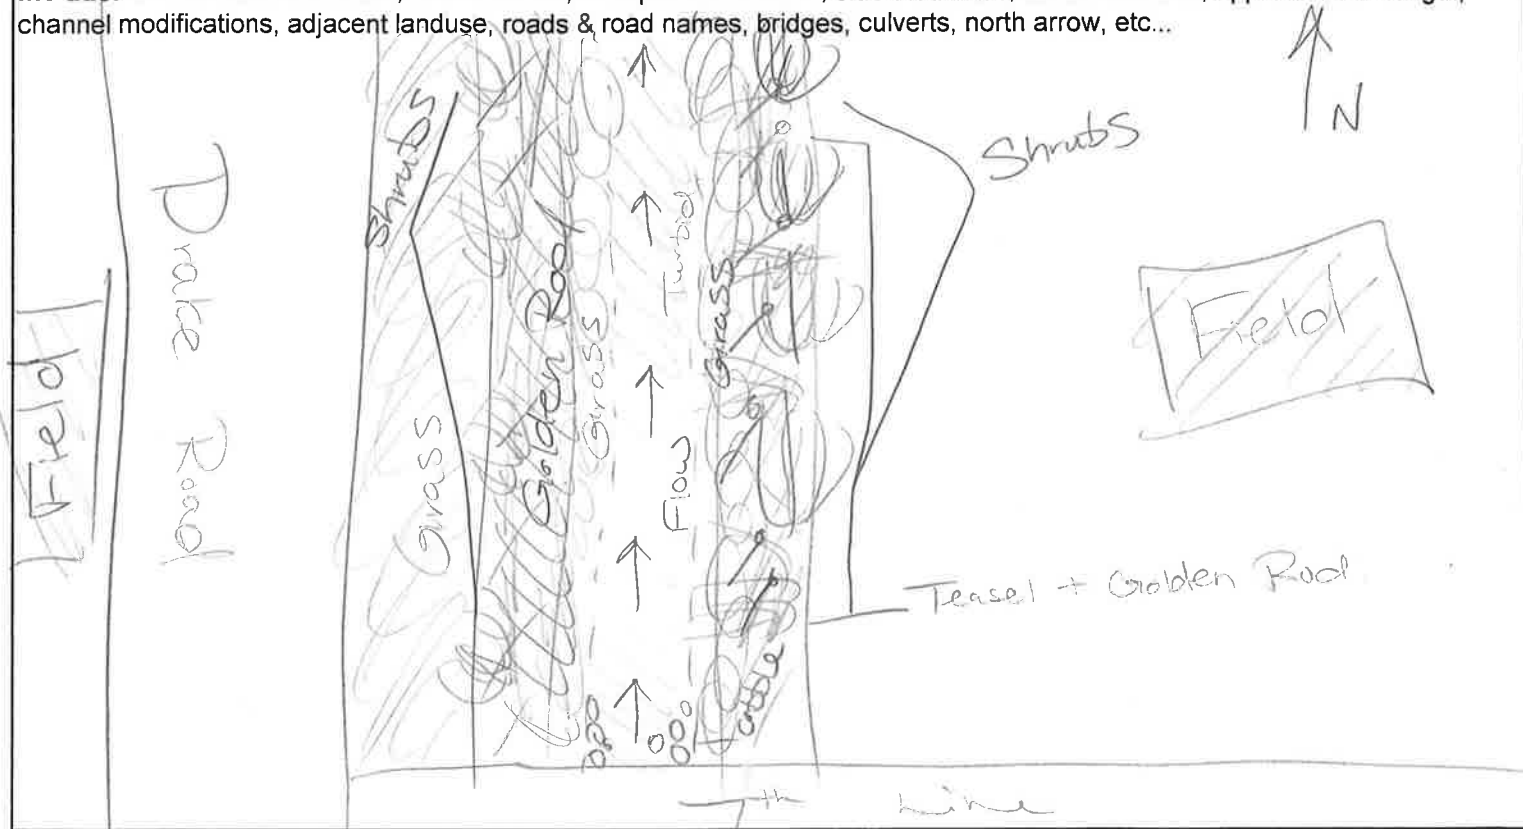
SITE DRAWING

- * water very turbid, but lots of it, could have cyprinids, but too turbid to see.
- * Cotton-tail observed.

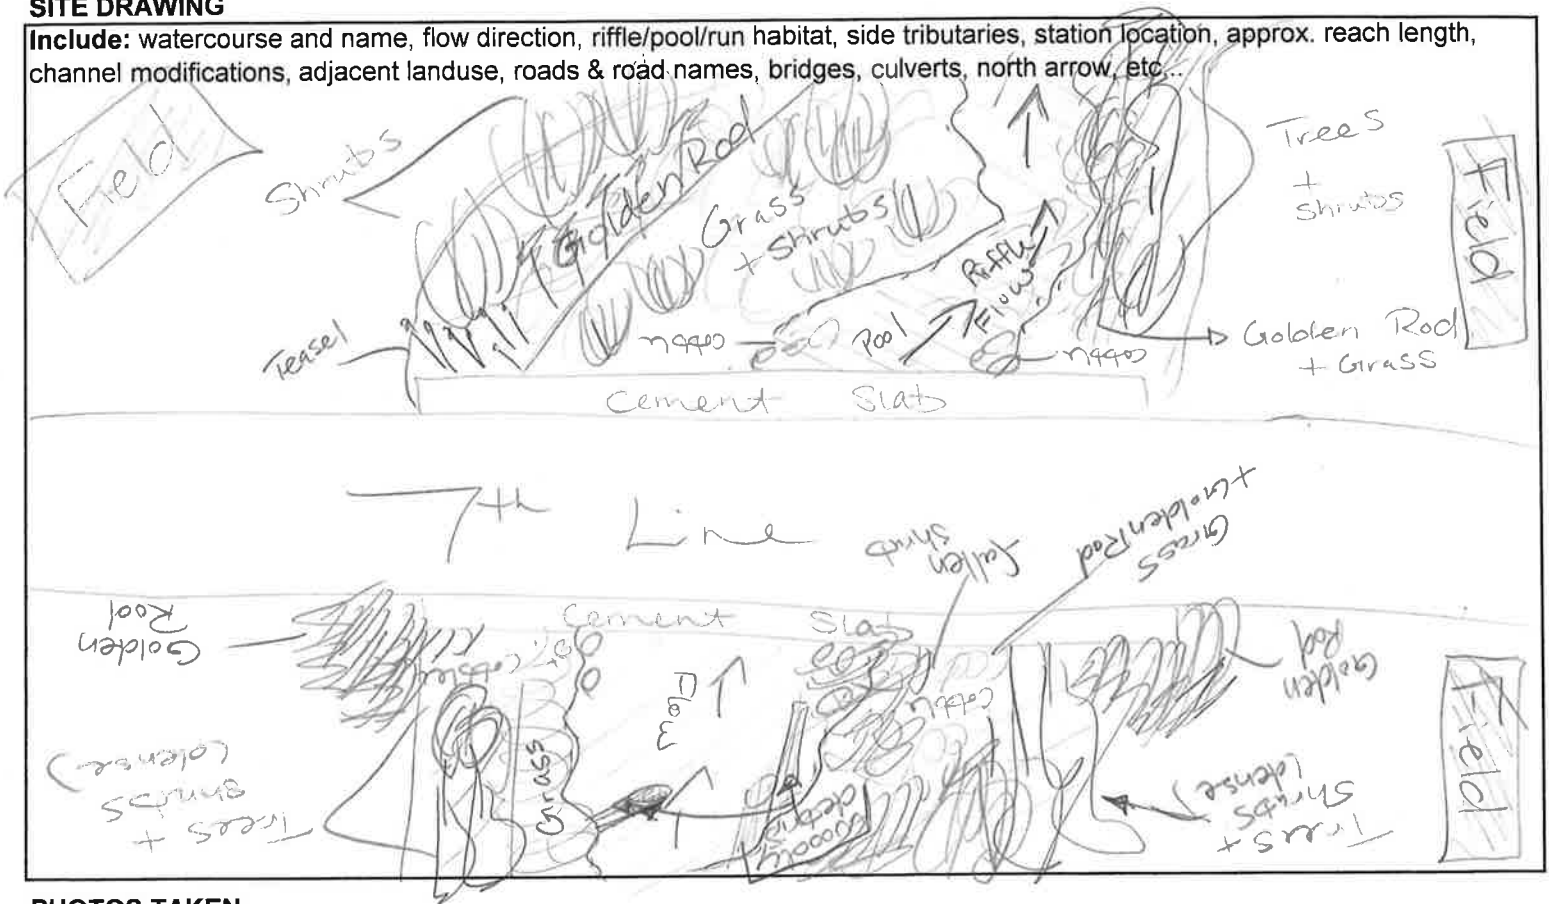
SITE DRAWING

- * aprinids observed.
- * lots of detritus ; only small amounts of filamentous algae observed.

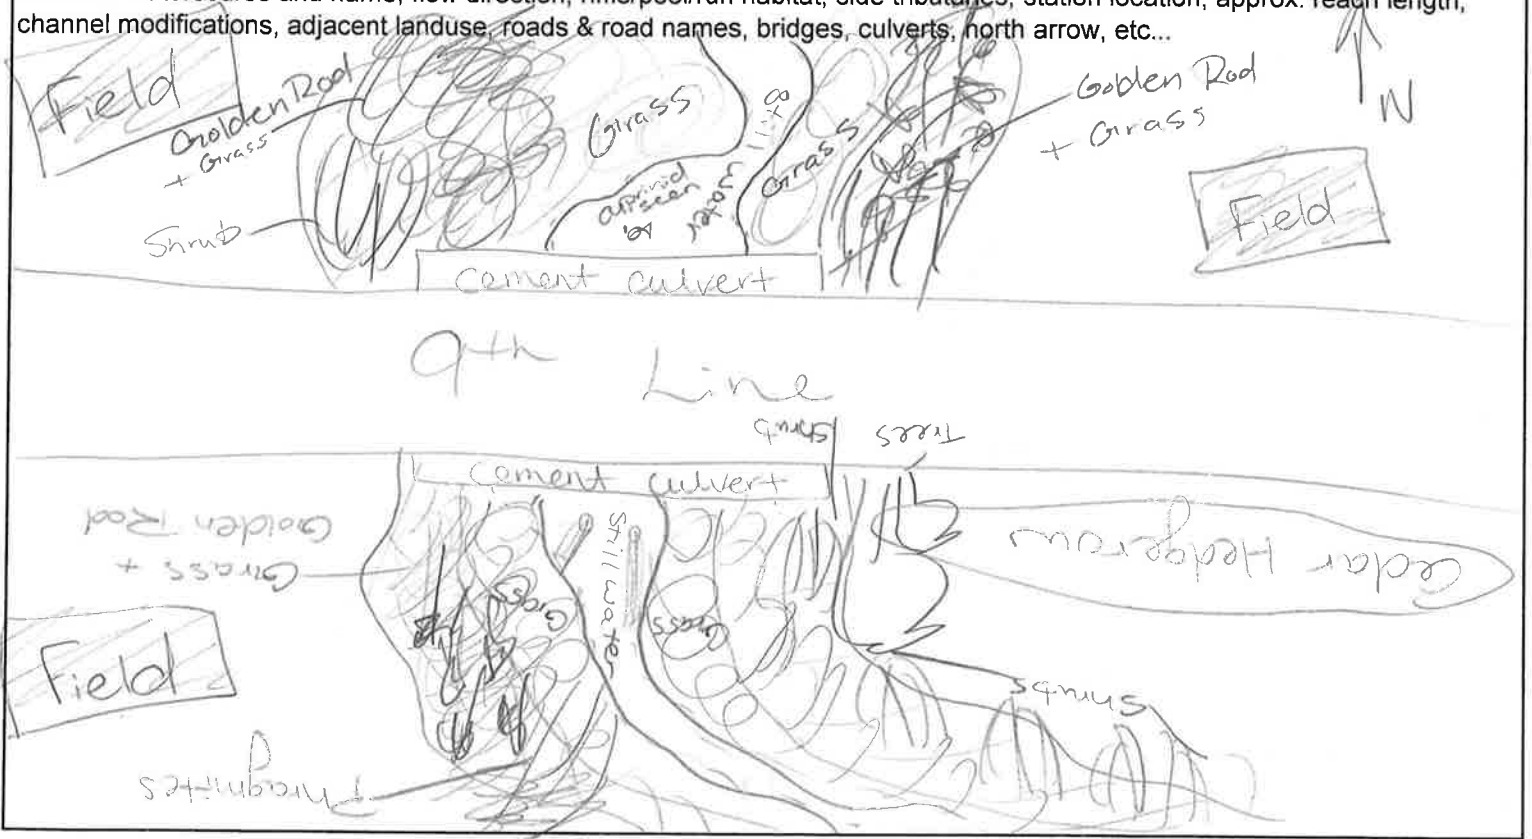
SITE DRAWING

- * cyprinids observed
- * raccoon tracks observed

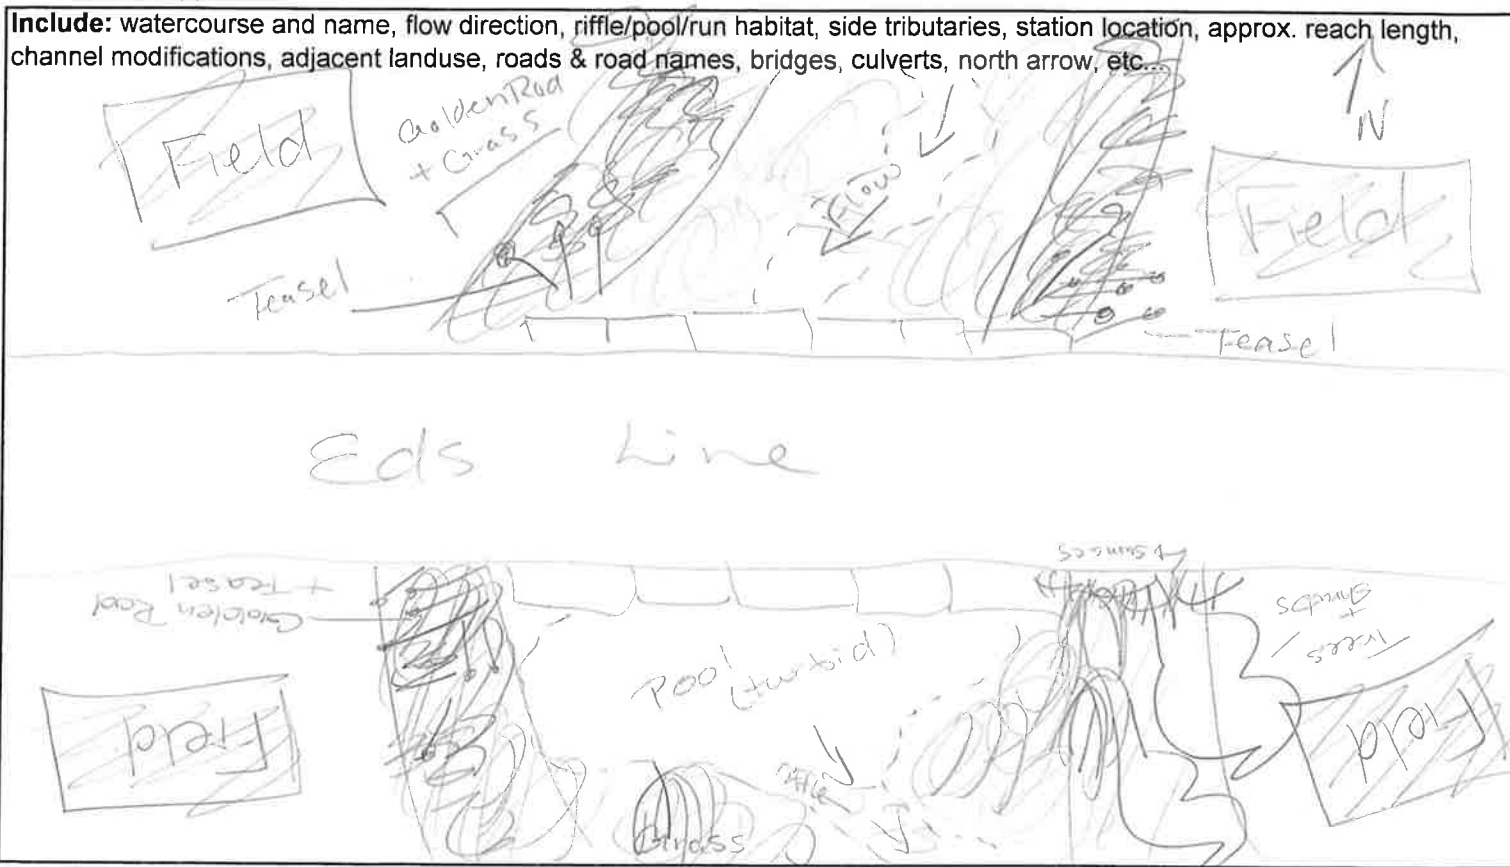
SITE DRAWING

Water Temp. (°C): 5°C	D.O. (ppm):	pH:	Visible Characteristics/Other Parameters: slow flow south turbid water
Air Temp. (°C): 6°C	D.O. (%):	TDS (ppm):	
Time Taken: 9:10	Conductivity (µs/cm):		
Location Taken: in stream

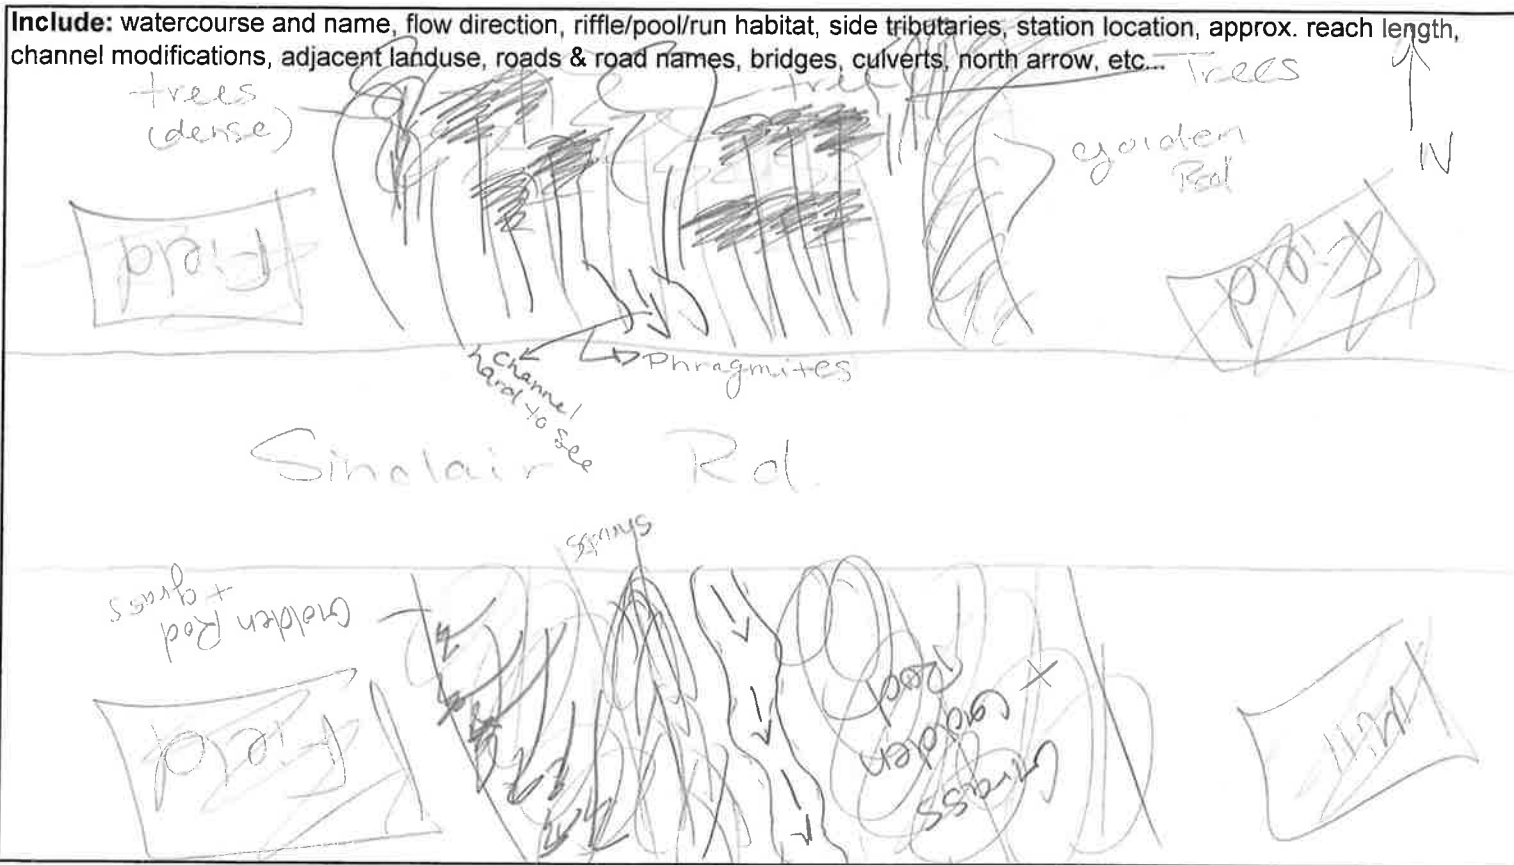
SITE DRAWING

Water Temp. (°C): 5°C	D.O. (ppm):	pH:	Visible Characteristics/Other Parameters: slow flow south very little water
Air Temp. (°C): 6°C	D.O. (%):	TDS (ppm):	
Time Taken: 9:45	Conductivity (µs/cm):		
Location Taken: In stream

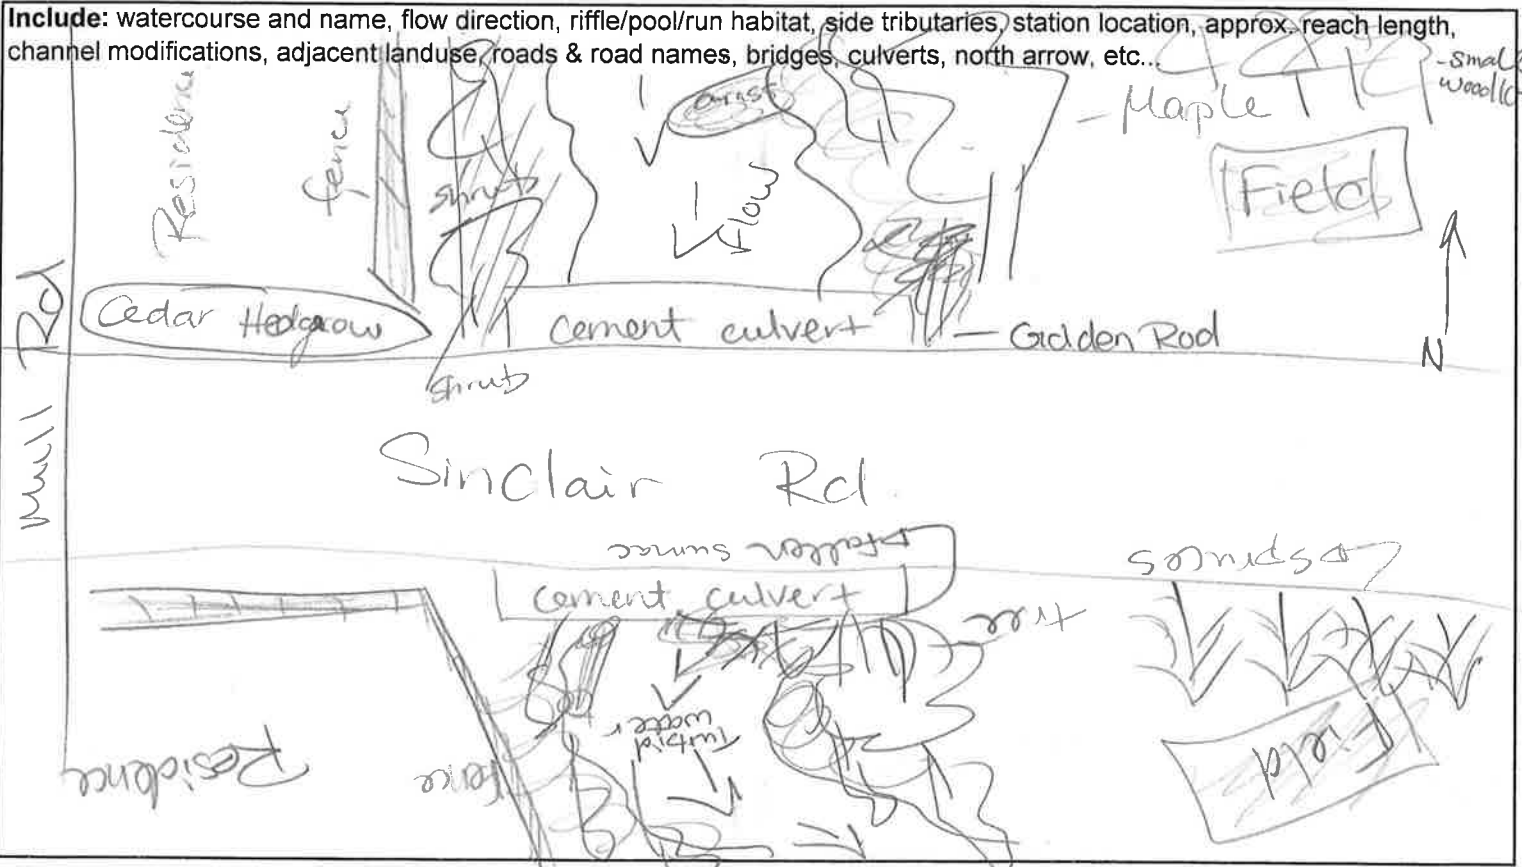
SITE DRAWING

Water Temp. (°C): 5°C	D.O. (ppm):	pH:	Visible Characteristics/Other Parameters: Southern flow.
Air Temp. (°C): 6°C	D.O. (%):	TDS (ppm):	
Time Taken: 10:05	Conductivity (µs/cm):		
Location Taken: In stream

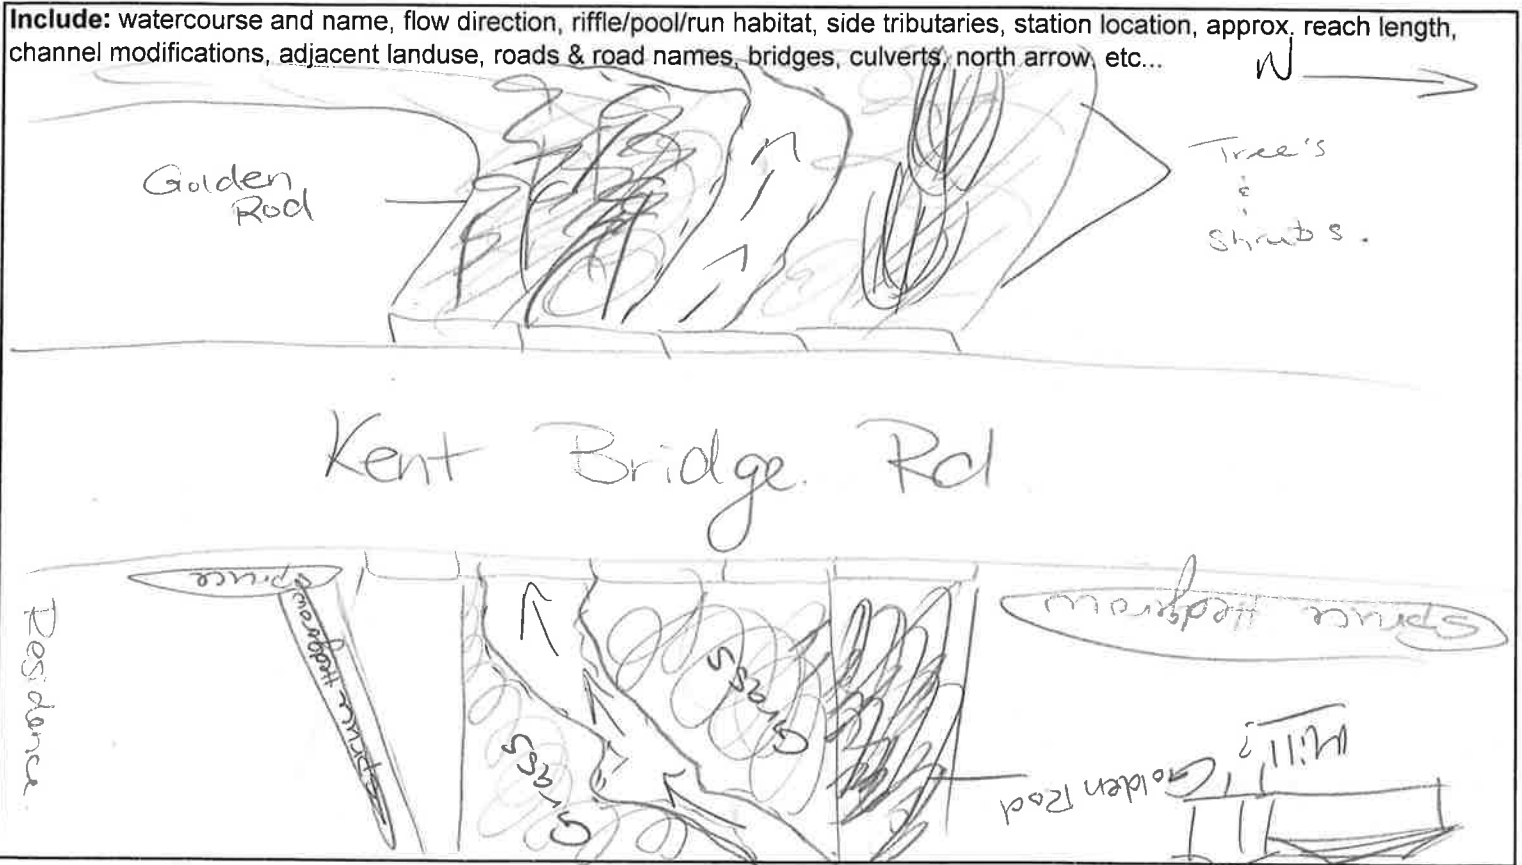
SITE DRAWING

Water Temp. (°C): 5°C	D.O. (ppm):	pH:	Visible Characteristics/Other Parameters: Slow flow south west (fairly turbid)
Air Temp. (°C): 7°C	D.O. (%):	TDS (ppm):	
Time Taken: 11:58	Conductivity (µs/cm):		
Location Taken: in stream

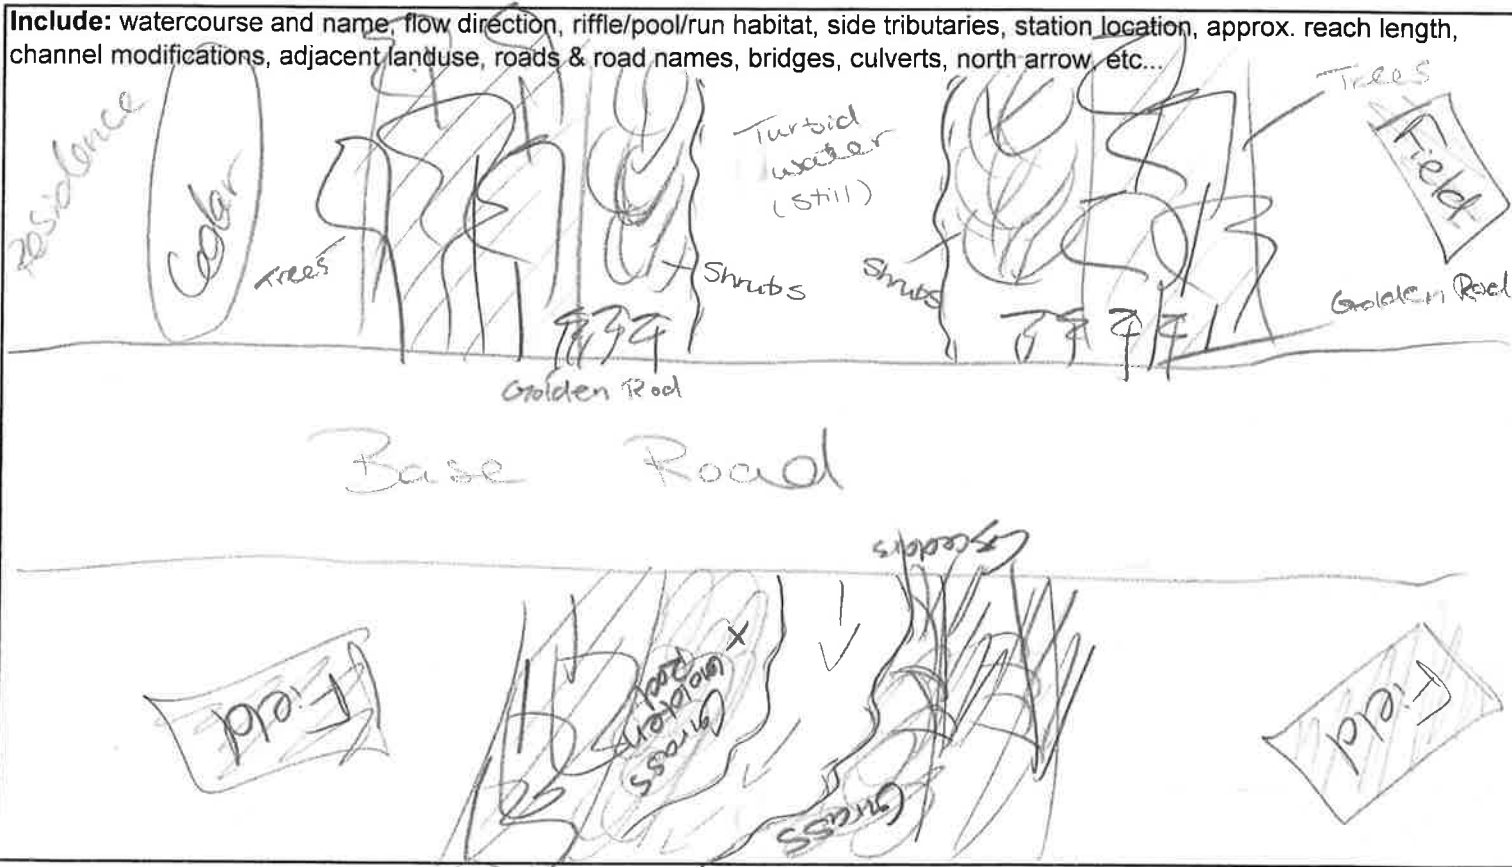
SITE DRAWING

Water Temp. (°C): 6°C	D.O. (ppm):	pH:	Visible Characteristics/Other Parameters: Slow flow west water very turbid
Air Temp. (°C): 8°C	D.O. (%):	TDS (ppm):	
Time Taken: 12:42	Conductivity (µs/cm):		
Location Taken:

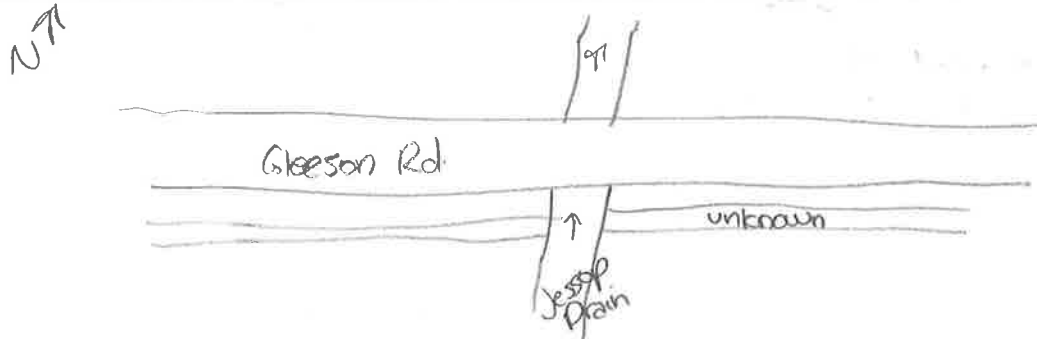
SITE DRAWING

Jessop Drain

- flowing, murky
- good fish habitat
- culvert box - 4m wide under rd.
- bankfull ~ 3m

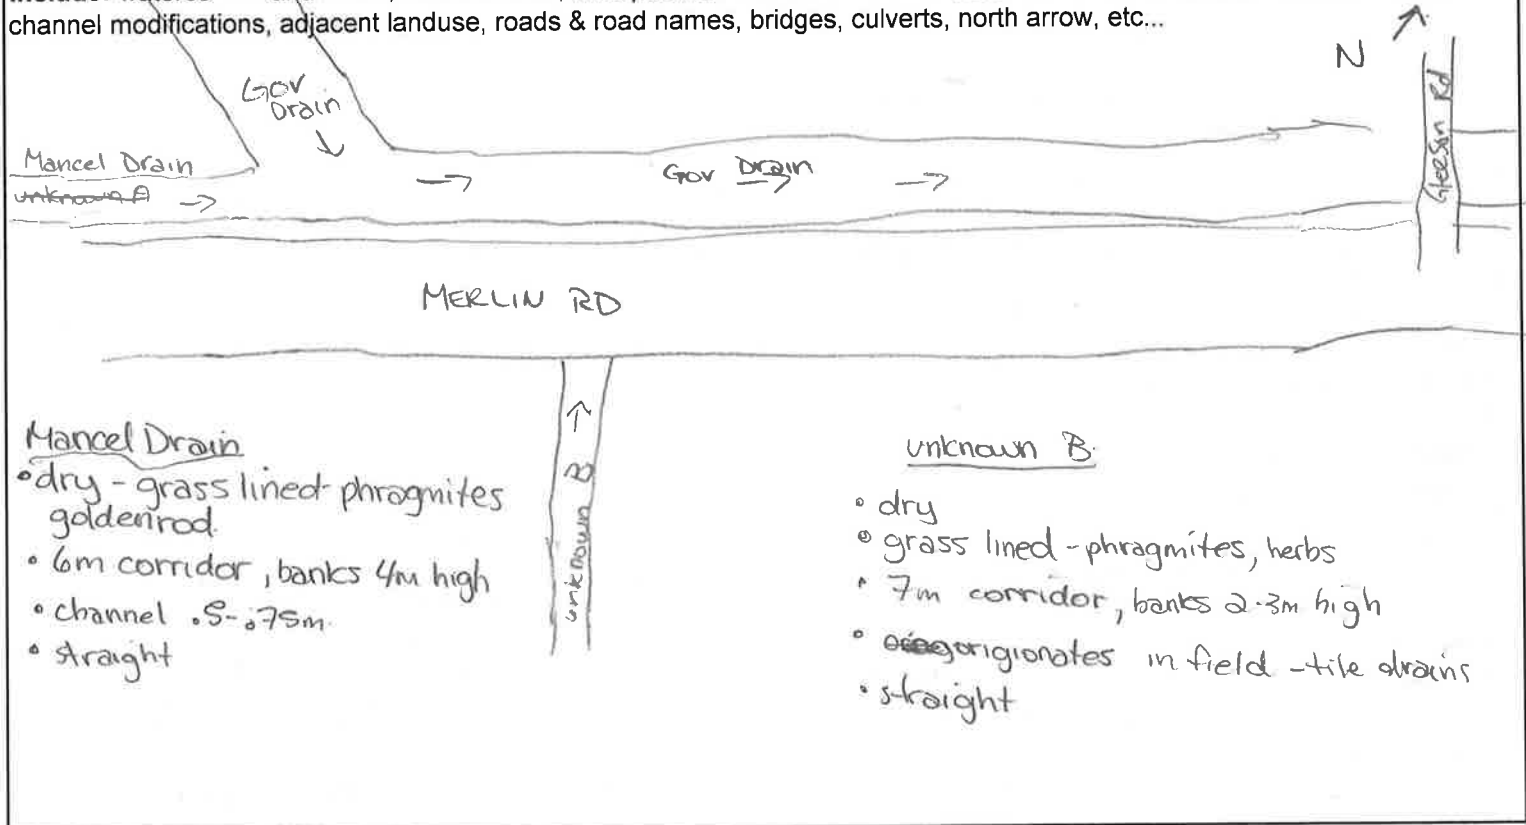
SITE DRAWING

Photo #	Description	Photo #	Description
100-54	- d/s view of gov drain #1		
100-55	- u/s view " " (meanders through field)		
100-56	- d/s view of unknown B - perp to Merlin Rd.		
100-57	- u/s view of Mancel Drain - parallel to Merlin Rd.

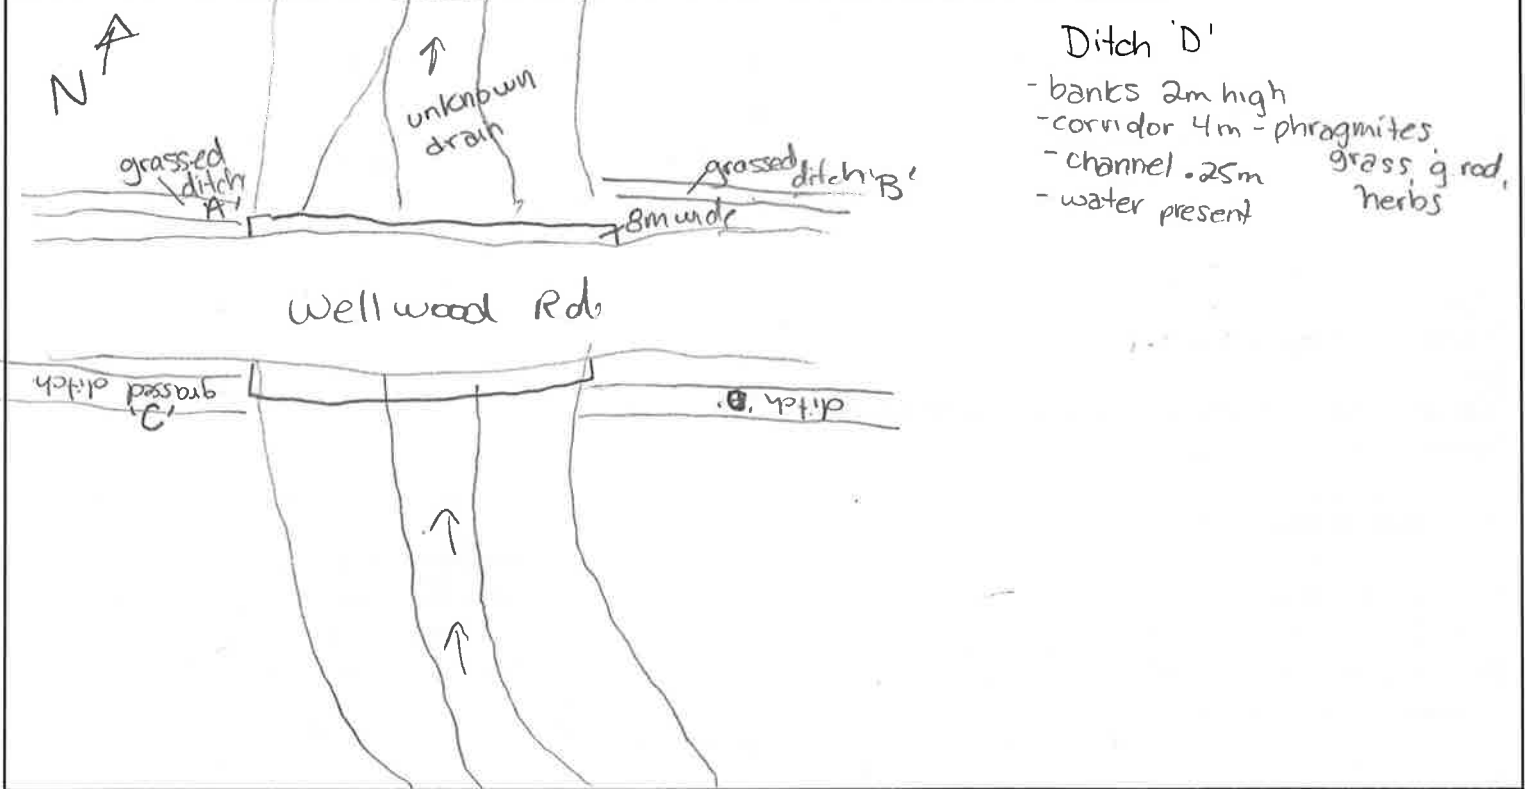
SITE DRAWING

Photo #	Description	Photo #	Description
100-072	-u/s view of unknown drain	100-077	-ditch 'D'
100-073	-d/s view of "		
100-074	- ditch 'A' view		
100-075	- ditch 'B' view		
100-076	- ditch 'C' view

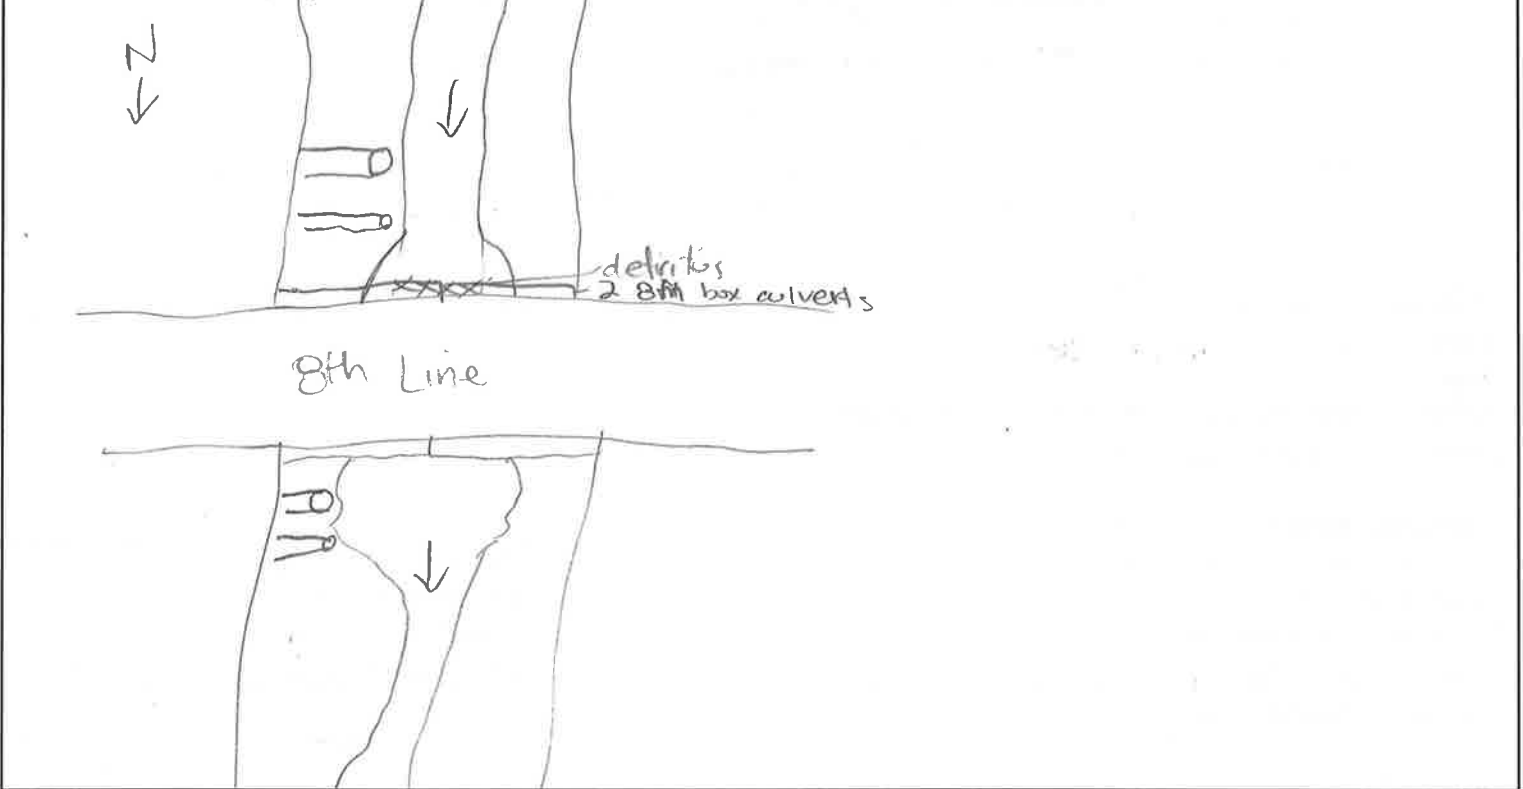
SITE DRAWING

Photo #	Description	Photo #	Description
100-083	- u/s view (south)		
100-084	- d/s view (north)

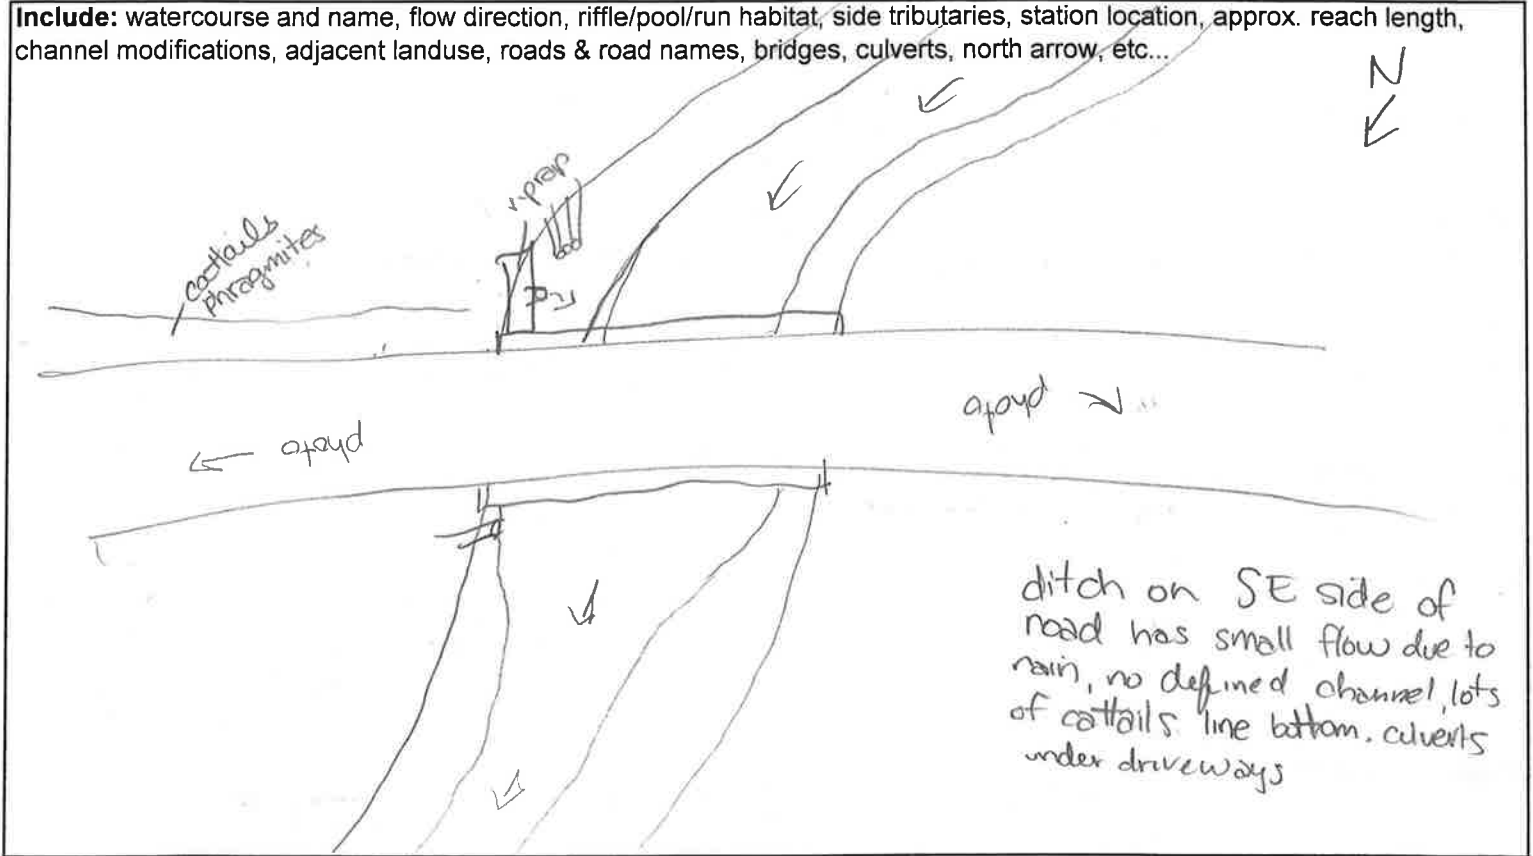
SITE DRAWING

Photo #	Description	Photo #	Description
100-111	u/s view of earthen drain		
100-112	d/s view of " "		
100-113	E facing shot		
100-114	w facing shot

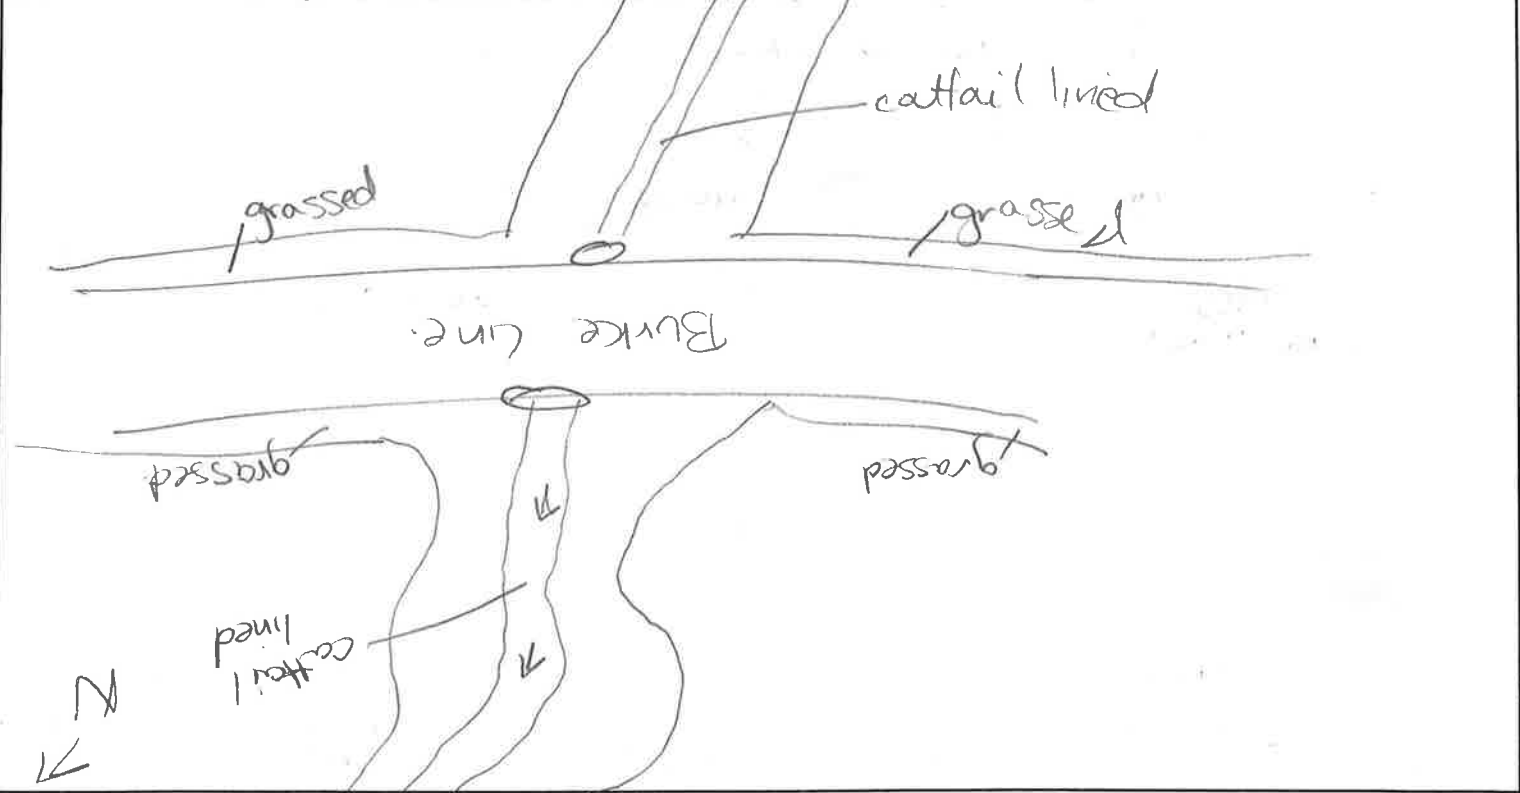
SITE DRAWING

Photo #	Description	Photo #	Description
100-149	u/s new Kneeborne Drain		
100-150	d/s new "

- pockets of water - no flow
- lined with cattails
- bankfull approx - 4-5m
- culvert round 1m dia.
- no fish observed
- dry or moist in summer
