6B Water Body Site Investigation
Report

For
South Kent Wind Project

SOUTH KENT WIND PROJECT **Water Body Site Investigation Report**

Date: May 2012

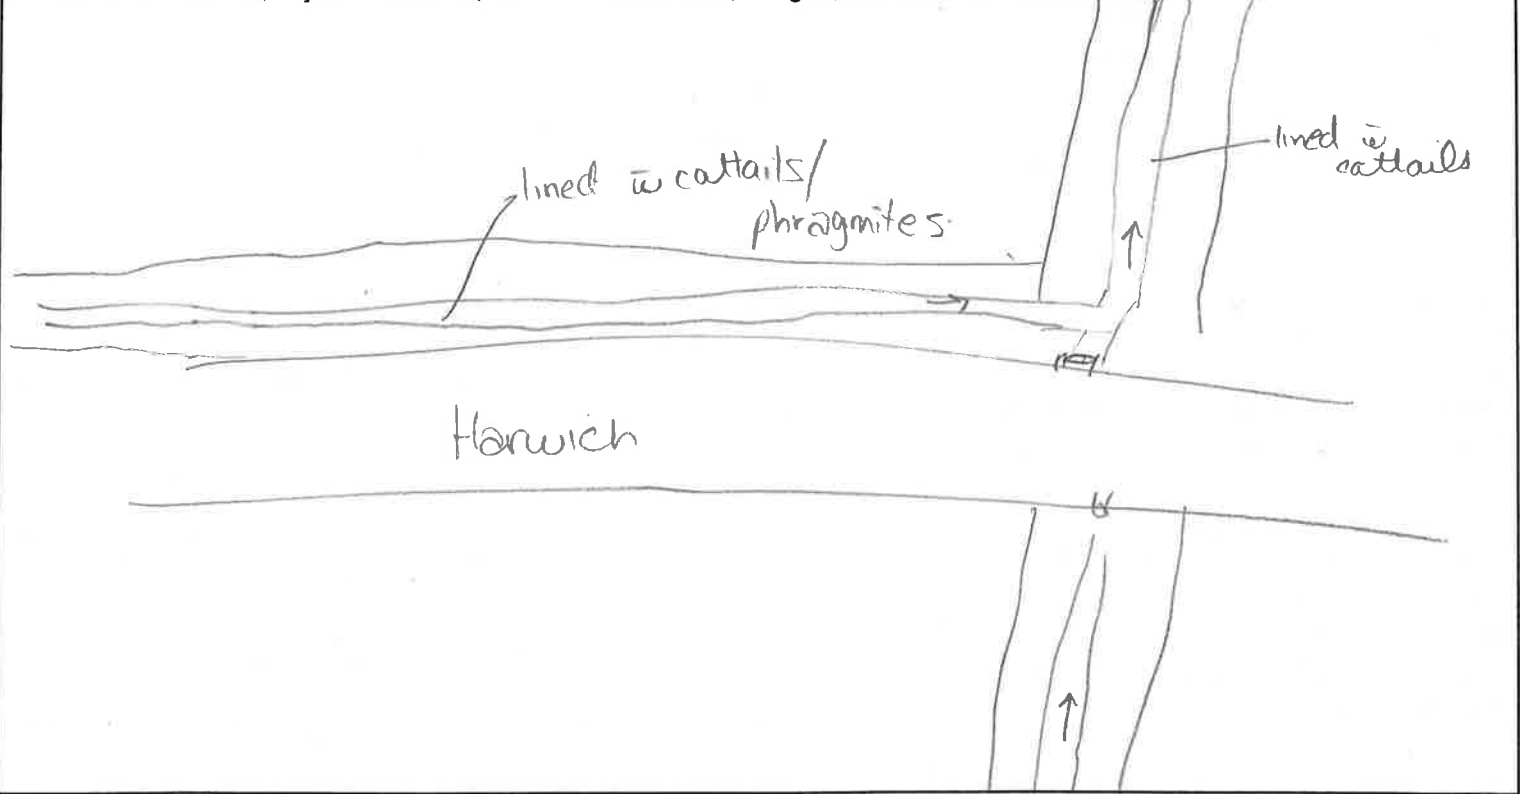
SITE DRAWING

Photo #	Description	Photo #	Description
100-173	d/s view of White Drain (perp)	100-173	westside
100-174	view parallel to Horwich (west side)	100-174	side
100-175	u/s view of white drain	100-175	of drain (u/s view)
100-176	u/s view of white drain

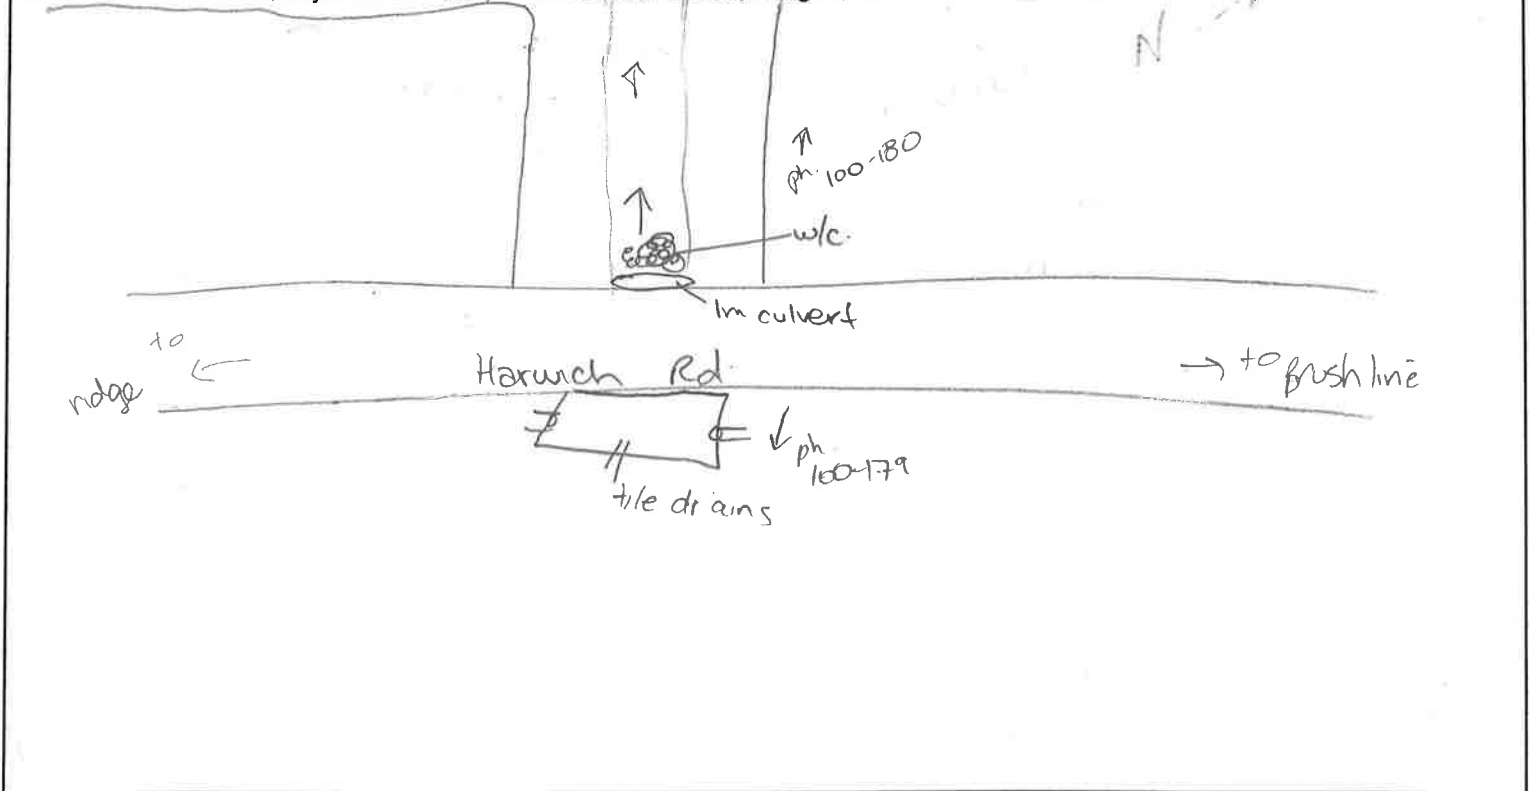
SITE DRAWING

Photo #	Description	Photo #	Description
100-179	ups view		
100-180	dfs view

- clear
- Bankful - 4-5m.
- no fish seen
- N. Harrier observed

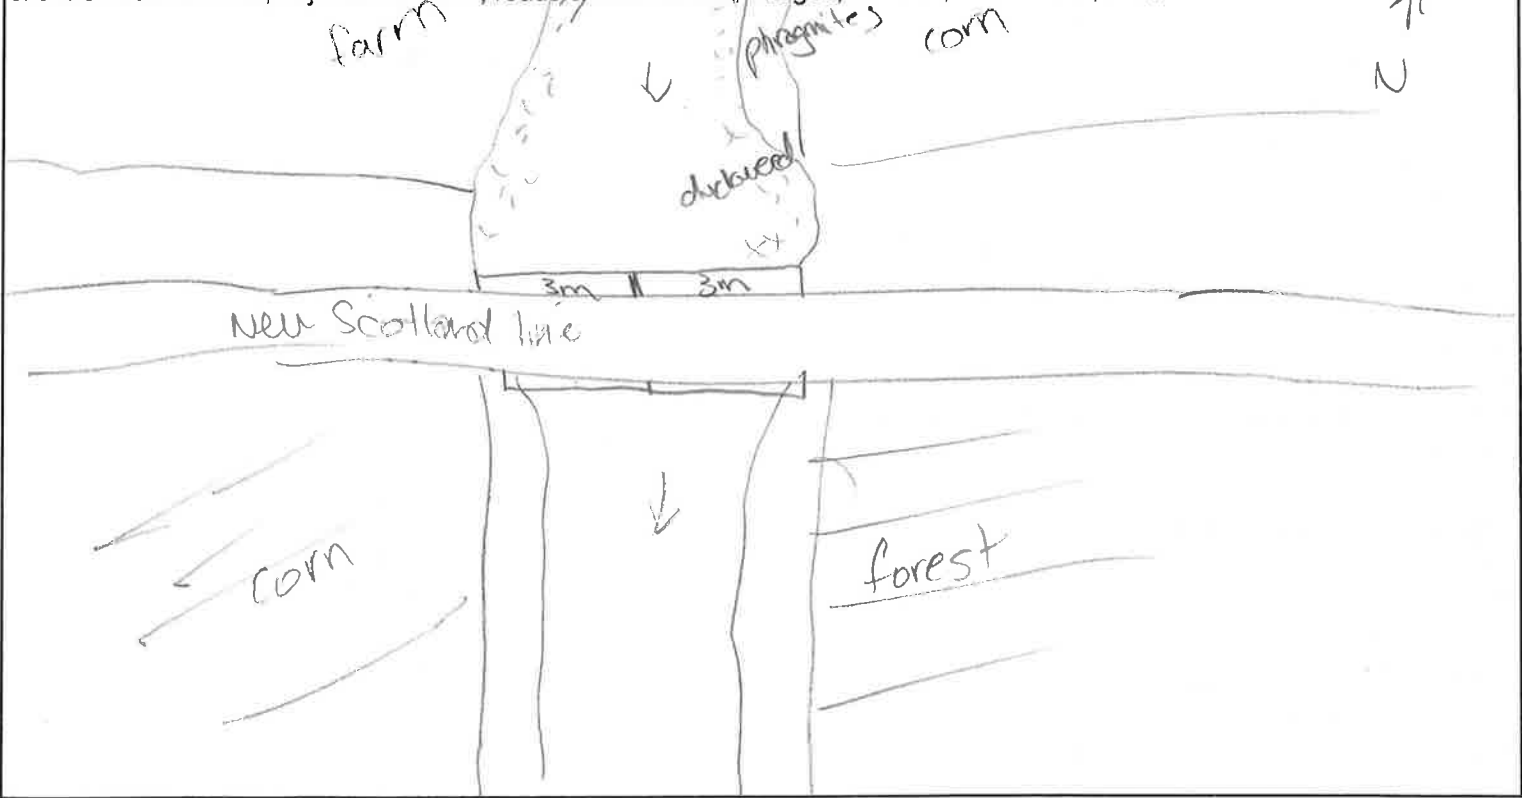
SITE DRAWING

Photo #	Description	Photo #	Description
100-196	u/s view		
100-197	d/s view

fish observed
frog seen
backflow effect

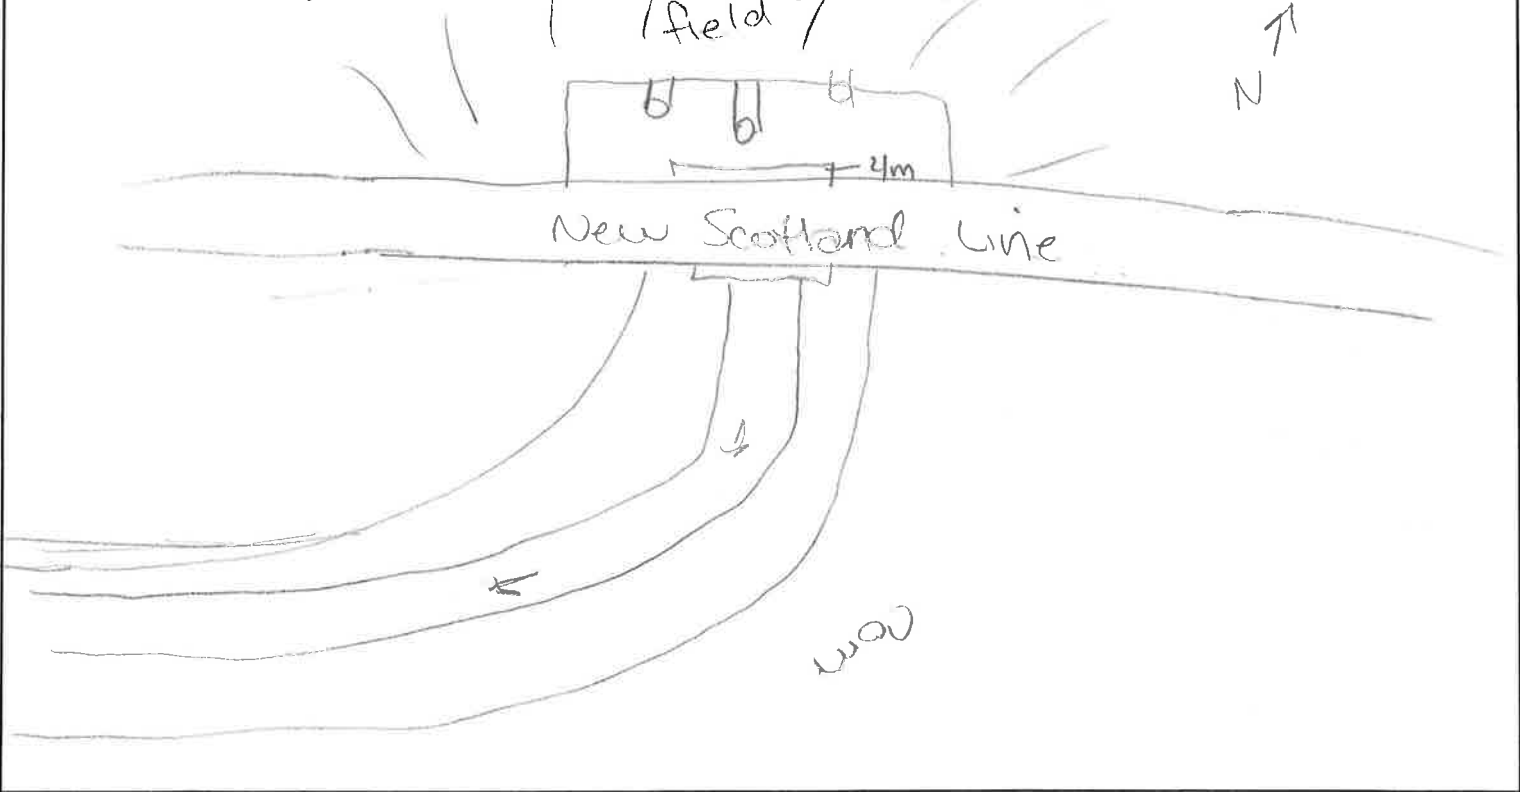
SITE DRAWING

Photo #	Description	Photo #	Description
100-194	- u/s view		
100-195	- d/s view

- fish observed
- bankfull - 4m
- no flow

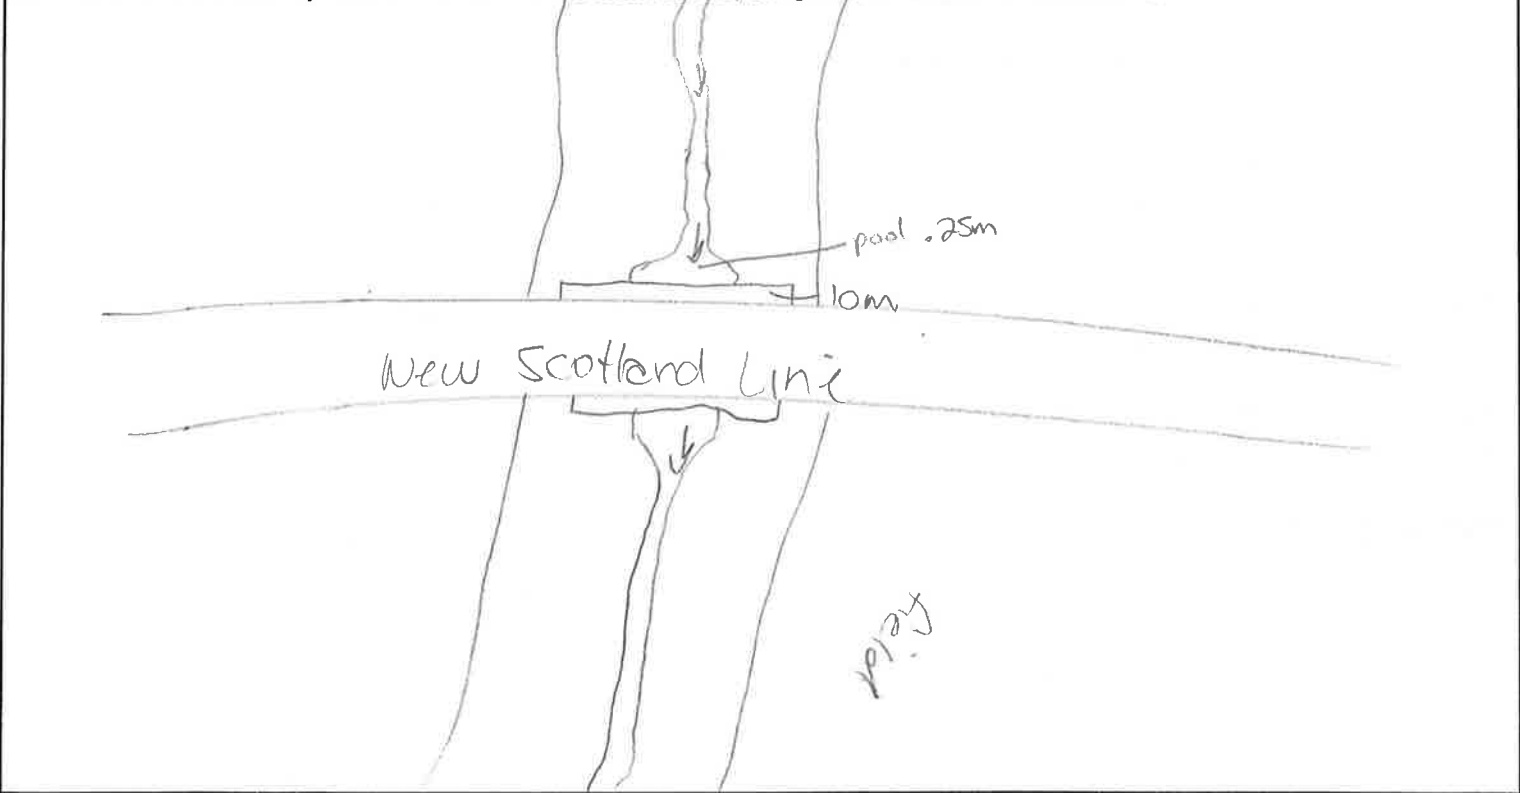
SITE DRAWING

Photo #	Description	Photo #	Description
100-204	u/s view		
100-205	d/s view

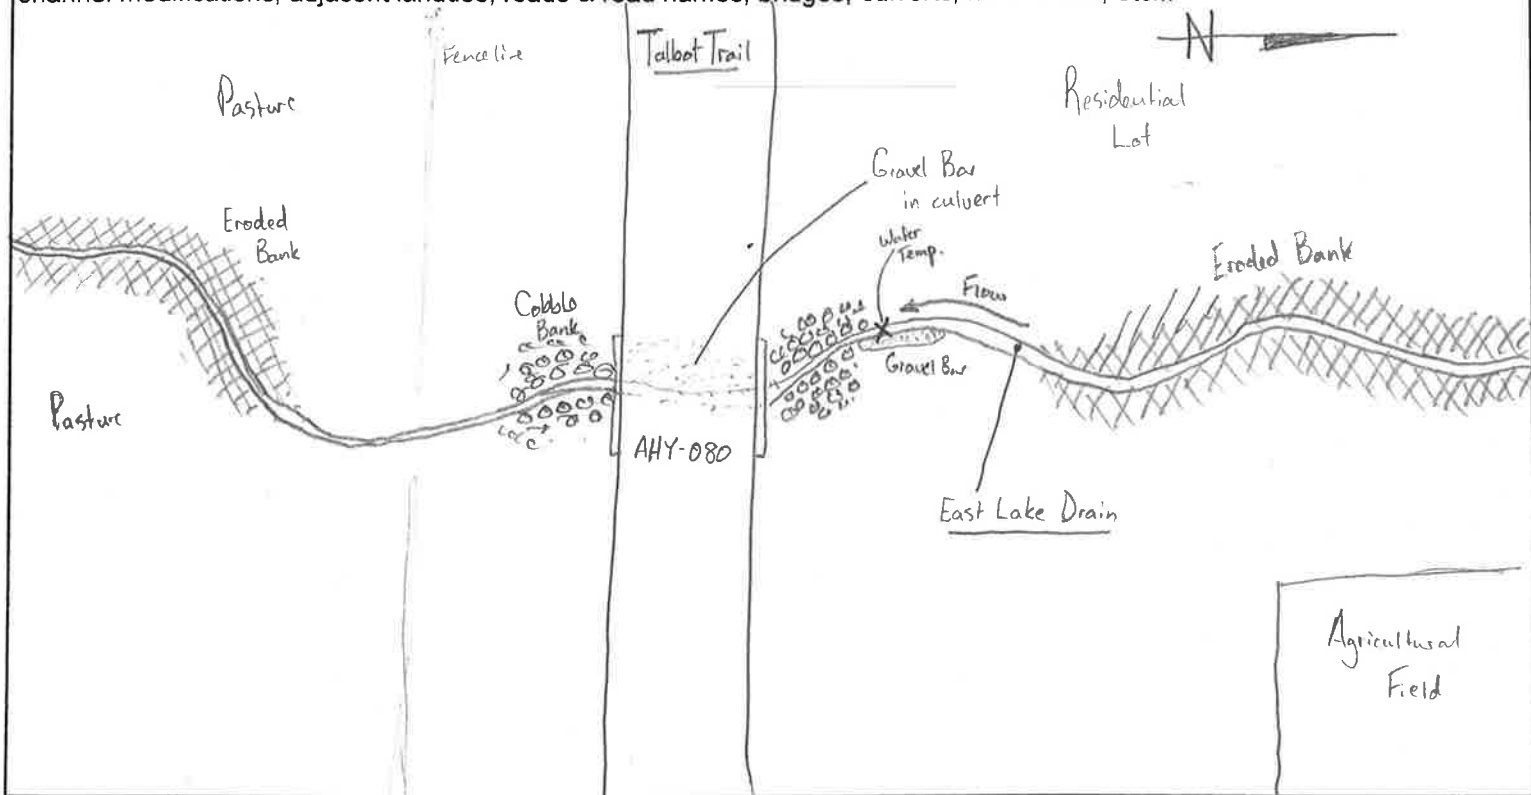
SITE DRAWING

Photo #	Description	Photo #	Description
100-357	Facing South from culvert	100-0362	Sedge Sp. on North Side of culvert
358	" " " "	0363	Facing North from culvert
359	Sedge sp. on South side		
360	Facing North from culvert		
361	" " " "

- No fish observed
- water cloudy
- Small amount of algae.

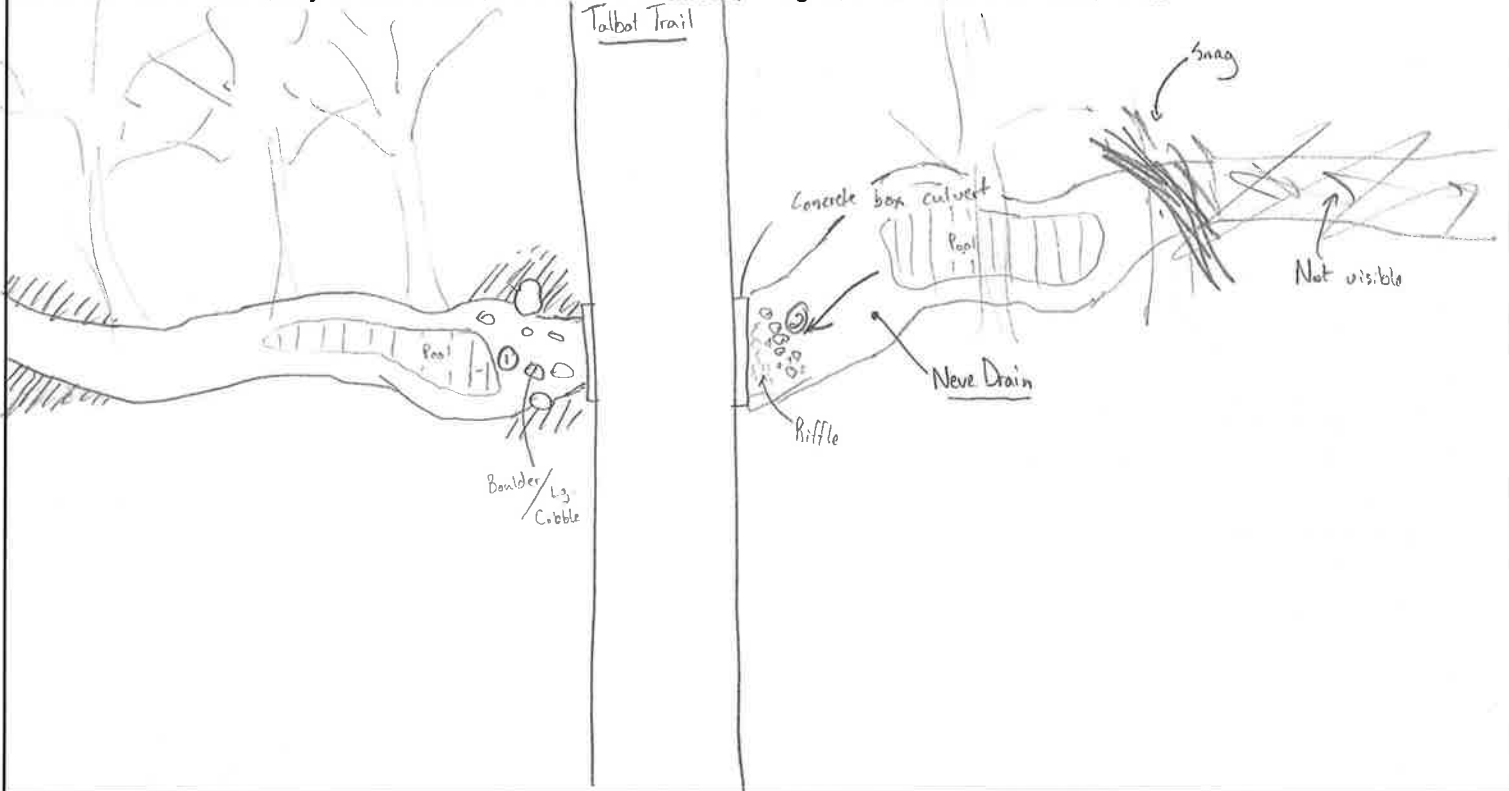
SITE DRAWING

Photo #	Description	Photo #	Description
100-0378	Facing South from Talbot Trail		
0379	" South " " "		
0380	" North " " "

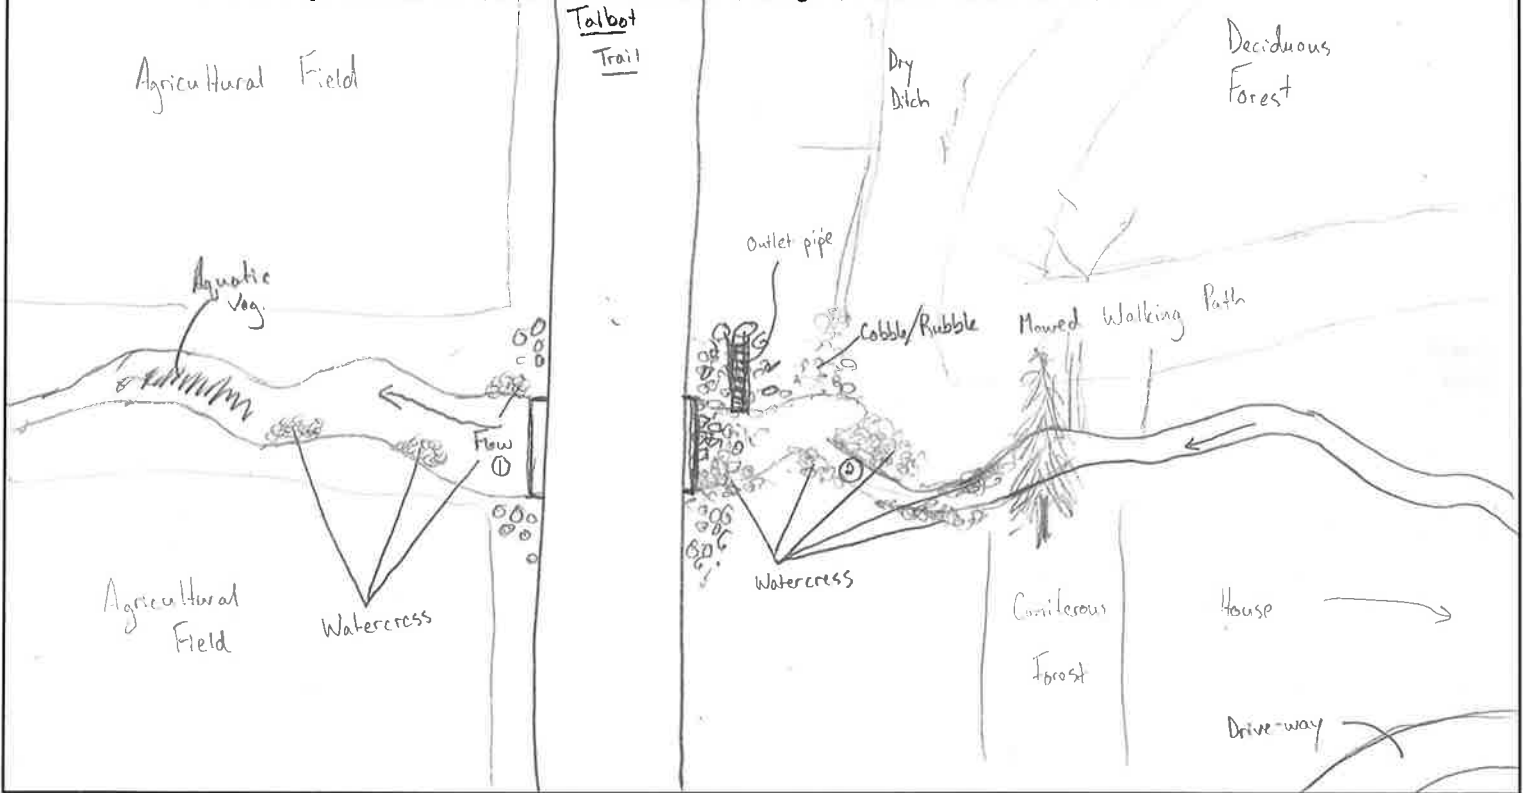
SITE DRAWING

Photo #	Description	Photo #	Description
100-0381	Facing South from Talbot Trail		
0382	Watercress South of Talbot Trail		
0383	Facing North		
0384	..
