North Kent Wind 1 Project **Water Body Assessment**

Project No. 1612 | November 2015

NATURAL RESOURCE SOLUTIONS INC.

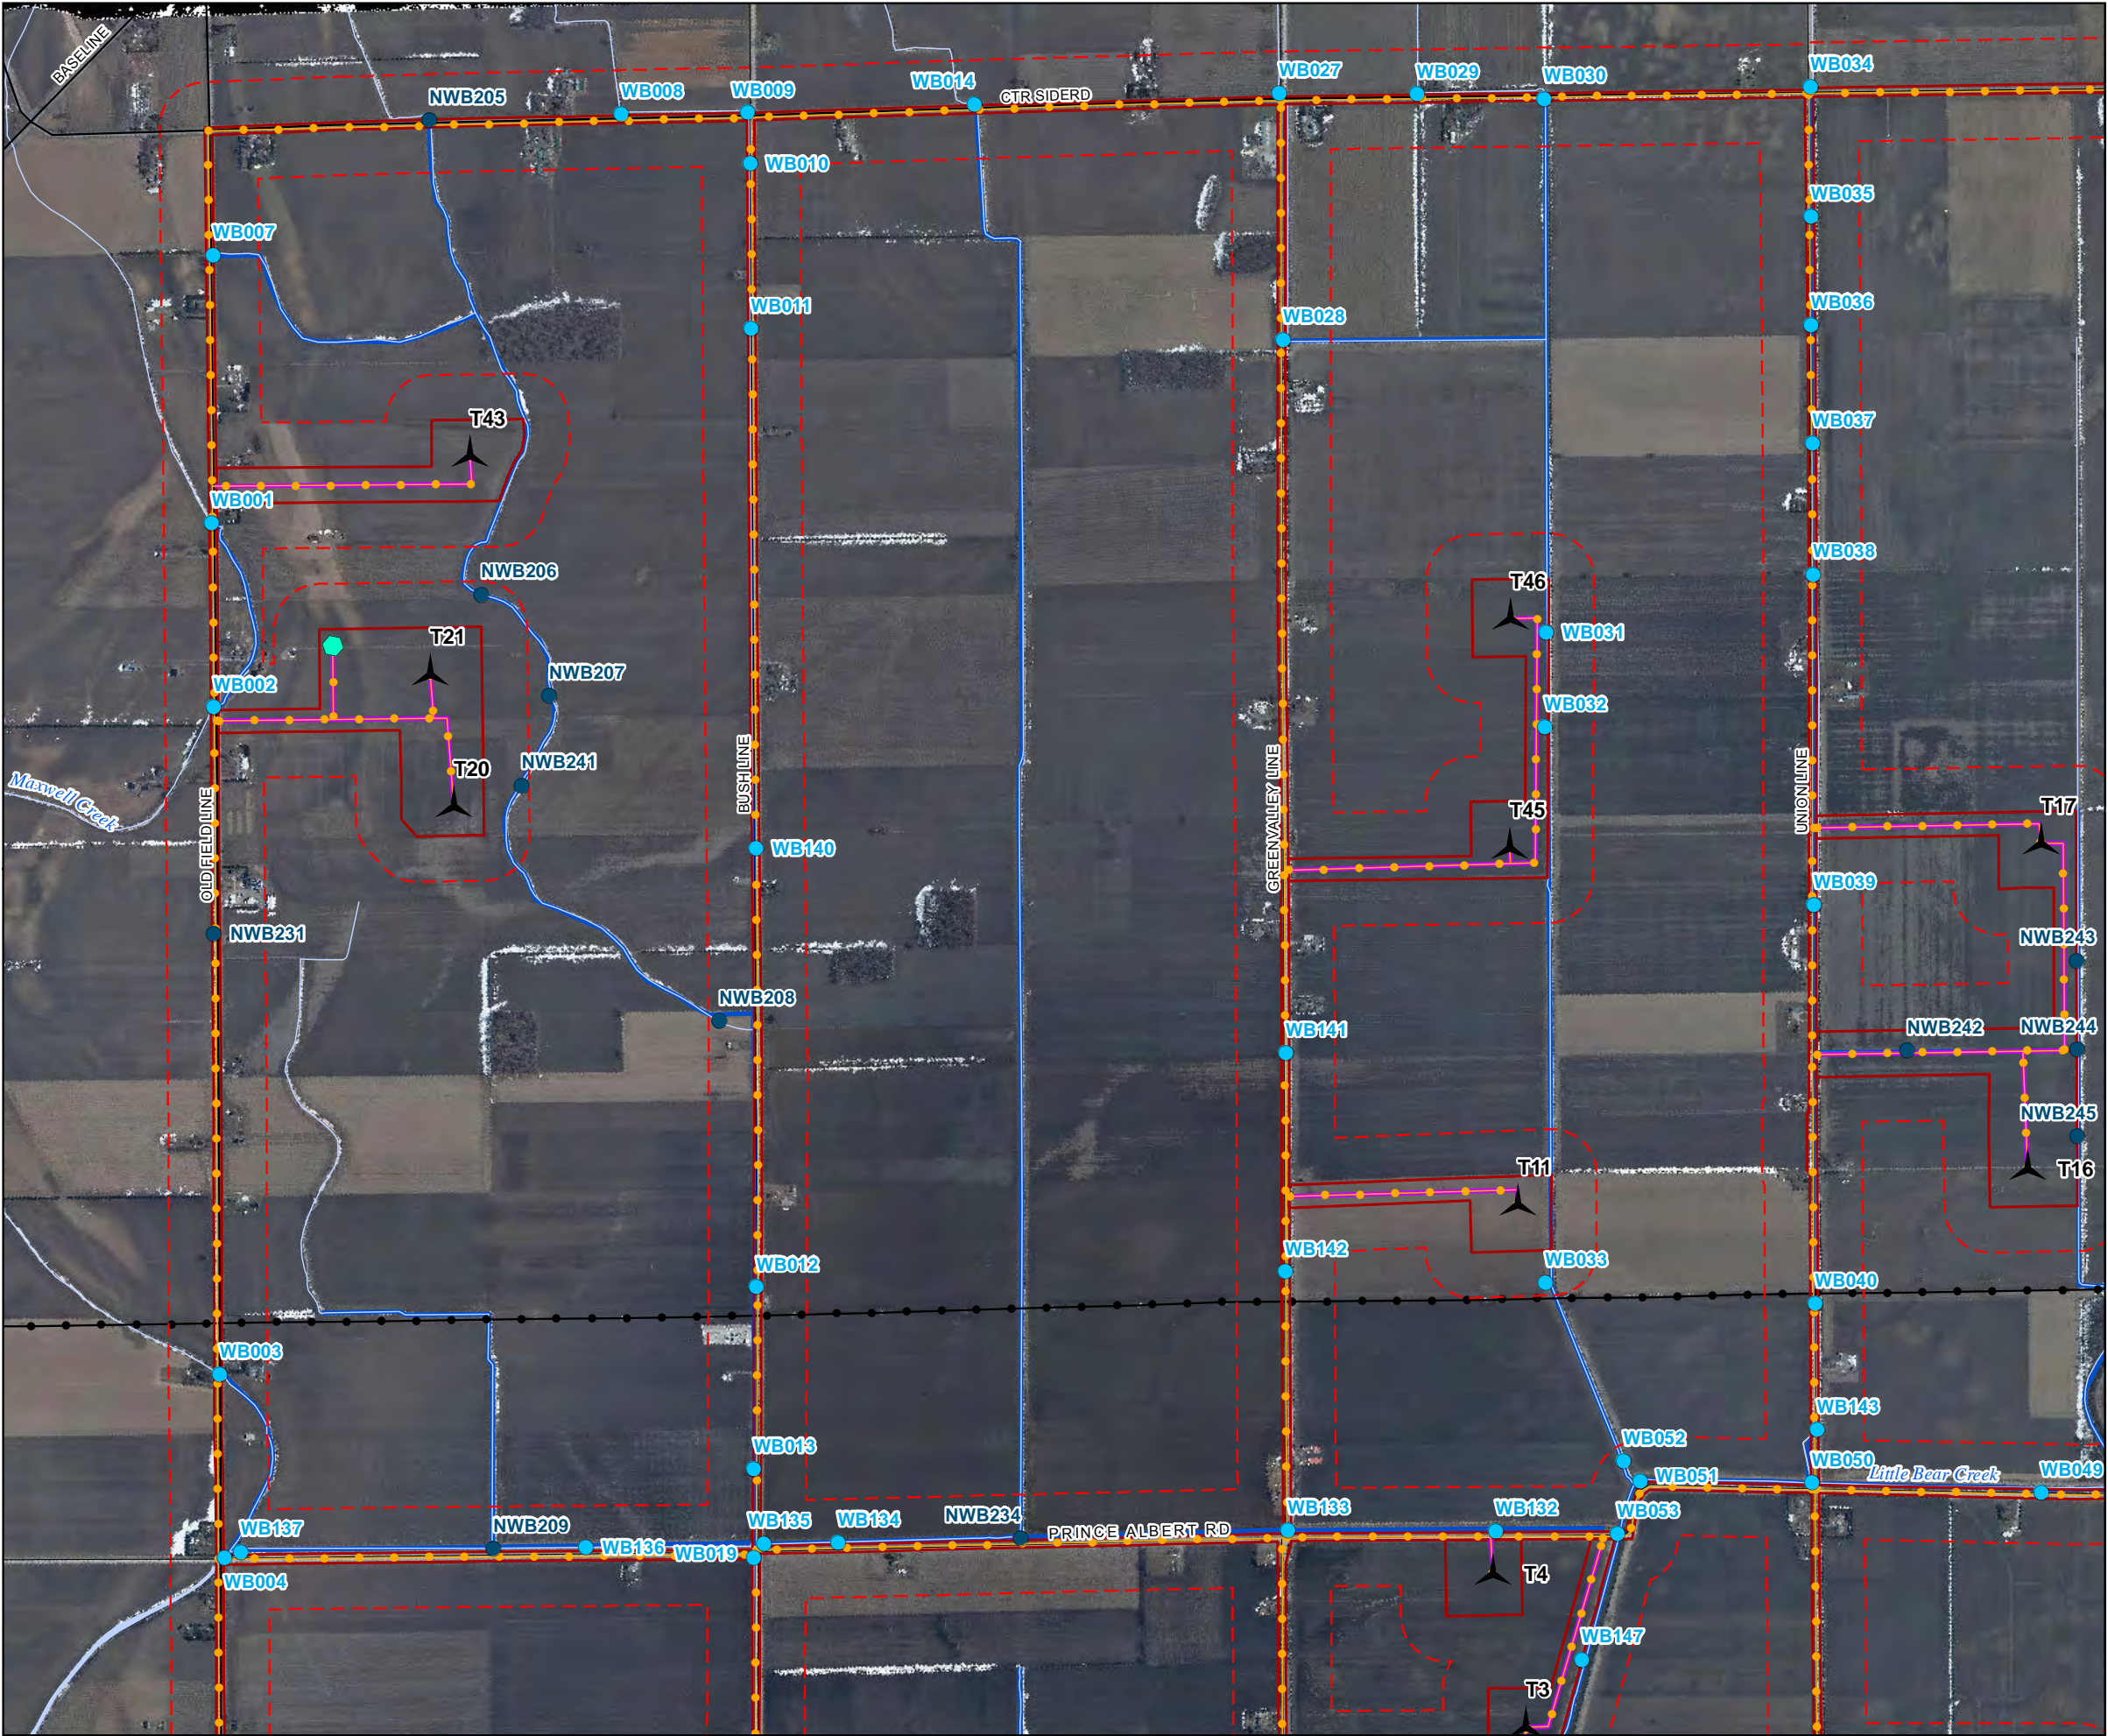
Map 2

Water Body Assessment

Watershed	Drainage Area	Details	Number of Permanent or Intermittent Drainage Features Identified
Sydenham River	Maxwell Creek	<p>Flows in a south westerly direction and drains into the Sydenham River. It originates from a combination of surface water runoff and tile drainage that consolidates to form a watercourse near Centre Side Road and Oldfield Line. The watercourse is channelized for the majority of its length. Several agricultural drains join Maxwell Creek to add to its volume and permanence.</p> <p>Maxwell Creek and its tributaries are found in the northern portion of the Project Area and can be seen on Maps 2 and 3.</p>	7
