Henvey Inlet Wind Energy Centre

Water Assessment and Waterbody Report

Final Draft

AECOM

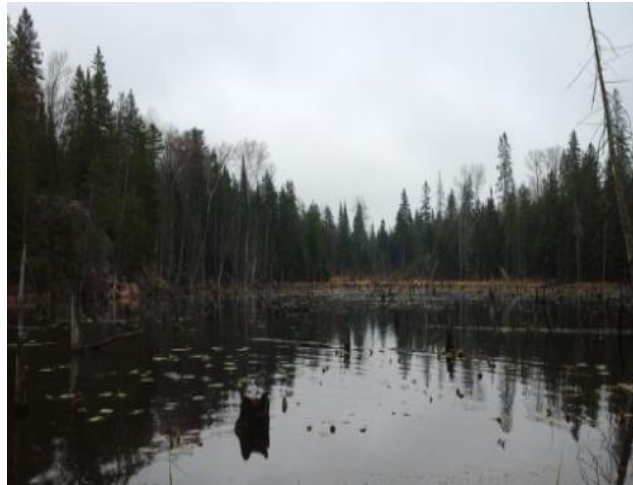
Photograph 1. Large pond with abundance of old snags looking south from centreline ↑

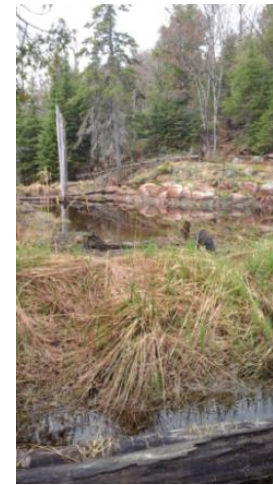
Photograph 2. Beaver dams approximately 30 m downstream of crossing. Fish passage impeded. Fish observed in pond. ↑

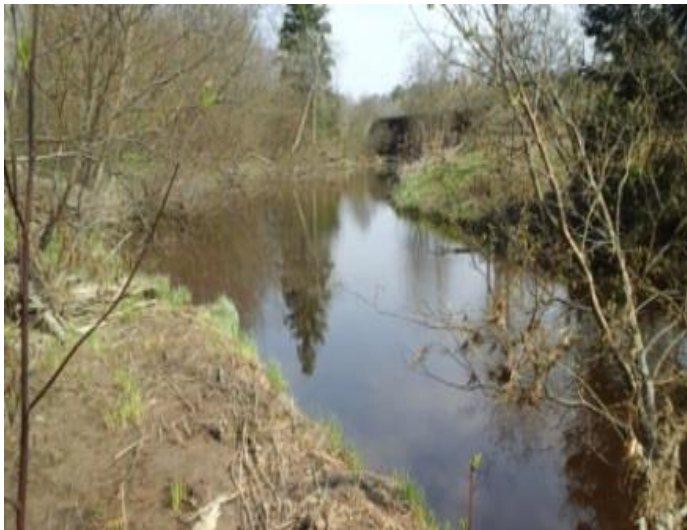
Photograph 1. Facing downstream (north) looking towards crossing from approximately 30 m upstream
↑

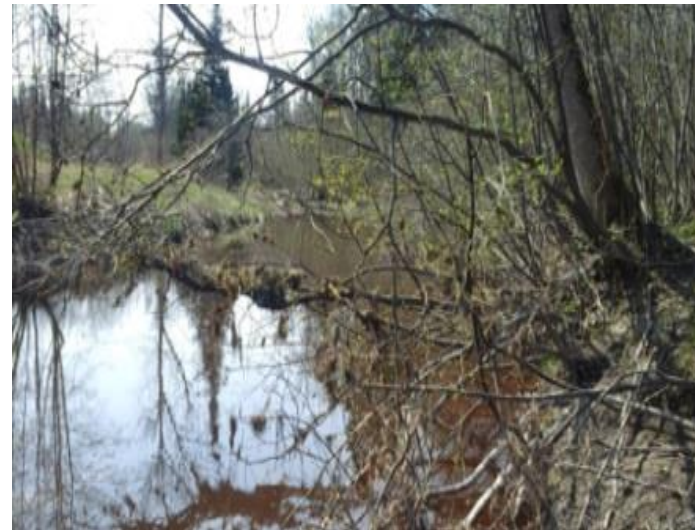
Photograph 2. Facing upstream towards crossing from approximately 35 m downstream ↑

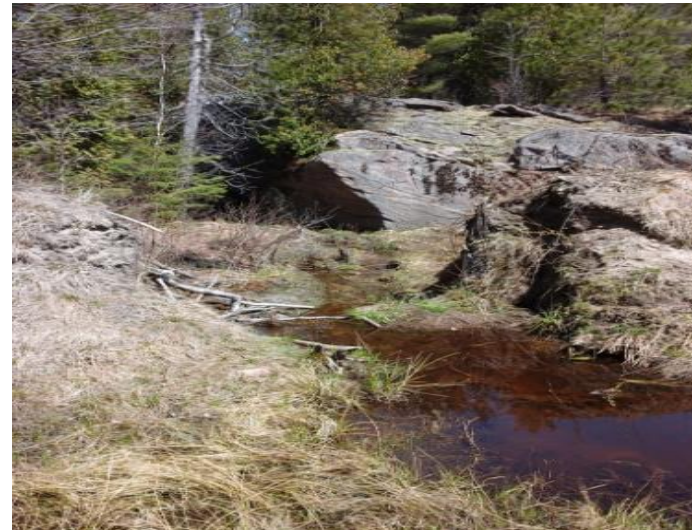
Photograph 2. Overview of pond looking south (upstream). ⬆

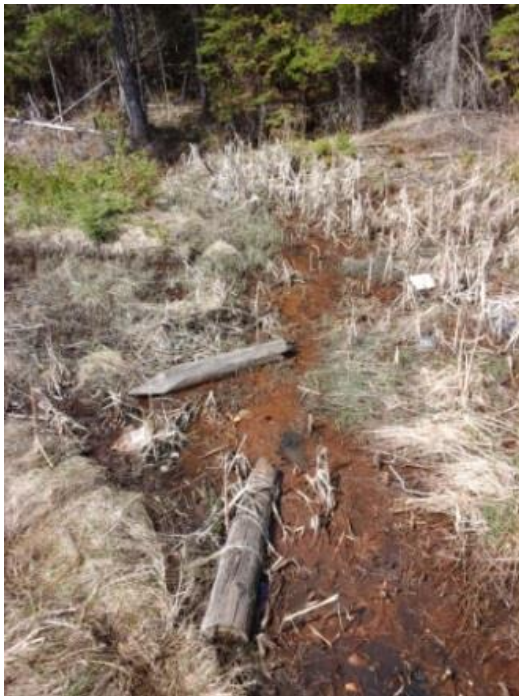
Photograph 1. Looking upstream from culvert. ↑

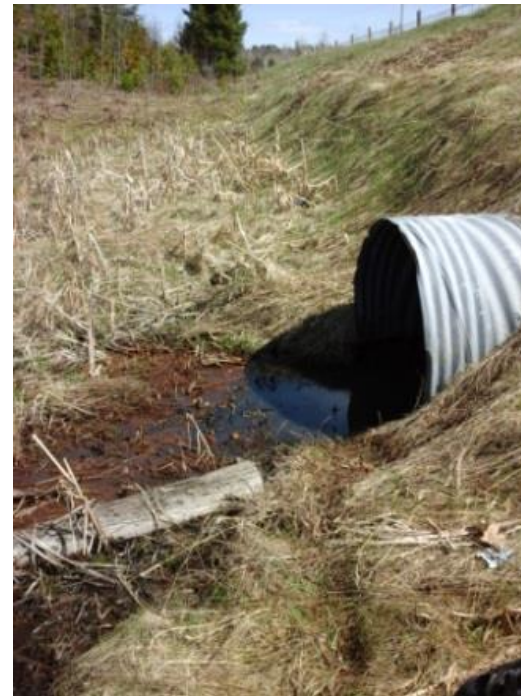
Photograph 2. Culvert discharging water underneath Highway 69. ↑

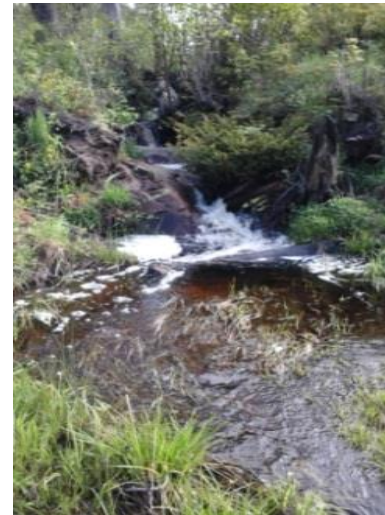
Photograph 2. Waterfall creating barrier to fish moving up. Approximately 3 m in height. Cobble, rock and log at base of waterfall. Pool at base of waterfall. High velocity. ↑

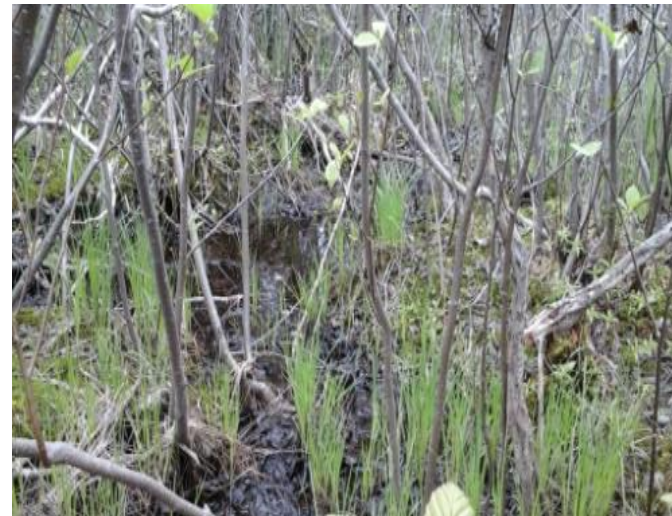
Photograph 2. View of pooling water and thicket understorey approximately 40 m N of centre line. ↑

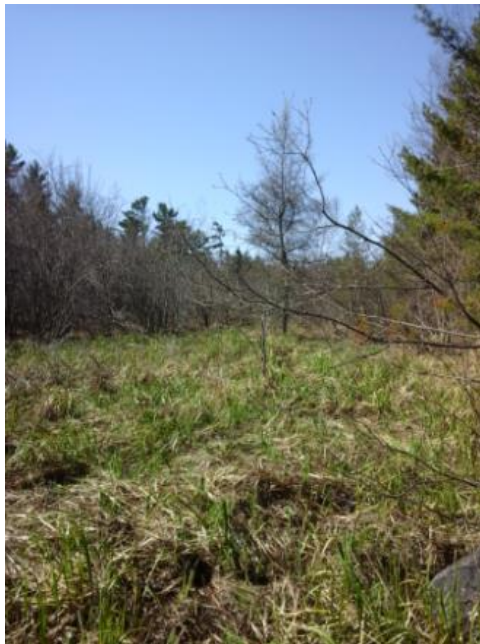
Photograph 1. Looking west from centre line ↗

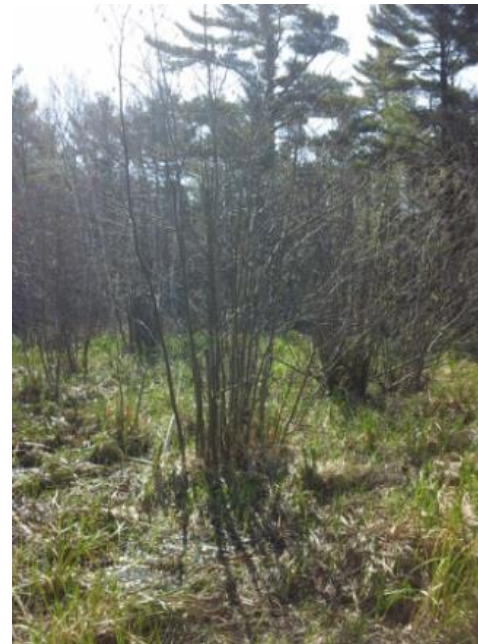
Photograph 2. Looking south from centre line ↗

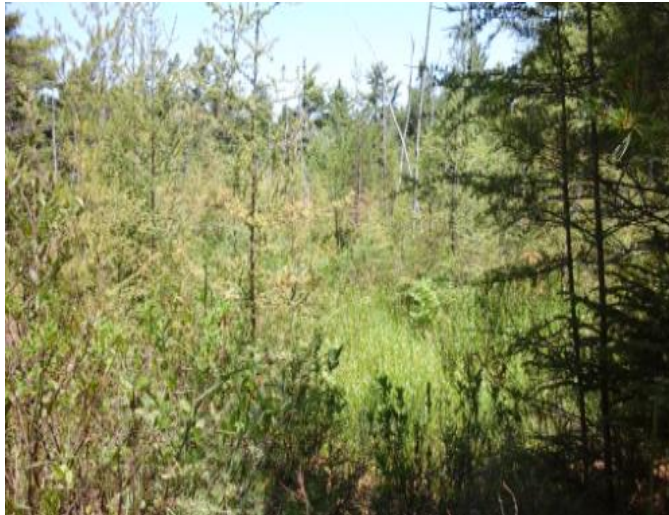
Photograph 1. General view of fen, looking north from centreline. ↑

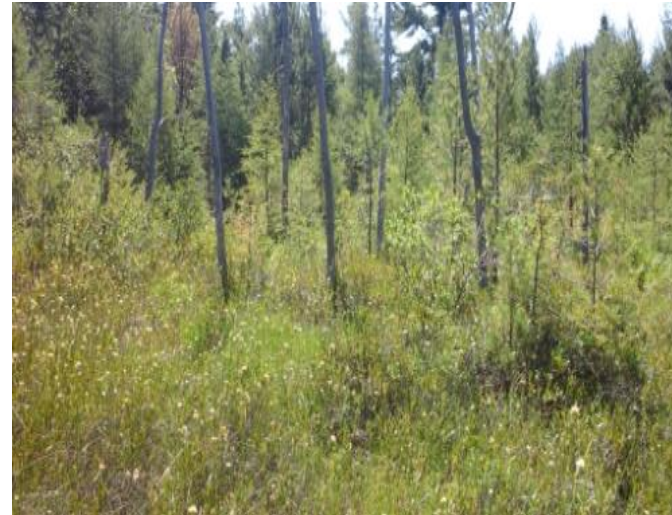
Photograph 2. View of the fen, looking south from approx. 30 m north of CL. ↑

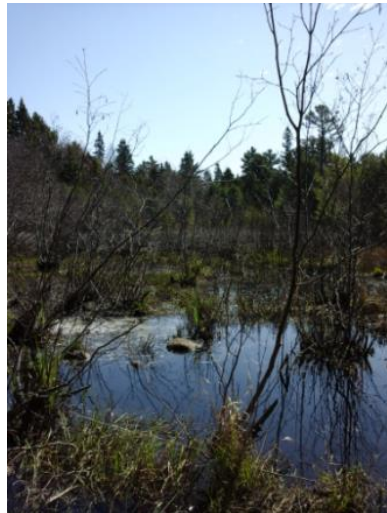
Photograph 1. Watercourse transitioning into wetland via beavers looking east (upstream)↑

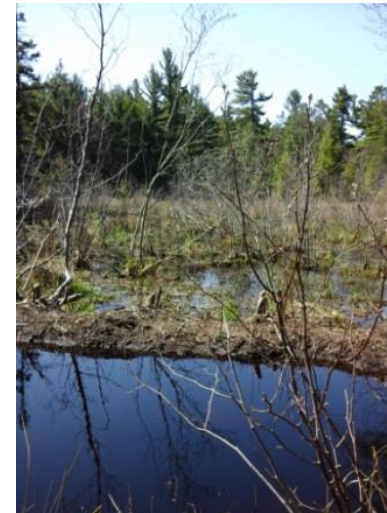
Photograph 2. Watercourse looking west (downstream)↑

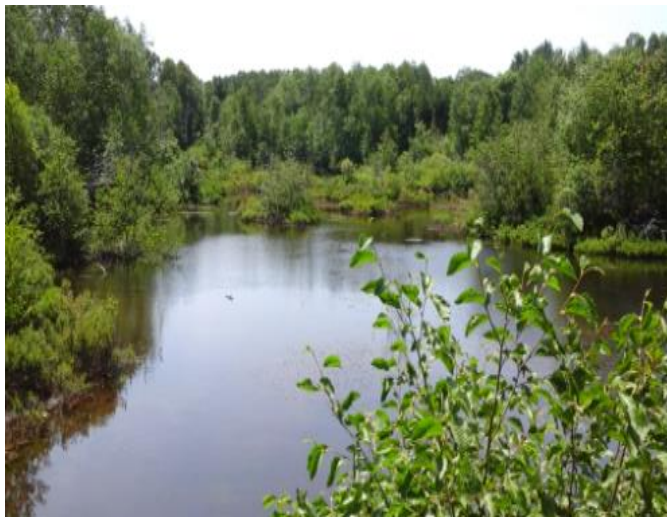
Photograph 1 Looking west at large pond from centre point atop gravel fill to east of large pond separating large pond from small stagnant pond. ↑

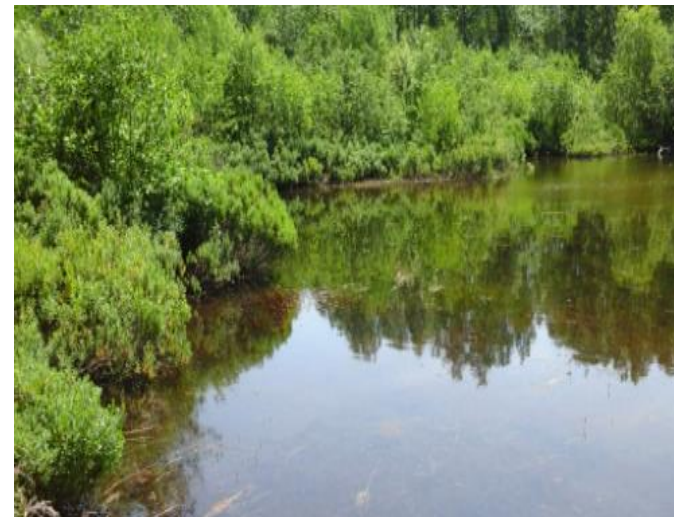
Photograph 2. Looking south from the north shore of the large pond. This view includes part of pond within area of disturbance. ↑

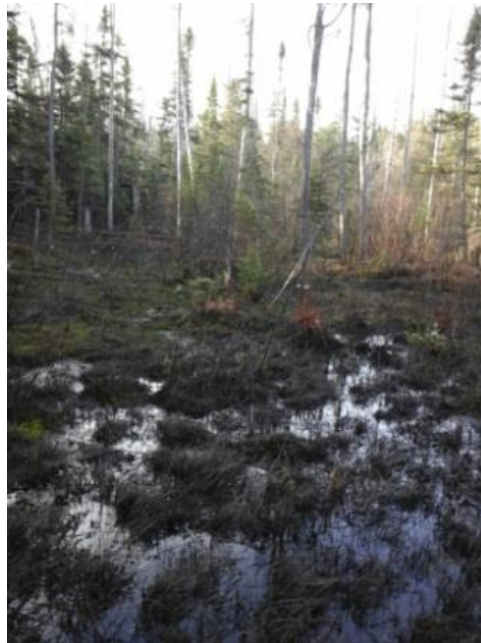
Photograph 1. Bog thicket with open standing water, downstream looking east ↑

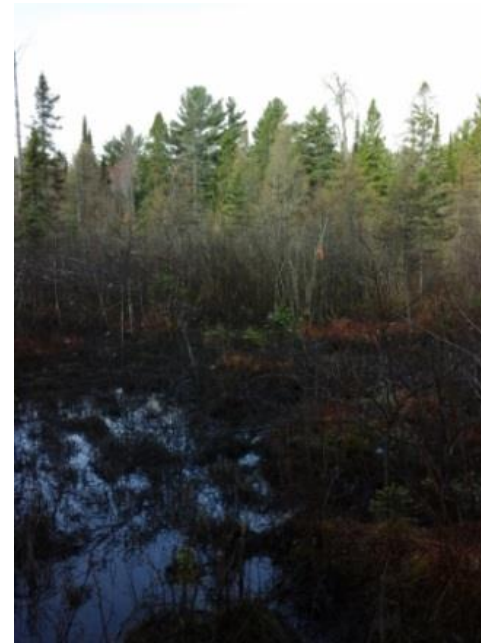
Photograph 2. Bog thicket with open water, general overview from centre of assessed area ↑

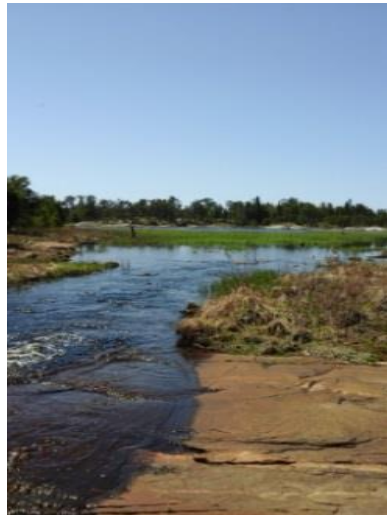
Photograph 1. Downstream 50 m looking downstream ↑

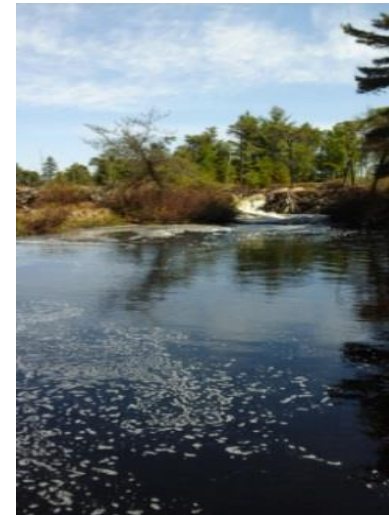
Photograph 2. At crossing looking upstream ↑

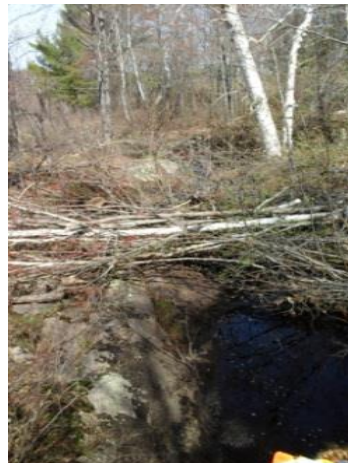
Photograph 1. General view of the watercourse facing downstream (DS) from the centreline (CL)
↑

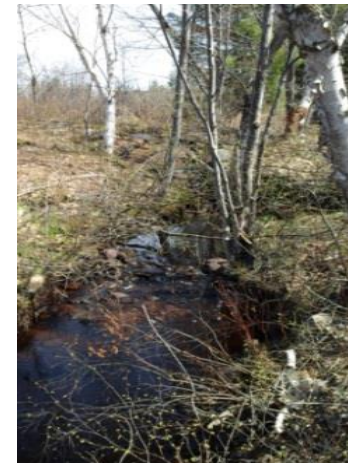
Photograph 2. General view of the watercourse facing upstream (US) from the centreline (CL) ↑

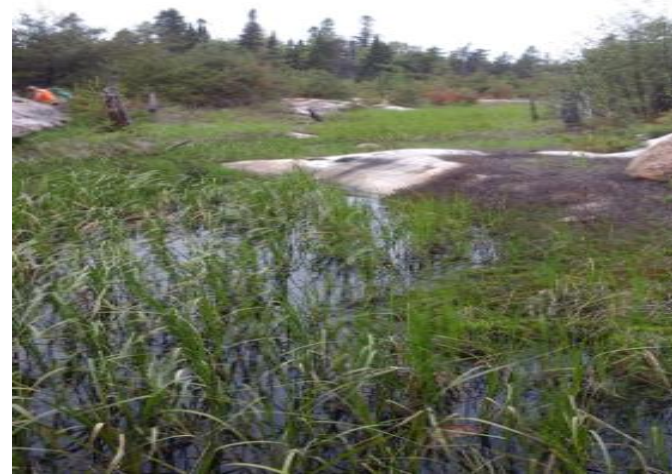
Photograph 2. Looking north from south end of channel feature towards centre line. ↑
