Henvey Inlet Wind Transmission Line

Appendix B6. Route B Waterbodies, Fish Habitat and Aquatic Ecosystems Environmental Baseline Report

AECOM

September 2015

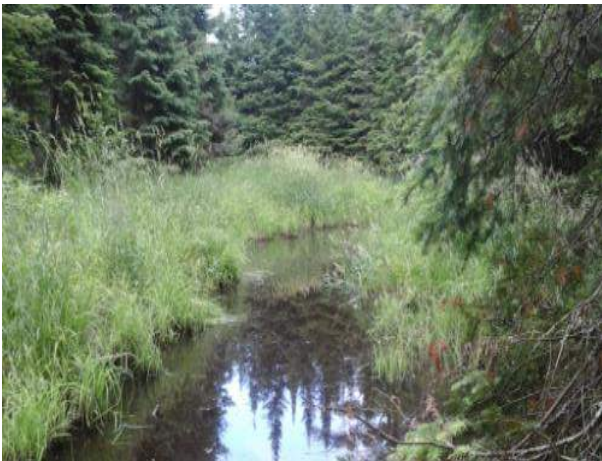
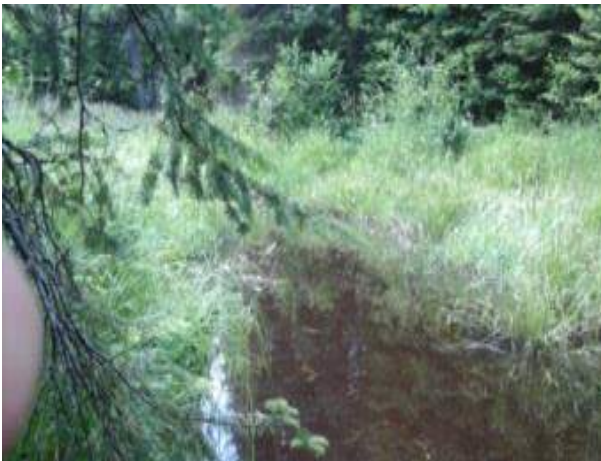
Fish Habitat?	Direct																
MWW (m)	0.90																
MBW (m)	1.15																
MWD (m)	0.27																
MBD (m)	0.45																
WB-A-M10-140	July 1 st , 2015	Permanent Stream	Stream bordered by forest with flat farm field above slope on south bank, east of Highway 69 and CN Rail, flowing west	<p>Slow moving channel through forested bedrock with dense riparian grasses. Trees provide some shade but most overhanging cover provided by grasses. Hummocks in-stream provide cover for fish. A 1 m tall beaver dam is located 25 m downstream of the crossing. Substrate consists of sand, silt and muck. No groundwater indicators are present. Fish observed at this location.</p> <table><tr><td>Fish Habitat?</td><td>Direct</td></tr><tr><td>MWW (m)</td><td>7.7</td></tr><tr><td>MBW (m)</td><td>10.5</td></tr><tr><td>MWD (m)</td><td>0.70</td></tr><tr><td>MBD (m)</td><td>0.90</td></tr></table>	Fish Habitat?	Direct	MWW (m)	7.7	MBW (m)	10.5	MWD (m)	0.70	MBD (m)	0.90	Low

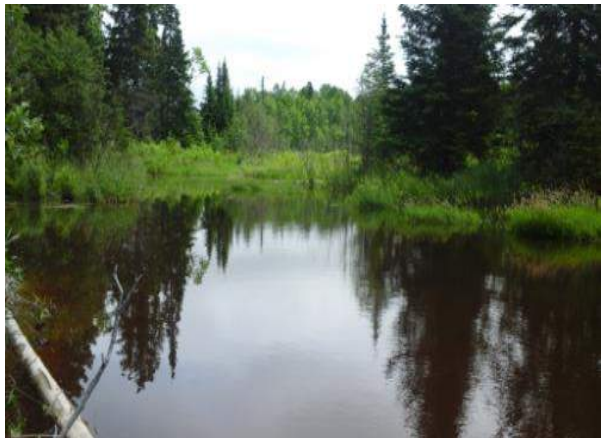
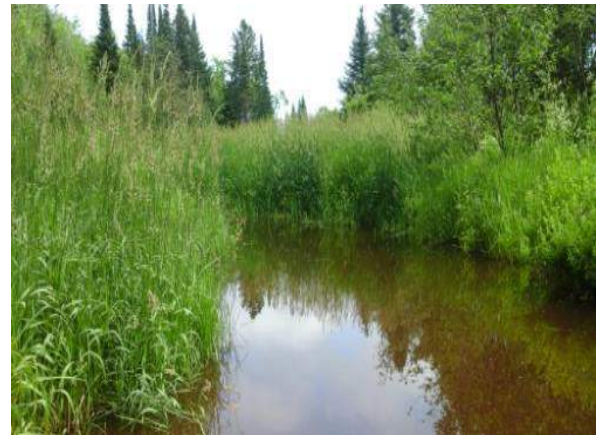
Fish Habitat?	Direct																
MWW (m)	7.7																
MBW (m)	10.5																
MWD (m)	0.70																
MBD (m)	0.90																
WB-B-M11-139	July 1st, 2015	Permanent Stream	Stream east of Highway 69, north of Still River, surrounded by forest, flowing west	<ul style="list-style-type: none">River is dammed by 1.5 m tall beaver dam downstream, creating a beaver pond at the crossing. Water trickles through dam to downstream channel through wet, dense reed marsh. Downstream active channel consists of slow flats. Floodplain is characterized as a flat black ash swamp. Substrate consists of silt, sand and detritus. Low canopy coverage is provided by herbaceous vegetation. No indicators of groundwater seepage are present. <table><tr><td>Fish Habitat?</td><td>Direct</td></tr><tr><td>MWW (m)</td><td>23.00</td></tr><tr><td>MBW (m)</td><td>23.25</td></tr><tr><td>MWD (m)</td><td>1.00</td></tr><tr><td>MBD (m)</td><td>1.10</td></tr></table>	Fish Habitat?	Direct	MWW (m)	23.00	MBW (m)	23.25	MWD (m)	1.00	MBD (m)	1.10	Low

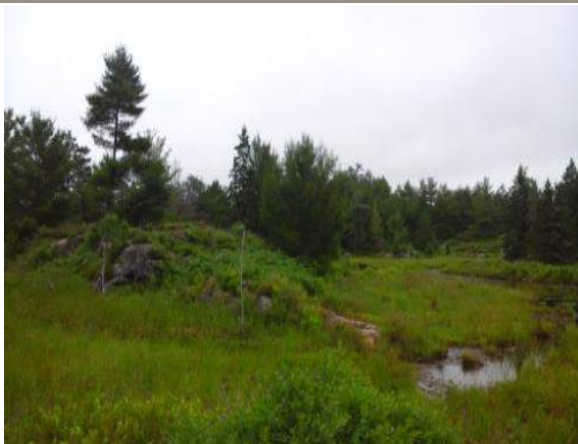
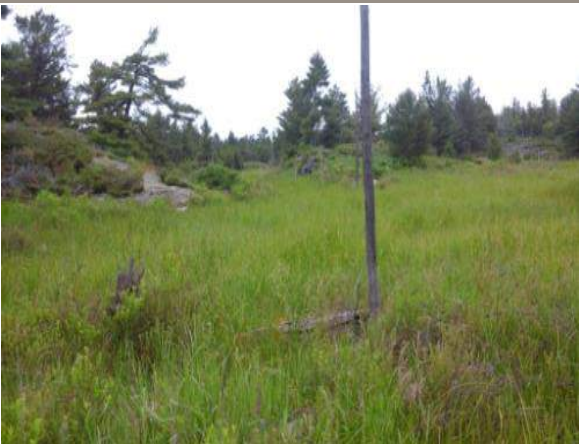
Feature ID	Investigation Date	Type of Waterbody	Description of Site	Feature Description	Feature Sensitivity												
WB-B-M12-138	July 1st, 2015	Permanent Pond	Mixed coniferous deciduous forest atop undulating bedrock east of Highway 69, north of Old Still River	<p>Large bedrock island within small pond causes a channel-like circle around island. A poorly drained area south of pond causes a wetland to occur. Water input is from the northeast, where open water occurs, but pond dries to northwest and south where saturated vegetated area occurs. Open water is shallow with thick detritus, some floating emergents and sparse canopy. Crossing does not occur over open water. No groundwater indicators are observed.</p> <table><tr><td>Fish Habitat?</td><td>Direct</td></tr><tr><td>Width (m)</td><td>16.00</td></tr><tr><td>Depth (m)</td><td>0.00</td></tr></table>	Fish Habitat?	Direct	Width (m)	16.00	Depth (m)	0.00	Low

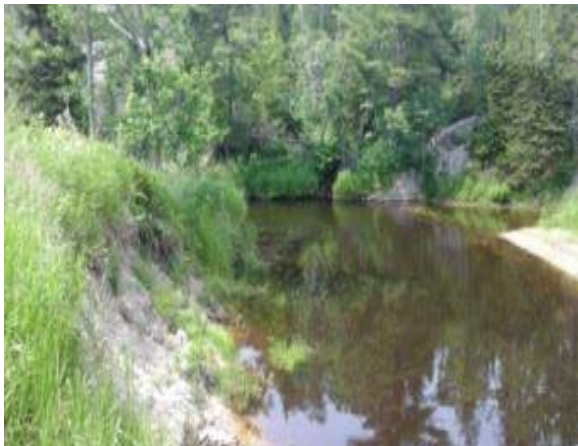
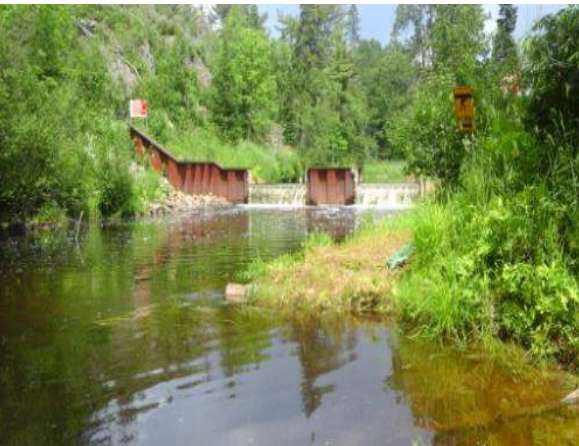
Fish Habitat?	Direct																
Width (m)	16.00																
Depth (m)	0.00																
WB-B-M13-137	June 30th, 2015	Permanent Stream	Private property east of Highway 69, north of farm lane, between forest to the north and agriculture to the south, river flowing west	<p>Dammed, flowing river with sloped, vegetated banks. Sea lamprey control weir downstream of crossing with marked canoe and portage route around it on the south bank. Downstream banks consist of hard substrate while upstream banks consist of erodible soils which are exposed in some areas. There is a sandy bar upstream with an eroded south bank. The north bank is mostly stable bedrock. Suitable habitat for walleye and brook lamprey downstream of weir. No groundwater indicators are present at this location.</p> <table><tr><td>Fish Habitat?</td><td>Direct</td></tr><tr><td>MWW (m)</td><td>15.70</td></tr><tr><td>MBW (m)</td><td>16.40</td></tr><tr><td>MWD (m)</td><td>1.30</td></tr><tr><td>MBD (m)</td><td>1.70</td></tr></table>	Fish Habitat?	Direct	MWW (m)	15.70	MBW (m)	16.40	MWD (m)	1.30	MBD (m)	1.70	Moderate

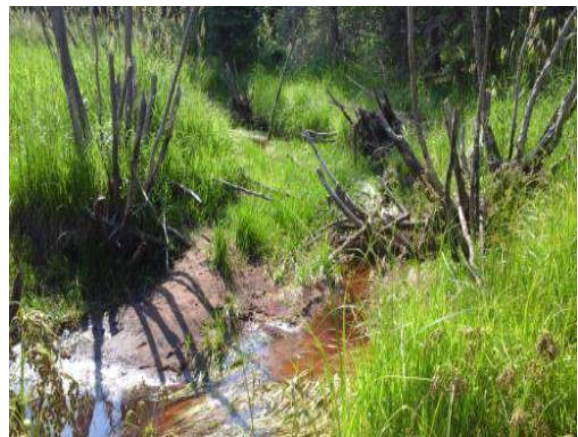
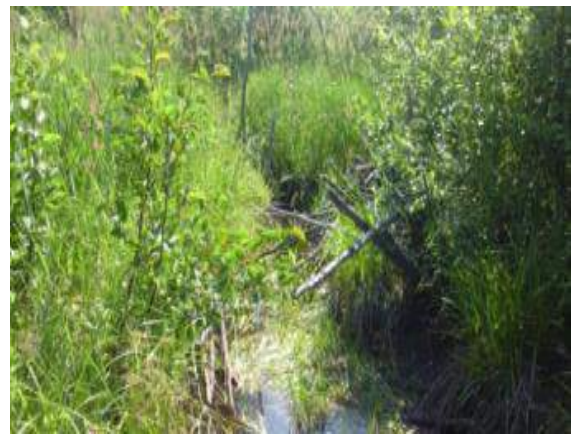
Fish Habitat?	Direct																
MWW (m)	15.70																
MBW (m)	16.40																
MWD (m)	1.30																
MBD (m)	1.70																
WB-B-M14-136	June 30th, 2015	Permanent Stream	Along proposed MTO corridor, south of farm lane, flowing west	<p>Defined, slow moving channel bordered by 50 m wide flat meadow floodplain between steep, forested bedrock slopes. Banks are heavily vegetated but erodible soils are exposed and undercut, and slumped and fallen banks dump their sediment load in the creek bed. Dense riparian shrubs and grass provide moderate cover. Submergent and emergent grasses, arrowhead, star duckweed, and common duckweed are present in-stream over sand and silt substrates. There is no indication of groundwater seepage at this location.</p> <table><tr><td>Fish Habitat?</td><td>Direct</td></tr><tr><td>MWW (m)</td><td>1.50</td></tr><tr><td>MBW (m)</td><td>3.10</td></tr><tr><td>MWD (m)</td><td>0.23</td></tr><tr><td>MBD (m)</td><td>1.04</td></tr></table>	Fish Habitat?	Direct	MWW (m)	1.50	MBW (m)	3.10	MWD (m)	0.23	MBD (m)	1.04	Low

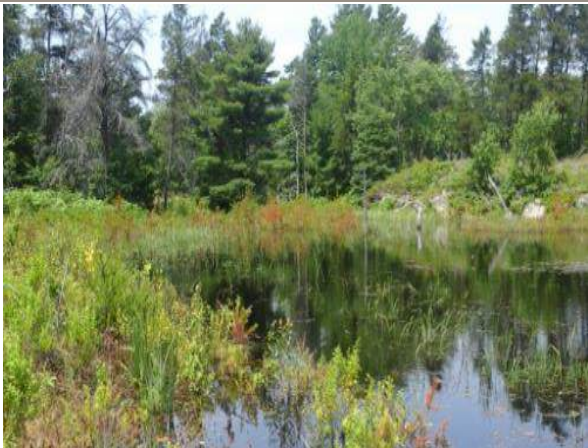
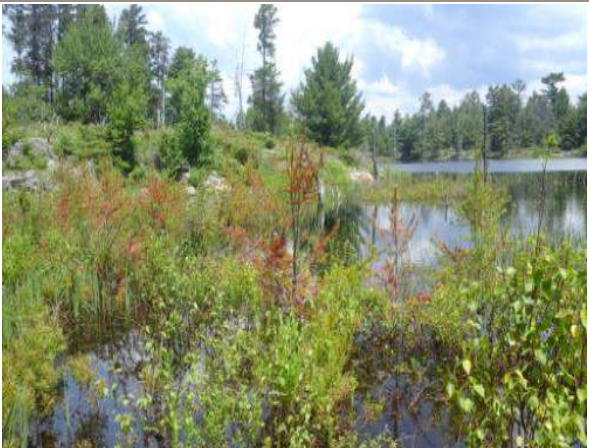
Feature ID	Investigation Date	Type of Waterbody	Description of Site	Feature Description	Feature Sensitivity												
WB-B-M15-135	June 30th, 2015	Permanent Pond	South of farm lane, east of Hwy 69	<p>Shore fen/backwater bay at crossing, open water pond to the east, bordered by forested bedrock. No emergent or floating vegetation in main pond. Small white water lily and bladderwort present in backwater bay with terrestrial vegetation such as pine and birch and other wetland vegetation. Fish observed. Dimensions are at the bay where crossing occurs. There is no indication of groundwater seepage.</p> <table><tr><td>Fish Habitat?</td><td>Direct</td></tr><tr><td>Width (m)</td><td>44.00</td></tr><tr><td>Depth (m)</td><td>0.50</td></tr></table>	Fish Habitat?	Direct	Width (m)	44.00	Depth (m)	0.50	Low

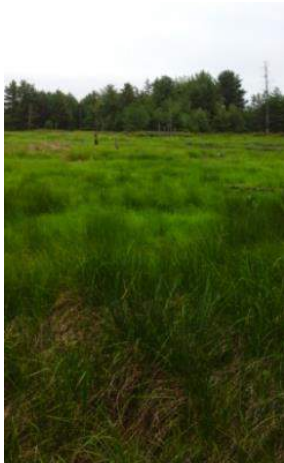
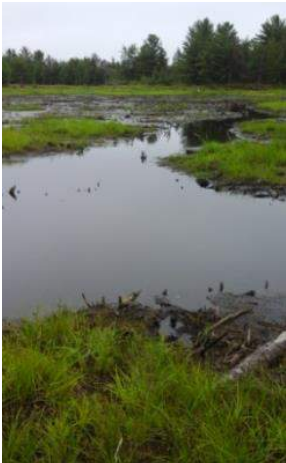
WB-B-M16-133	June 8th, 2015	Intermittent Wetland	Coniferous forest on bedrock barrens	<p>Open water is present as pools and channels among saturated soils and detritus in large breached beaver pond. Successional vegetation appearing to form a wet meadow. There is no indication of groundwater seepage at this location.</p> <table><tr><td>Fish Habitat?</td><td>Direct</td></tr><tr><td>Width (m)</td><td>140.00</td></tr><tr><td>Depth (m)</td><td>0.25</td></tr></table>	Fish Habitat?	Direct	Width (m)	140.00	Depth (m)	0.25	Low

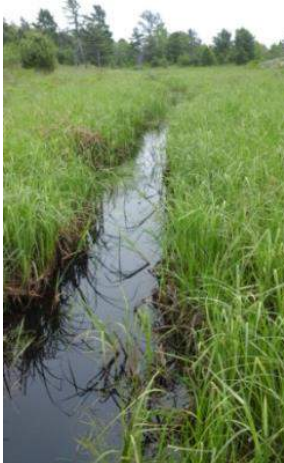
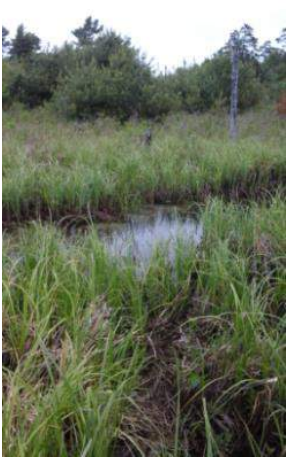
Fish Habitat?	Direct																
Width (m)	140.00																
Depth (m)	0.25																
WB-B-M16-134	June 8th, 2015	Permanent Stream	Sedge meadow marsh with water tolerant vegetation, mixed deciduous/coniferous forest on rolling bedrock barrens	<p>Straight channel flowing from north to south with slow moving flats through sedge meadow marsh between bedrock opens up 20 m downstream from crossing into 45 m wide pond. Substrate consists of detritus, silt and sand. Overhanging grasses provide cover. Groundwater seepage does not appear to occur at this site.</p> <table><tr><td>Fish Habitat?</td><td>Direct</td></tr><tr><td>MWW (m)</td><td>1.25</td></tr><tr><td>MBW (m)</td><td>20.00</td></tr><tr><td>MWD (m)</td><td>0.50</td></tr><tr><td>MBD (m)</td><td>0.70</td></tr></table>	Fish Habitat?	Direct	MWW (m)	1.25	MBW (m)	20.00	MWD (m)	0.50	MBD (m)	0.70	Low

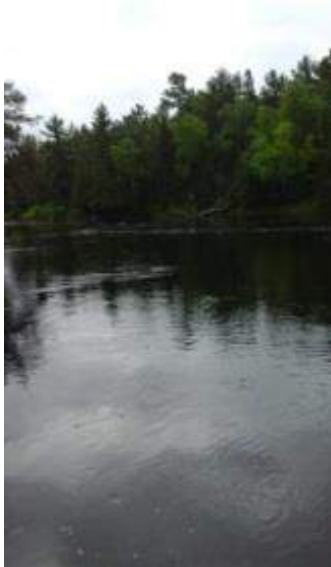
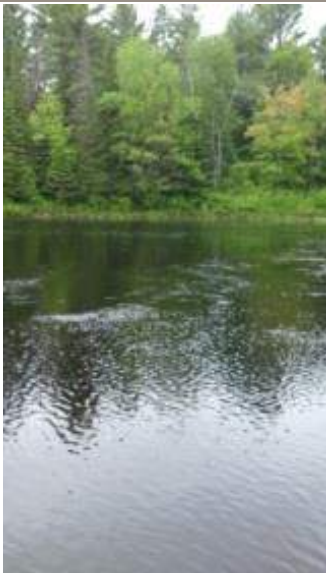
Feature ID	Investigation Date	Type of Waterbody	Description of Site	Feature Description	Feature Sensitivity												
WB-B-M17-131	June 8th, 2015	Permanent Stream	Mixed coniferous/deciduous forest on rolling bedrock sloping toward Magnetawan River, Magnetawan River flows west	Magnetawan River; a large river that flows west into Georgian Bay. Large boulders and bedrock along shores of river, no undercutting present. Moderate flow with eddies occur in deep water. Depth is greater than 2 m but is too deep to determine by wading. Substrate is dominated by boulders, then sand, gravel and cobble. This river is dominantly run with some pools. Trees provide canopy cover. There is no indication of groundwater seepage at this site. <div><table><tr><td>Fish Habitat?</td><td>Direct</td></tr><tr><td>MWW (m)</td><td>50.00</td></tr><tr><td>MBW (m)</td><td>53.00</td></tr><tr><td>MWD (m)</td><td>2.00</td></tr><tr><td>MBD (m)</td><td>3.00</td></tr></table></div>	Fish Habitat?	Direct	MWW (m)	50.00	MBW (m)	53.00	MWD (m)	2.00	MBD (m)	3.00	High

Fish Habitat?	Direct																
MWW (m)	50.00																
MBW (m)	53.00																
MWD (m)	2.00																
MBD (m)	3.00																
						Photo 1. View upstream of downstream limit ⬆	Photo 2. View of crossing from north bank ⬆										
WB-B-M17-132	June 8th, 2015	Permanent Pond	Pond east of Highway 69, north of Magnetawan River; mixed deciduous/coniferous forest on bedrock sloping towards middle of watercourse	Part of a series of beaver dams that flow into the Magnetawan River. Perched beaver pond upstream feeds into main pond from east. Beaver dam upstream and low flow create fish migration barriers. Aquatic and riparian vegetation and woody debris provide cover in addition to detritus on bedrock substate. Riparian vegetation and forest provide canopy cover. No indicators of groundwater are present. <div><table><tr><td>Fish Habitat?</td><td>Direct</td></tr><tr><td>Width (m)</td><td>40.00</td></tr><tr><td>Depth (m)</td><td>1.00</td></tr></table></div>	Fish Habitat?	Direct	Width (m)	40.00	Depth (m)	1.00	Low

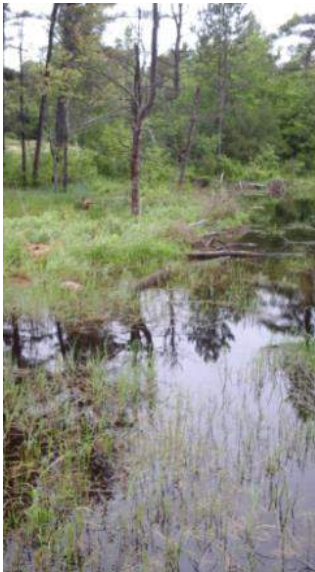
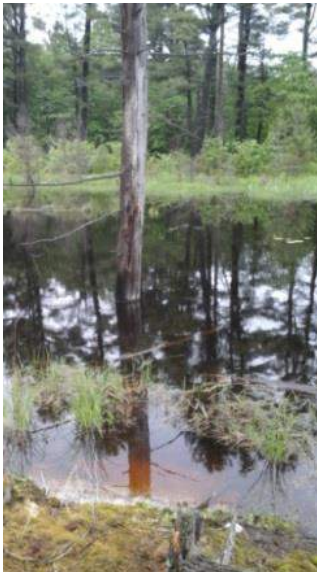
Fish Habitat?	Direct																
Width (m)	40.00																
Depth (m)	1.00																
						Photo 1. View of beaver dam to west (downstream) of pond ⬆	Photo 2. View of crossing from south bank ⬆										
WB-B-M18-130	N/A	Unknown	Site was on private property with no granted access	N/A	Unknown	No photographs available.											
WB-B-M19-127	N/A	Unknown	Site was on private property with no granted access	N/A	Unknown	No photographs available.											
WB-B-M19-128	N/A	Unknown	Site was on private property with no granted access	N/A	Unknown	No photographs available.											
WB-B-M19-129	N/A	Unknown	Site was on private property with no granted access	N/A	Unknown	No photographs available.											
WB-B-M20-125	N/A	Unknown	Site was on private property with no granted access	N/A	Unknown	No photographs available.

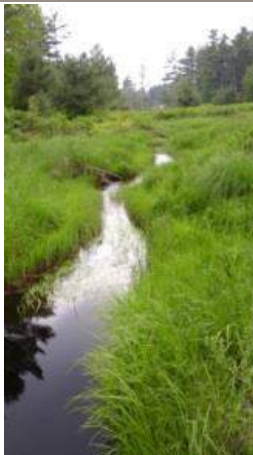
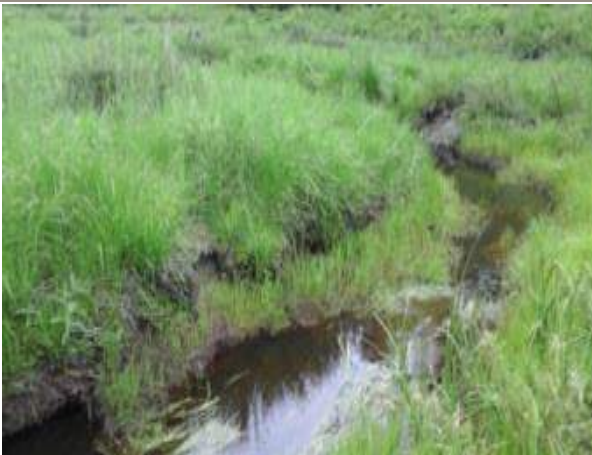
Feature ID	Investigation Date	Type of Waterbody	Description of Site	Feature Description	Feature Sensitivity												
WB-B-M28-107	June 10th, 2015	Permanent Stream	Mixed deciduous/coniferous forest atop bedrock, creek flows to the west	<p>Meandering creek through grass meadow directly upstream of breached beaver dam. Soft banks with grass and weak root structure have given way to slumping and eroded banks. Grasses bordering channel were previously flooded by beaver dam. This creek has moderate flows over silt, sand, detritus and muck with submergent grasses and emergent lilies. There are no indicators of groundwater seepage present at this site</p> <table><tr><td>Fish Habitat?</td><td>Direct</td></tr><tr><td>MWW (m)</td><td>2.60</td></tr><tr><td>MBW (m)</td><td>4.40</td></tr><tr><td>MWD (m)</td><td>0.60</td></tr><tr><td>MBD (m)</td><td>0.90</td></tr></table>	Fish Habitat?	Direct	MWW (m)	2.60	MBW (m)	4.40	MWD (m)	0.60	MBD (m)	0.90	Low

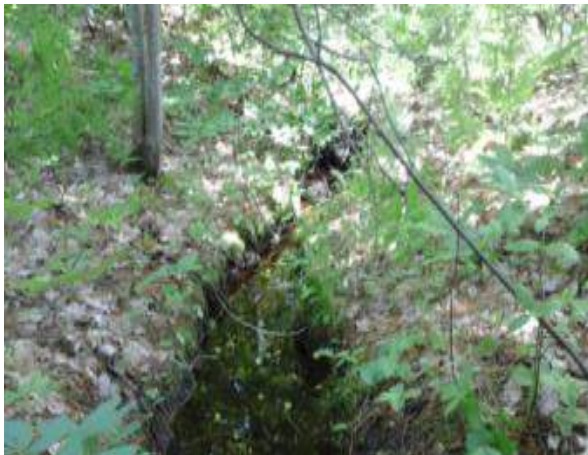
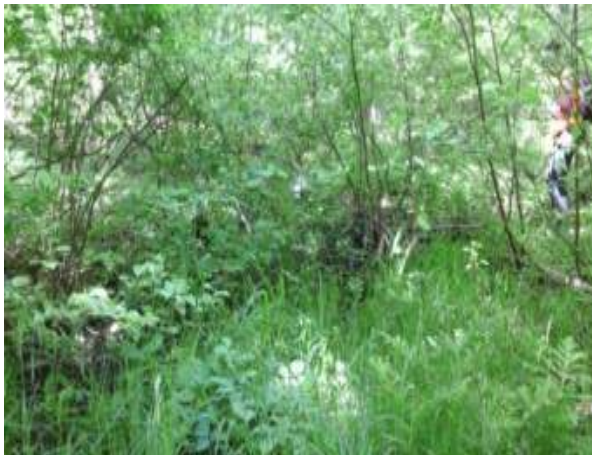
Fish Habitat?	Direct																
MWW (m)	2.60																
MBW (m)	4.40																
MWD (m)	0.60																
MBD (m)	0.90																
WB-B-M28-107-2	June 11th, 2015	Permanent Stream	360 m east of Highway 69 surrounded by meadow, wetland. At crossing there is a thicket on rolling bedrock sloping to watercourse to the east and wetland upstream	<p>At the upstream limit of the study area a saturated swale occurs, with no open water upstream. There may be flows here during the spring. At crossing there is a channel with defined bank. Approximately 25 m downstream channel dissipates through vegetation and no flow observed. There is a low flow barrier and slope barrier. Substrate consists of detritus and silt. There is no indication of groundwater seepage at this site.</p> <table><tr><td>Fish Habitat?</td><td>Indirect</td></tr><tr><td>MWW (m)</td><td>0.50</td></tr><tr><td>MBW (m)</td><td>0.80</td></tr><tr><td>MWD (m)</td><td>0.10</td></tr><tr><td>MBD (m)</td><td>0.20</td></tr></table>	Fish Habitat?	Indirect	MWW (m)	0.50	MBW (m)	0.80	MWD (m)	0.10	MBD (m)	0.20	Low

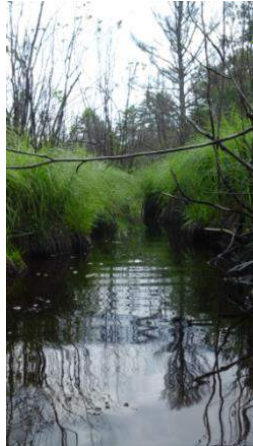
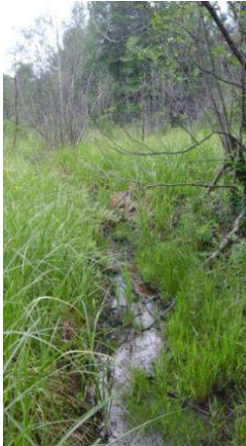
Fish Habitat?	Indirect																
MWW (m)	0.50																
MBW (m)	0.80																
MWD (m)	0.10																
MBD (m)	0.20																
WB-B-M28-108	June 10th, 2015	Permanent Stream	Mixed coniferous/deciduous forest atop bedrock, stream flows west towards highway	<p>Area confined by active beaver dam upstream and breached beaver dam downstream. Area is transitioning from meadow to alder thicket after dam breach. There is a creek through dead alders and grassy meadow. Upstream beaver dam impedes fish migration. Substrate consists of detritus, sand and muck with algae and submergent grasses present. Lots of overhanging vegetation (grasses, herbaceous plants, and alders provide shade). No indicators of groundwater seepage are observed.</p> <table><tr><td>Fish Habitat?</td><td>Direct</td></tr><tr><td>MWW (m)</td><td>0.82</td></tr><tr><td>MBW (m)</td><td>0.97</td></tr><tr><td>MWD (m)</td><td>0.17</td></tr><tr><td>MBD (m)</td><td>0.28</td></tr></table>	Fish Habitat?	Direct	MWW (m)	0.82	MBW (m)	0.97	MWD (m)	0.17	MBD (m)	0.28	Low

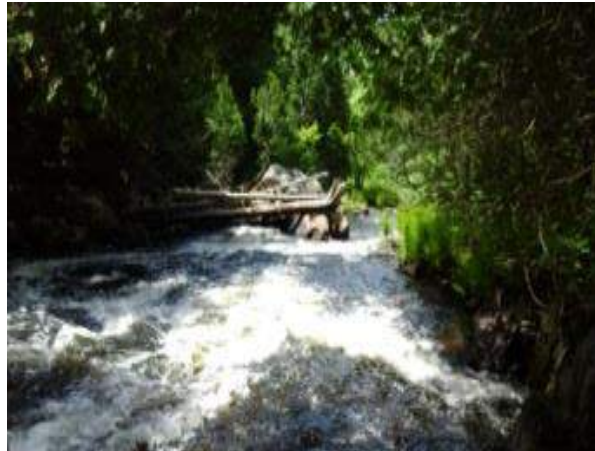
<p>Photo 1. View of downstream from crossing where rapids occur ⬆</p>

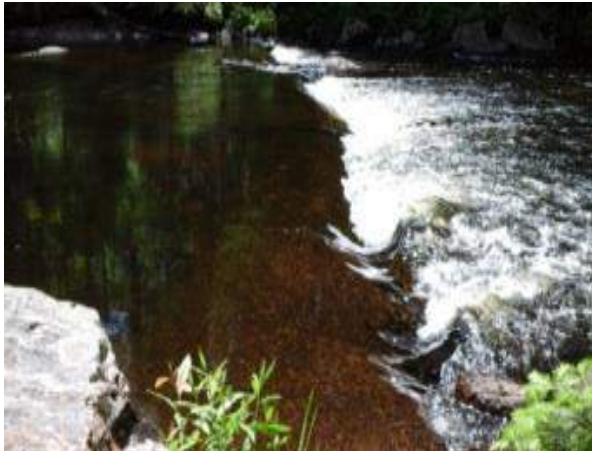
<p>Photo 2. View of man-made concrete structure from north bank ⬆</p>
Fish Habitat?	Direct																
MWW (m)	14.00																
MBW (m)	18.30																
MWD (m)	1.00																
MBD (m)	3.00

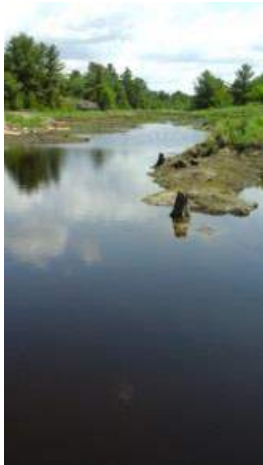
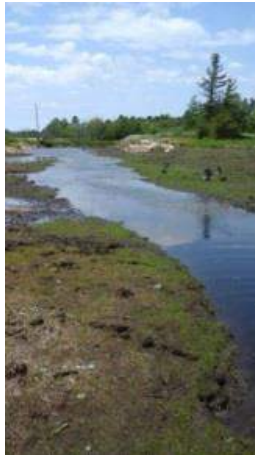
Feature ID	Investigation Date	Type of Waterbody	Description of Site	Feature Description	Feature Sensitivity												
WB-B-M25-115	June 9 th , 2015	Permanent Pond	Beaver pond east of Highway 69, south of Magnetawan Reserve, surrounded by mixed coniferous/deciduous forest on bedrock outcrops.	<p>Beaver pond with dam to the west. Water levels are low and dam appears to be draining. Substrate is soft with detritus, aquatic vegetation, and some woody debris providing in situ cover. There is little to no canopy cover. Minnows, leeches, and mudpuppies observed. No indicators of groundwater are present at this site.</p> <table><tr><td>Fish Habitat?</td><td>Direct</td></tr><tr><td>Width (m)</td><td>53.00</td></tr><tr><td>Depth (m)</td><td>1.00</td></tr></table>	Fish Habitat?	Direct	Width (m)	53.00	Depth (m)	1.00	Low

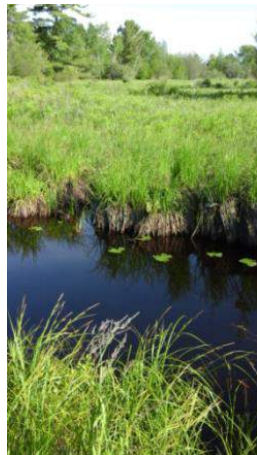
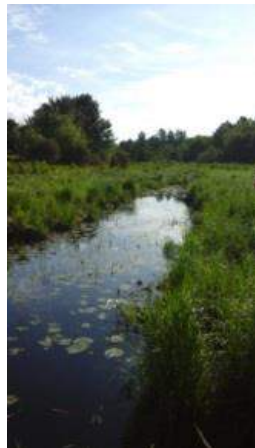
Depth (m)	1.00																
WB-B-M26-112	June 9th, 2015	Permanent Stream	Mixed deciduous/coniferous forest atop bedrock and sedge meadow east of Highway 69, south of Magnetawan Reserve. Stream flows to west	<p>West flowing flats in active channel in sedge meadow. Low lying sedge meadow floodplain is inundated with water during high flows, causing hummocks. Substrate consists of detritus, muck, silt and bedrock. Riparian shrubs do not provide notable amount of shade. Groundwater indicators are not observed at this site.</p> <table><tr><td>Fish Habitat?</td><td>Direct</td></tr><tr><td>MWW (m)</td><td>4.00</td></tr><tr><td>MBW (m)</td><td>100.00</td></tr><tr><td>MWD (m)</td><td>0.40</td></tr><tr><td>MBD (m)</td><td>0.80</td></tr></table>	Fish Habitat?	Direct	MWW (m)	4.00	MBW (m)	100.00	MWD (m)	0.40	MBD (m)	0.80	Low

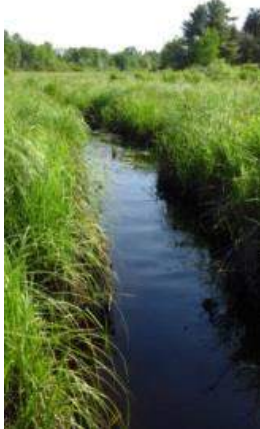
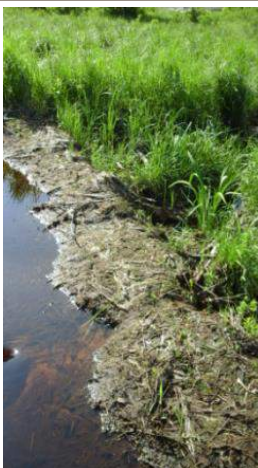
MWD (m)	0.40																
MBD (m)	0.80																
WB-B-M26-113	June 9th, 2015	Permanent Stream	Mixed deciduous/coniferous forest on bedrock and sedge meadow east of Highway 69, stream flows to west	<p>Active channel within low lying sedge meadow that is inundated during high flows with channels and pools. Channel flows in westerly direction dominated by runs then some pools. There are large sedge hummocks along creek margins. Substrate dominated by sand, detritus, and muck. Little canopy cover is provided by grasses and some shrubs. Two beaver dams upstream may impede some fish movement. There is unexpectedly low dissolved oxygen considering some areas have water flowing over logs allow oxygenation of water. There are no groundwater indicators at this site.</p> <table><tr><td>Fish Habitat?</td><td>Direct</td></tr><tr><td>MWW (m)</td><td>1.40</td></tr><tr><td>MBW (m)</td><td>100.00</td></tr><tr><td>MWD (m)</td><td>0.37</td></tr><tr><td>MBD (m)</td><td>0.50</td></tr></table>	Fish Habitat?	Direct	MWW (m)	1.40	MBW (m)	100.00	MWD (m)	0.37	MBD (m)	0.50	Low

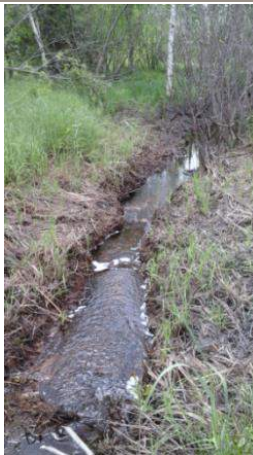
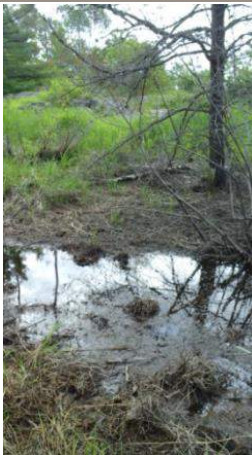
Feature ID	Investigation Date	Type of Waterbody	Description of Site	Feature Description	Feature Sensitivity												
WB-B-M26-114	June 9th, 2015	Permanent Stream	Creek east of Highway 69, south of Magnetawan Reserve, surrounded by mixed deciduous/coniferous forest on bedrock barrens and wetland upstream. Stream flows to west	<p>Water flows in southeast direction confined by bedrock outcrops. An abandoned beaver dam downstream has allowed draining. Previous flooding has deposited detritus on banks. There are moderate velocities upstream, but they decrease where channel widens. Beaver dam upstream of study area may impede passage upstream for some fish. Pond from west side of road joins this site and flows southwards downstream of study area. Downstream portion of study area transitions into pond. Measurements are of stream portion only. Substrate consists of detritus, sand, boulder and silt. River is predominantly flats. High cover is dominated by shrubs. Groundwater seepage does not seem to occur at this site.</p> <table><tr><td>Fish Habitat?</td><td>Direct</td></tr><tr><td>MWW (m)</td><td>1.50</td></tr><tr><td>MBW (m)</td><td>1.40</td></tr><tr><td>MWD (m)</td><td>0.30</td></tr><tr><td>MBD (m)</td><td>0.40</td></tr></table>	Fish Habitat?	Direct	MWW (m)	1.50	MBW (m)	1.40	MWD (m)	0.30	MBD (m)	0.40	Low

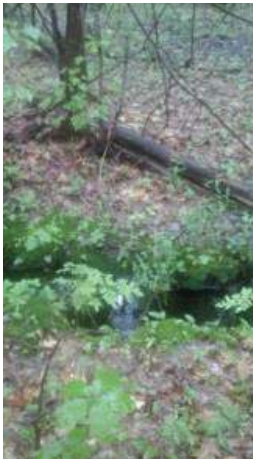
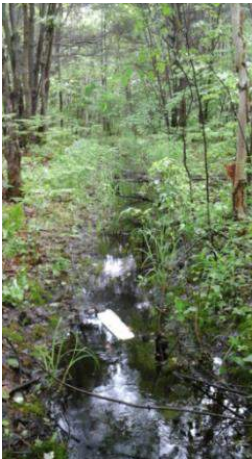
Fish Habitat?	Direct																
MWW (m)	1.50																
MBW (m)	1.40																
MWD (m)	0.30																
MBD (m)	0.40																
WB-B-M27-109	June 10th, 2015	Permanent Stream	Mixed deciduous/coniferous forest atop bedrock sloping toward watercourse, stream flows to west	<p>Small creek flowing east to west through forest and open area. This creek is characterized by low flow run over detritus, sand and muck with rooted vegetation on banks and moss-like submergents. Creek opens up into wide pond-like feature. Measurements below are of downstream. No indicators of groundwater seepage are observed.</p> <table><tr><td>Fish Habitat?</td><td>Direct</td></tr><tr><td>MWW (m)</td><td>16.00</td></tr><tr><td>MBW (m)</td><td>17.00</td></tr><tr><td>MWD (m)</td><td>0.50</td></tr><tr><td>MBD (m)</td><td>0.60</td></tr></table>	Fish Habitat?	Direct	MWW (m)	16.00	MBW (m)	17.00	MWD (m)	0.50	MBD (m)	0.60	Low

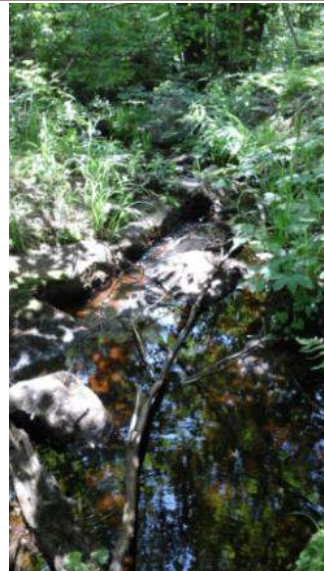
</div> <div>Photo 1. View of downstream from upstream limit. ⬆</div>	<div>

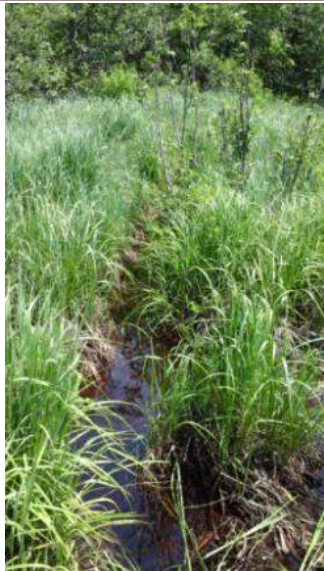
</div> <div>Photo 2. View of upstream from downstream limit. ⬆</div>
Fish Habitat?	Direct																
MWW (m)	0.50																
MBW (m)	0.50																
MWD (m)	0.50																
MBD (m)	0.65																
WB-B-M20-123	N/A	Unknown	Site was on private property with no granted access.	N/A	Unknown	N/A	N/A										
WB-B-M20-124	N/A	Unknown	Site was on private property with no granted access.	N/A	Unknown	N/A	N/A										
WB-B-M20-126	N/A	Unknown	Site was on private property with no granted access	N/A	Unknown	N/A	N/A										
WB-B-M21-121	N/A	Unknown	Site was on private property with no granted access	N/A	Unknown	N/A	N/A										
WB-B-M21-122	N/A	Unknown	Site was on private property with no granted access	N/A	Unknown	N/A	N/A										
WB-B-M22-120	N/A	Unknown	Site was on private property with no granted access	N/A	Unknown	N/A	N/A										
WB-B-M23-118	N/A	Unknown	Site was on private property with no granted access	N/A	Unknown	N/A	N/A										
WB-B-M23-119	N/A	Unknown	Site was on private property with no granted access	N/A	Unknown	N/A	N/A										
WB-B-M24-116	N/A	Unknown	Site was on private property with no granted access	N/A	Unknown	N/A	N/A										
WB-B-M24-117	N/A	Unknown	Site was on private property with no granted access	N/A	Unknown	N/A	N/A

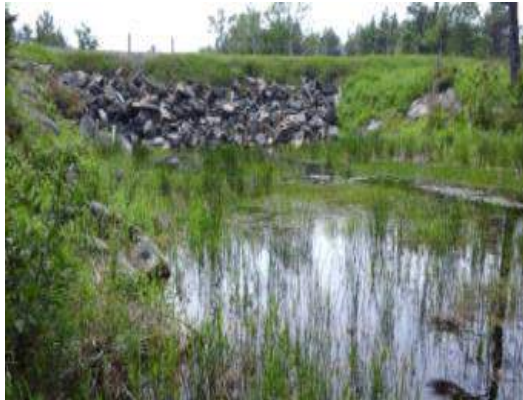
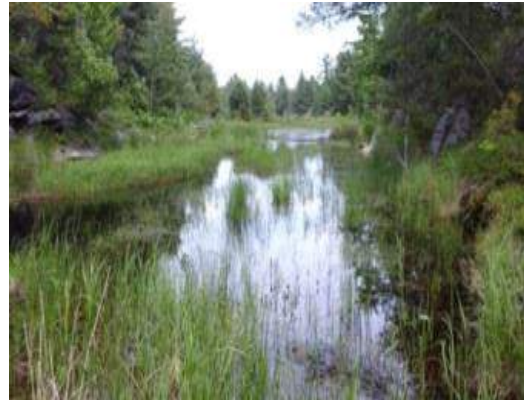
Feature ID	Investigation Date	Type of Waterbody	Description of Site	Feature Description	Feature Sensitivity												
WB-B-M30-104	June 11th, 2015	Permanent Stream	East of Highway 69, surrounded by forest and wetland, stream flows to west	<p>Standing watercourse drains southwesterly from beaver dam 90m upstream to Highway 69 through corrugated steel pipe. The stream is heavily vegetated between bedrock slopes. Bedrock and riprap protection are present on highway embankment. Substrate consists of detritus, silt and muck. There is a diverse community of aquatic vegetation species. No groundwater indicators are present.</p> <table><tr><td>Fish Habitat?</td><td>Direct</td></tr><tr><td>MWW (m)</td><td>14.00</td></tr><tr><td>MBW (m)</td><td>14.20</td></tr><tr><td>MWD (m)</td><td>0.80</td></tr><tr><td>MBD (m)</td><td>1.00</td></tr></table>	Fish Habitat?	Direct	MWW (m)	14.00	MBW (m)	14.20	MWD (m)	0.80	MBD (m)	1.00	Low

Fish Habitat?	Direct																
MWW (m)	14.00																
MBW (m)	14.20																
MWD (m)	0.80																
MBD (m)	1.00																
						Photo 1. View of stream downstream of crossing. ⬆	Photo 2. View of stream upstream from crossing. ⬆										
WB-B-M30-105	June 12th, 2015	Permanent Stream	Mixed coniferous/deciduous forest atop bedrock east of Highway 69, stream flows to west	<p>West flowing channel through saturated meadow marsh with occasional pools and side channels in floodplain. Heavily vegetated, grassy banks border flat moving water over detritus, muck, and silt. A beaver dam 10 m upstream of study site impedes fish migration. No groundwater indicators are present.</p> <table><tr><td>Fish Habitat?</td><td>Direct</td></tr><tr><td>MWW (m)</td><td>2.15</td></tr><tr><td>MBW (m)</td><td>54.6</td></tr><tr><td>MWD (m)</td><td>0.23</td></tr><tr><td>MBD (m)</td><td>0.42</td></tr></table>	Fish Habitat?	Direct	MWW (m)	2.15	MBW (m)	54.6	MWD (m)	0.23	MBD (m)	0.42	Low

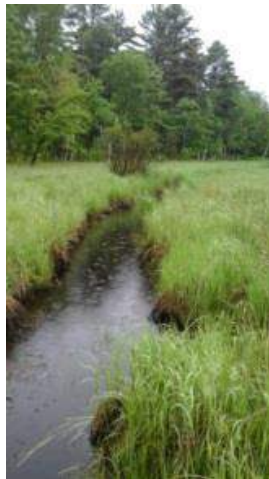
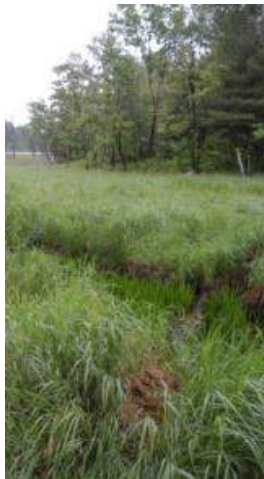
Fish Habitat?	Direct																
MWW (m)	2.15																
MBW (m)	54.6																
MWD (m)	0.23																
MBD (m)	0.42																
						Photo 1. View of stream upstream of downstream limit. ⬆	Photo 2. View of crossing from south bank. ⬆										
WB-B-M30-105-2	June 12th, 2015	Permanent Stream	Mixed coniferous/deciduous forest atop bedrock east of Highway 69, stream flows to west	<p>Drainage channel flowing through meadow to west flows into pool with another input from east and drained to north through breached beaver dam. Low to moderate flows with mixed morphological structure over bedrock, detritus, muck and silt have trees and grasses provide canopy and algae, emergent grasses, and floating emergent vegetation present in-stream. A low flow barrier prevents fish migration at this time. Groundwater seepage does not appear to occur at this site.</p> <table><tr><td>Fish Habitat?</td><td>Direct</td></tr><tr><td>MWW (m)</td><td>5.00</td></tr><tr><td>MBW (m)</td><td>5.70</td></tr><tr><td>MWD (m)</td><td>0.23</td></tr><tr><td>MBD (m)</td><td>0.32</td></tr></table>	Fish Habitat?	Direct	MWW (m)	5.00	MBW (m)	5.70	MWD (m)	0.23	MBD (m)	0.32	Low

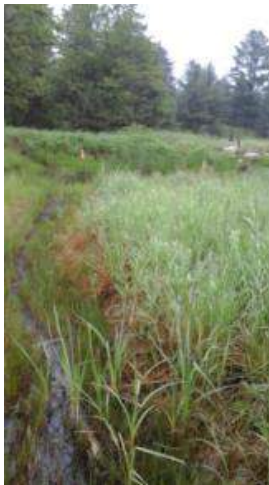
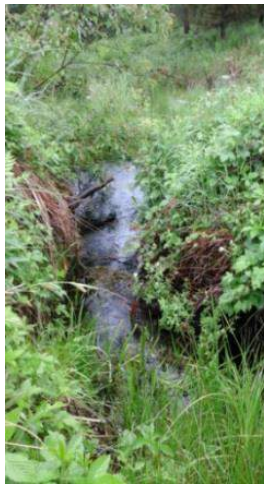
Fish Habitat?	Direct																
MWW (m)	5.00																
MBW (m)	5.70																
MWD (m)	0.23																
MBD (m)	0.32																
						Photo 1. View of stream downstream of crossing ⬆	Photo 2. View of breached beaver dam provides outlet to north. ⬆

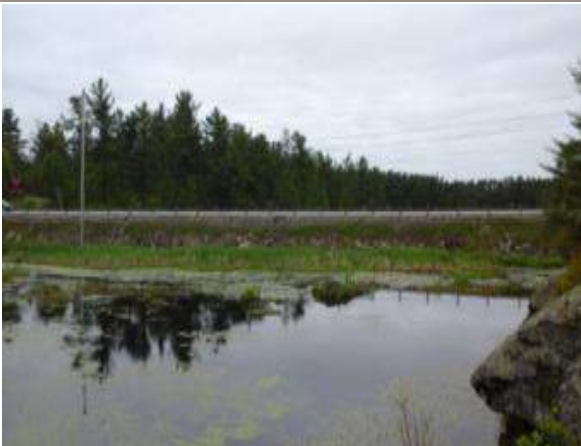
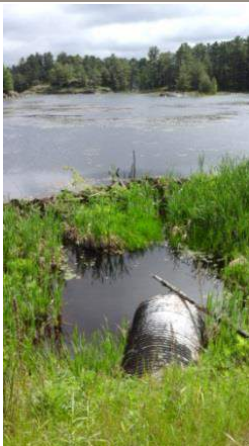
Feature ID	Investigation Date	Type of Waterbody	Description of Site	Feature Description	Feature Sensitivity								
WB-B-M31-103	June 8th, 2015	Permanent Pond	East of Highway 69, south of unnamed gravel road, surrounded by bedrock and forest	<p>Large pond directly on east side of Highway 69. Cattails and grasses growing on banks, connected to pond on west side of highway via csp. Pond weed and lily pads provide in situ habitat. Vegetation may provide spawning habitat for pike, especially since this pond has connectivity. There is little to no canopy cover. There are no indicators of groundwater present.</p> <table><tr><td>Fish Habitat?</td><td>Direct</td></tr><tr><td>Width (m)</td><td>200</td></tr><tr><td>Depth (m)</td><td>1.00</td></tr></table>	Fish Habitat?	Direct	Width (m)	200	Depth (m)	1.00	Moderate

<p>Photo 1. View of pond and highway from north side of pond facing west ↑</p>	<p>Photo 2. View of culvert on east bank of highway facing east ↑</p>						
WB-B-M31-142	June 8th, 2015	Permanent Wetland	East of Highway 69, surrounded by bedrock and forest. A large, flat gravel area that may have been used for highway construction	<p>Large, “U”-shaped pond with rock barren in middle. Large boulders dumped along banks (probably from previous construction). Pond weed and lily pad provide lots of in situ cover. Bedrock banks prevent trees from providing canopy cover. There are no indicators of groundwater present.</p> <table><tr><td>Fish Habitat?</td><td>Direct</td></tr><tr><td>Width (m)</td><td>80</td></tr><tr><td>Depth (m)</td><td>1</td></tr></table>	Fish Habitat?	Direct	Width (m)	80	Depth (m)	1	Moderate

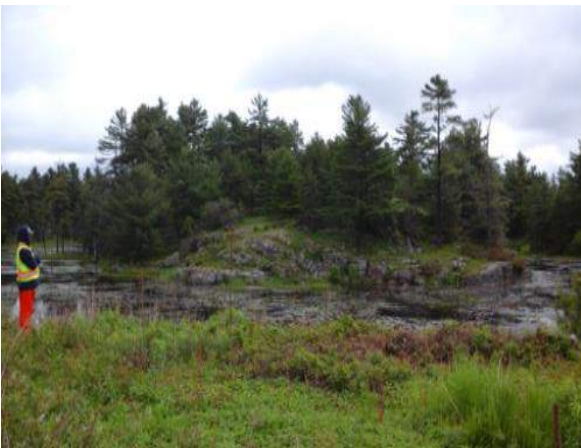
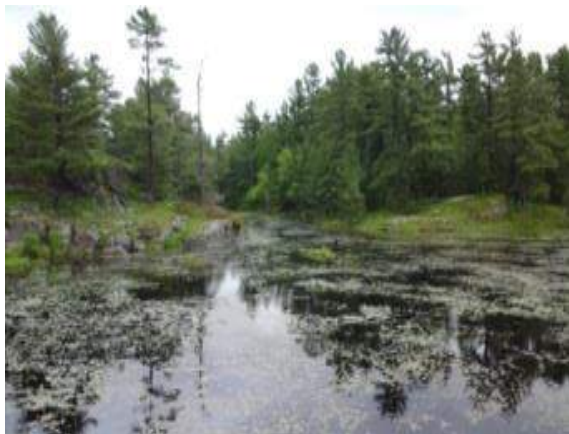
<p>Photo 1. View of both upper and lower reaches of wetland, and rock barren in middle looking west. ↑</p>	<p>Photo 2. View of lower branch of wetland taken from east. ↑</p>						
WB-B-M32-101	June 8th, 2015	Permanent Wetland	East of Highway 69	<p>Bog completely choked by wetland vegetation with a thick floating vegetated mat. There is no open water for fish to reside in. A culvert at Hwy 69 south west of the survey point has some water movement but not enough to suffice fish migration. No indicators of groundwater are present.</p> <table><tr><td>Fish Habitat?</td><td>Not Habitat</td></tr><tr><td>Width (m)</td><td>Not measured</td></tr><tr><td>Depth (m)</td><td>0.00</td></tr></table>	Fish Habitat?	Not Habitat	Width (m)	Not measured	Depth (m)	0.00	Low

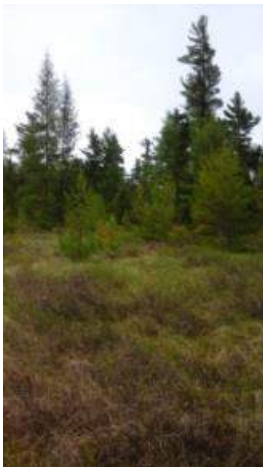
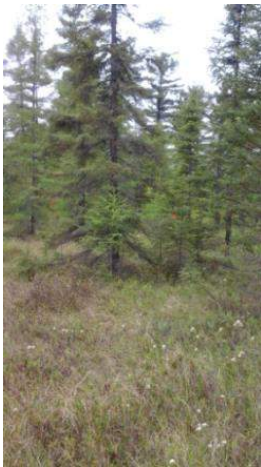
Fish Habitat?	Not Habitat												
Width (m)	Not measured												
Depth (m)	0.00												
						<p>Photo 1. View of bog from the north. ↑</p>	<p>Photo 2. View of study area from the east. ↑</p>

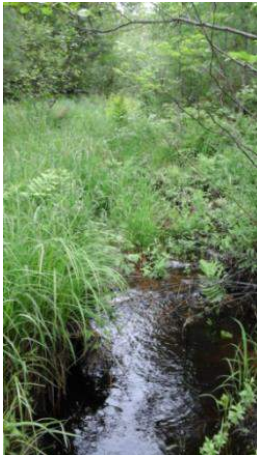
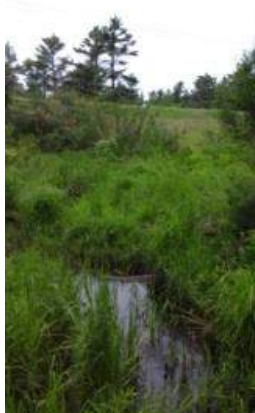
Feature ID	Investigation Date	Type of Waterbody	Description of Site	Feature Description	Feature Sensitivity												
WB-B-M32-102	June 8th, 2015	Permanent Stream	East of Highway 69 surrounded by forest, stream flows to west	<p>Watercourse flowing west towards culvert at Highway 69. There appears to be an old marsh at the upstream limit of study area. Wet substrate and some water pooling in depression to the side probably connects to watercourse during precipitation events. Minnow observed. Undercutting occurs on both banks. Substrate is sand, silt and gravel. Little cover is provided by grasses, trees, herbaceous plants and shrubs. Creek has run, riffle, pool morphological structure. No indicators of groundwater seepage are observed.</p> <table><tr><td>Fish Habitat?</td><td>Direct</td></tr><tr><td>MWW (m)</td><td>2.00</td></tr><tr><td>MBW (m)</td><td>3.00</td></tr><tr><td>MWD (m)</td><td>0.35</td></tr><tr><td>MBD (m)</td><td>0.40</td></tr></table>	Fish Habitat?	Direct	MWW (m)	2.00	MBW (m)	3.00	MWD (m)	0.35	MBD (m)	0.40	Moderate

Fish Habitat?	Direct																
MWW (m)	2.00																
MBW (m)	3.00																
MWD (m)	0.35																
MBD (m)	0.40																
						Photo 1. View of stream upstream of crossing. ⬆	Photo 2. View of stream to west with highway in background. ⬆										
WB-B-M33-100	June 8th, 2015	Permanent Stream	East of Highway 69, stream flows perpendicular to road in west direction	<p>Natural, permanent watercourse flowing between bedrock and forest. Moderate flow conditions throughout watercourse. Substrate dominated by sand, then silt and organic material. Stream morphological structure is mostly run, then pool, then flat. Submergent grasses dominate aquatic vegetation. Grass on banks provide some canopy cover although not much because the watercourse is quite wide. Large beaver dam at upstream limit poses natural barrier to fish movement. Deep pools throughout channel mixed with shallow rifles. Groundwater seepage does not appear to occur at this site.</p> <table><tr><td>Fish Habitat?</td><td>Direct</td></tr><tr><td>MWW (m)</td><td>0.75</td></tr><tr><td>MBW (m)</td><td>0.90</td></tr><tr><td>MWD (m)</td><td>0.15</td></tr><tr><td>MBD (m)</td><td>0.40</td></tr></table>	Fish Habitat?	Direct	MWW (m)	0.75	MBW (m)	0.90	MWD (m)	0.15	MBD (m)	0.40	Low

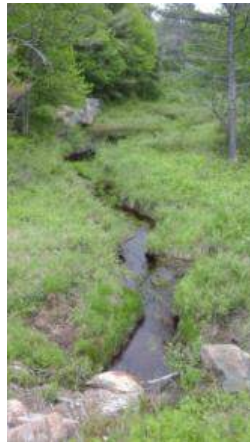
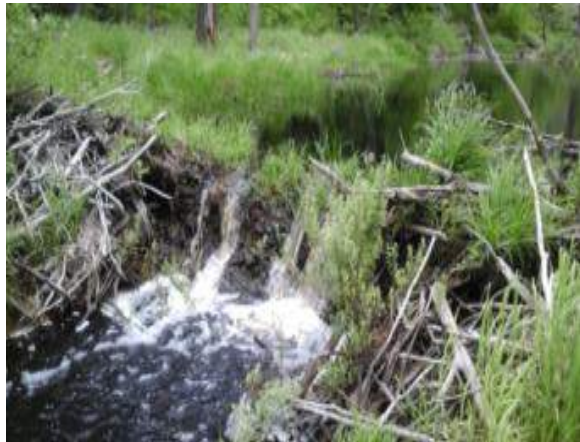
Fish Habitat?	Direct																
MWW (m)	0.75																
MBW (m)	0.90																
MWD (m)	0.15																
MBD (m)	0.40																
						Photo 1. View of watercourse looking east from highway⬆	Photo 2. View of beaver dam located 25 m east of survey point. ⬆										
WB-B-M33-99	June 8th, 2015	Permanent Wetland	Wetland located east of Highway 69 surrounded by forest with small bedrock outcrops throughout study area.	<p>No open water or defined channel. Area is saturated and choked by wetland vegetation. Small bedrock outcrops are within the study area. No indicators of groundwater seepage occur at this site.</p> <table><tr><td>Fish Habitat?</td><td>Not Habitat</td></tr><tr><td>Width (m)</td><td>Not measured</td></tr><tr><td>Depth (m)</td><td>0.00</td></tr></table>	Fish Habitat?	Not Habitat	Width (m)	Not measured	Depth (m)	0.00	Low

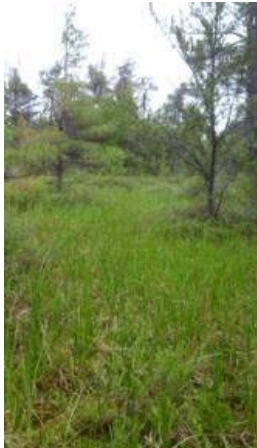
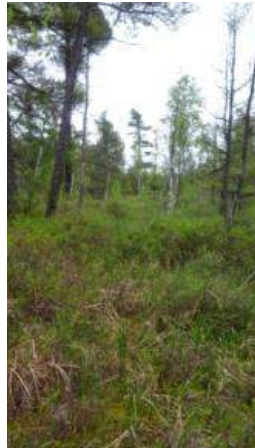
Width (m)	Not measured																
Depth (m)	0.00																
						Photo 1. View of study area from southern limit. ⬆	Photo 2. View of study area from northern limit. ⬆

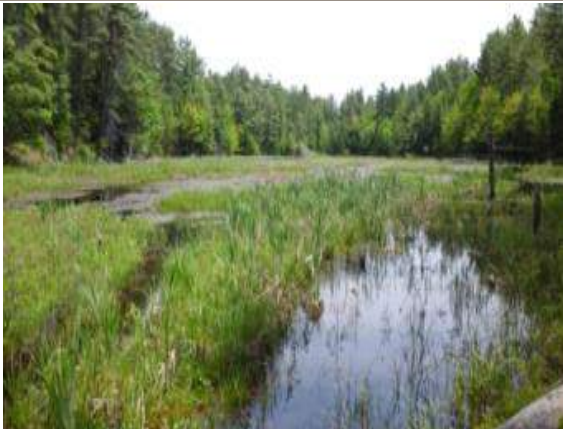
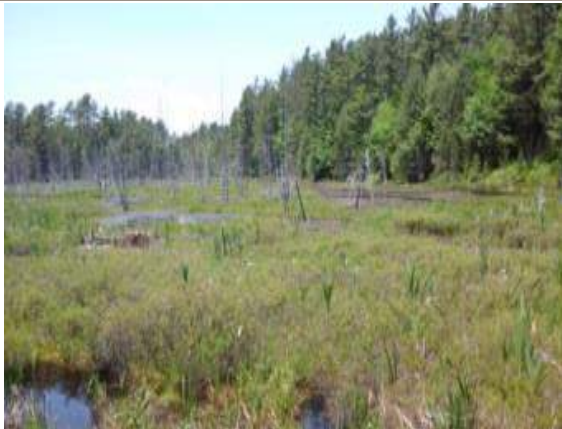
Feature ID	Investigation Date	Type of Waterbody	Description of Site	Feature Description	Feature Sensitivity								
WB-B-M35-95	May 5th, 2015	Permanent Pond	150 km east of Highway 60 on rock barren, wetland to the northwest, forested area to the southeast	<p>Same pond as WB-B-M34-96. Dammed to the northeast side. There are more floating mats of vegetation here. Substrate is soft and muck is dominant with vegetation and detritus providing cover. Many standing snags and fallen logs are present. Minnows observed. No groundwater indicators are present.</p> <table><tr><td>Fish Habitat?</td><td>Direct</td></tr><tr><td>Width (m)</td><td>90</td></tr><tr><td>Depth (m)</td><td>1.50</td></tr></table>	Fish Habitat?	Direct	Width (m)	90	Depth (m)	1.50	Low

Fish Habitat?	Direct												
Width (m)	90												
Depth (m)	1.50												
						Photo 1. View of wetland east of crossing. ⬆	Photo 2. View of study area southeast of crossing. ⬆

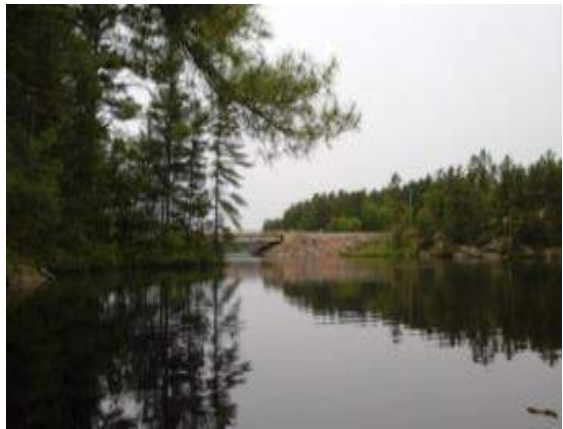
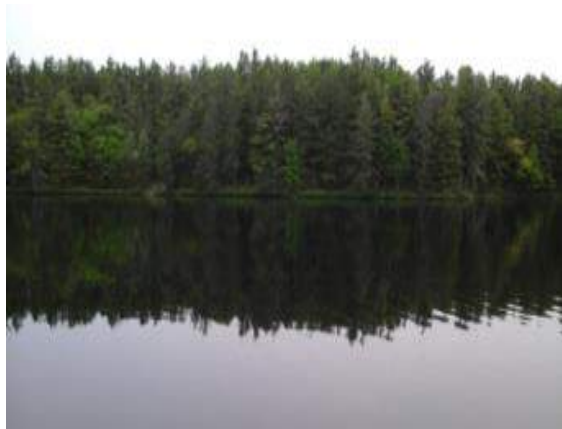
WB-B-M36-94	May 5th, 2015	Permanent Lake	Naiscoot Lake east of Highway 69, forested on north and south banks. Cottages upstream on Naiscoot Lake. Lake is long along its east-west axis and transected by highway	<p>Large lake with cottages upstream (east) of crossing. Assumed to be deeper than 1.5 m. Overhanging shrubs and trees provide canopy cover. Only bedrock (no aquatic vegetation) can be seen in water from vantage point. No groundwater indicators are present</p> <table><tr><td>Fish Habitat?</td><td>Direct</td></tr><tr><td>Width (m)</td><td>170.00</td></tr><tr><td>Depth (m)</td><td>1.50</td></tr></table>	Fish Habitat?	Direct	Width (m)	170.00	Depth (m)	1.50	Moderate

Fish Habitat?	Direct												
Width (m)	170.00												
Depth (m)	1.50												
						Photo 1. View of lake south of crossing toward highway. ⬆	Photo 2. View north bank where crossing will occur. ⬆						
WB-B-M37-93	June 10th, 2015	Permanent Pond	East of Highway 69	<p>Beaver dammed wetland to the west. Transmission line crosses over open water, more aquatic vegetation (grasses mostly) to the east. Lots of standing snags (birch). Approximate depth is greater than 1m. Aquatic grasses, submerged logs and fallen trees provide in situ habitat. Grasses, ferns and shrubs provide cover. No groundwater indicators are present.</p> <table><tr><td>Fish Habitat?</td><td>Direct</td></tr><tr><td>Width (m)</td><td>30.00</td></tr><tr><td>Depth (m)</td><td>1.00</td></tr></table>	Fish Habitat?	Direct	Width (m)	30.00	Depth (m)	1.00	Low

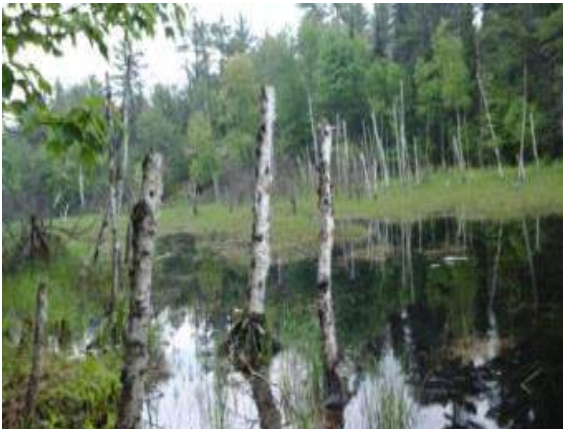
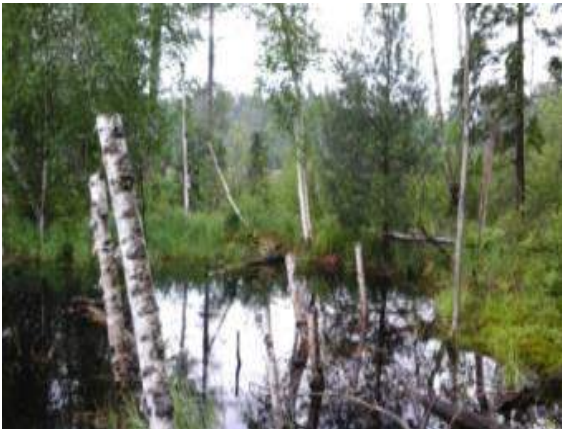
Fish Habitat?	Direct												
Width (m)	30.00												
Depth (m)	1.00												
						Photo 1. View of pond east from crossing. ⬆	Photo 2. View of pond west from crossing, with beaver dam and highway. ⬆

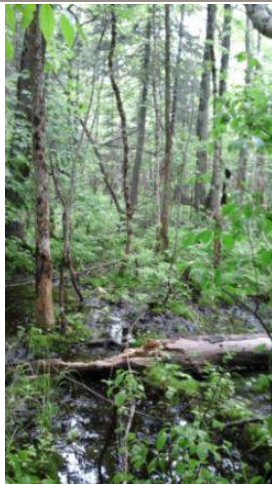
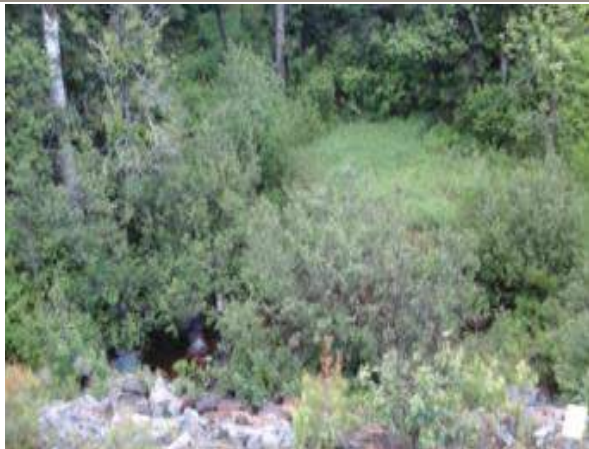
Feature ID	Investigation Date	Type of Waterbody	Description of Site	Feature Description	Feature Sensitivity												
WB-B-M38-90	June 10th, 2015	Permanent Swamp	East of Highway 69	<p>Green ash swamp consists of interconnecting pools of water (various saturated areas). Total width of wetted area 20m. Lots of ash trees, ferns, herbaceous and sphagnum moss growing in swamp. Mean depth of pools are 0.12 m. Surrounding topography slopes down towards swampy area. There is no indication of groundwater seepage at this site.</p> <table><tr><td>Fish Habitat?</td><td>Not habitat</td></tr><tr><td>Width (m)</td><td>20</td></tr><tr><td>Depth (m)</td><td>0.12</td></tr></table>	Fish Habitat?	Not habitat	Width (m)	20	Depth (m)	0.12	Low

Fish Habitat?	Not habitat																
Width (m)	20																
Depth (m)	0.12																
						Photo 1. View of study area west from crossing. ⬆	Photo 2. View of study area from highway where swamp ends. ⬆
