Henvey Inlet Wind Transmission Line

Appendix B6. Route B Waterbodies, Fish Habitat and Aquatic Ecosystems Environmental Baseline Report

AECOM

September 2015

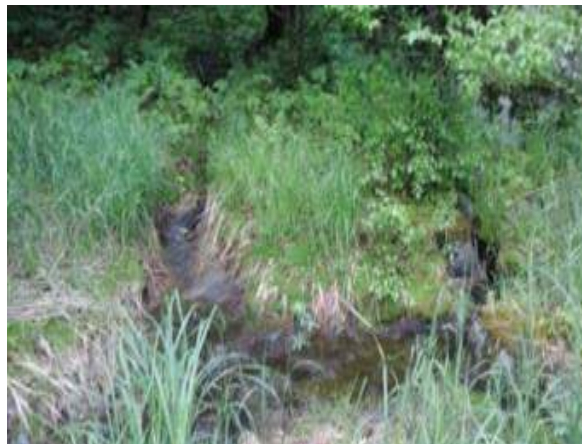
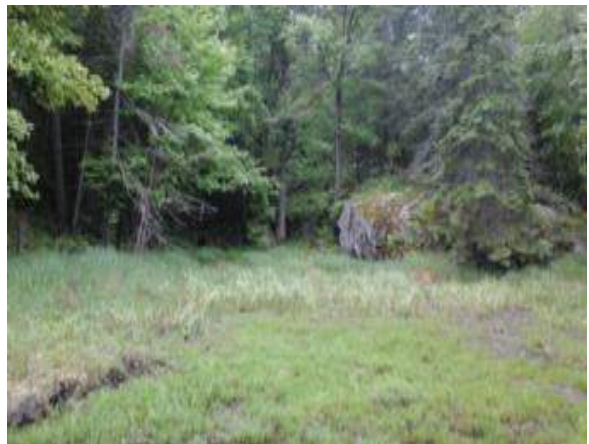
WB-B-M38-91	June 10th, 2015	Intermittent Stream	East of highway 69 surrounded by wetland and forest, flows to the west	<p>Small meandering channel for ~14m before topography slopes upwards into the forest. Some evidence of water movement in forest (some small pools present), likely flowing east towards pond during spring melt or heavy rain events. Groundwater seepage does not appear to occur at this site.</p> <table><tr><td>Fish Habitat?</td><td>Not habitat</td></tr><tr><td>MWW (m)</td><td>Not measured</td></tr><tr><td>MBW (m)</td><td>Not measured</td></tr><tr><td>MWD (m)</td><td>Not measured</td></tr><tr><td>MBD (m)</td><td>Not measured</td></tr></table>	Fish Habitat?	Not habitat	MWW (m)	Not measured	MBW (m)	Not measured	MWD (m)	Not measured	MBD (m)	Not measured	Low

MBD (m)	Not measured																
						Photo 1. View of watercourse ending 14 m meandering from pond. ⬆	Photo 2. View of area where watercourse supposedly begins (west from pond). ⬆										
WB-B-M38-92	June 10th, 2015	Permanent Pond	East of Highway 69. Forest north and sound of pond. Survey point in wetland/beaver pond surrounded by steep bedrock cliffs and forest.	<p>Long pond stretching east from highway, open water divided by some large rectangular sections of shrubs. Beaver dam ~60 m upstream from centreline . Depth is over 1.5 m but too deep to wade. In-situ cover is dominated by aquatic vegetation and grasses on bedrock. Groundwater seepage does not appear to occur at this site.</p> <table><tr><td>Fish Habitat?</td><td>Direct</td></tr><tr><td>Width (m)</td><td>40.00</td></tr><tr><td>Depth (m)</td><td>1.50</td></tr></table>	Fish Habitat?	Direct	Width (m)	40.00	Depth (m)	1.50	Low

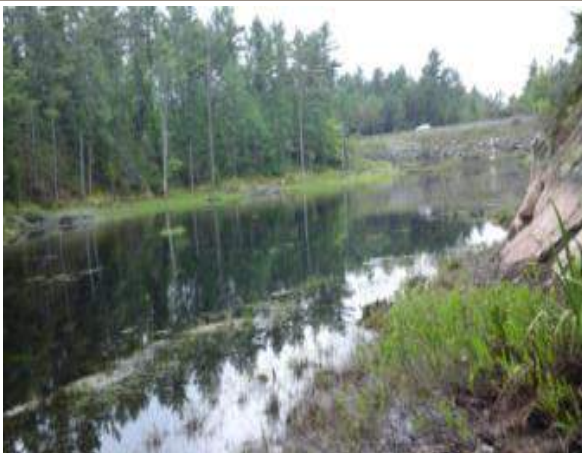
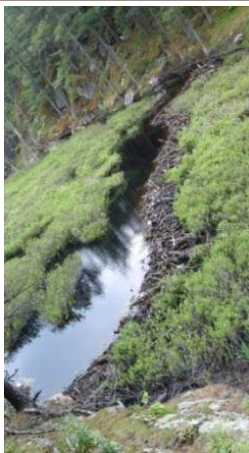
Fish Habitat?	Direct																
Width (m)	40.00																
Depth (m)	1.50																
						Photo 1. View of study area west from crossing. ⬆	Photo 2. View of large beaver dam upstream (east) of crossing. ⬆

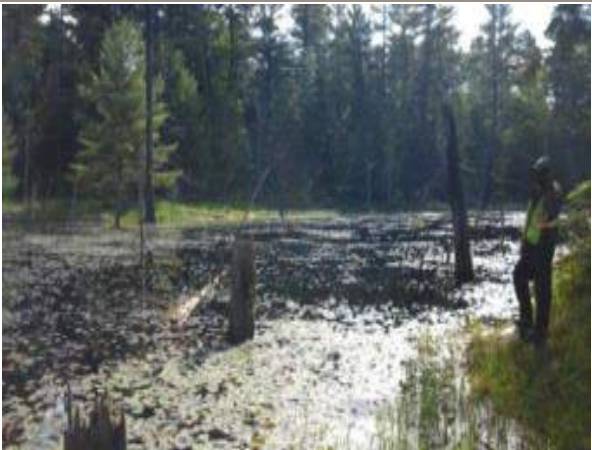
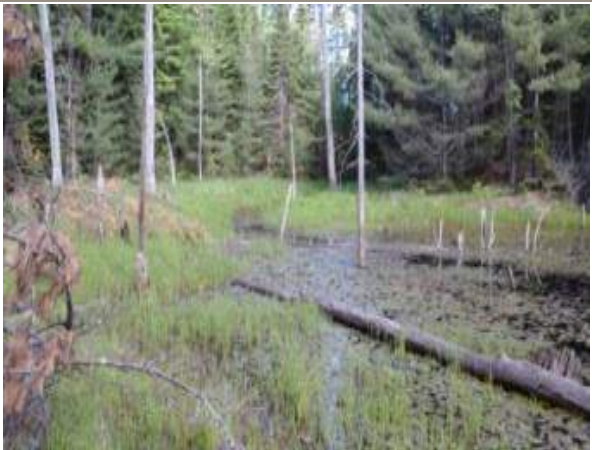
Feature ID	Investigation Date	Type of Waterbody	Description of Site	Feature Description	Feature Sensitivity												
WB-B-M39-87	June 11th, 2015	Permanent Pond	East of Highway 69	<p>Large pond with abundance of fragrant white lilies, standing snags and fallen logs. Probably connected to larger Moose Lake east of the moose lake trading post. Painted turtle observed. . A small channel to the west flows into pond. Substrate was not determined. There is no indication of groundwater seepage at this site.</p> <table><tr><td>Fish Habitat?</td><td>Direct</td></tr><tr><td>Width (m)</td><td>30.00</td></tr><tr><td>Depth (m)</td><td>0.40</td></tr></table>	Fish Habitat?	Direct	Width (m)	30.00	Depth (m)	0.40	Moderate

Fish Habitat?	Direct																
Width (m)	30.00																
Depth (m)	0.40																
						Photo 1. View of pond east from crossing. ⬆	Photo 2. View of pond west from crossing. ⬆

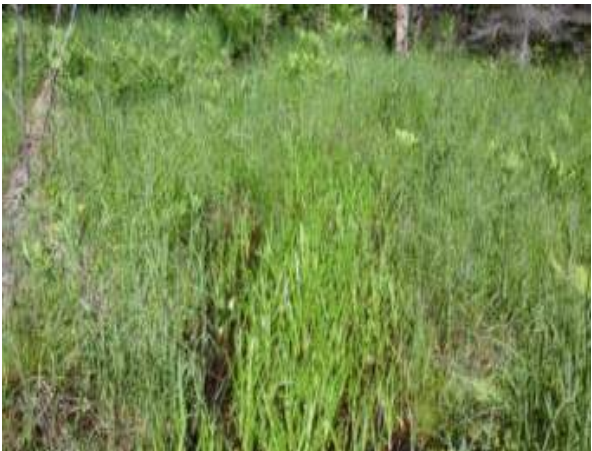
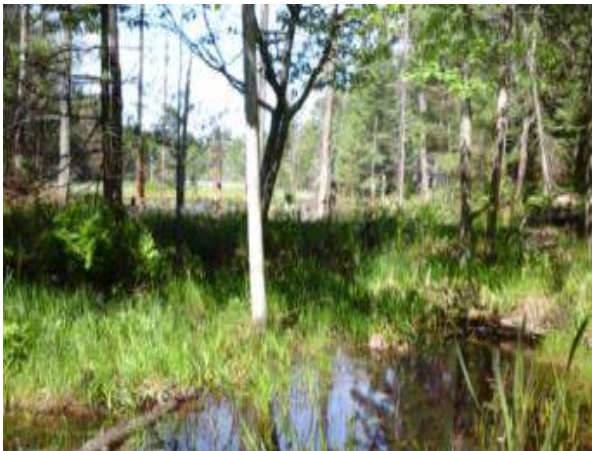
WB-B-M39-88	June 11th, 2015	Permanent Stream	Wetland surrounded by forest.. Stream flows south, parallel 200 m east of Hwy 69 and 300 m north of Moose Trading Post.	<p>Water flows towards larger pond (WB-B-M39-87). Obvious wide channel with grasses growing in and on banks of watercourse. Some logs have fallen over top. Defined banks in main channel, but watercourse could flood to 12m in floodplain. 30m upstream of centerline the channel flows through 15m of small forested area; banks are taller and channel is smaller. Beaver dam at the end of survey site, water escaping to small pool and then flowing downstream into main channel. Watercourse slow moving over detritus for most of the survey site. Groundwater seepage does not appear to occur at this site.</p> <table><tr><td>Fish Habitat?</td><td>Direct</td></tr><tr><td>MWW (m)</td><td>1.50</td></tr><tr><td>MBW (m)</td><td>2.00</td></tr><tr><td>MWD (m)</td><td>0.25</td></tr><tr><td>MBD (m)</td><td>0.35</td></tr></table>	Fish Habitat?	Direct	MWW (m)	1.50	MBW (m)	2.00	MWD (m)	0.25	MBD (m)	0.35	Low

Fish Habitat?	Direct																
MWW (m)	1.50																
MBW (m)	2.00																
MWD (m)	0.25																
MBD (m)	0.35																
						Photo 1. View of banks and instream vegetation at crossing. ⬆	Photo 2. View of beaver dam at upstream end of survey location. ⬆										
WB-B-M39-89	June 11th, 2015	Permanent Wetland	Highway 69 to the west. Wetland surrounded by forest.	<p>Saturated fen with some deeper pools of water. Predominantly covered by floating mats of vegetation or shrubs. Rock barren outcrop in middle of wetland. Transmission line crossing approximately 30 m of this wetland to the bedrock outcrop. There is no indication of groundwater present.</p> <table><tr><td>Fish Habitat?</td><td>Not habitat</td></tr><tr><td>Width (m)</td><td>37.00</td></tr><tr><td>Depth (m)</td><td>0.50</td></tr></table>	Fish Habitat?	Not habitat	Width (m)	37.00	Depth (m)	0.50	Low

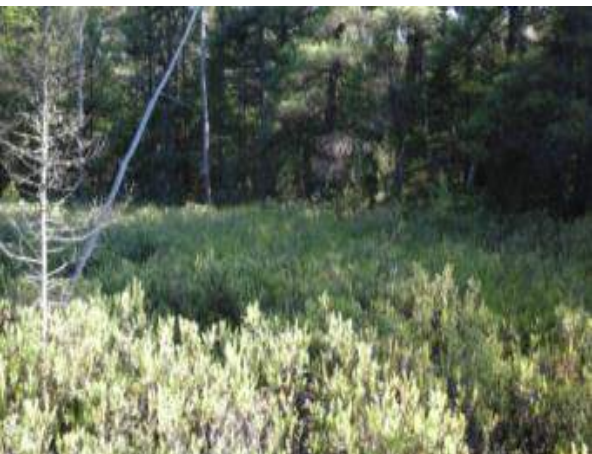
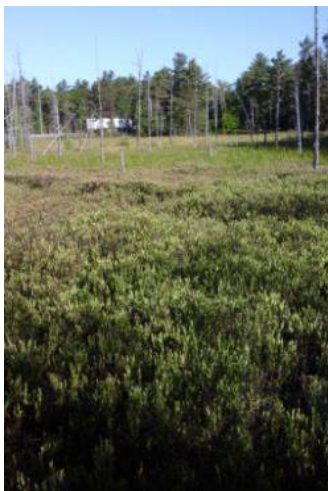
Fish Habitat?	Not habitat																
Width (m)	37.00																
Depth (m)	0.50																
						Photo 1. View of saturated fen, east of crossing. ⬆	Photo 2. View of study area north of crossing. ⬆

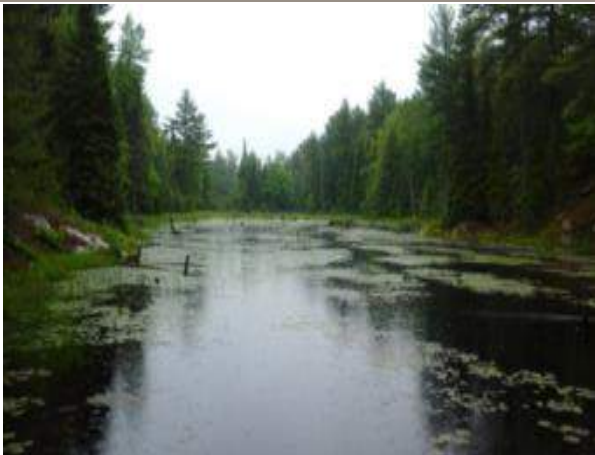
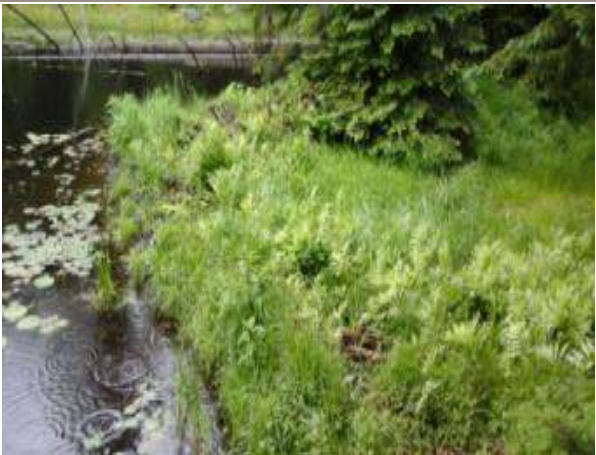
Feature ID	Investigation Date	Type of Waterbody	Description of Site	Feature Description	Feature Sensitivity												
WB-B-M41-82	June 12th, 2015	Permanent Lake	Beaver pond surrounded by forest approximately 400 m east of Hwy 69	<p>Large beaver pond, dammed at west end. Lots of water lilies. Small grassy channel with large riparian zone flowing into pond approx. 100 m upstream from centerline. Water passes through beaver dam and flows west into vegetated channel. Aquatic vegetation and some woody debris provide in stream cover. No groundwater indicators are present.</p> <table><tr><td>Fish Habitat?</td><td>Direct</td></tr><tr><td>Width (m)</td><td>140.00</td></tr><tr><td>Depth (m)</td><td>1.50</td></tr></table>	Fish Habitat?	Direct	Width (m)	140.00	Depth (m)	1.50	Low

Fish Habitat?	Direct																
Width (m)	140.00																
Depth (m)	1.50																
						<p>Photo 1. View of pond taken from beaver dam at west limit. ⬆</p>	<p>Photo 2. View of old beaver dam 50 m downstream from crossing. ⬆</p>

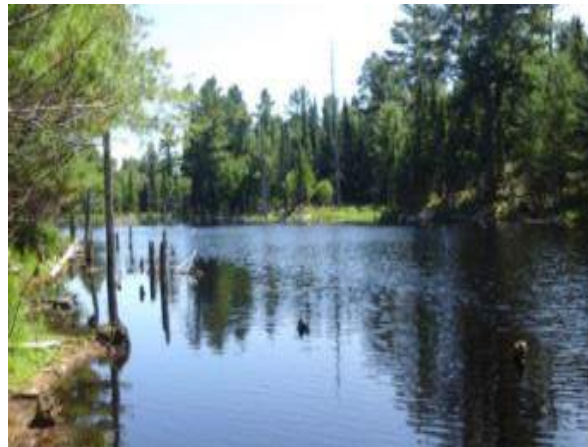
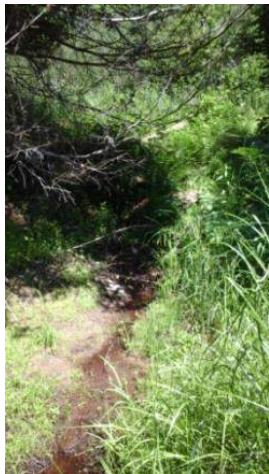
WB-B-M42-79	July 2nd, 2015	Permanent Stream	East of Highway 69 near Pointe au Baril. Stream flows southwest	<p>Watercourse confined by beaver dams upstream and downstream outside of study area. Small tributary to west provides little flow. Fish would not be able to migrate up tributary due to low flow over high gradient. Substrate consists of detritus, muck, and silt over bedrock. Little to no canopy cover is provided by trees. No indication of groundwater seepage is present.</p> <table><tr><td>Fish Habitat?</td><td>Direct</td></tr><tr><td>MWW (m)</td><td>35.0</td></tr><tr><td>MBW (m)</td><td>40.0</td></tr><tr><td>MWD (m)</td><td>1.00</td></tr><tr><td>MBD (m)</td><td>1.15</td></tr></table>	Fish Habitat?	Direct	MWW (m)	35.0	MBW (m)	40.0	MWD (m)	1.00	MBD (m)	1.15	Low

MBD (m)	1.15																
						<p>Photo 1. View of stream upstream of downstream limit. ⬆</p>	<p>Photo 2. View of small tributary to west that has low flow and high relief preventing fish migration. ⬆</p>										
WB-B-M42-81	July 2nd, 2015	Permanent Lake	“Sucker Lake,” east of Highway 69 near Pointe au Baril surrounded by coniferous dominant forest atop steep bedrock cliffs flows to the west. A bridge for snowmobiles is located downstream of study site.	<p>Large lake-like river flowing from west to east bordered by steep bedrock cliff to south. Beaver dam is located downstream of crossing. Substrate consists of detritus, sand, silt and muck on bedrock. Plenty of aquatic vegetation provides in-stream cover but little canopy cover is provided by trees and shrubs. There is no indication of groundwater seepage at this site.</p> <table><tr><td>Fish Habitat?</td><td>Direct</td></tr><tr><td>MWW (m)</td><td>30.00</td></tr><tr><td>MBW (m)</td><td>35.00</td></tr><tr><td>MWD (m)</td><td>1.00</td></tr><tr><td>MBD (m)</td><td>1.10</td></tr></table>	Fish Habitat?	Direct	MWW (m)	30.00	MBW (m)	35.00	MWD (m)	1.00	MBD (m)	1.10	Moderate

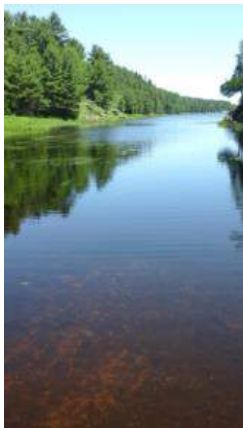
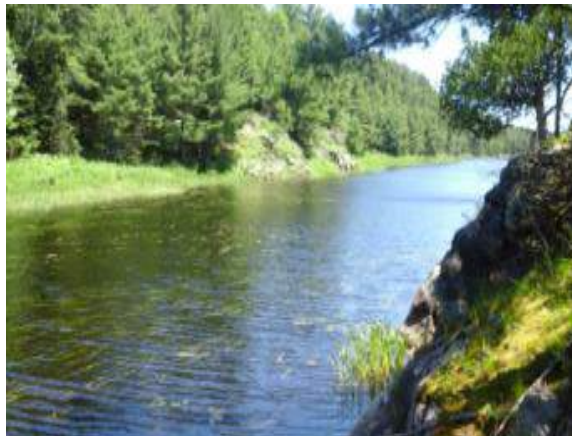
Fish Habitat?	Direct																
MWW (m)	30.00																
MBW (m)	35.00																
MWD (m)	1.00																
MBD (m)	1.10																
						<p>Photo 1. View of stream upstream of downstream limit ⬆</p>	<p>Photo 2. View of study area upstream of crossing. ⬆</p>

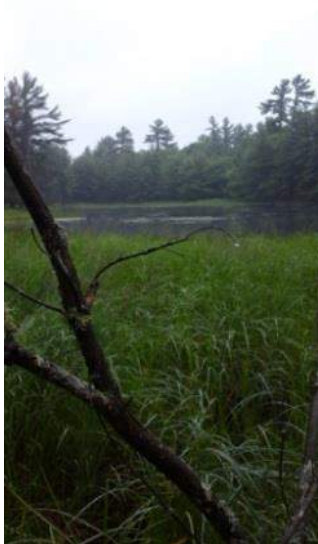
<p>Photo 1. View of study area east from crossing across lake from southwest bank. Ideal pike spawning habitat in foreground. ⬆</p>
Fish Habitat?	Direct												
Width (m)	71.00												
Depth (m)	1.00

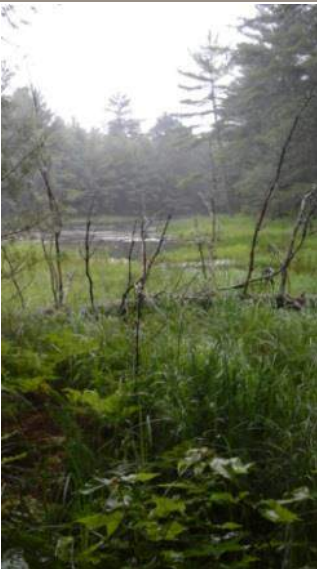
<p>Photo 2. View of study area looking southeast along crossing from southwest bank. ⬆</p>

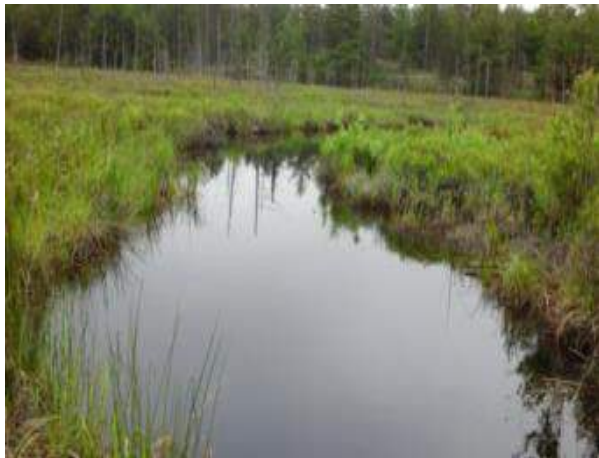
Fish Habitat?	Direct																
Width (m)	106.00																
Depth (m)	2.00																
WB-B-M45-73	June 15th, 2015	Permanent Stream	Mixed coniferous and deciduous forest atop bedrock open fen with sedges and herbaceous plants. Some dead trees. Stream flows perpendicular to road in north direction	<p>Defined channel in highly saturated wet meadow. Frequent side channels and pools. Potential fish habitat. . Waterbody fed by CSP and upstream wetland across highway 69. Potential beaver activity has led to flooded upstream conditions. Bedrock and heavily vegetated banks provide bank stability for low flows over detritus, muck, and some gravel over bedrock. Wetland plant species are present but there is no aquatic vegetation species. Upstream has minimal canopy cover while downstream has 100% cover. No groundwater indicators are present.</p> <table><tr><td>Fish Habitat?</td><td>Direct</td></tr><tr><td>MWW (m)</td><td>3.30</td></tr><tr><td>MBW (m)</td><td>3.30</td></tr><tr><td>MWD (m)</td><td>0.70</td></tr><tr><td>MBD (m)</td><td>0.70</td></tr></table>	Fish Habitat?	Direct	MWW (m)	3.30	MBW (m)	3.30	MWD (m)	0.70	MBD (m)	0.70	Low

<p>Photo 1. View of upstream from left bank at crossing. ⬆</p>

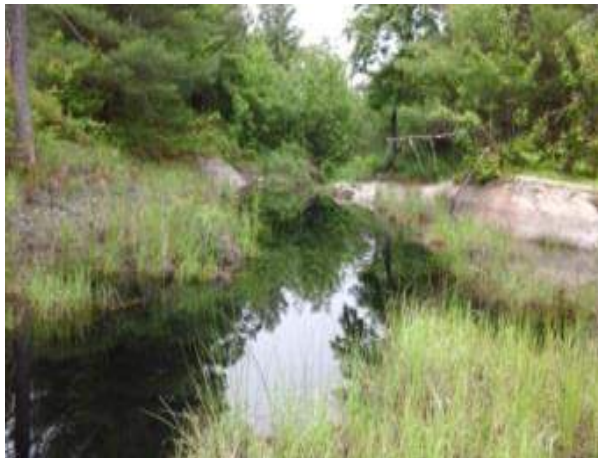
<p>Photo 2. View of downstream from left bank at crossing. ⬆</p>

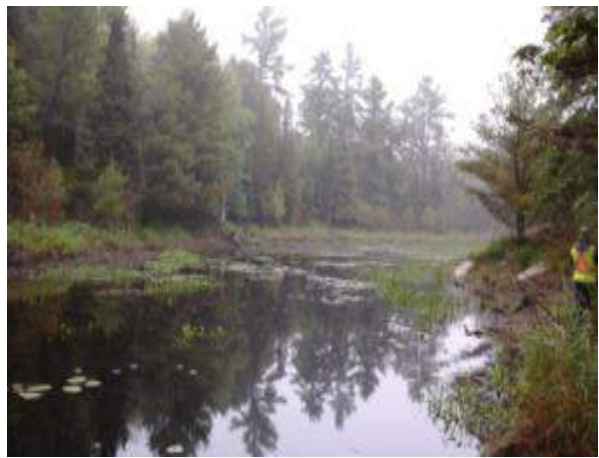
Fish Habitat?	Direct																
MWW (m)	3.30																
MBW (m)	3.30																
MWD (m)	0.70																
MBD (m)	0.70																
WB-B-M45-74	June 15th, 2015	Permanent Stream	Mixed deciduous coniferous forest atop bedrock, stream flows west, perpendicular to Highway 69	<p>West flowing river confined by vegetated bedrock. Low flows create flats over muck, detritus, silt, and bedrock. Narrow and floating emergent present in-stream. Watercourse is drained by CSP downstream. Suitable habitat for cyprinids and warm water tolerant fish species. Bullfrogs observed. There is no indication of groundwater seepage at this site.</p> <table><tr><td>Fish Habitat?</td><td>Direct</td></tr><tr><td>MWW (m)</td><td>18.00</td></tr><tr><td>MBW (m)</td><td>19.25</td></tr><tr><td>MWD (m)</td><td>1.00</td></tr><tr><td>MBD (m)</td><td>1.80</td></tr></table>	Fish Habitat?	Direct	MWW (m)	18.00	MBW (m)	19.25	MWD (m)	1.00	MBD (m)	1.80	Low

<p>Photo 1. View of upstream from centre line on south bank. ⬆</p>

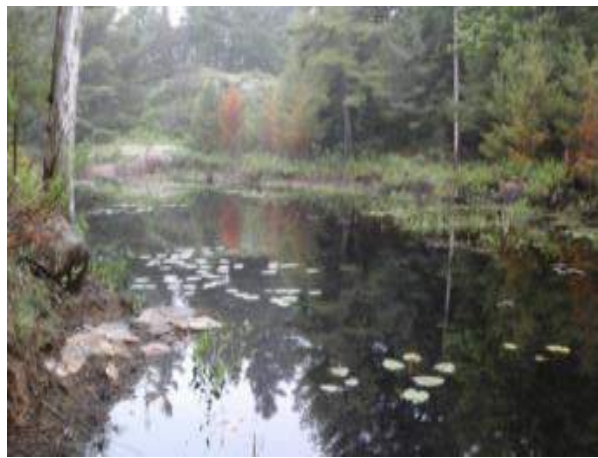
<p>Photo 2. View of downstream from centreline on south bank. ⬆</p>

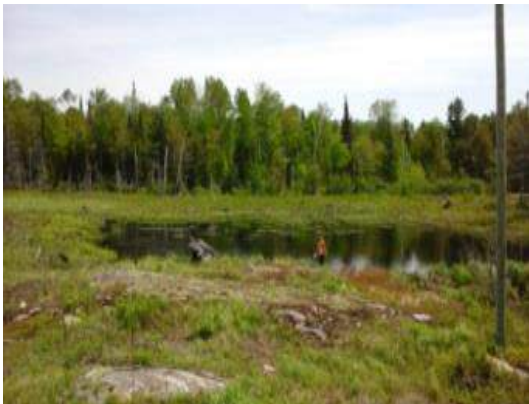
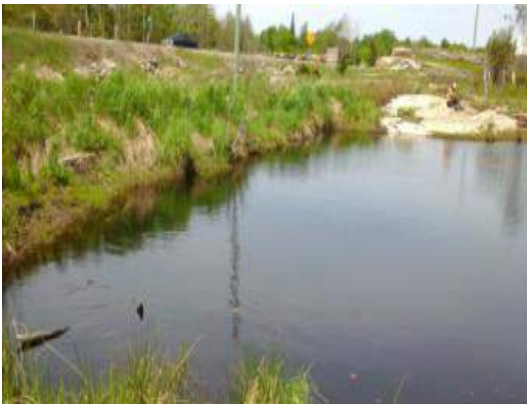
WB-B-M-50-64	N/A	Unknown	Site was on private property with no granted access	N/A	Unknown	No photographs available.											
WB-B-M50-65	N/A	Unknown	Site was on private property with no granted access	N/A	Unknown	No photographs available.											
WB-B-M51-63	N/A	Unknown	Site was on private property with no granted access	N/A	Unknown	No photographs available.											
WB-B-M52-59	June 3rd, 2015	Permanent Pond	East of Highway 69, mixed forest surrounding pond from northeast and south sides and road on west side	<div>Narrow channel from upstream lake feeds into beaver pond and drained by a csp on east side of road. Muck and detritus substrate dominant in the middle, with sand and silt dominant on banks with woody debris. Beaver dam possibly impeding fish passage. Upstream lake is also drained to the south by another stream that may be impacted by transmission line. Woody debris and aquatic vegetation provide in-situ cover. Forest is too far from pond to provide canopy cover. No indicators of groundwater are present.</div> <table><tr><td>Fish Habitat?</td><td>Direct</td></tr><tr><td>Width (m)</td><td>55.00</td></tr><tr><td>Depth (m)</td><td>1.00</td></tr></table>	Fish Habitat?	Direct	Width (m)	55.00	Depth (m)	1.00	Low

Fish Habitat?	Direct																
Width (m)	55.00																
Depth (m)	1.00																
						Photo 1. View of pond from western limit of study at the Highway embankment. ⬆	Photo 2. View from beaver dam approximately 20 m downstream of crossing. ⬆										
WB-B-M52-59-2	June 3rd, 2015	Intermittent Stream	Beaver meadow, scrub land bordered by highway and forest	<div>Mostly dry intermittent channel through scrub meadow. Approximately 10 m east of crossing stagnant water in channel between 2 old beaver dams. Potential intermittent fish habitat for tolerant cyprinids during high flows downstream of crossing however lack of channel form at crossing. Substrate consists of sand, silt and detritus in this exclusively pool system. Overhanging grasses provide most cover with some riparian shrubs providing canopy cover. There is no evidence of groundwater seepage.</div> <table><tr><td>Fish Habitat?</td><td>Direct</td></tr><tr><td>MWW (m)</td><td>0.30</td></tr><tr><td>MBW (m)</td><td>1.00</td></tr><tr><td>MWD (m)</td><td>0.20</td></tr><tr><td>MBD (m)</td><td>0.30</td></tr></table>	Fish Habitat?	Direct	MWW (m)	0.30	MBW (m)	1.00	MWD (m)	0.20	MBD (m)	0.30	Low

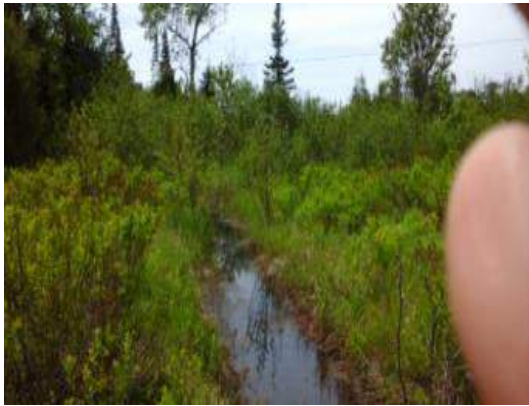
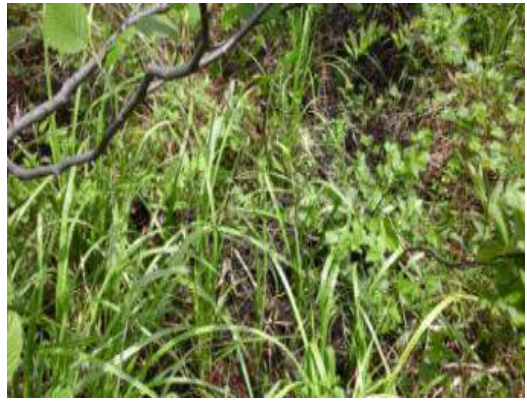
Fish Habitat?	Direct																
MWW (m)	0.30																
MBW (m)	1.00																
MWD (m)	0.20																
MBD (m)	0.30																
						Photo 1. View of downstream from upstream (northwest) limit of study area. ⬆	Photo 2. View of intermittent channel at crossing. ⬆

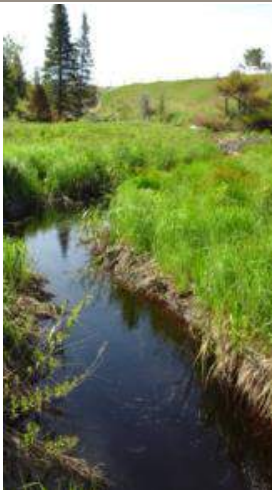
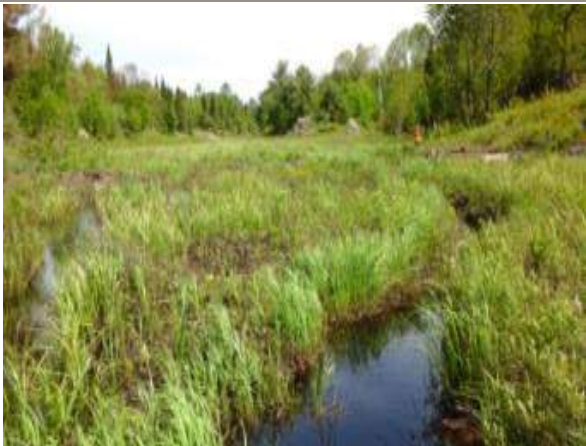
Feature ID	Investigation Date	Type of Waterbody	Description of Site	Feature Description	Feature Sensitivity												
WB-B-M52-61	June 3rd, 2015	Permanent Stream	Two culverts converge on east side of Highway 69 in low lying area between two bedrock outcrops	<p>Two channels deriving from corrugated steel pipes come to a confluence east of highway in large, low lying riparian zone. The two channels are predominantly run over sand, silt, detritus, and gravel with the north channel more defined than the south channel with some undercutting. Overhanging grasses provide cover, with some aquatic emergents, submergents, and riparian plant species present. Beaver activity may impede fish migration in north channel. Groundwater seepage does not appear to occur at this site.</p> <table><tr><td>Fish Habitat?</td><td>Direct</td></tr><tr><td>MWW (m)</td><td>2.25</td></tr><tr><td>MBW (m)</td><td>30.00</td></tr><tr><td>MWD (m)</td><td>0.50</td></tr><tr><td>MBD (m)</td><td>0.75</td></tr></table>	Fish Habitat?	Direct	MWW (m)	2.25	MBW (m)	30.00	MWD (m)	0.50	MBD (m)	0.75	Low

Photo 2. Overview of study area from west. ⬆

Fish Habitat?	Direct																
MWW (m)	2.25																
MBW (m)	30.00																
MWD (m)	0.50																
MBD (m)	0.75																
						Photo 1. View of eastern branch looking upstream. ⬆											
WB-B-M56-48	June 16th, 2015	Permanent Wetland	East of Highway 69	<p>Marsh with sedges, cattails, and sweetgale in low lying area. No connectivity. Groundwater seepage does not appear to occur here.</p> <table><tr><td>Fish Habitat?</td><td>Not habitat</td></tr><tr><td>Width (m)</td><td>71.00</td></tr><tr><td>Depth (m)</td><td>0.20</td></tr></table>	Fish Habitat?	Not habitat	Width (m)	71.00	Depth (m)	0.20	Low

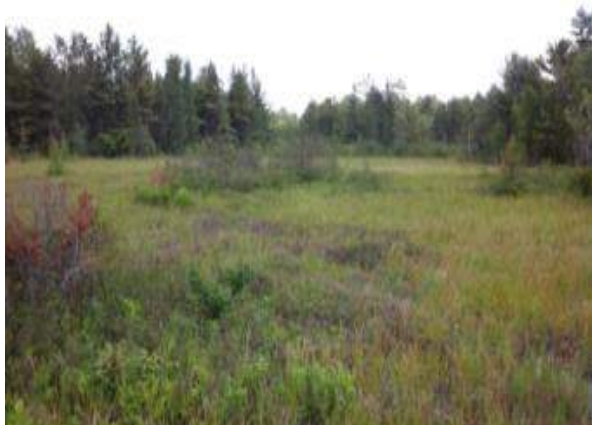
Fish Habitat?	Not habitat																
Width (m)	71.00																
Depth (m)	0.20																
						Photo 1. View of marsh from road looking east. ⬆											
WB-B-M57-44	June 19th, 2015	Permanent Wetland	East of Highway 69, waterbody flows northeast into downstream wetland. Wetland feeds Round Lake Nature Reserve.	<p>Open water wetland transitioning into fen. Downstream pond a result of beaver activity. Emergent grasses, shrubs and sedges grow in water providing cover. Substrate unknown. No groundwater indicators are present.</p> <table><tr><td>Fish Habitat?</td><td>Direct</td></tr><tr><td>Width (m)</td><td>115.00</td></tr><tr><td>Depth (m)</td><td>1.50</td></tr></table>	Fish Habitat?	Direct	Width (m)	115.00	Depth (m)	1.50	Low

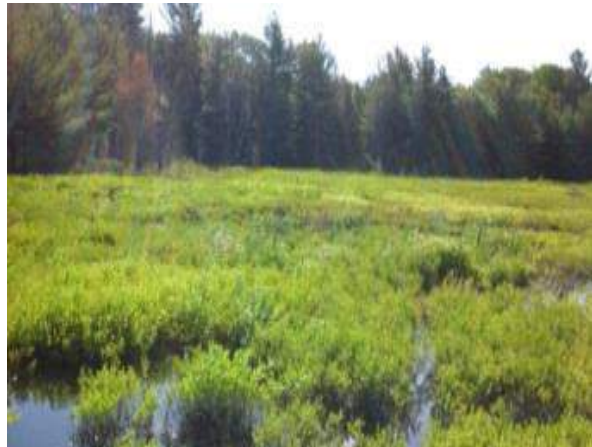
Fish Habitat?	Direct																
Width (m)	115.00																
Depth (m)	1.50																
						Photo 1. View of waterbody looking east from crossing. ⬆

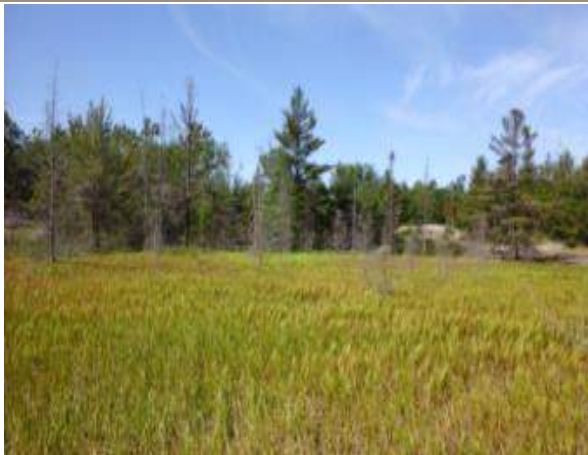
Feature ID	Investigation Date	Type of Waterbody	Description of Site	Feature Description	Feature Sensitivity									
WB-B-M57-45	June 19th, 2015	Permanent Wetland	East of Highway 69, inland bog.	<div>No open water present with ferns, sedges, and Sphagnum moss. There is no connectivity. There is no indication of groundwater seepage here.</div> <table><tr><td>Fish Habitat?</td><td>Not habitat</td></tr><tr><td>Width (m)</td><td>82.00</td></tr><tr><td>Depth (m)</td><td>0.00</td></tr></table>	Fish Habitat?	Not habitat	Width (m)	82.00	Depth (m)	0.00	Low

<p>Photo 1. View of study area looking southwest from east bank at crossing. ⬆</p>	
Fish Habitat?	Not habitat													
Width (m)	82.00													
Depth (m)	0.00													
WB-B-M58-38	July 6th, 2015	Seasonal Wetland	Meadow at crossing bordered by forest, northeast of water treatment plant	<div>Grassy moist meadow likely flooded seasonally from freshet/surface flows and from adjacent wetland. Groundwater seepage does not appear to occur here.</div> <table><tr><td>Fish Habitat?</td><td>Not habitat</td></tr><tr><td>Width (m)</td><td>21.00</td></tr><tr><td>Depth (m)</td><td>0.00</td></tr></table>	Fish Habitat?	Not habitat	Width (m)	21.00	Depth (m)	0.00	Low

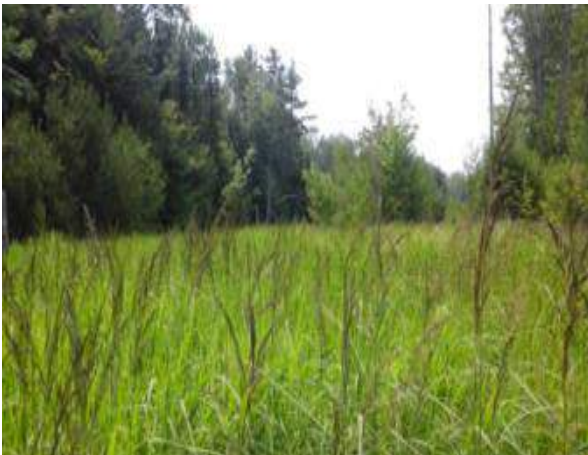
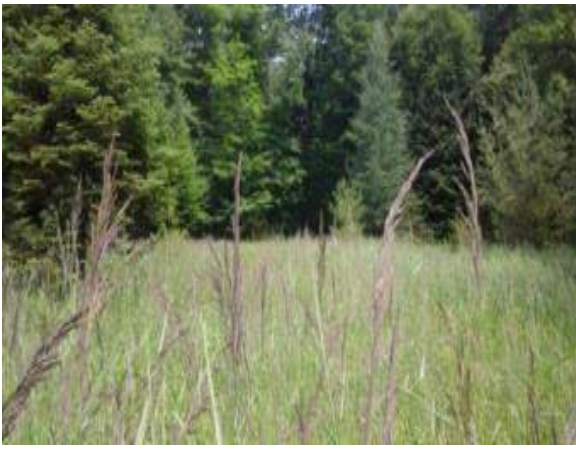
<p>Photo 1. View of study area south from crossing. ⬆</p> <p>Photo 2. View of study area north from crossing. ⬆</p>

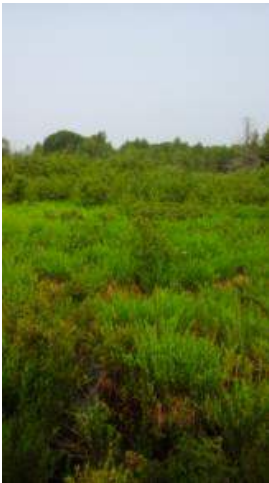
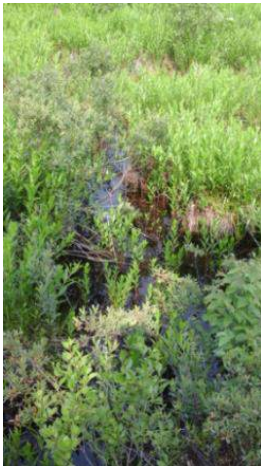
Fish Habitat?	Not habitat													
Width (m)	21.00													
Depth (m)	0.00													
WB-B-M58-39	July 6th, 2015	Permanent Wetland	East of Highway 69, north of Hoover Road	<div>Large wetland complex with interconnected channels on sphagnum mat downstream of beaver dam at Round Lake Provincial Nature Reserve. Just downstream of dam are very deep cut channels. Transmission line goes along northwest to southeast direction and splits at cl to go east-southeast as well. At deep cut channels there are narrow emergent vegetation that provide ideal pike spawning habitat. There is no indication of groundwater seepage at this site.</div> <table><tr><td>Fish Habitat?</td><td>Direct</td></tr><tr><td>Width (m)</td><td>270.00</td></tr><tr><td>Depth (m)</td><td>0.14</td></tr></table>	Fish Habitat?	Direct	Width (m)	270.00	Depth (m)	0.14	Moderate

<p>Photo 1. View of study area from southeast bank. ⬆</p> <p>Photo 2. View of channels near crossing downstream of beaver pond. ⬆</p>

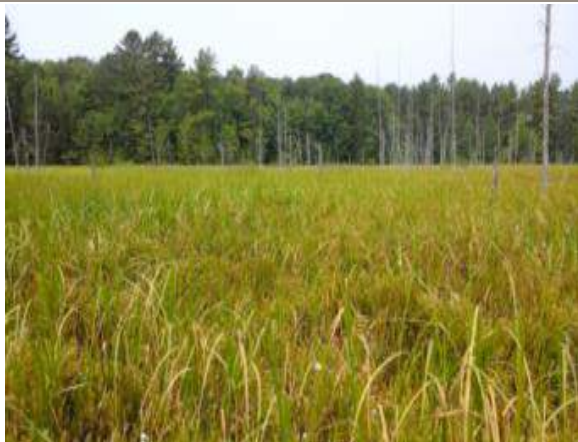
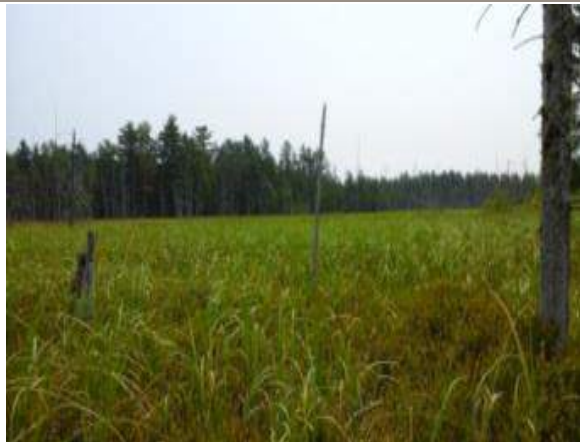
Feature ID	Investigation Date	Type of Waterbody	Description of Site	Feature Description	Feature Sensitivity								
WB-B-M59-40		Permanent Wetland	East of water treatment plant and Highway 69.	<div>Fen wetland bordered by forest/black ash, conifer swamp. No open water observed. A floating mat of vegetated sphagnum occurs. There are no indicators of groundwater seepage.</div>

Fish Habitat?	Not habitat												
Width (m)	180.00												
Depth (m)	0.00												
						Photo 1. View of study area west along crossing. ↑	Photo 2. View of study area east along crossing. ↑

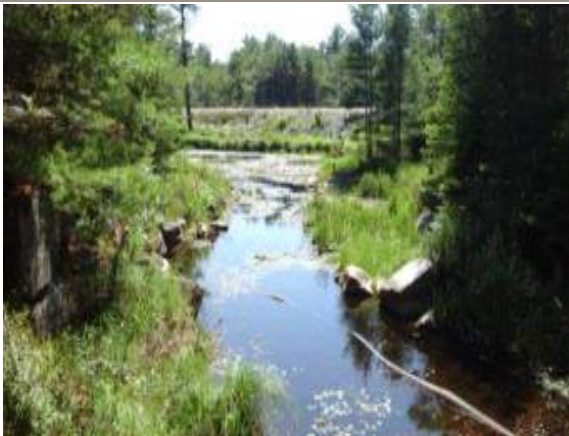
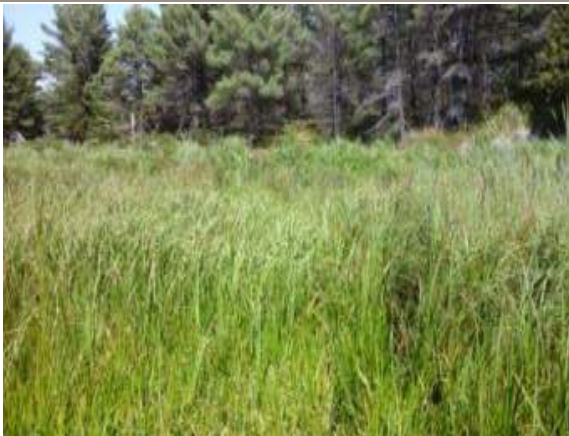
Feature ID	Investigation Date	Type of Waterbody	Description of Site	Feature Description	Feature Sensitivity												
WB-B-M53-57	July 23rd. 2015	Permanent Pond	East of Highway 69, south of Shawanaga Reserve	<p>Standing pond of water between beaver dams. Heavily vegetated bedrock shorelines. Detritus over bedrock boulder. Downstream of beaver dam is trickle of water through marsh meadow to highway CSP. No fish passage through dam. Fish observed in pond just upstream of study area. No indication of groundwater seepage occurs here.</p> <table><tr><td>Fish Habitat?</td><td>Direct</td></tr><tr><td>Width (m)</td><td>15.00</td></tr><tr><td>Depth (m)</td><td>0.60</td></tr></table>	Fish Habitat?	Direct	Width (m)	15.00	Depth (m)	0.60	Low

Fish Habitat?	Direct																
Width (m)	15.00																
Depth (m)	0.60																
						Photo 1. View of downstream from upstream limit of study area ↑	Photo 2. View of marsh meadow below beaver dam near downstream limit. ↑

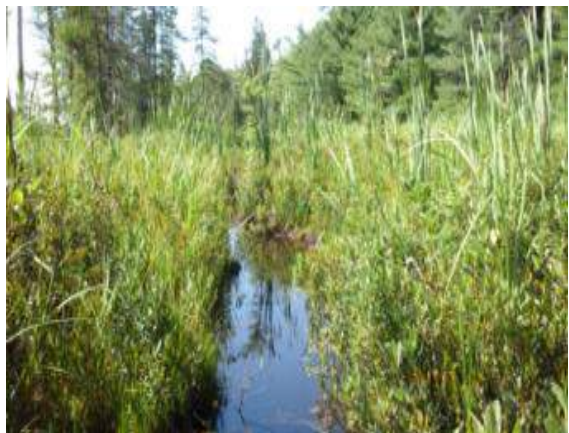
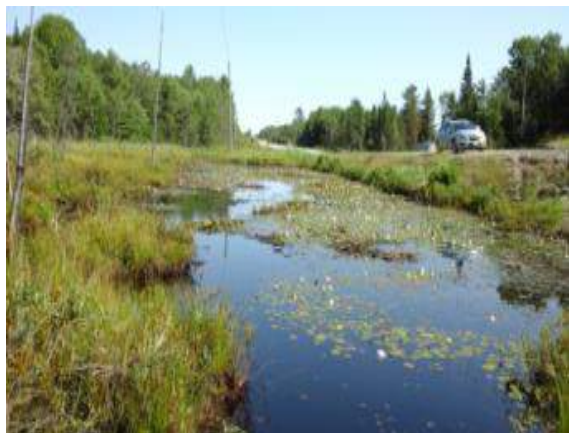
WB-B-M53-58	July 23rd. 2015	Permanent Wetland	East of Highway 69, south of Shawanaga Reserve	<p>Pooled water adjacent to highway is drained by channel in fen that connects to wetland on west side of highway by a csp. Open water is bordered by floating mat with wetland vegetation. Substrate is detritus. There is no indication of groundwater seepage. Open water consists of flats and pools. Groundwater seepage does not appear to occur here.</p> <table><tr><td>Fish Habitat?</td><td>Direct</td></tr><tr><td>Width (m)</td><td>130.00</td></tr><tr><td>Depth (m)</td><td>0.80</td></tr></table>	Fish Habitat?	Direct	Width (m)	130.00	Depth (m)	0.80	Low

Fish Habitat?	Direct																
Width (m)	130.00																
Depth (m)	0.80																
						Photo 1. View of channel through fen. ↑	Photo 2. View of open water pocket in fen between crossing and highway, facing south from northern limit of study area. ↑

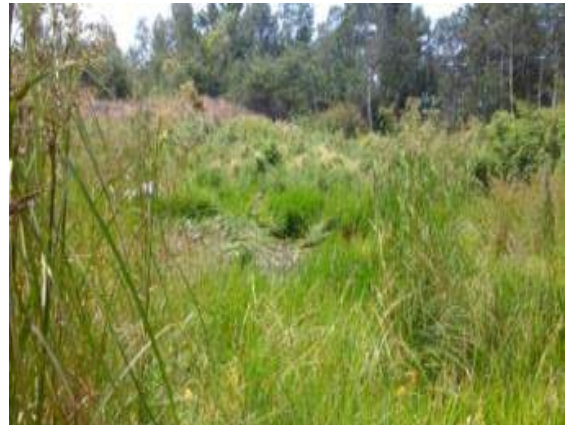
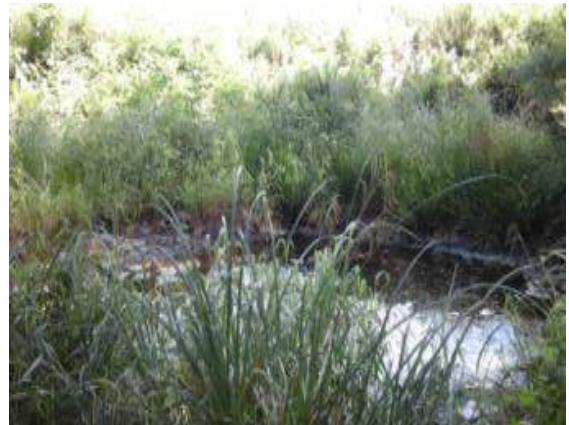
WB-B-M54-55	N/A	Unknown	Site not assessed	N/A	Unknown	No photographs available.											
WB-B-M54-56	July 23rd, 2015	Intermittent Stream	East of Highway 69, south of Shawanaga Reserve. Surrounded by forested bedrock, beaver pond upstream. Downstream scrub meadow between bedrock. Water flows in southwest direction	<p>Dry, intermittent watercourse draining from upstream beaver pond. Dry, poorly defined channel in upstream section. Downstream is a swale with moist soils, no defined channel, and water-tolerant terrestrial vegetation. Fish habitat is located in upstream beaver pond only. Intermittent flow only through remainder of site (or small stagnant pockets). Downstream of centreline a series of beaver dams (3) with small, stagnant pockets of water choked with vegetation in between are not likely to support fish. There are no indicators of groundwater seepage at this site.</p> <table><tr><td>Fish Habitat?</td><td>Direct</td></tr><tr><td>MWW (m)</td><td>45.00</td></tr><tr><td>MBW (m)</td><td>46.20</td></tr><tr><td>MWD (m)</td><td>0.75</td></tr><tr><td>MBD (m)</td><td>0.82</td></tr></table>	Fish Habitat?	Direct	MWW (m)	45.00	MBW (m)	46.20	MWD (m)	0.75	MBD (m)	0.82	Low

Fish Habitat?	Direct																
MWW (m)	45.00																
MBW (m)	46.20																
MWD (m)	0.75																
MBD (m)	0.82																
						Photo 1. General view of watercourse looking west from crossing. ↑	Photo 2. View of upstream beaver dam and stagnant pool between two dams ↑

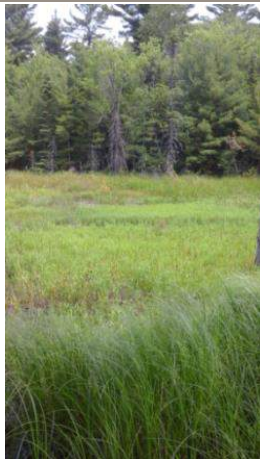
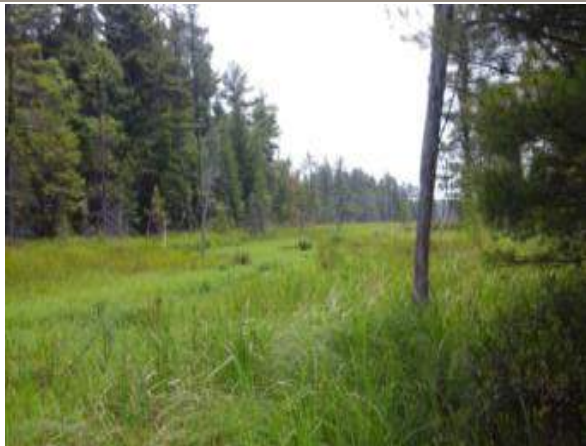
Feature ID	Investigation Date	Type of Waterbody	Description of Site	Feature Description	Feature Sensitivity												
WB-B-M59-41	July 6th, 2015	Permanent Wetland	East of Highway 69, north of Hoover Road	<p>Braided channel in low lying saturated area between forested bedrock with very deep cut active channels. Floating vegetation, detritus, and algae provide cover in-stream, and overhanging grasses provide shade, but there is little canopy cover provided by trees. Substrate is unknown. No groundwater indicators were observed.</p> <table><tr><td>Fish Habitat?</td><td>Direct</td></tr><tr><td>Width (m)</td><td>34.00</td></tr><tr><td>Depth (m)</td><td>0.60</td></tr></table>	Fish Habitat?	Direct	Width (m)	34.00	Depth (m)	0.60	Low

Fish Habitat?	Direct																
Width (m)	34.00																
Depth (m)	0.60																
						Photo 1. View of crossing from west bank. ⬆	Photo 2. View of study area downstream of crossing from west bank. ⬆

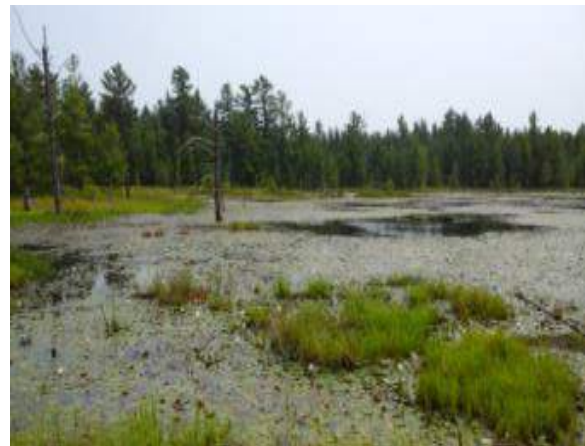
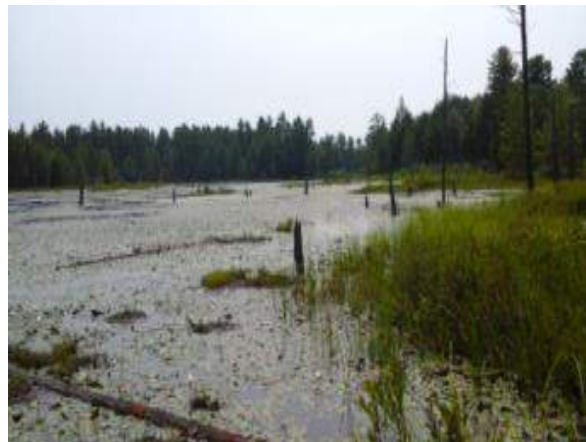
WB-B-M59-32	July 6th, 2015	Permanent Pond	Open water pond bordered by forest east of Highway 69	<p>Heavily vegetated open water pond with shore fen border, vegetated hummocks. Abundant floating vegetation provides cover in addition to detritus over bedrock. No groundwater indicators observed.</p> <table><tr><td>Fish Habitat?</td><td>Direct</td></tr><tr><td>Width (m)</td><td>180.00</td></tr><tr><td>Depth (m)</td><td>1.00</td></tr></table>	Fish Habitat?	Direct	Width (m)	180.00	Depth (m)	1.00	Low

Fish Habitat?	Direct																
Width (m)	180.00																
Depth (m)	1.00																
						Photo 1. View of pond looking east from north bank. ⬆	Photo 2. View of pond looking southwest from crossing on north bank. ⬆										
WB-B-M60-22	July 6th, 2015	Permanent Stream	North of Hoover Road, east of Highway 69, water flows west, parallel to Hoover Road	<p>Slow-moving flats in dammed, vegetated channel is bordered by forest. Substrate consists of detritus, muck, silt, and boulders. Riparian trees provide little shade while floating emergents and sedges provide in-stream cover. There is no indication of groundwater seepage at this site.</p> <table><tr><td>Fish Habitat?</td><td>Direct</td></tr><tr><td>MWW (m)</td><td>22.30</td></tr><tr><td>MBW (m)</td><td>22.80</td></tr><tr><td>MWD (m)</td><td>0.86</td></tr><tr><td>MBD (m)</td><td>0.96</td></tr></table>	Fish Habitat?	Direct	MWW (m)	22.30	MBW (m)	22.80	MWD (m)	0.86	MBD (m)	0.96	Low

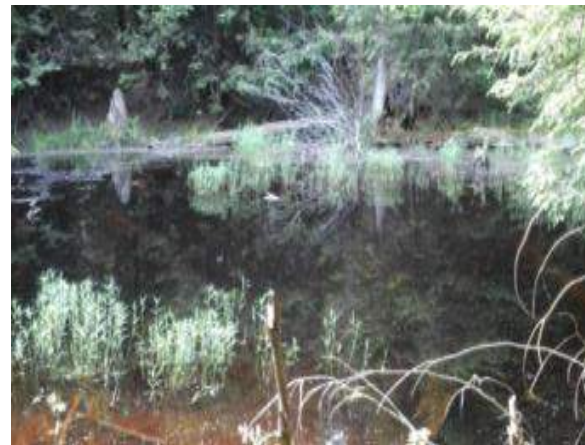
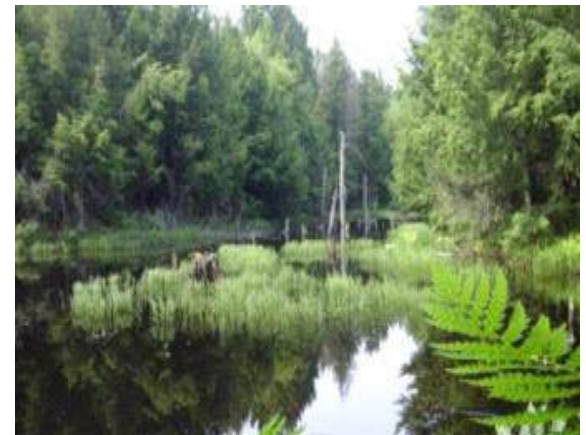
Fish Habitat?	Direct																
MWW (m)	22.30																
MBW (m)	22.80																
MWD (m)	0.86																
MBD (m)	0.96																
						Photo 1. View of study area looking northwest from crossing. ⬆	Photo 2. View of study area from downstream limit. ⬆

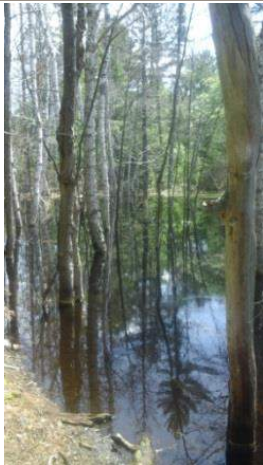
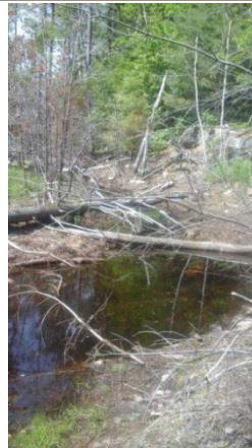
Feature ID	Investigation Date	Type of Waterbody	Description of Site	Feature Description	Feature Sensitivity												
WB-B-M61-26	June 22nd, 2015	Permanent Stream	North of Hoover Road, water flows south perpendicular to road	<p>Series of beaver ponds flowing south. Low relief banks gently slope into watercourse without defined banks. Low flow over detritus, muck and silt create flats. Plenty of fallen trees and snags create structure. Low to moderate shade is provided due to dead trees. Pond adjacent to road is drained by a 4 inch PVC pipe. No indicators of groundwater seepage are present.</p> <table><tr><td>Fish Habitat?</td><td>Direct</td></tr><tr><td>MWW (m)</td><td>31.20</td></tr><tr><td>MBW (m)</td><td>35.30</td></tr><tr><td>MWD (m)</td><td>0.80</td></tr><tr><td>MBD (m)</td><td>1.40</td></tr></table>	Fish Habitat?	Direct	MWW (m)	31.20	MBW (m)	35.30	MWD (m)	0.80	MBD (m)	1.40	Low

Fish Habitat?	Direct																
MWW (m)	31.20																
MBW (m)	35.30																
MWD (m)	0.80																
MBD (m)	1.40																
						Photo 1. View of downstream from upstream limit on east bank. ⬆	Photo 2. View of upstream from downstream limit on east bank. ⬆										
WB-B-M62-29	June 22nd, 2015	Permanent Stream	South of Hoover Road, water flows southeast perpendicular from road	<p>Southward flowing creek, flows beneath road from swamp, through forest, to open wet meadow. Low flows over muck and silt with high canopy coverage may not be suitable for fish due to low flows (terrestrial vegetation growing in-stream) and thick, gelatinous red-brown algae. Fallen trees create ledges that help to aerate watercourse. No indication of groundwater seepage present.</p> <table><tr><td>Fish Habitat?</td><td>Direct</td></tr><tr><td>MWW (m)</td><td>1.10</td></tr><tr><td>MBW (m)</td><td>2.70</td></tr><tr><td>MWD (m)</td><td>0.10</td></tr><tr><td>MBD (m)</td><td>0.30</td></tr></table>	Fish Habitat?	Direct	MWW (m)	1.10	MBW (m)	2.70	MWD (m)	0.10	MBD (m)	0.30	Low

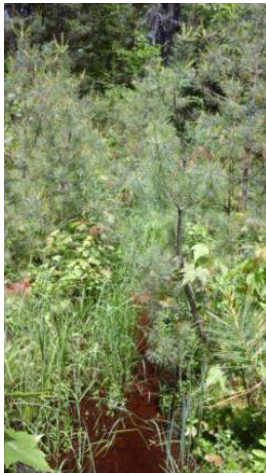
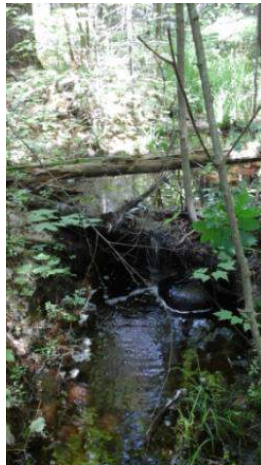
Fish Habitat?	Direct																
MWW (m)	1.10																
MBW (m)	2.70																
MWD (m)	0.10																
MBD (m)	0.30																
						Photo 1. View of upstream from downstream limit. ⬆	Photo 2. View of ledge barrier obstructing fish passage. ⬆										
WB-B-M62-30	June 22nd, 2015	Permanent Stream	South of Hoover Road, water flows southeast perpendicular from road	<p>Small brook crosses road and flows in south west direction. No migration upstream due to beaver dam south of centreline. Channel flows into open floodplain with lots of grasses. Low to moderate flows over gravel, sand, silt and bedrock give way to mixed morphological structure. High cover is present due to overhanging grasses. No indicators of groundwater present.</p> <table><tr><td>Fish Habitat?</td><td>Direct</td></tr><tr><td>MWW (m)</td><td>0.30</td></tr><tr><td>MBW (m)</td><td>2.50</td></tr><tr><td>MWD (m)</td><td>0.18</td></tr><tr><td>MBD (m)</td><td>0.38</td></tr></table>	Fish Habitat?	Direct	MWW (m)	0.30	MBW (m)	2.50	MWD (m)	0.18	MBD (m)	0.38	Low

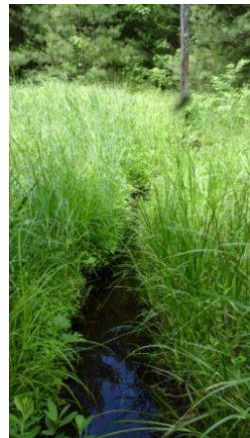
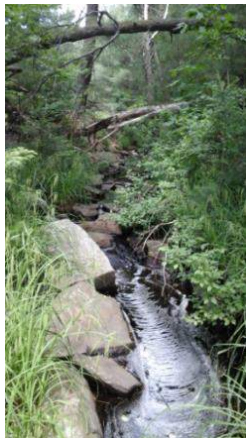
Fish Habitat?	Direct																
MWW (m)	0.30																
MBW (m)	2.50																
MWD (m)	0.18																
MBD (m)	0.38																
						Photo 1. View of downstream from upstream limit. ⬆	Photo 2. View of upstream from downstream limit. ⬆

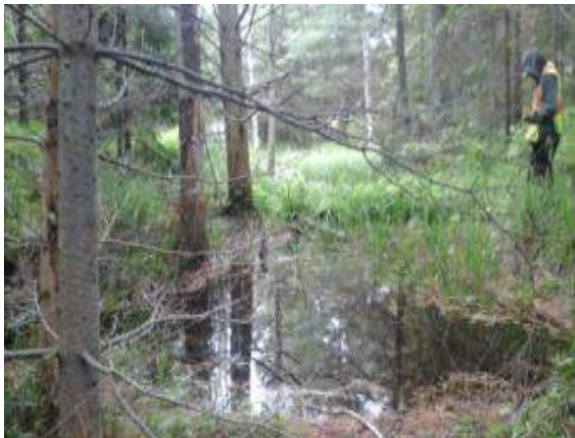
<p>Photo 1. General view of watercourse facing upstream (southwest) from crossing. ⬆</p>

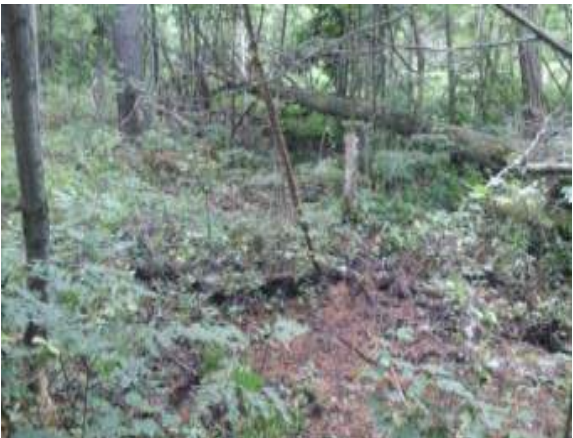
<p>Photo 2. General view of dry channel downstream of crossing, facing southeast. ⬆</p>

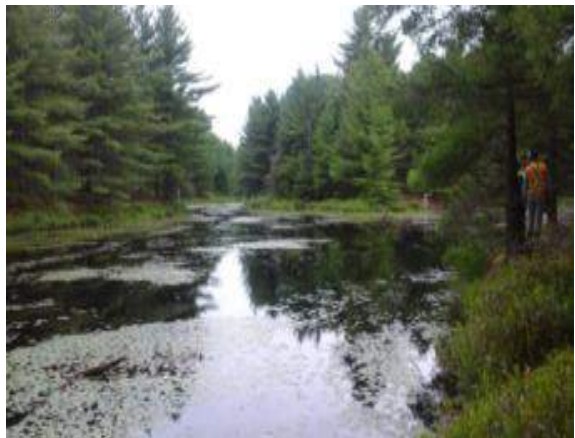
<p>Photo 1. View of western limit of study area, facing north on south bank. ⬆</p>

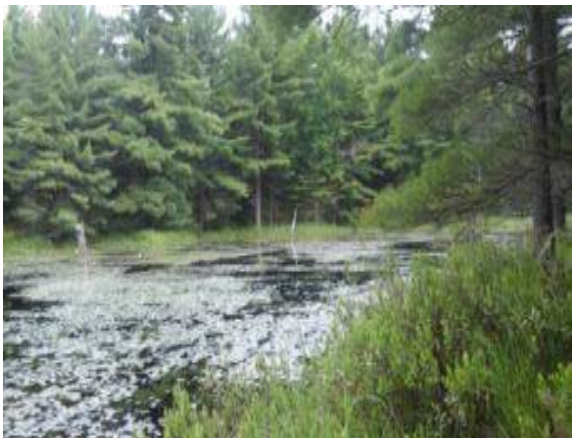
<p>Photo 2. View of study area from south bank at crossing looking east. ⬆</p>				
Fish Habitat?	Direct																
Width (m)	42.00																
Depth (m)	2.00

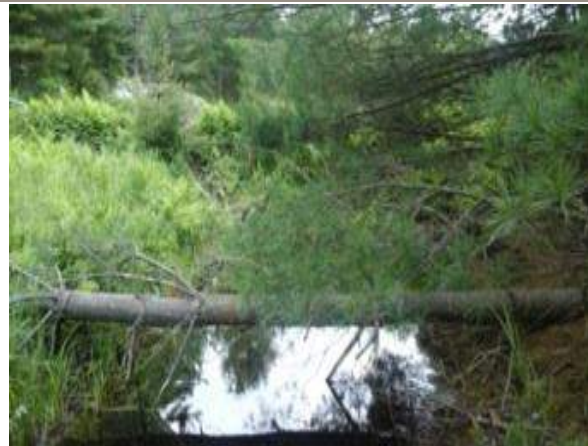
<p>Photo 1. View of watercourse and beaver dam upstream from crossing. ⬆</p>

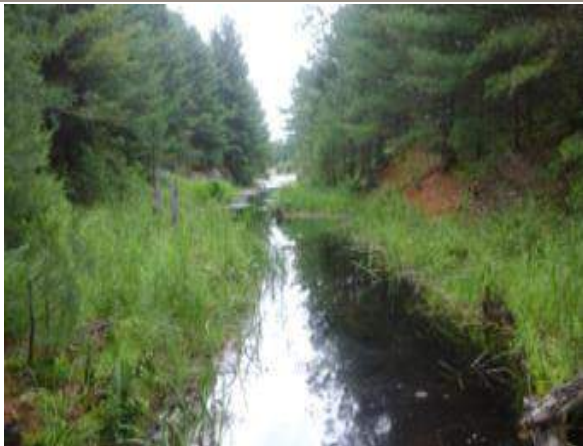
<p>Photo 2. View of watercourse downstream from crossing. ⬆</p>
