Henvey Inlet Wind Transmission Line

Appendix B6. Route B Waterbodies, Fish Habitat and Aquatic Ecosystems Environmental Baseline Report

AECOM

September 2015

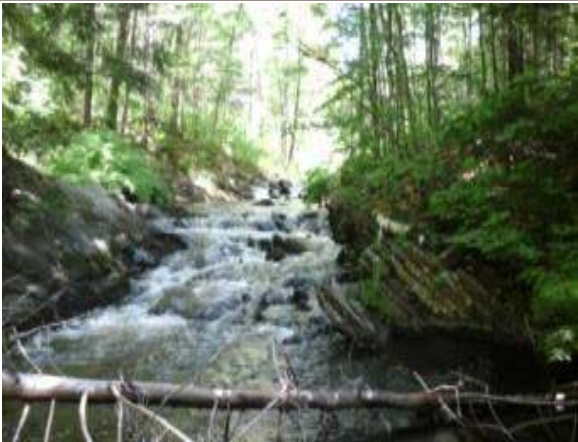
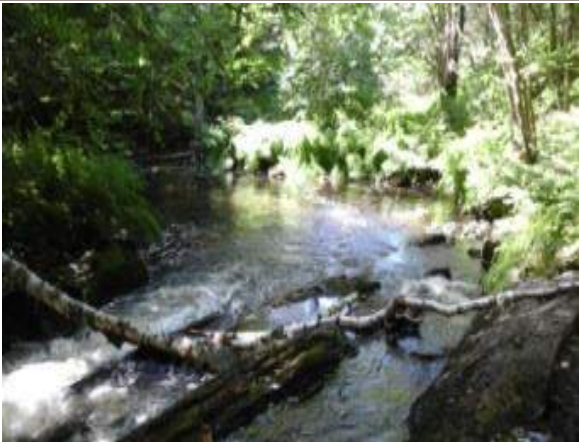
Feature ID	Investigation Date	Type of Waterbody	Description of Site	Feature Description	Feature Sensitivity												
WB-B-M72-13	June 22nd, 2015	Permanent Stream	South of Long Lake Estates Road and Highway 124	<p>Fast flowing rapids with riffle/run/pool sequences over coarse substrate. Aerated, clean coarse substrates (cobble gravel boulder) at base of riffle 50 m downstream of crossing is suitable spawning habitat for walleye, or maybe white sucker. Overhanging trees provide high coverage. High velocity and slope may impede passage for fish with low burst speed. There is no indication of groundwater seepage present.</p> <table><tr><td>Fish Habitat?</td><td>Direct</td></tr><tr><td>MWW (m)</td><td>11.00</td></tr><tr><td>MBW (m)</td><td>13.00</td></tr><tr><td>MWD (m)</td><td>0.40</td></tr><tr><td>MBD (m)</td><td>0.60</td></tr></table>	Fish Habitat?	Direct	MWW (m)	11.00	MBW (m)	13.00	MWD (m)	0.40	MBD (m)	0.60	Moderate

Fish Habitat?	Direct																
MWW (m)	11.00																
MBW (m)	13.00																
MWD (m)	0.40																
MBD (m)	0.60																
						Photo 1. View of upstream from crossing. ⬆	Photo 2. View of downstream from crossing. ⬆										
WB-B-M73-11	June 22nd, 2015	Permanent Pond	East of hydro corridor south of Pinewood Drive, east of Bell Lake	<p>Large oval pond stretching east to west. Proposed transmission line cuts approx. 30 m north northwest to south southeast across pond. Some fallen logs in water, providing shade for aquatic species. Very old stumps. Dammed to the west. Standing snags, fallen logs and aquatic vegetation provide cover. Detritus assumed to be substrate. No groundwater indicators are present.</p> <table><tr><td>Fish Habitat?</td><td>Direct</td></tr><tr><td>Width (m)</td><td>30.00</td></tr><tr><td>Depth (m)</td><td>1.50</td></tr></table>	Fish Habitat?	Direct	Width (m)	30.00	Depth (m)	1.50	Low

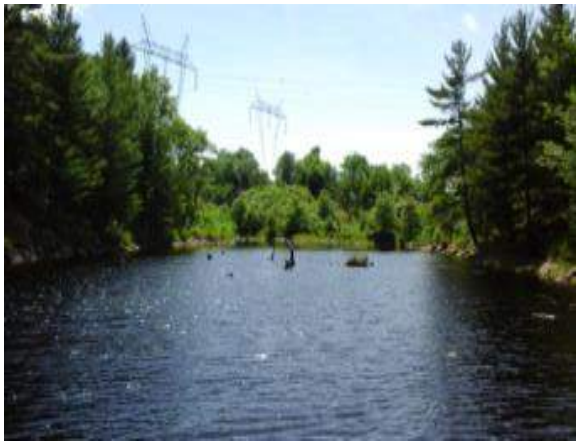
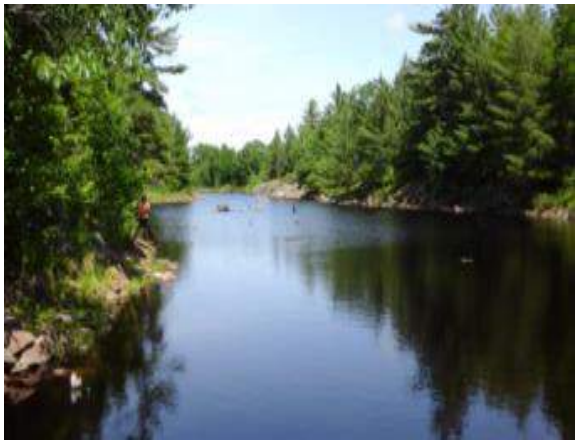
Fish Habitat?	Direct																
Width (m)	30.00																
Depth (m)	1.50																
						Photo 1. View of eastern limit of survey, facing west toward crossing. ⬆	Photo 2. View of western limit of survey, facing east toward crossing. ⬆										
WB-B-M73-12	June 22nd, 2015	Permanent Wetland	East of hydro corridor, south of Long Lake Estates Road.	<p>Pond bordered by scrub land with occasional saturated areas with cattail. Lots of fragrant white water lilies, pickerel weed, meadowsweet, sweet gale, cattails, blueberries and marsh cinque-foil. Wetland bordered by upland forest. DO is low but cyprinids were observed. No indication of groundwater is present.</p> <table><tr><td>Fish Habitat?</td><td>Direct</td></tr><tr><td>Width (m)</td><td>45.00</td></tr><tr><td>Depth (m)</td><td>1.00</td></tr></table>	Fish Habitat?	Direct	Width (m)	45.00	Depth (m)	1.00	Low

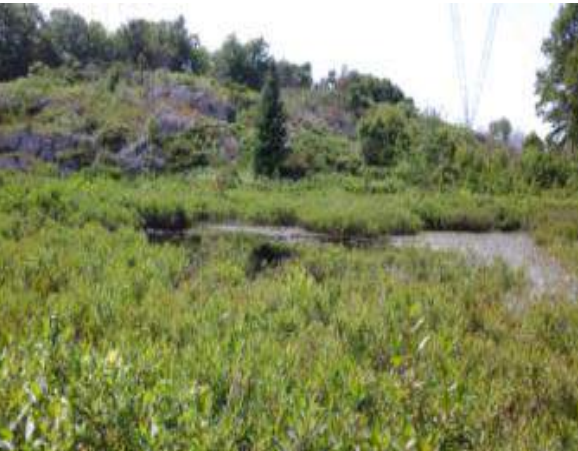
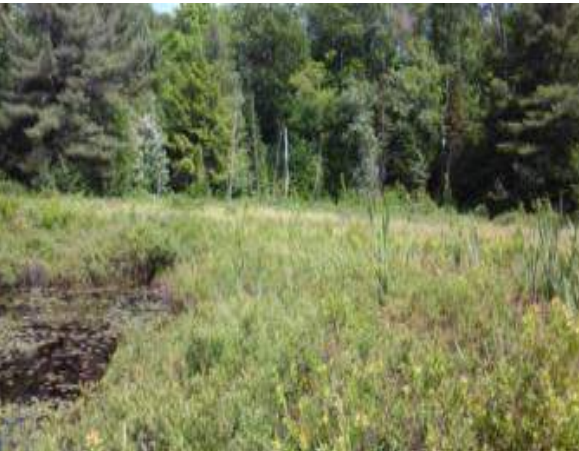
Width (m)	45.00																
Depth (m)	1.00																
						Photo 1. View of northwest wetland at crossing. ⬆	Photo 2. View of southeast wetland at crossing. ⬆

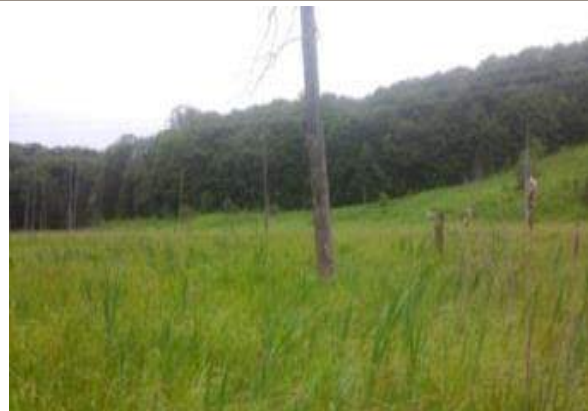
Depth (m)	0.00																
						Photo 1. View of wet meadow from the east. ⬆											
WB-B-M78-6	June 23rd, 2015	Intermittent Wetland	East of hydro corridor, south of McDougall Road	<p>Low-lying forest floor collects overland flow. Mostly damp with intermittent pools. Creek to the northeast but not in study area. No groundwater indicators present.</p> <table><tr><td>Fish Habitat?</td><td>Not habitat</td></tr><tr><td>Width (m)</td><td>110.00</td></tr><tr><td>Depth (m)</td><td>0.05</td></tr></table>	Fish Habitat?	Not habitat	Width (m)	110.00	Depth (m)	0.05	Low

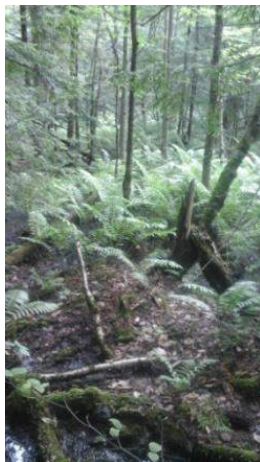
Fish Habitat?	Not habitat																
Width (m)	110.00																
Depth (m)	0.05																
						Photo 1. View of swamp from west bank. ⬆

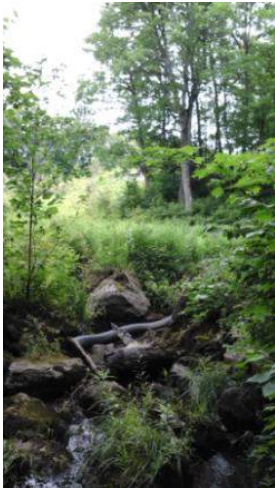
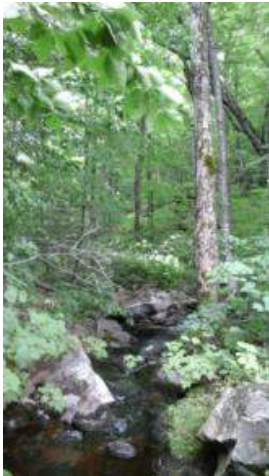
Feature ID	Investigation Date	Type of Waterbody	Description of Site	Feature Description	Feature Sensitivity												
WB-B-M79-4	June 23rd, 2015	Permanent Stream	North of Highway 518 along hydro corridor	<p>Stream morphology changes east and west of centreline. To the west of centreline, watercourse meanders through grassy meadow under hydro corridor. Sand and gravel substrate and overhanging grasses dominate watercourse. To the east of the centreline, watercourse flows through forested area with boulders, cobbles, sand and gravel. Trees dominate canopy, giving lots of shade to stream. Natural riffles and pools created by boulders in watercourse. There is no indication of groundwater seepage present.</p> <table><tr><td>Fish Habitat?</td><td>Direct</td></tr><tr><td>MWW (m)</td><td>2.40</td></tr><tr><td>MBW (m)</td><td>2.54</td></tr><tr><td>MWD (m)</td><td>0.12</td></tr><tr><td>MBD (m)</td><td>0.24</td></tr></table>	Fish Habitat?	Direct	MWW (m)	2.40	MBW (m)	2.54	MWD (m)	0.12	MBD (m)	0.24	Low

Fish Habitat?	Direct																
MWW (m)	2.40																
MBW (m)	2.54																
MWD (m)	0.12																
MBD (m)	0.24																
<p>Photo 1. View of upstream of crossing. ⬆</p> <p>Photo 2. View of downstream of crossing. ⬆</p>																	
WB-B-M80-2	June 23rd, 2015	Seasonal Wetland	North of Highway 518 and east of hydro corridor	<p>Low-lying area with moist soils and water-tolerant terrestrial vegetation. No open water or evidence of channel or flow. Seasonal drainage, not likely to support fish. No evidence of groundwater present.</p> <table><tr><td>Fish Habitat?</td><td>Not habitat</td></tr><tr><td>Width (m)</td><td>10.00</td></tr><tr><td>Depth (m)</td><td>0.00</td></tr></table>	Fish Habitat?	Not habitat	Width (m)	10.00	Depth (m)	0.00	Low

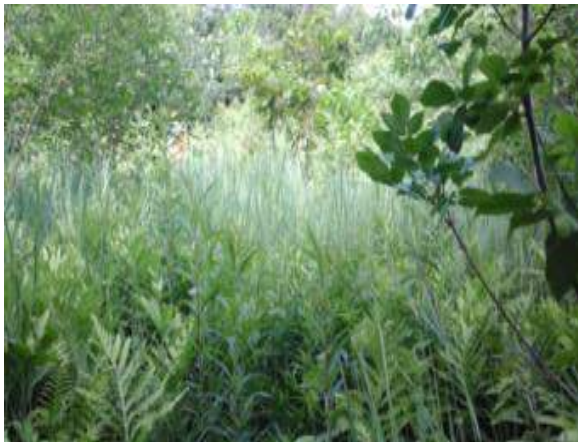
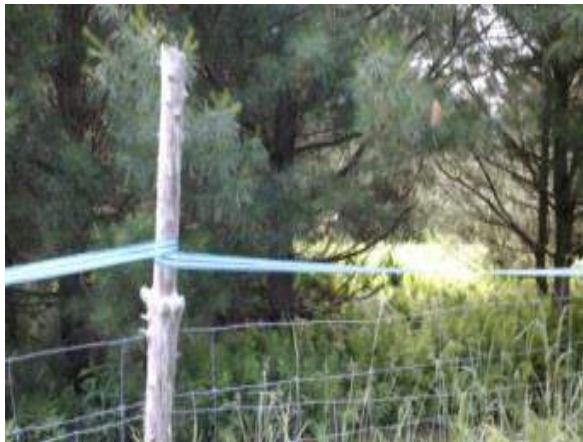
Fish Habitat?	Not habitat																
Width (m)	10.00																
Depth (m)	0.00																
<p>Photo 1. View of study area west from crossing. ⬆</p> <p>Photo 2. View of study area east from crossing. Fence is private property delineation. ⬆</p>

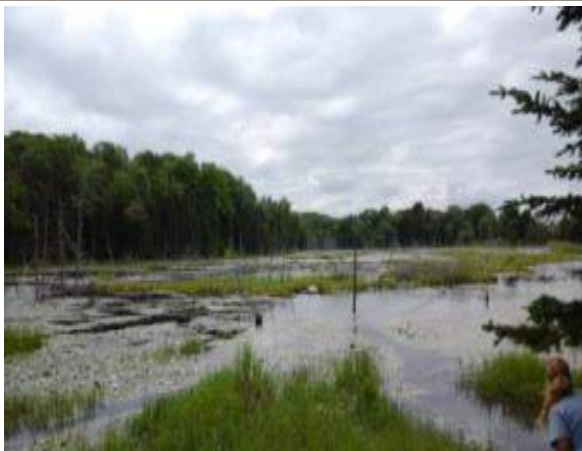
WB-B-M80-2-2	June 23rd, 2015	Permanent Wetland	North of Highway 518 along hydro corridor	<p>Large wetland on private property, lots of aquatic vegetation provides cover along with some standing snags. Substrate unknown but likely to be dominated by detritus. No indication of groundwater seepage.</p> <table><tr><td>Fish Habitat?</td><td>Direct</td></tr><tr><td>Width (m)</td><td>80.00</td></tr><tr><td>Depth (m)</td><td>1.00</td></tr></table>	Fish Habitat?	Direct	Width (m)	80.00	Depth (m)	1.00	Low

Fish Habitat?	Direct																
Width (m)	80.00																
Depth (m)	1.00																
<p>Photo 1. View of study area from western limit facing east. ⬆</p>

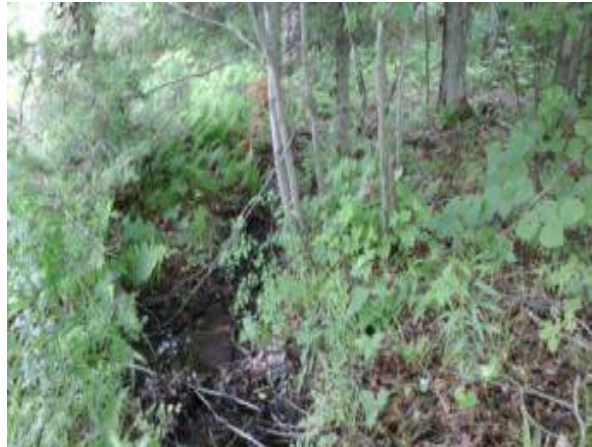
Fish Habitat?	Indirect																
MWW (m)	0.10																
MBW (m)	0.50																
MWD (m)	0.02																
MBD (m)	0.18																
						<p>Photo 1. View from west of property line, looking east along channel ↗</p>	<p>Photo 2. View of moist overland drainage within hydro corridor facing northeast ↗</p>

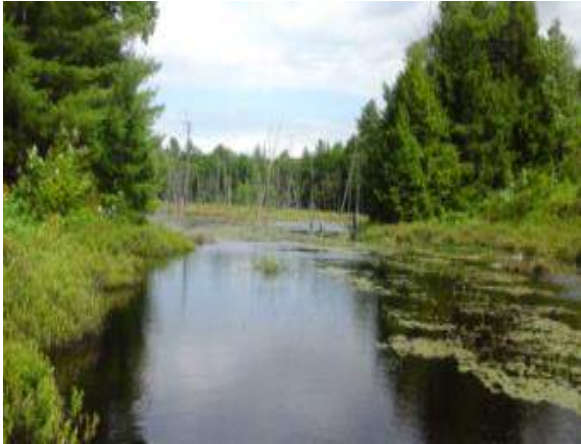
Fish Habitat?	Direct												
Width (m)	30.00												
Depth (m)	1.00												
						<p>Photo 1. View of study area facing east from western limit. ↑</p>	<p>Photo 2. View of study area facing west from eastern limit. ↑</p>
