Heritage Impact Assessment, Grand Renewable Energy Park, Haldimand County, ON

HERITAGE IMPACT ASSESSMENT, GRAND RENEWABLE ENERGY PARK, HALDIMAND COUNTY, ON – FINAL REPORT

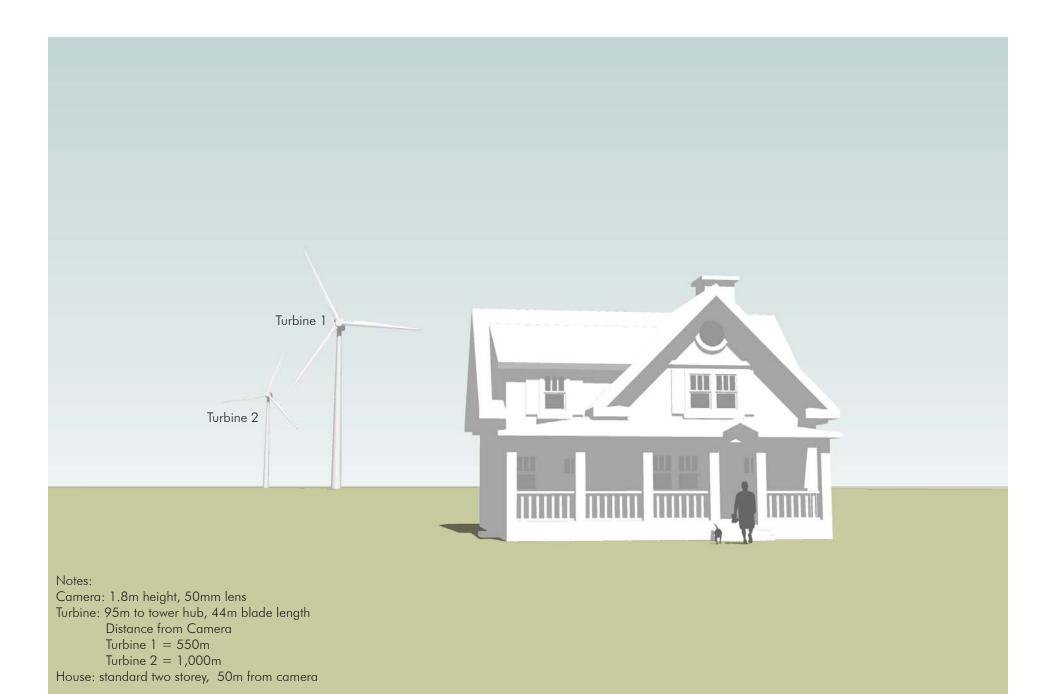
WIND TURBINE SCALE SCHEMATIC, MARCH 2011

As discussed in Section 1.2, this assessment includes all significant resources located within 1km of visible Project components. The distance of wind turbines to significant resources, in particular, was considered to be an important factor in the measurement of potential negative impacts. Visual Aid 1 illustrates the scale of a wind turbine in relation to a typical 2 storey residential building at distances of 550m and 1000m.

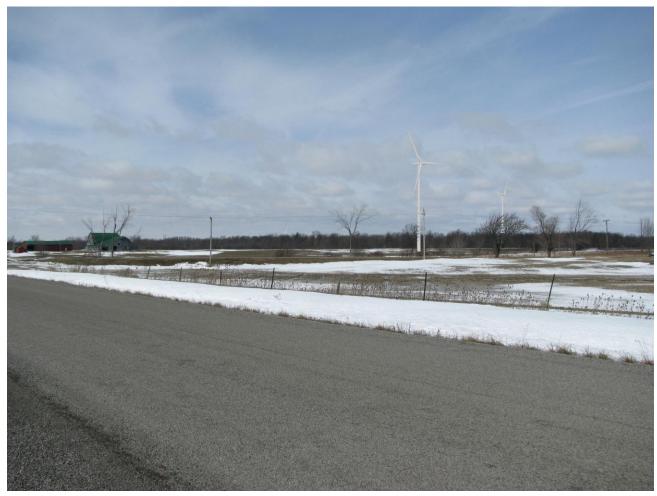
Visual Aid 3 Simulated view from Bethel Cemetery facing northwest towards Turbines #20 and #24

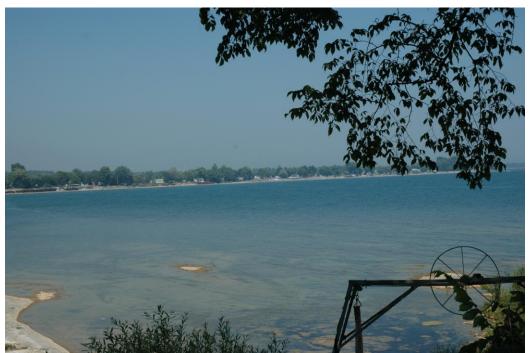
Photograph 6 View of east end of Lakeshore Road CHL as seen from near Haldimand Road 50, facing southeast.

Important views to be conserved include: views from the road to the houses and cottages along either side, beneath the canopy; and views from the road to the lake (Photographs 1, 2, 4 and 5). Visual Aid 4 shows the location from which Photograph 6 was taken. The location indicated on the map is a rare vantage point from which the shoreline can be viewed from within the CHL without being blocked by trees. Although Turbines 1, 3, 6, 8, 54 and 69 are located approximately 2000 m from the vantage point, it is unlikely that they will be visible as a result of trees north of the vantage point. Turbines that may be within the viewshed include Turbines 65, 66 and 67, which are located approximately 7000 m east-northeast of the vantage point (Visual Aid 4). At a distance of 7000 m

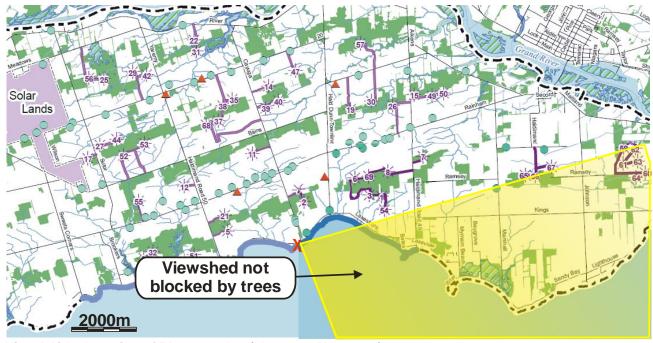
Visual Aid 4 Location of Photograph 6 (shown as X on map)

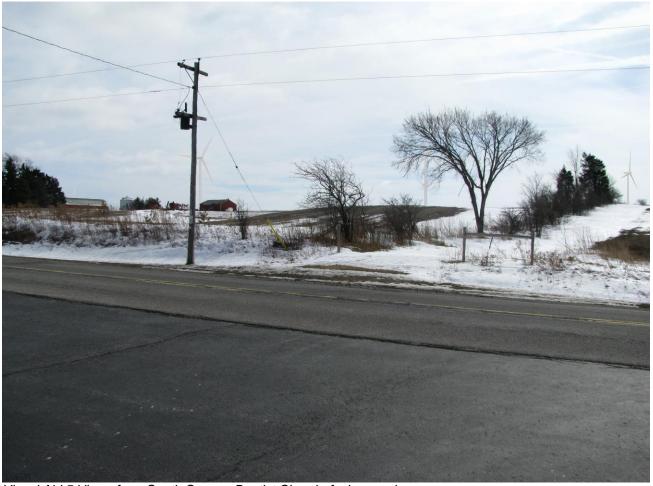
Visual Aid 5 Views from South Cayuga Baptist Church, facing south

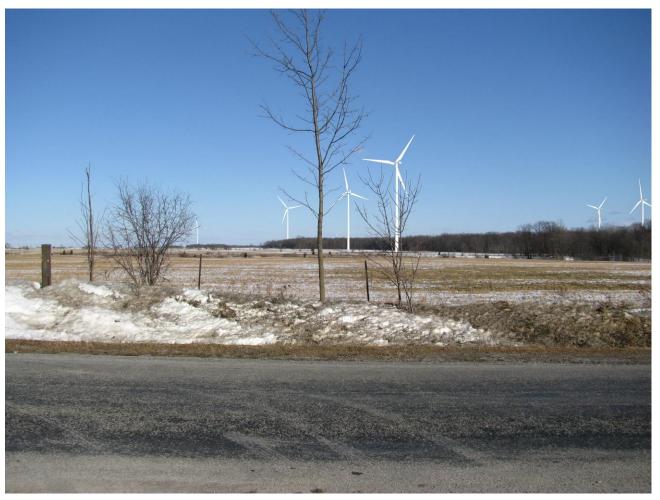
Visual Aid 6 View from Hald-Dunn Townline at St. John's Anglican Church, facing east

The CHL of St. John's Anglican Church and Cemetery is located within a 1 km radius of Project components, but not within the 500 m zone of influence. The church property is lined with trees which link the CHL to the surrounding area and will act to soften views of Turbine 4, which will be visible to the west of St. John's from some, but not all, angles (Figure 4-13).

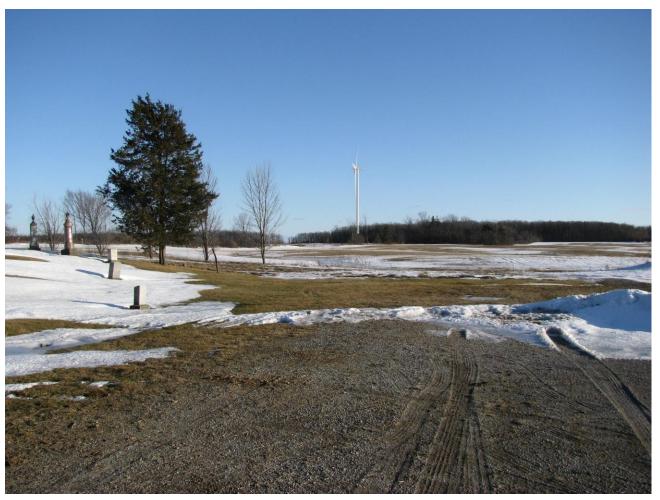
Visual Aid 7 View from Dunn United Church, facing south.

When viewing Dunn United Church from Regional Road 20, it may be possible to see Turbines 19 and 30 in the background to the south and south east respectively. Both turbines are located directly alongside wooded lots and are more than 1 km away from Dunn United (Figure 4-14). As a result of the distance, the scale should be such that the turbines have little impact on the visual integrity of the Dunn United CHL.

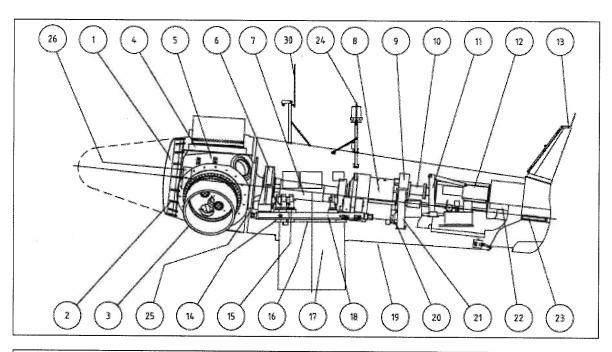
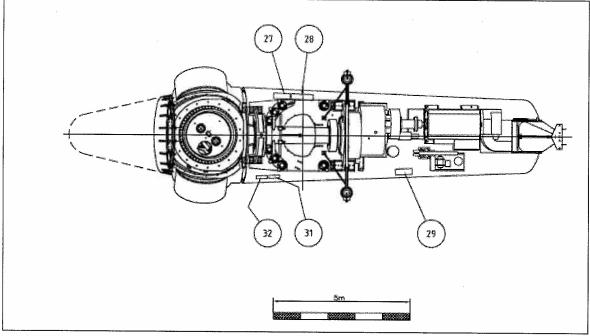
SWT-2.3-101 **Nacelle Arrangement**

| Dan | sk | Eng | lish | Deu | tsch |
|---|---|---|---|---|--|
| 1. | Spinner, option: lang spinner | 1. | Spinner, optional long spinner | 1. | Spinner, Option: langer Spinner |

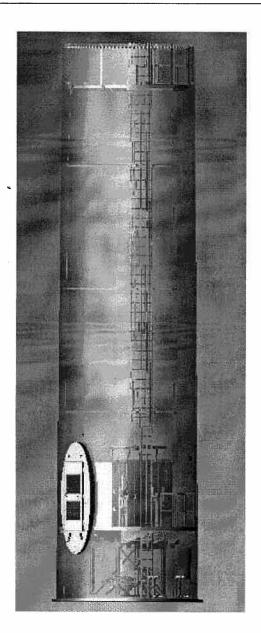
SWT-2.3-101 60 Hz 80m, General Tower Arrangement
Document ID: E R WP-EN-25-0000-0004-00
DSR / 13.01.2010 Confidential

Top Section

Intermediate Section

Bottom Section

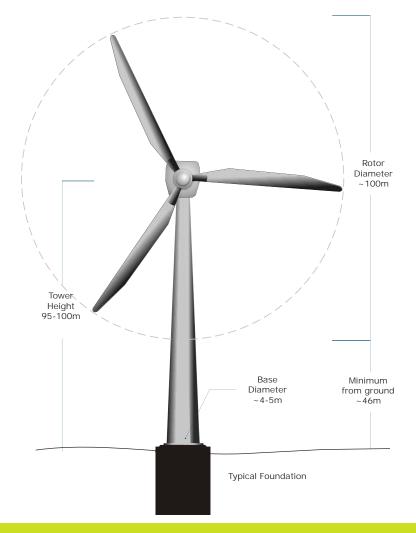
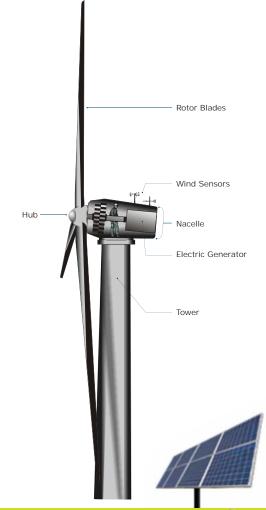
- Turbine technology (i.e., make and model) will be selected during the Renewable Energy Approval process.
- Schematic at right shows generalized turbine components and dimensions.
- Final design selected for Project may vary from schematic.

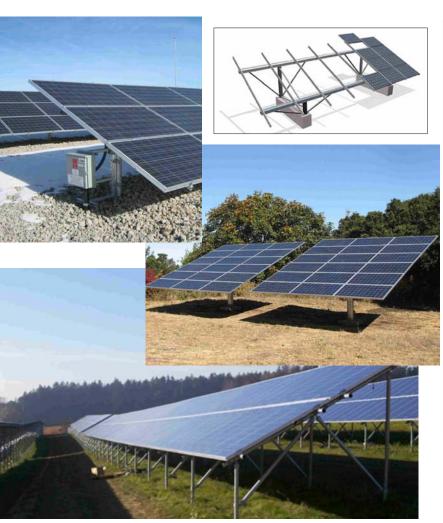
Typical Solar Panel Schematic and Photos

- Solar panels will utilize crystalline solar cells mounted on ground-based racking systems.
- Solar panel and mounting (i.e., single post, double post, or ballast mount) technology will be selected during the Renewable Energy Approval process.
- Schematics and photos at right show a variety of panel types and mounting designs.

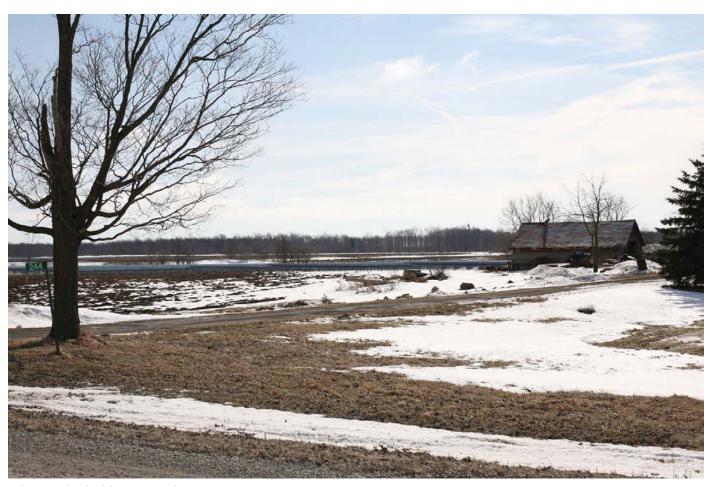
INSTALLATION OF SOLAR PANELS

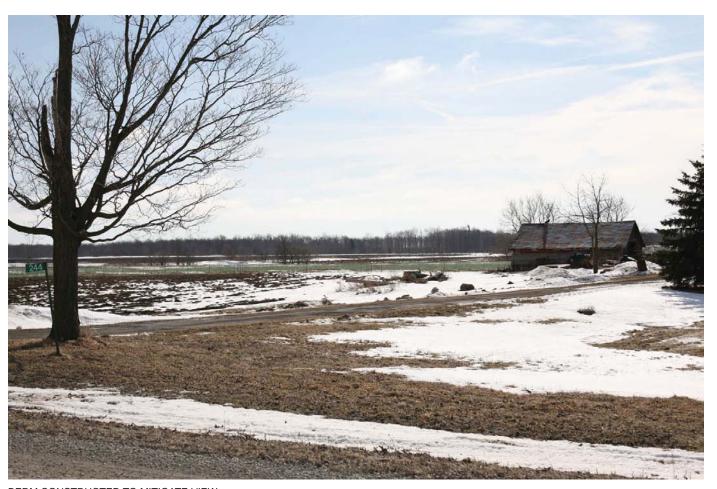
BERM CONSTRUCTED TO MITIGATE VIEW

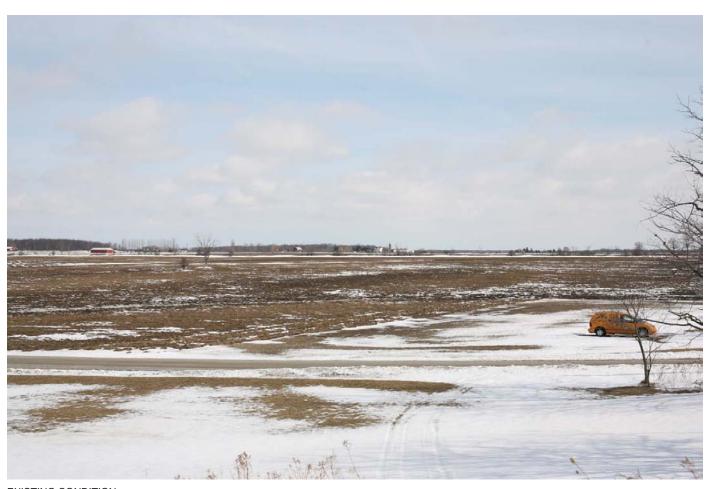
EXISTING CONDITION

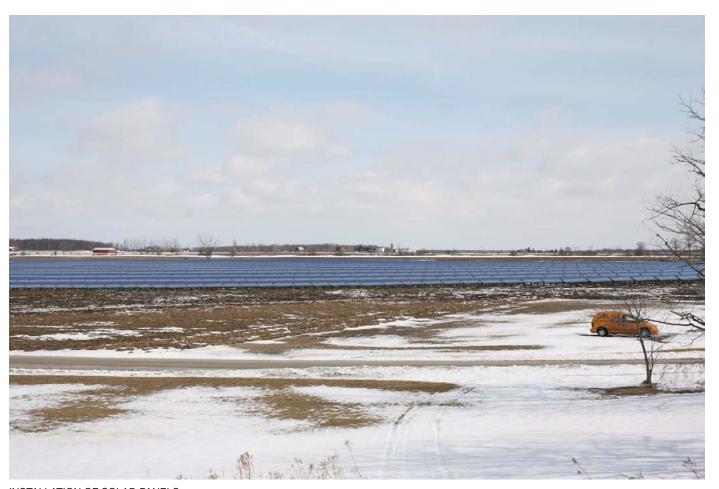
INSTALLATION OF SOLAR PANELS

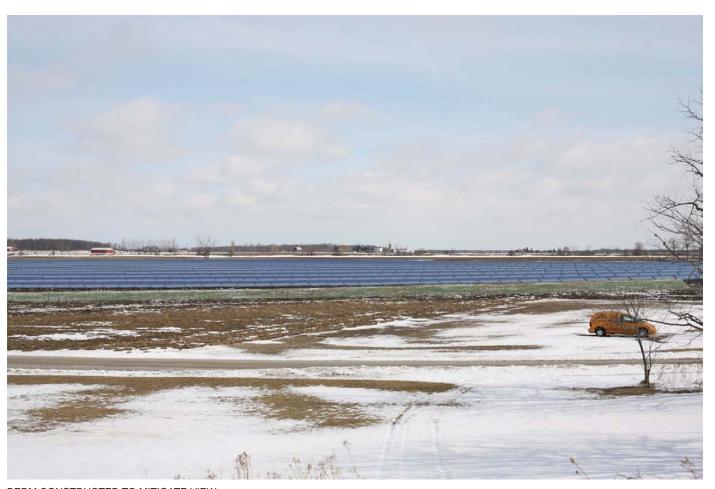
BERM CONSTRUCTED TO MITIGATE VIEW

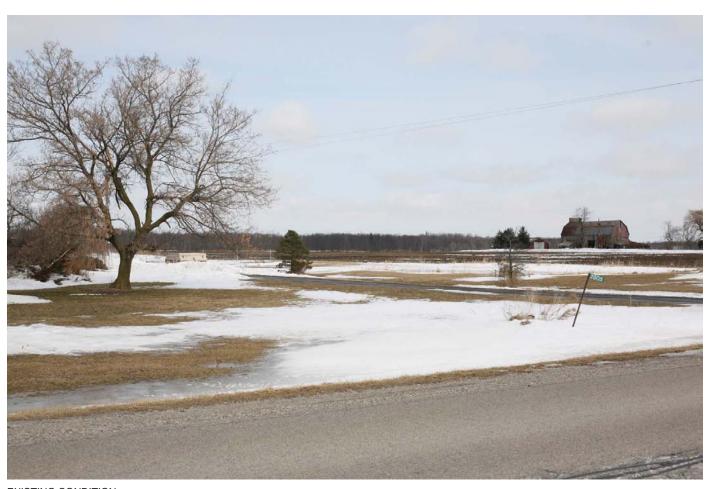
EXISTING CONDITION

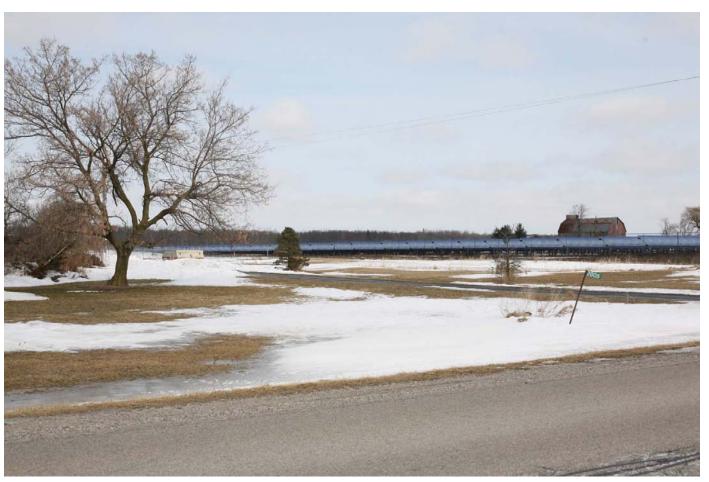
INSTALLATION OF SOLAR PANELS

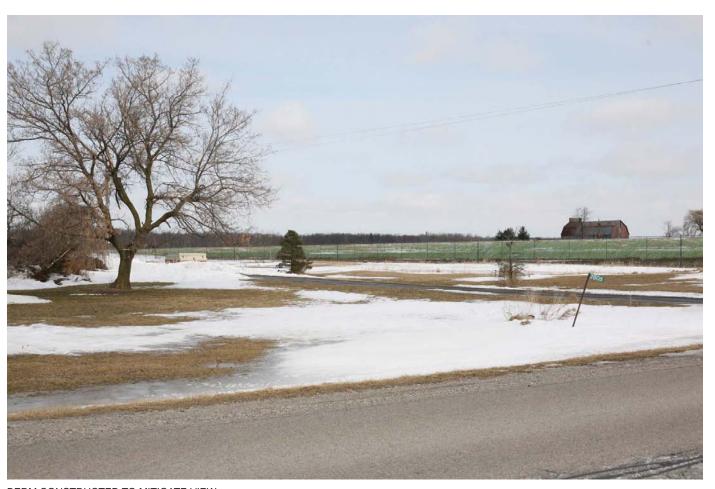
BERM CONSTRUCTED TO MITIGATE VIEW
