Technical Memorandum

То	North Kent 1 LP		Page 1
сс	Mark Van der Woerd (AECOM), Jo	dy Law (Pattern), Joshu	a Vaidhyan (Samsung)
Subject	North Kent Wind 1 (Chatham-Ken Well Water Impact Complaint Inv PIN 0074	nt, ON) estigation 450074,	(Dresden, ON)
From	Jason Murchison, P.Geo.		
Date	March 22 nd , 2018	Project No.	60343599

North Kent Wind 1 (Chatham-Kent, ON) Well Water Impact Complaint Investigation #2 PIN 007450074,

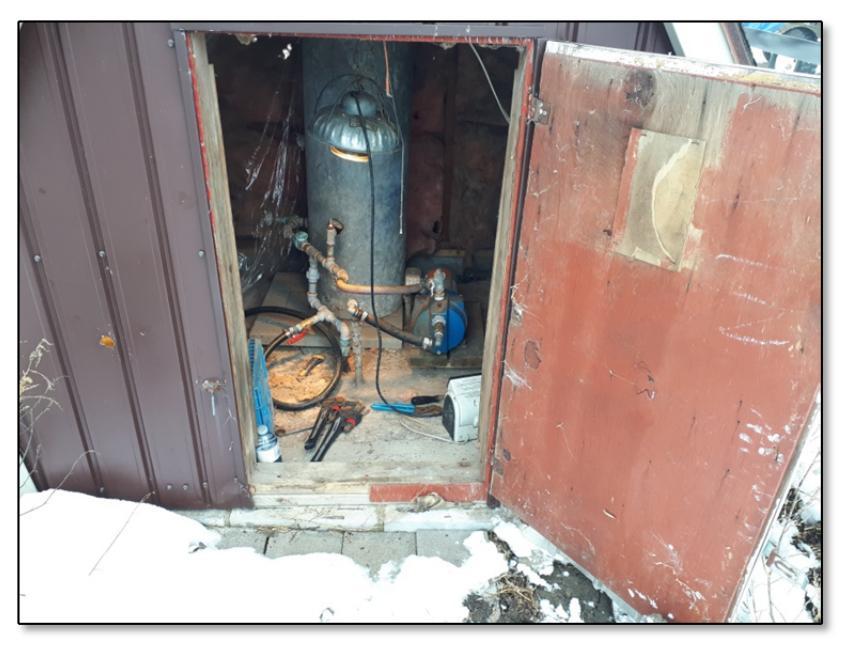
PHOTO 1: REPORTED WELL LOCATION (BELOW PUMPHOUSE FLOOR)

Measurement of well details (i.e., including total depth, water level, etc.) was not completed by AECOM during our 18-December-2017 site visit due to the wellhead being buried below grade within a pumphouse located to the rear of the residence. A photograph of the reported well location is provided herein as **Photo 1**.

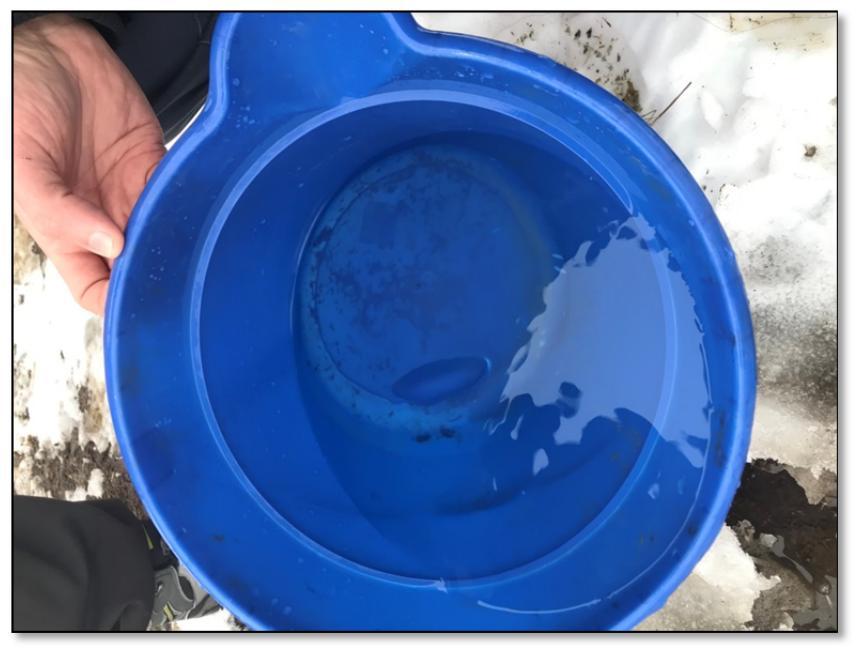
PHOTO 2: SEDIMENT WITHIN FLOW SAMPLING PAIL

No variation in flow rate (including increasing or decreasing trends) was observed during testing. Similarly, no detectable changes in the quality of the water discharge stream (eg. colour, odour, dissolved gas, sediment, etc.) were identified. The water pumped from the well was odourless, clear and colourless, with a small amount of sediment being observed within the calibrated pail at the conclusion of each flow rate test (Photo 2).

Total suspended solids (TSS) within the 18-December-2017 raw (untreated) groundwater sample was reported as being below the laboratory's Reported Detection Limit (RDL) of 10 mg/L, indicating the

presence of a low sediment load in the groundwater source pumped from the well. An ODWQS criteria limit has not been established for this parameter.

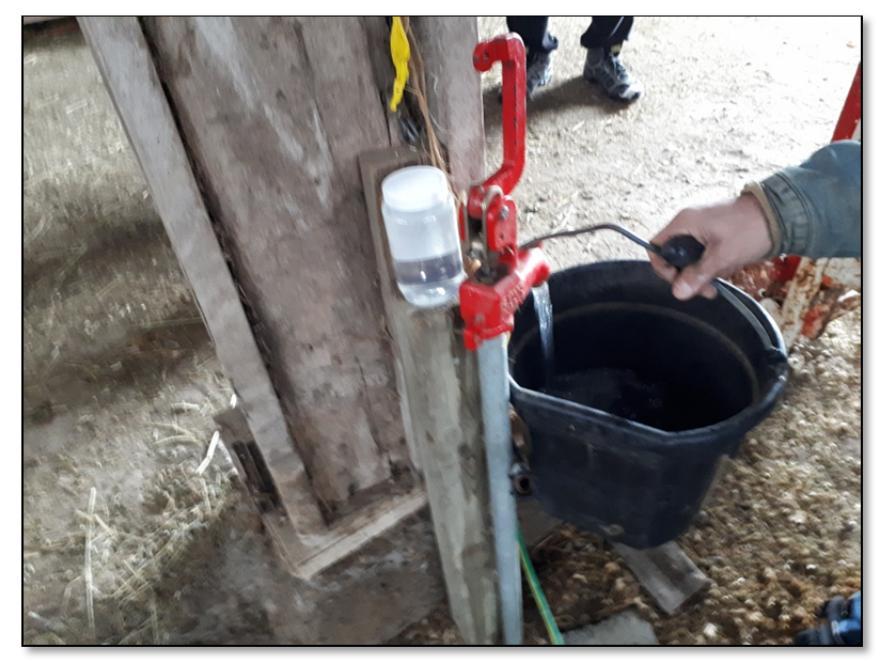
PHOTO 3: SAMPLING AND FLOW RATE TESTING LOCATION (WITHIN BARN)

Raw (untreated) groundwater sample collection during AECOM's 18-December-2017 site visit was completed using the same yard hydrant in the barn as was utilized during flow rate testing (**Photo 3**). Prior to sampling, the faucet was permitted to flush thoroughly with the pumped water being collected within a pail. Prior to sample collection, the faucet orifice was disinfected (using chlorine) and flushed. Clean nitrile gloves were worn by AECOM staff during sample collection.

At the time of sample collection, the raw (untreated) groundwater pumped from the well was observed to be clear and colourless, with a minor amount of sediment observed at the base of the sample bottles. No apparent odour(s) or entrained gas was detected.

The water well interference impact(s) reported by the property owners appear to be related to local water system and/or well construction / condition issues versus an area-wide impact to the local groundwater system. It is recommended that the property owners consult with a qualified water well contractor regarding the current condition of their on-site well supply and pumping system.
