Technical Memorandum

То	North Kent 1 LP		Page 1			
СС	Mark Van der Woerd (AECOM), Jody Law (Pattern), Joshua Vaidhyan (Samsung					
Subject	North Kent Wind 1 (Chatham-Ken Well Water Impact Complaint Inv (Dresden, ON)	· ·				
From	Jason Murchison, P.Geo.					
Date	December 8 th , 2017	Project No.	60343599

1. Introduction and Background

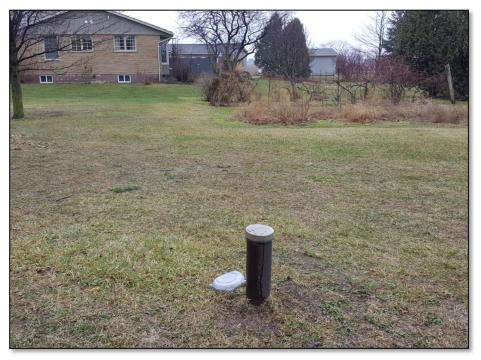
PHOTO 1: Drilled Water Well (as observed on 20-January-2017)

Gas bubbles were observed within the discharge water stream which remained relatively consistent during testing and subsequent sample collection activities.

No variation in flow rate (including increasing or decreasing trends) was observed during testing. Similarly, no detectable changes in the quality of the water discharge stream (eg. colour, odour, dissolved gas, sediment, etc.) were identified.

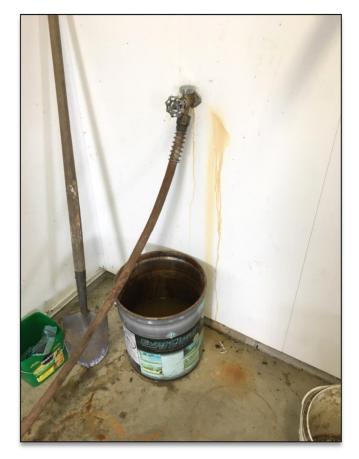
PHOTO 2: Sampling and Flow Rate Testing Location in Garage (as observed on 11-October-2017)

Raw (untreated) groundwater sample collection during AECOM's 13-October-2017 site visit was completed using a standard hose faucet located in the garage portion of the residence; that same location as that which was utilized during baseline sampling (ref. **Photo 2**). Prior to sampling, the faucet was permitted to flush thoroughly with the pumped water being directed to ground at the exterior of the residence. Prior to sample collection, the discharge hose was removed and the faucet orifice was disinfected (using chlorine) and flushed. Clean nitrile gloves were worn by AECOM staff during sample collection.

The groundwater sample was examined by AECOM in the field for visual and olfactory evidence of impact then immediately placed in laboratory-supplied sample bottles prepared in advance with the appropriate preservatives, sealed, labeled and stored on ice to maintain a sample temperature of 10°C or lower during transportation under chain of custody documentation to a CALA-accredited environmental analytical laboratory within the specified sample analyte holding times.

A detectable population of total coliforms (90 CFU/100 mL) was identified within the raw (untreated) groundwater sample collected from the well on 11-October-2017. This result is consistent with baseline sampling results where significant (ie. overgrown) bacteriological populations for both total coliforms and Escherichia coli (E.coli) were identified. It is noted that E.coli was determined to be absent in the most recent water quality sample. Both total coliforms and E.coli represent health-related parameters of the Ontario Drinking Water Quality Standards (ODWQS). It is recommended that the property owner seek the guidance of MOECC, their local Public Health Unit, and/or an experienced water treatment specialist to address the elevated levels of bacteria within the well.

The water well impact(s) reported by the property owner appear to be related to local water system issues versus an area-wide impact to the local groundwater system. As noted within this report, consultation with a qualified professional regarding the current condition of the on-site well supply / pumping system, and bacteriological quality of the raw water source is recommended.

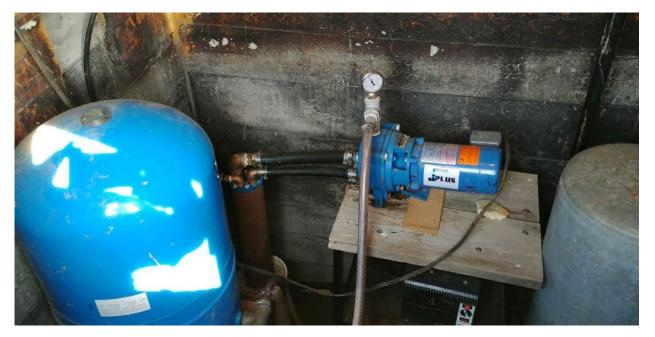
Photograph 1: Well 6 illustrating proximity of pump, hoses and tank to well casing.

Monitoring Notes: Tractor was observed operating frequently near Well 6. Water pump was observed cycling on and off during pile driving operations and remaining on for periods of 2 to 4 minutes. When pump was operating, casing at Well 6 exhibited particle velocities in the range of 0.08 to 0.12 mm/s and dominated analysis of data. Pile restrike events were of short duration with the following total number of hammer blows shown in parentheses: Pile 1 (20), Pile 10 (5 to 7), 13 (205), 14 (140), 16 (51), 15 (214). Pile 17 experienced 446 hammer blows over a period of 9 minutes. Piles noted with PDA indicate restrike events during which pile dynamics analyzer monitoring was completed. Piles noted with "A" represent piles installed to replace similarly-numbered piles. After installation, selected piles were struck again with the hammer to demonstrate resistance performance and these are noted as "restrikes". Monitoring of deliberate pump operation at Well 6 on July 13, 2017, during a period when no pile driving was occuring, measured maximum particle velocities of 0.08 to 0.8 mm/s. Where total driving duration between till/rock start and end times noted above is not representative, actual driving duration is shown in parentheses in minutes and seconds: 13A(10:00), 15A(6:24), 17 restrike (14:00), 13PDA(6:20). Total pile driving durations derived from start and end times noted above includes labour breaks, equipment work, splicing, welding and other standby time.

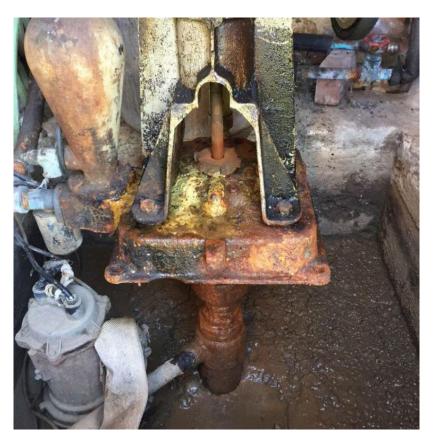
Photograph 3: Well 12 illustrating pump mounted directly on well casing.

Monitoring Notes: After installation, selected piles were struck again with the hammer to demonstrate resistance performance and these are noted as "restrikes". Vibration measurements were undertaken on August 17, 2017 at Wells 11 and 12 during water quality sampling events in the absence of pile driving within the cluster. Both pumps turned on and operated during the sampling events. Maximum vibration measurements for Well 11 were 0.016 mm/s and this pump was located within the residence approximately 40 m from the well. Maximum vibration measurements for Well 12 were 0.896 mm/s and the pump was mounted on the well casing. During pile driving on August 23, 2017, the maximum vibration measurement of the Well 12 casing was 2.4 mm/s for clearly definable periods during which the pump was operating. Data shown for the "no pump" condition was obtained during pile driving when the pump was not operating. Data not available for Piles 1, 6, 7, 8 and 9 at Well 12 on August 30, 2017 due to battery failure in monitoring equipment. Battery was subsequently replaced. Total driving duration between till/rock start and end times noted above for Pile 1 is not representative and actual driving duration was 00:7:40 due to pauses in actual hammering. Total pile driving durations derived from start and end times noted above includes labour breaks, equipment work, splicing, welding and other standby time.
