Long-Term Vibration Monitoring Interim Report No.4

North Kent Wind 1, Chatham-Kent, Ontario

1668031-4000-R04-Rev3

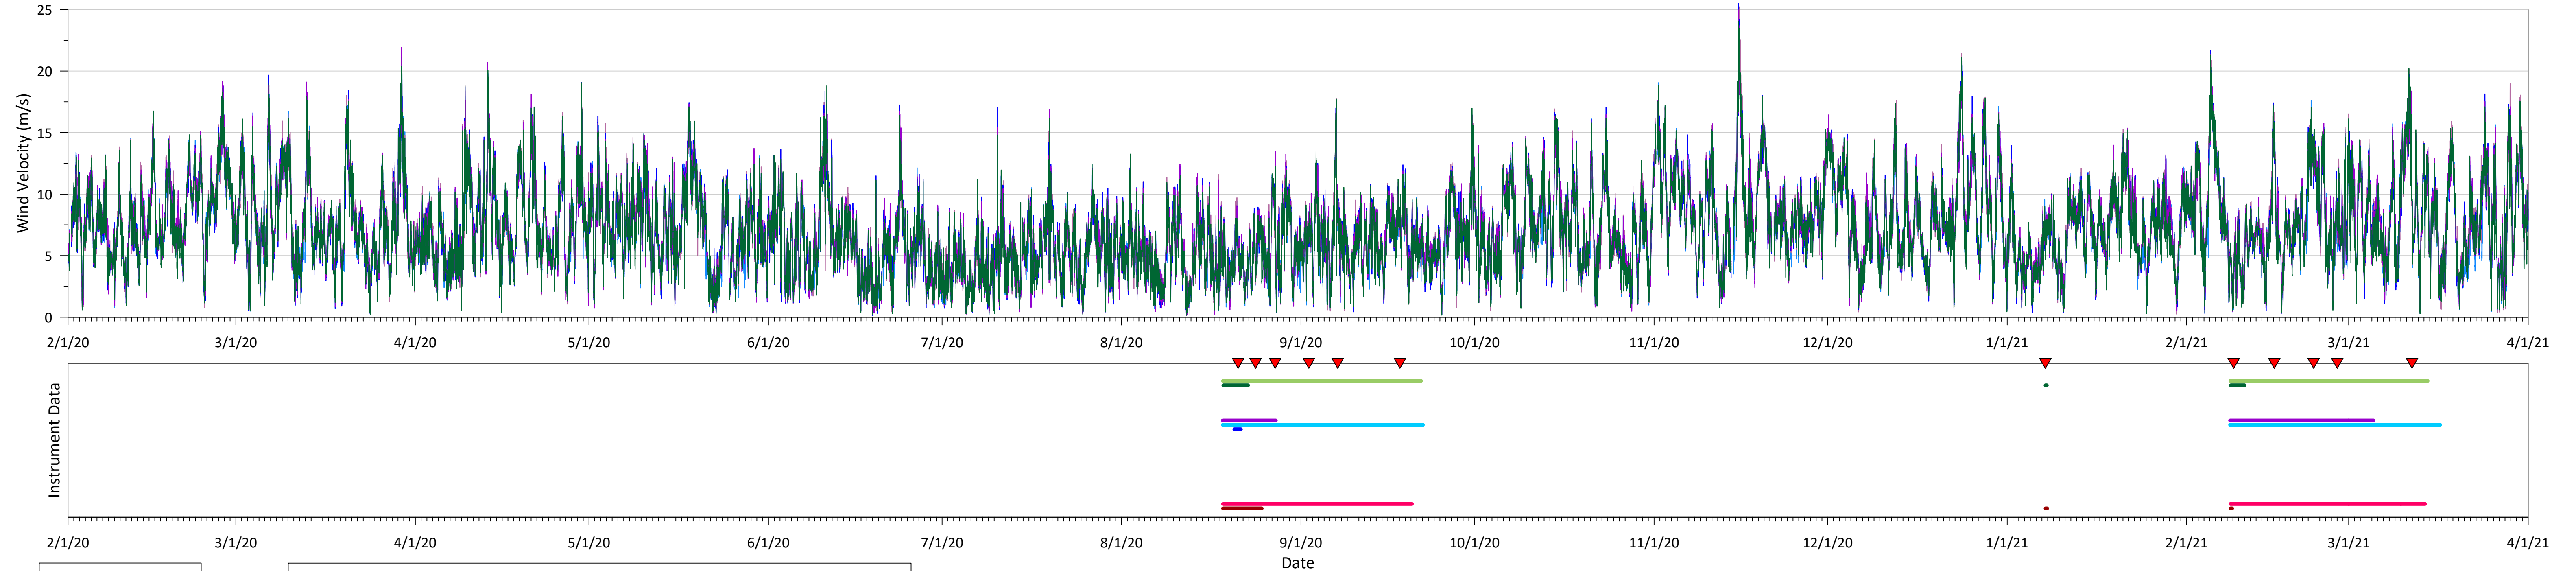
PROJECT		NORTH KENT 1 VIBRATION MONITORING	
TITLE		WIND VELOCITY AND DATA AVAILABILITY (FEB. 2020 TO APR. 2021)	
GOLDER MEMBER OF WSP	PROJECT No.	1668031	FILE No. 1668031-4000-R01006 (updated)
	DRAWN	JGH	May 2021
CHECK	SSS		
		SCALE	AS SHOWN
		REV.	0
FIGURE 6

Dates for which data was collected and available for analysis are illustrated on Figure 6.

Meteorological and turbine operation data was provided to Golder by North Kent Wind 1 in Microsoft Excel file format for the time period between February 2020 and April 2021. This data included wind velocity, yaw angle and the power generated for each of the monitored turbines obtained at 10-minute intervals during operation. The wind velocity data provided over the specific time period is shown in Figure 6.

Data selected for analysis was processed and analysed following the procedures covered in Section 6.0 of Report No. 1. The dates picked for the analyses are shown on Figure 6. The results from the data analysis are presented on Figures 9A through 9D where the particle velocity (tower, turbine foundation, mock well casing or rock) is illustrated as related to the distance from the turbine tower centre. In this case, the data closest to the centre represent the measurements made by the accelerometers mounted within the tower (off set approximately 1.9 m from the centre). The instruments mounted on the foundations are approximately 7.9 m from the turbine tower centre. Also shown in Figures 9A to 9D are the results obtained for the first twenty-two months of vibration monitoring documented in Reports No. 1, 2 and 3 for comparison. These results are presented in grey colour scale as follows: light grey for low wind velocities (5 to 10 m/s), medium grey for moderate velocities (10 to 15 m/s), and dark grey for high velocity wind events (15 to 20 m/s). Data obtained during the period covered by this report are illustrated in full colour to facilitate comparison among the reporting periods.

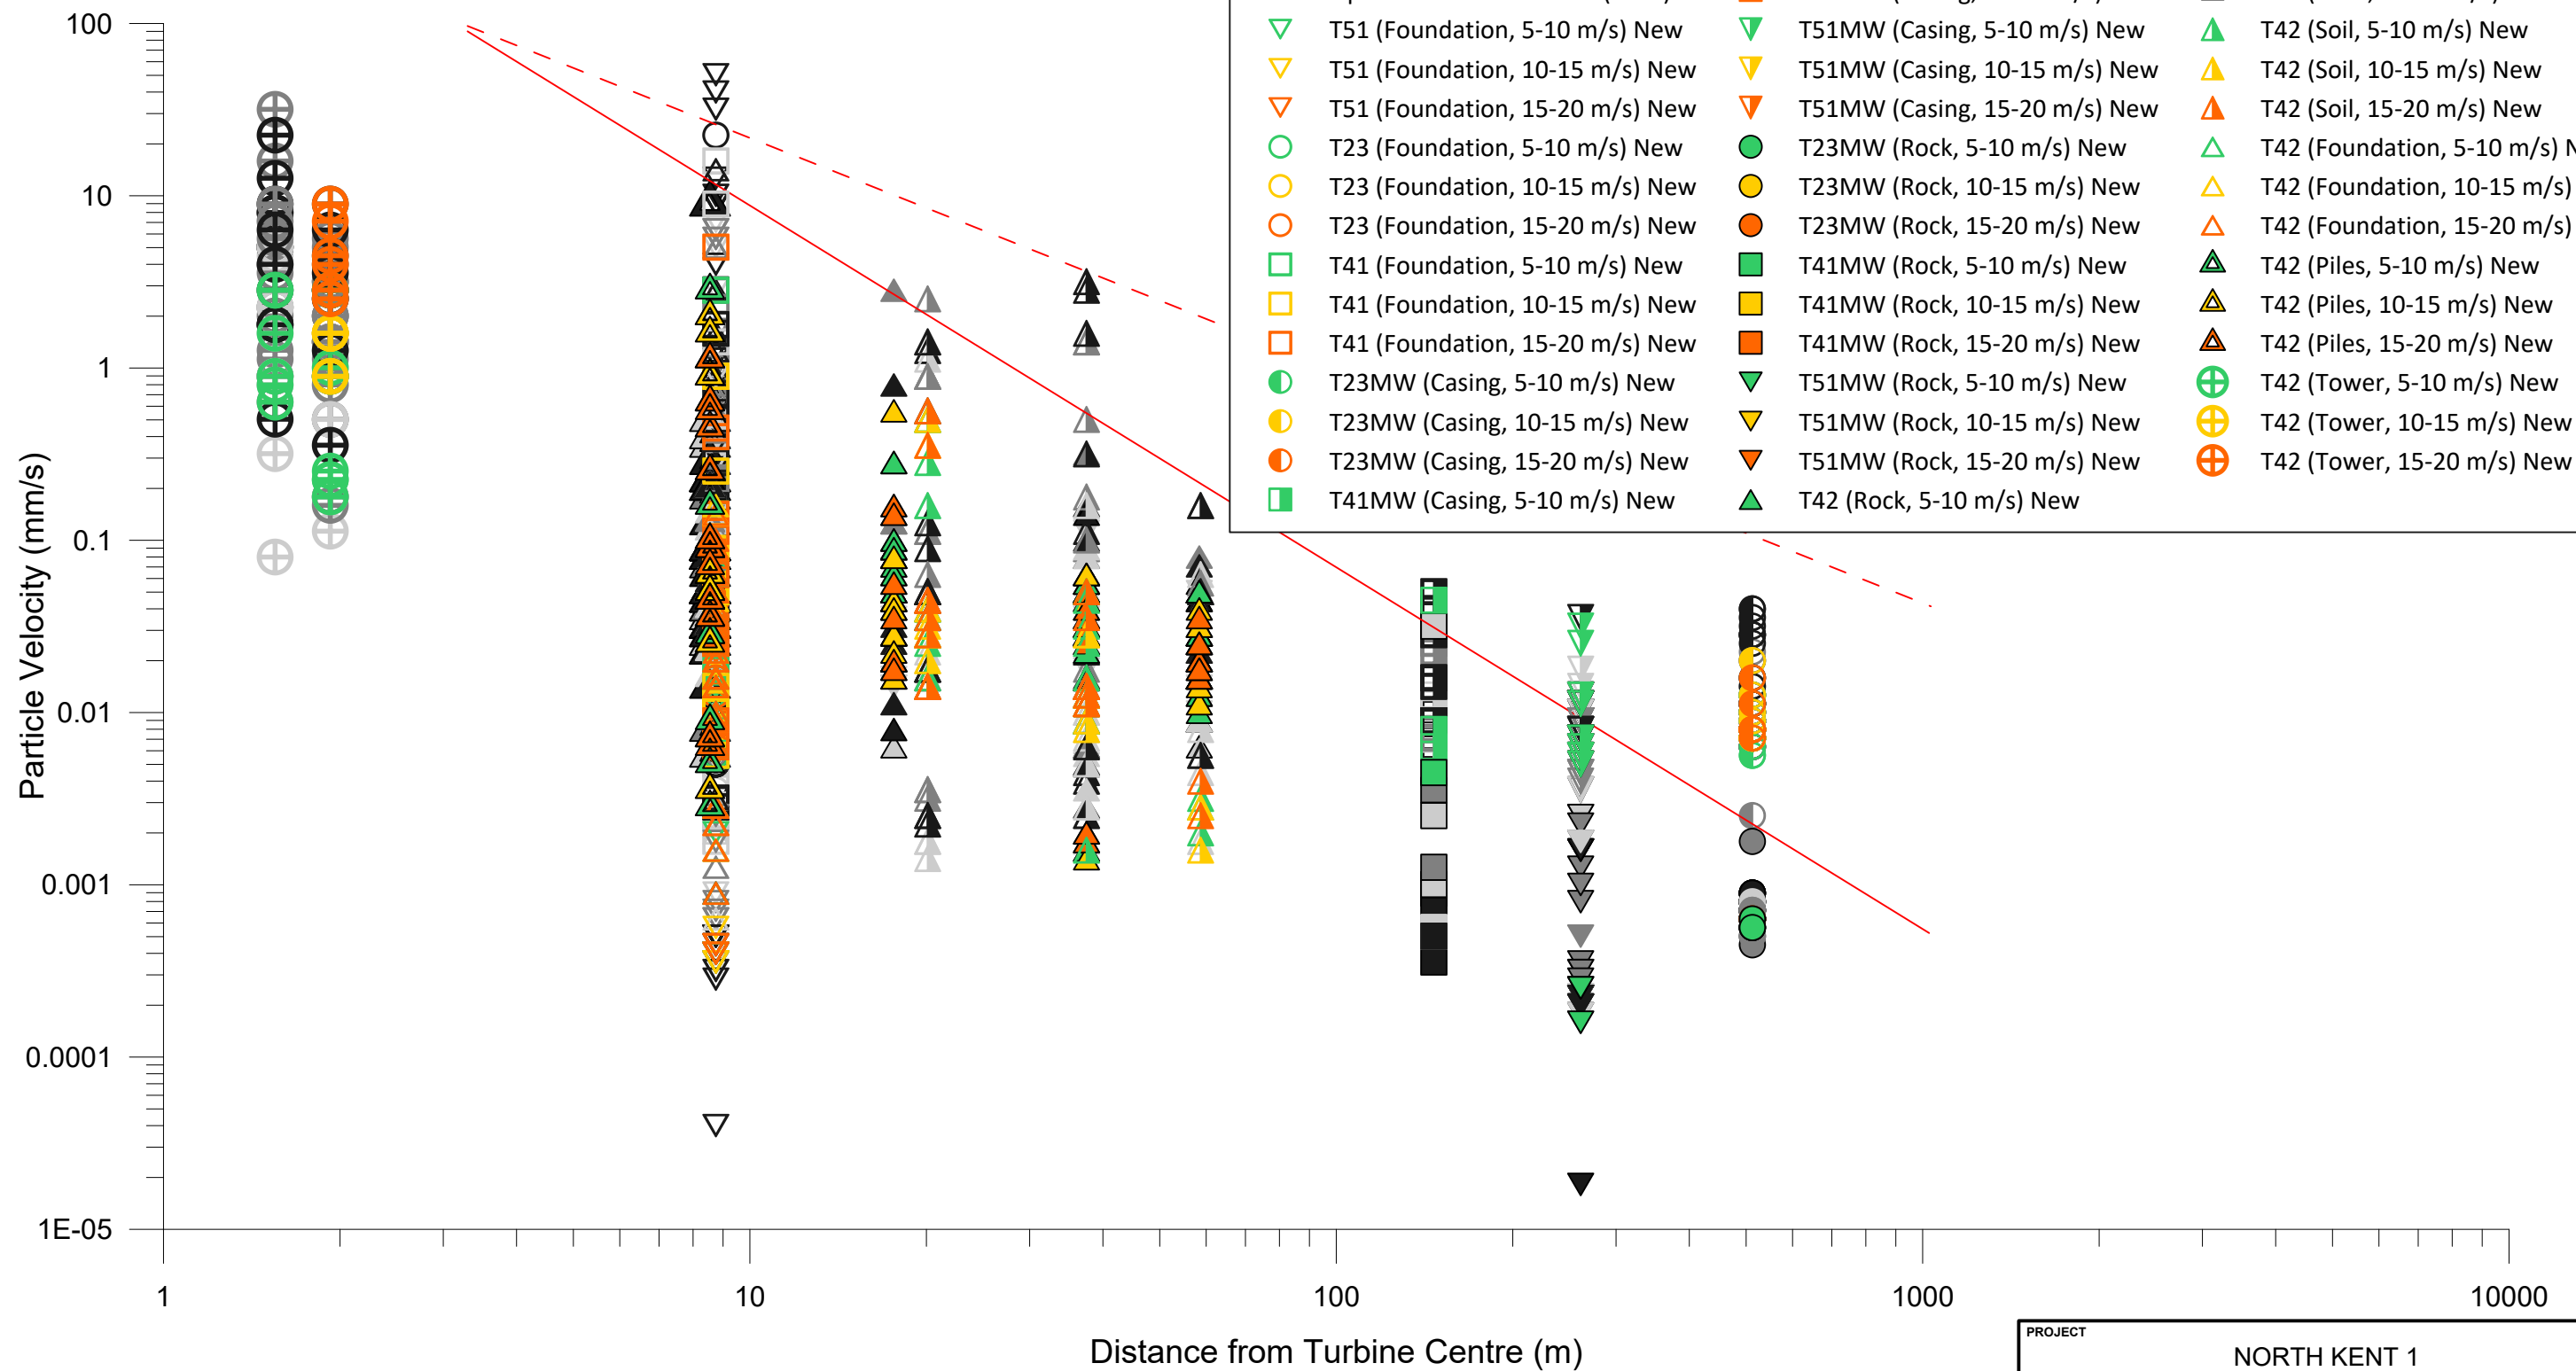
1. This figure must be read with accompanying report.
2. Well casing vibration measurements based on persistence spectra and exclude transient influences (e.g., traffic, farm equipment, etc.).

PROJECT		NORTH KENT 1 VIBRATION MONITORING	
TITLE		VIBRATION VELOCITY AND ATTENUATION (1 Hz) (MAY 2021)	
PROJECT No. 1668031-4000		FILE No. 1668031-4000-R01009A (Add#3)	
DRAWN	JGH	May 2021	SCALE AS SHOWN
CHECK	SSS		REV. 0
GOLDER MEMBER OF WSP		FIGURE 9A

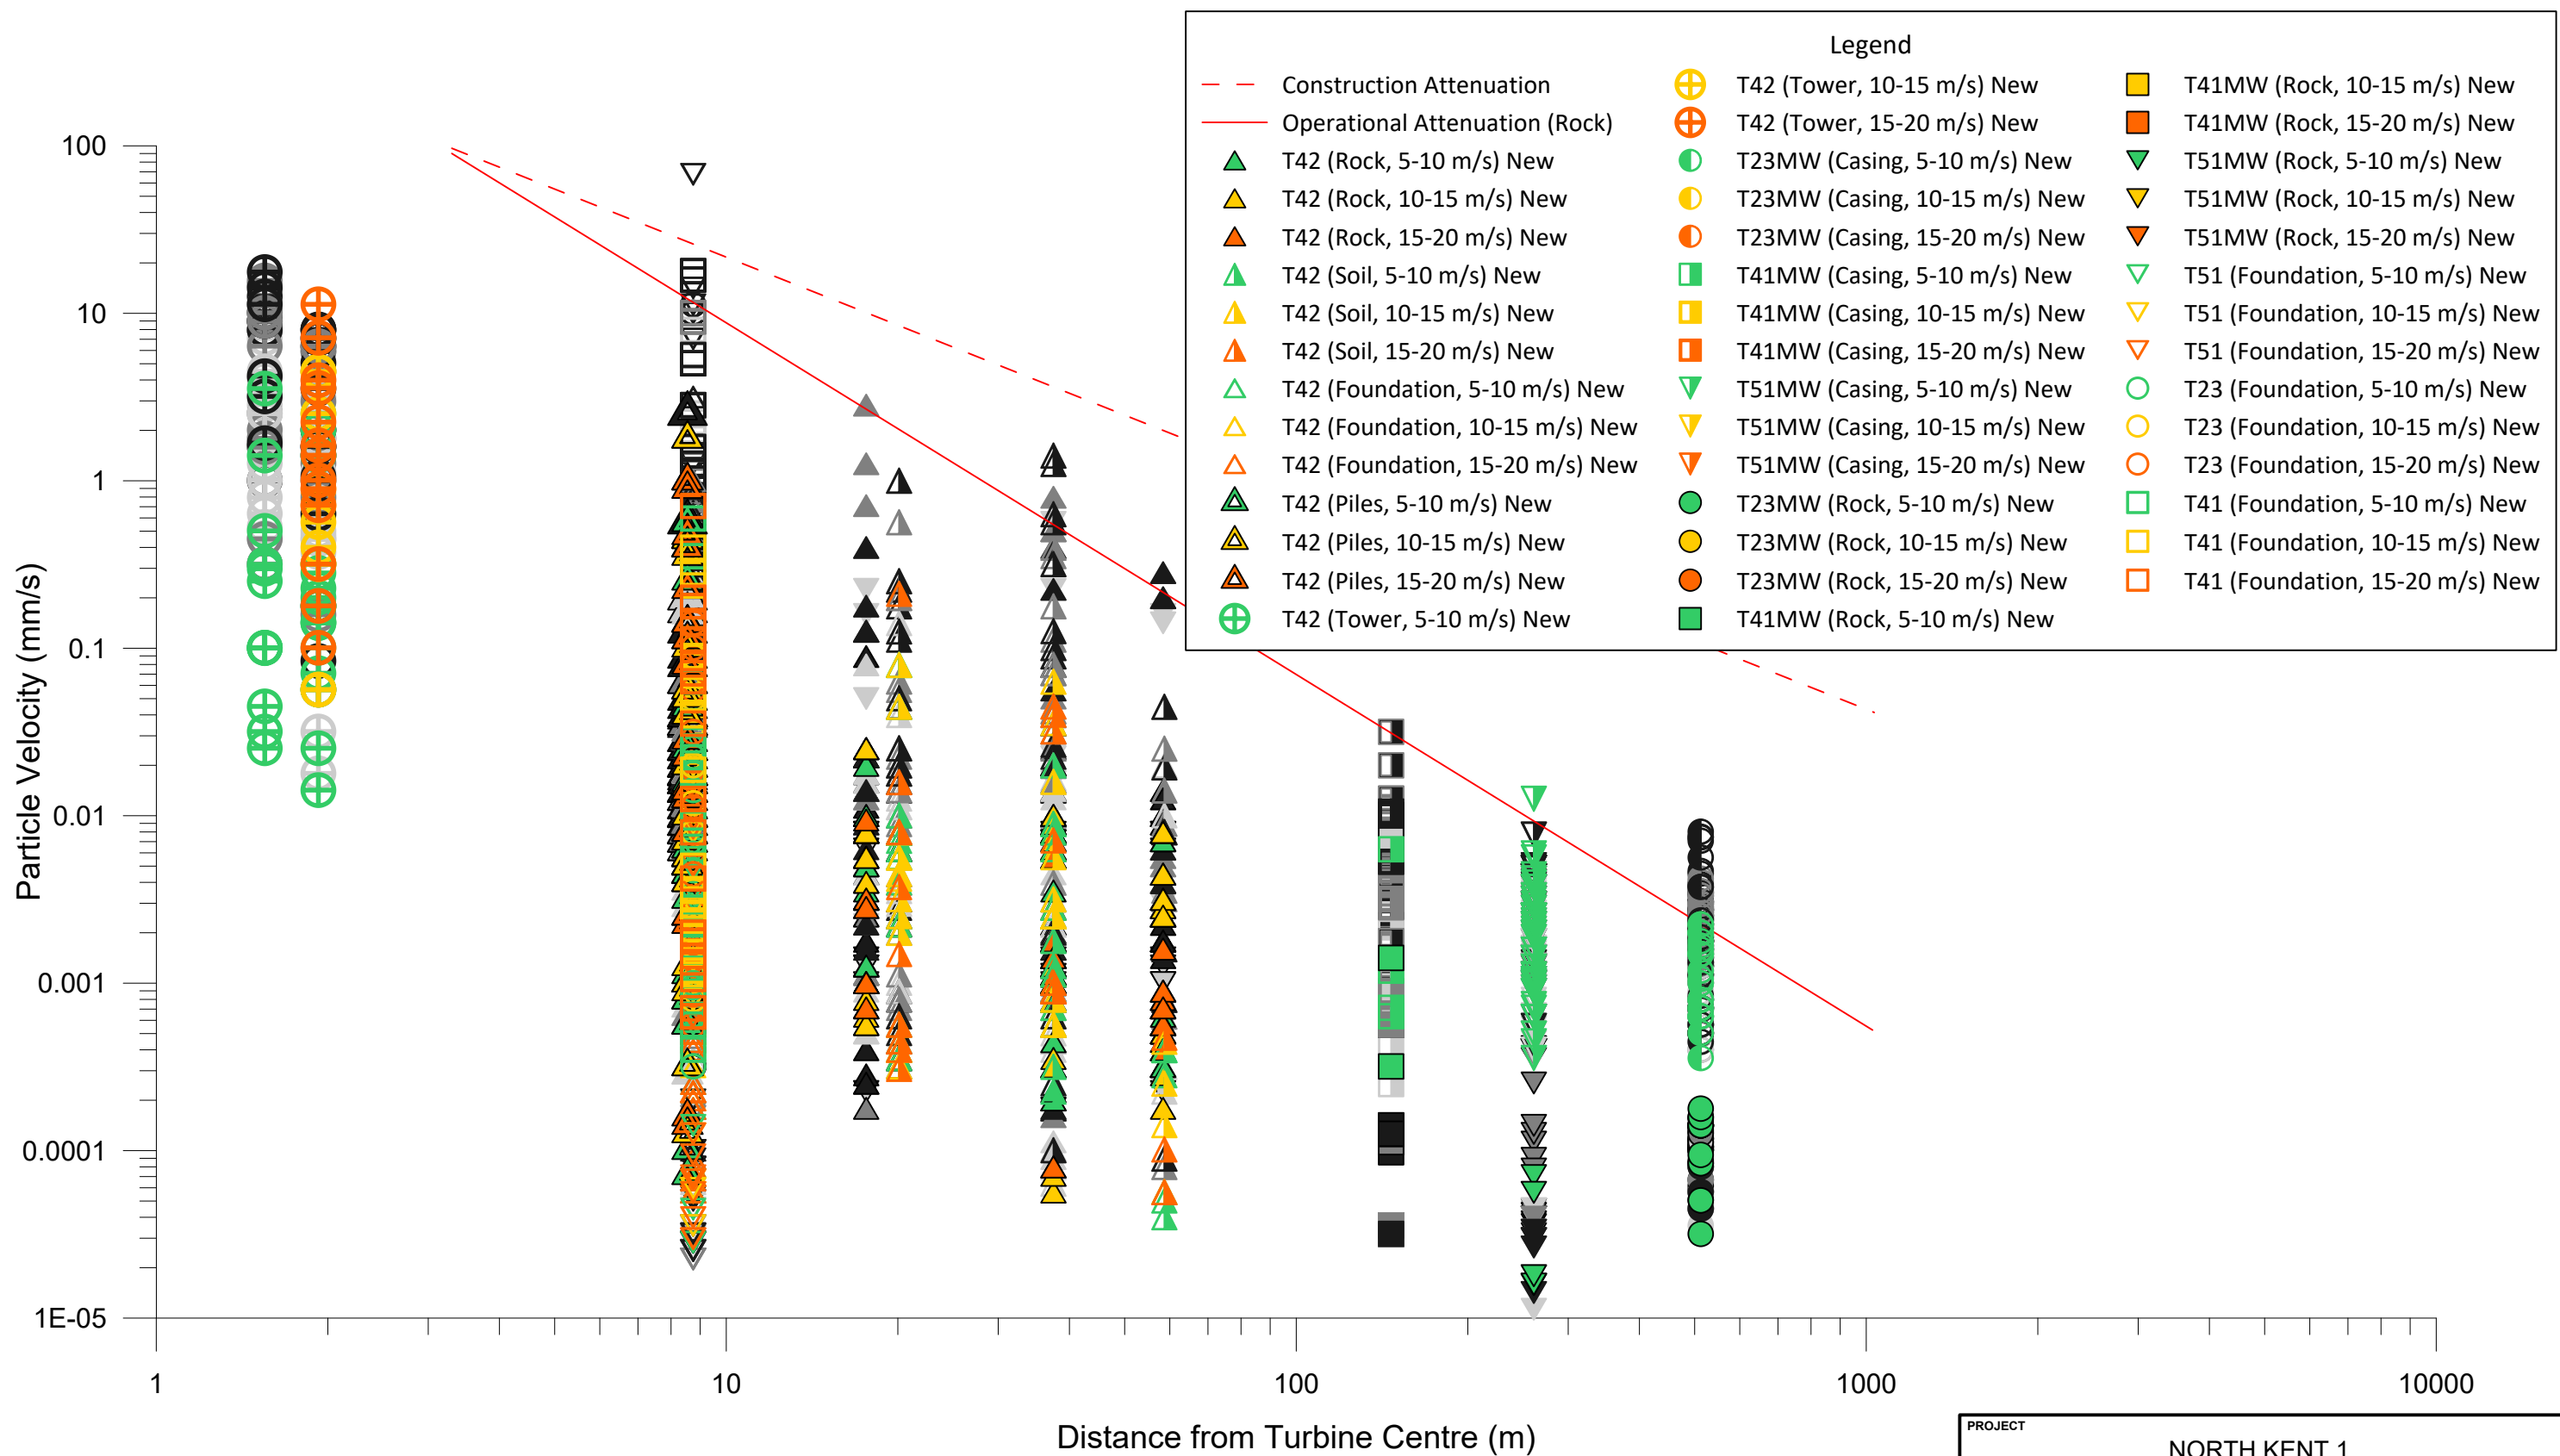
1. This figure must be read with accompanying report.
2. Well casing vibration measurements based on persistence spectra and exclude transient influences (e.g., traffic, farm equipment, etc.).

PROJECT		NORTH KENT 1 VIBRATION MONITORING			
TITLE		VIBRATION VELOCITY AND ATTENUATION (>1 to 5 Hz) (MAY 2021)			
		PROJECT No.	1668031-4000	FILE No.	1668031-4000-R01009B (Add#3)
		DRAWN	JGH	May 2021	SCALE AS SHOWN
		CHECK	ESB		REV. 0
		FIGURE 9B

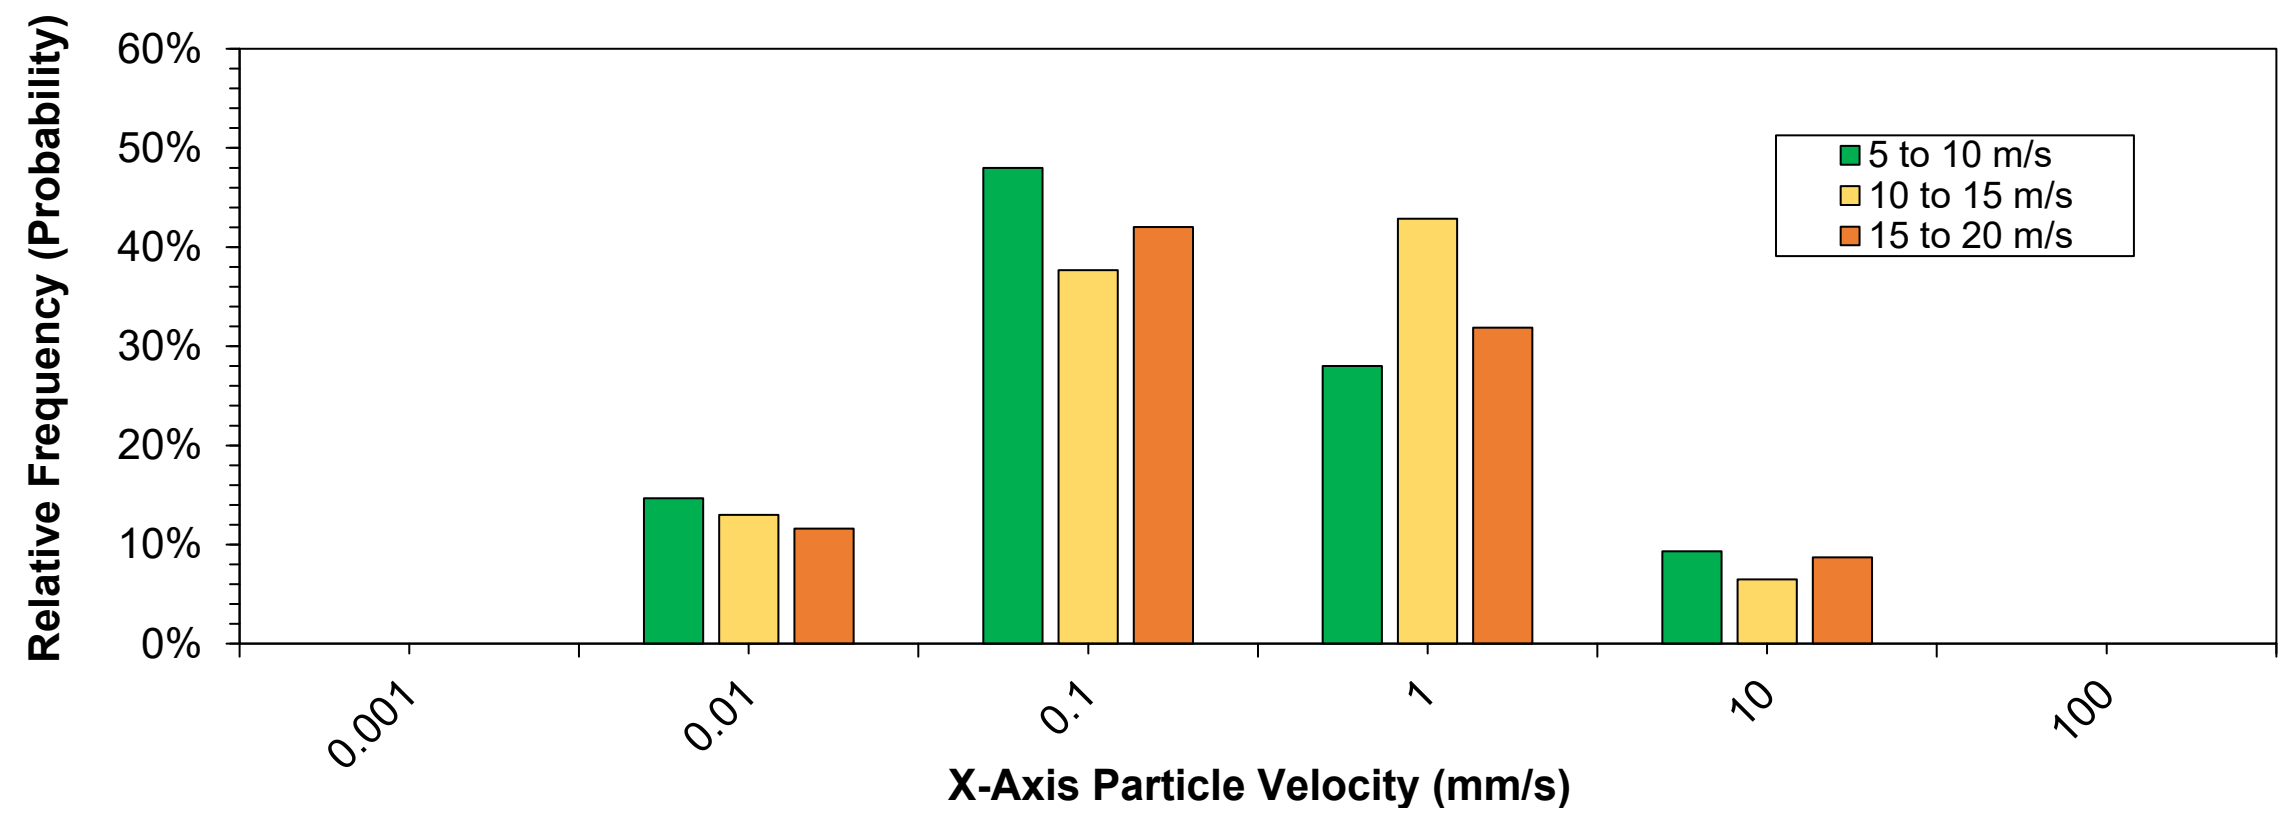
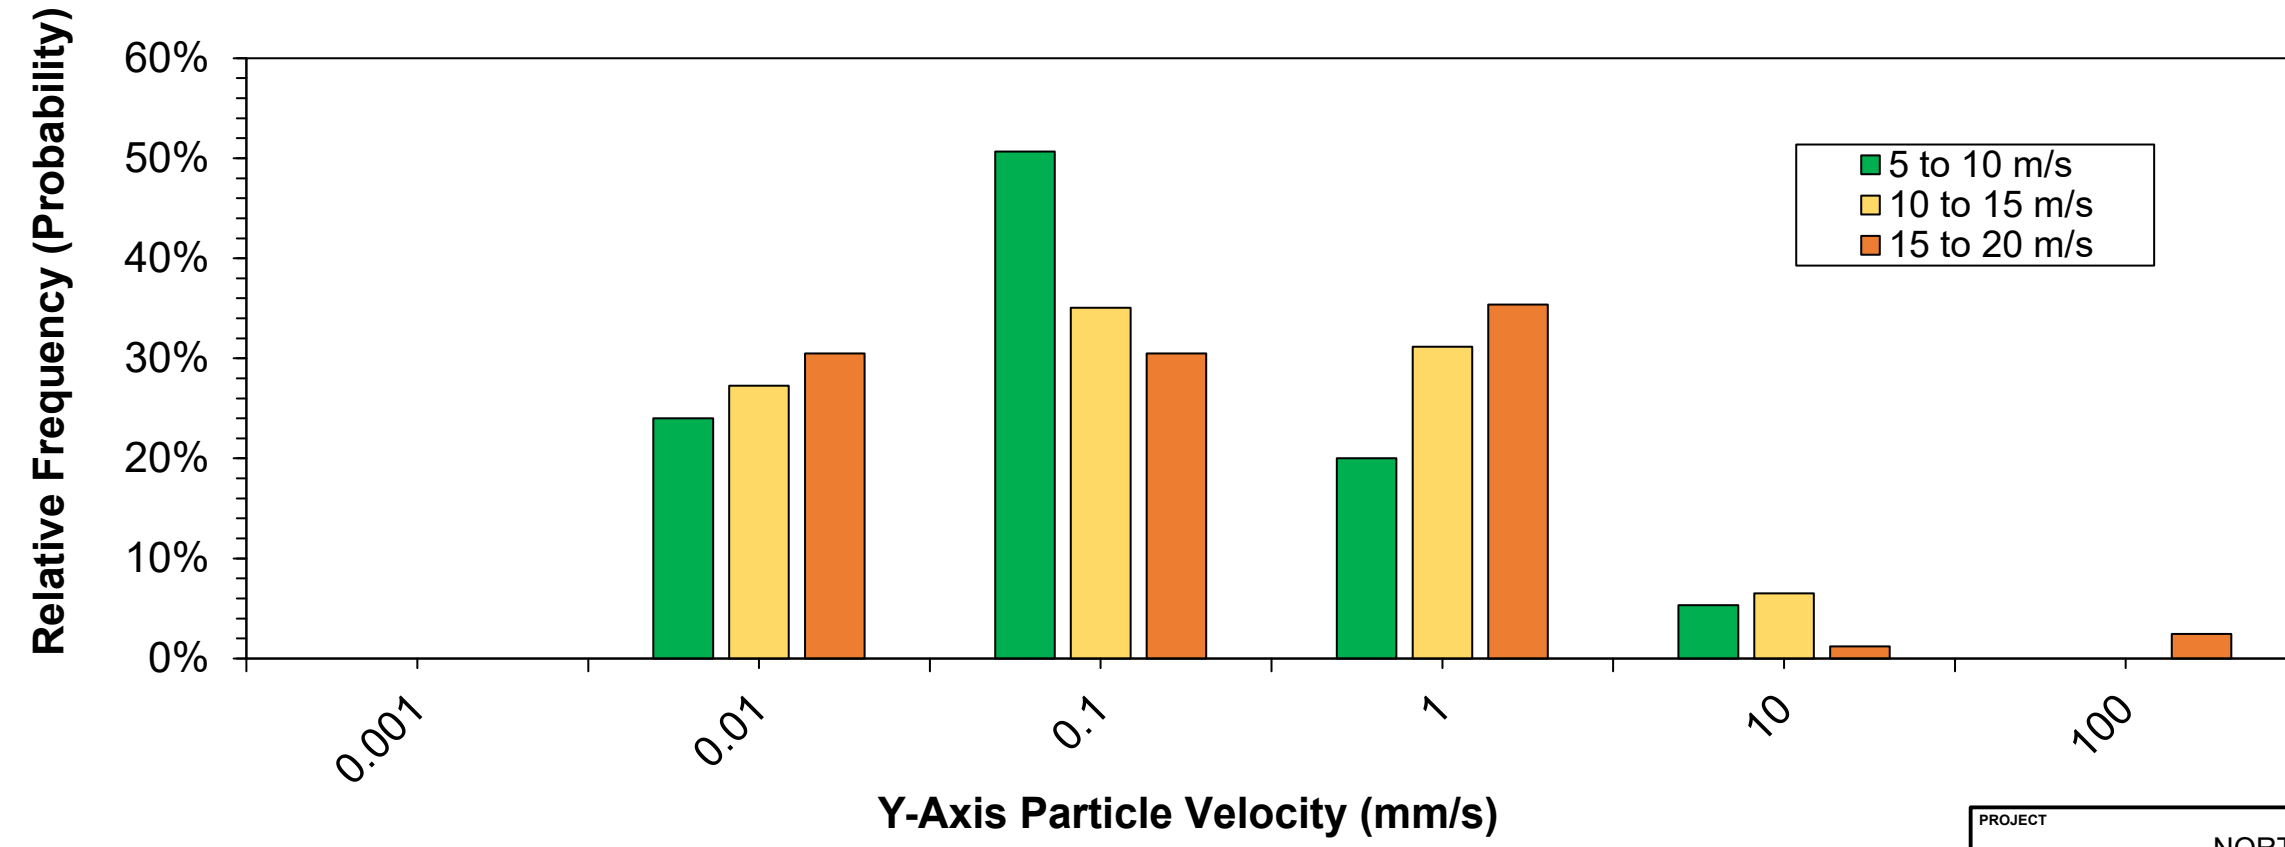
Notes:
1. This figure must be read with accompanying report.
2. Foundation vibration measurements based on persistence spectra and exclude transient influences (e.g., traffic, farm equipment, etc.).

PROJECT			
NORTH KENT 1 VIBRATION MONITORING			
TITLE			
RELATIVE FREQUENCY OF VIBRATION VELOCITY AT DIFFERENT WIND SPEED RANGES FOR TURBINE FOUNDATIONS AT 1 Hz (PERIOD JANUARY 2018 TO APRIL 2021)			
PROJECT No. 1668031-4000		FILE No. 1668031-4000-R04010A (Add#3)	SCALE AS SHOWN
DRAWN JGH		June 2021	REV. 0
CHECK SSS			
GOLDER MEMBER OF WSP		FIGURE 10A

Figures 10A and 10B illustrate histograms of particle velocity measured on the turbine foundations as compared to the wind velocity categories associated with the 10-minute interval meteorological data. Data from the triaxial accelerometers mounted on the turbine foundations was selected for this comparison since, by coupling of the foundation with the ground, the foundations would be the source of ground vibrations away from the turbine. In general, if foundation particle velocity is directly and strongly correlated to wind velocity, these histograms should show more frequent measurements (higher bars in the histograms) of stronger ground particle velocities (bins to the right in the histograms) being associated with the stronger wind velocity categories (i.e., the histogram bars would cluster toward the left for the low wind velocities – green category – and to the right for high wind velocities – orange category). While some rightward shift in the foundation particle velocity histograms can be seen, this shift and the inferred relationship between wind velocity and foundation particle velocity is not strong. While intuitively a strong relationship between wind velocity and foundation vibration magnitude might be expected, the turbine and blade dynamics are not necessarily proportional to wind velocity, particularly at higher wind speeds. Golder understands that above a wind velocity of approximately 14 to 15 meters per second, the turbine blades are feathered (the pitch of the blades is changed) to result in a constant power output and blade rotational velocity remains constant. Given this control of the turbines and their blade angles, the components that might respond directly to changing wind velocity are only the exposed faces of the towers and nacelle. Therefore, the relatively weak relationship between measured foundation particle velocity and wind velocity is consistent with the design and operational characteristics of the turbine.

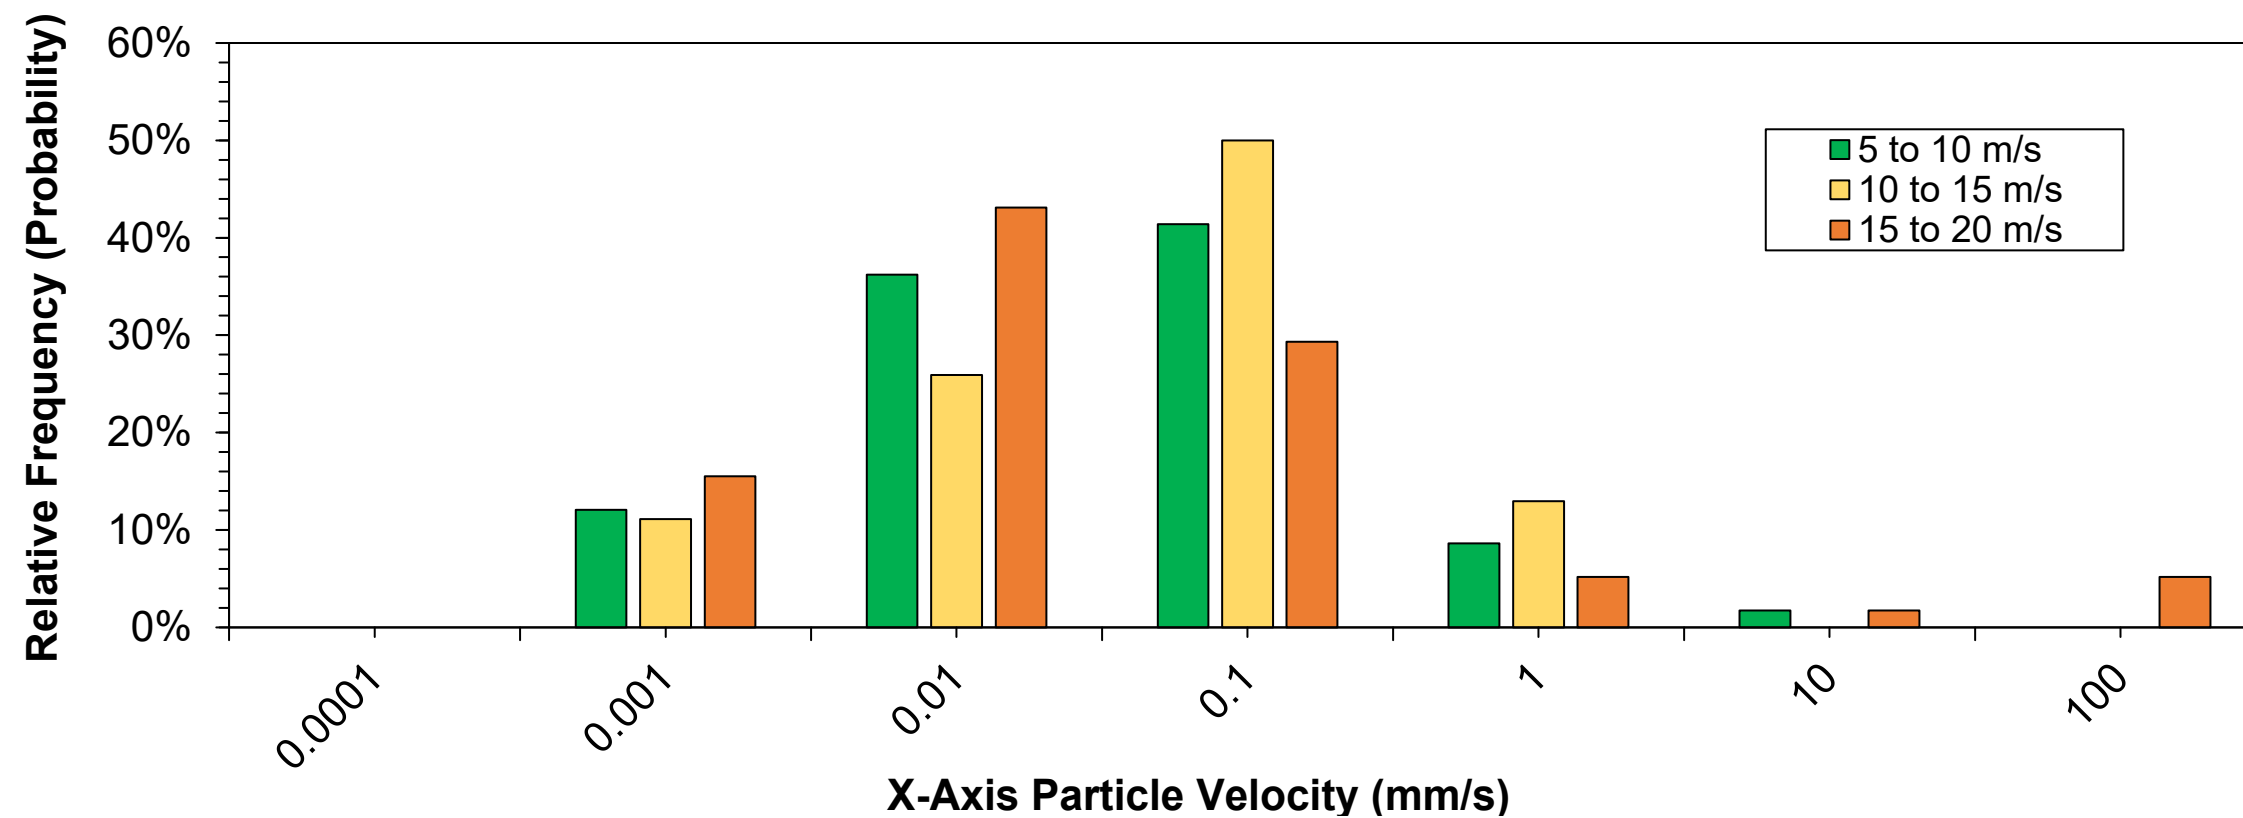
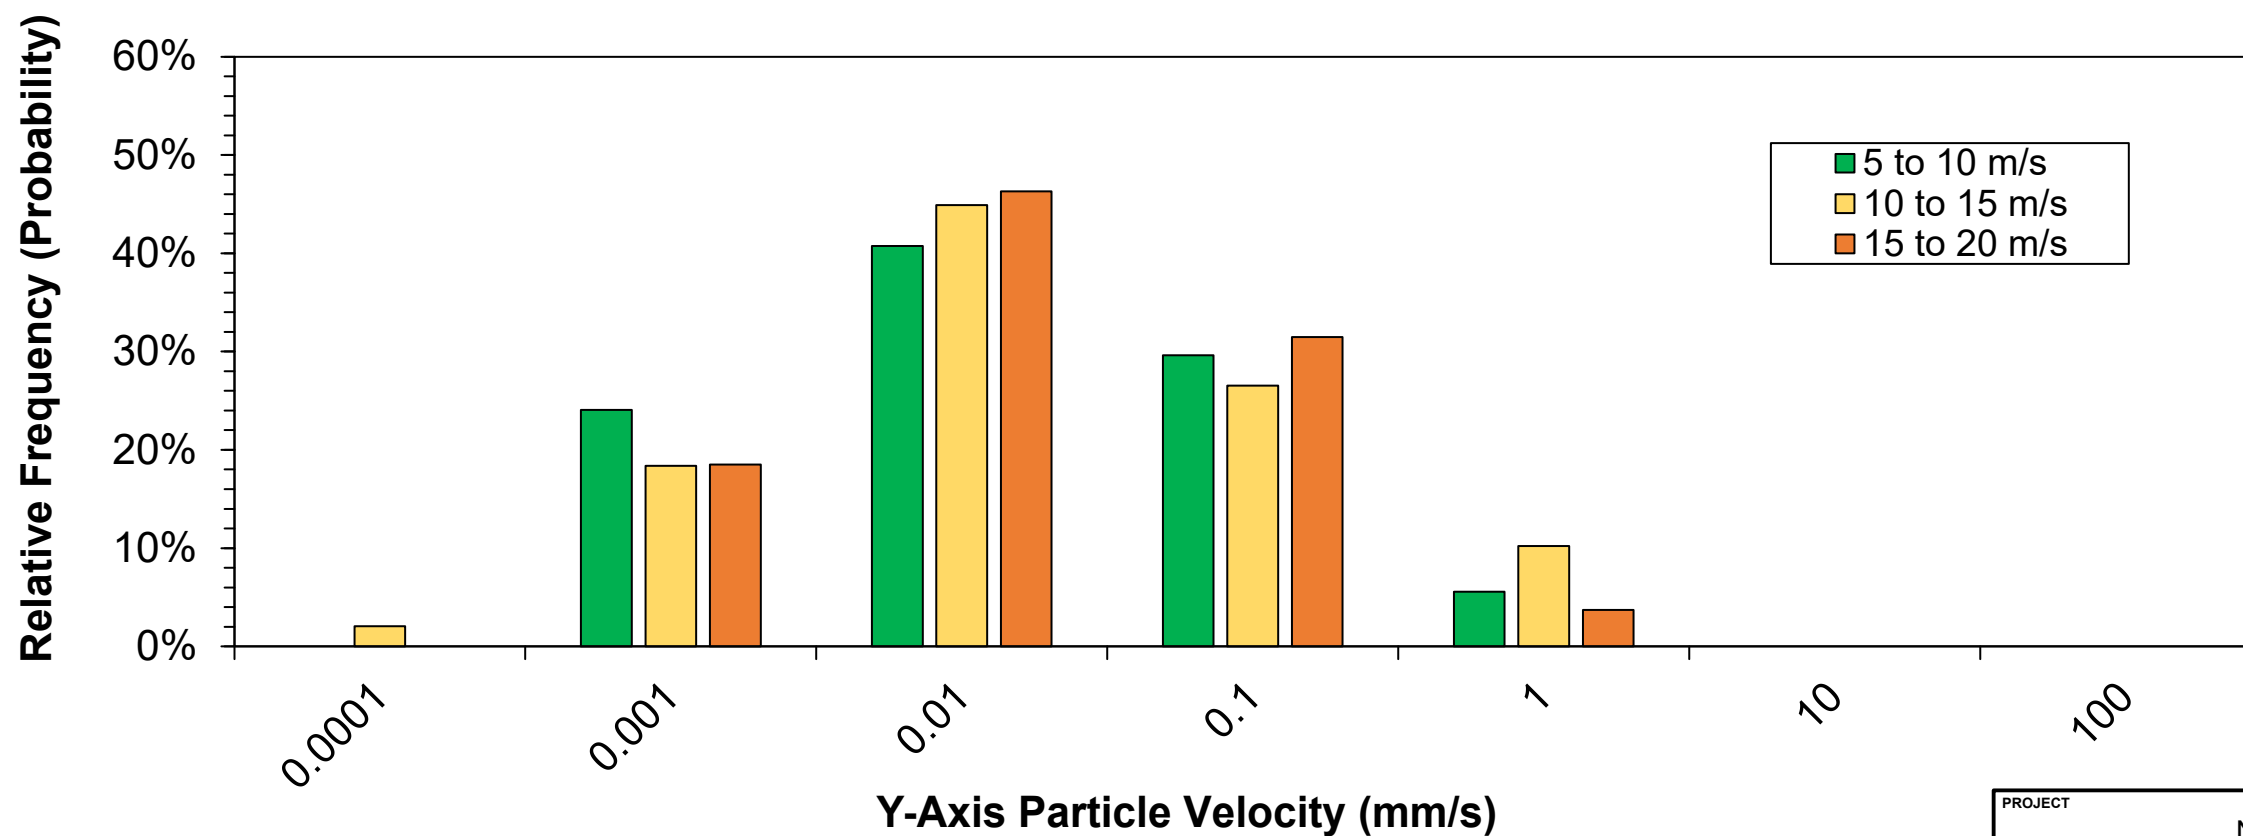
- Notes:
1. This figure must be read with accompanying report.
 2. Foundation vibration measurements based on persistence spectra and exclude transient influences (e.g., traffic, farm equipment, etc.).

PROJECT		NORTH KENT 1 VIBRATION MONITORING	
TITLE		RELATIVE FREQUENCY OF VIBRATION VELOCITY AT DIFFERENT WIND SPEED RANGES FOR TURBINE FOUNDATIONS AT 5 Hz (PERIOD JANUARY 2018 TO APRIL 2021)

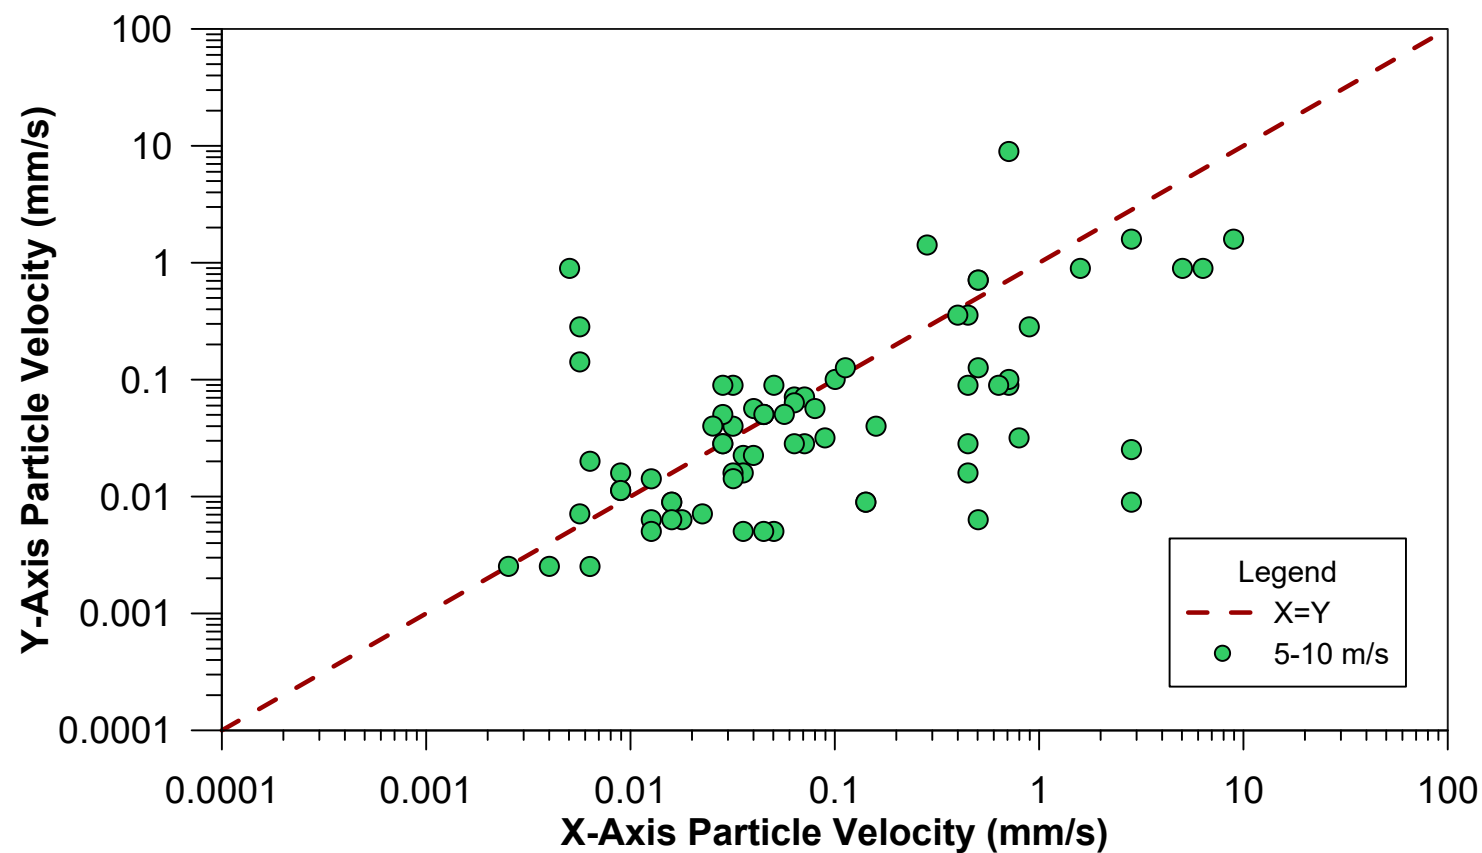
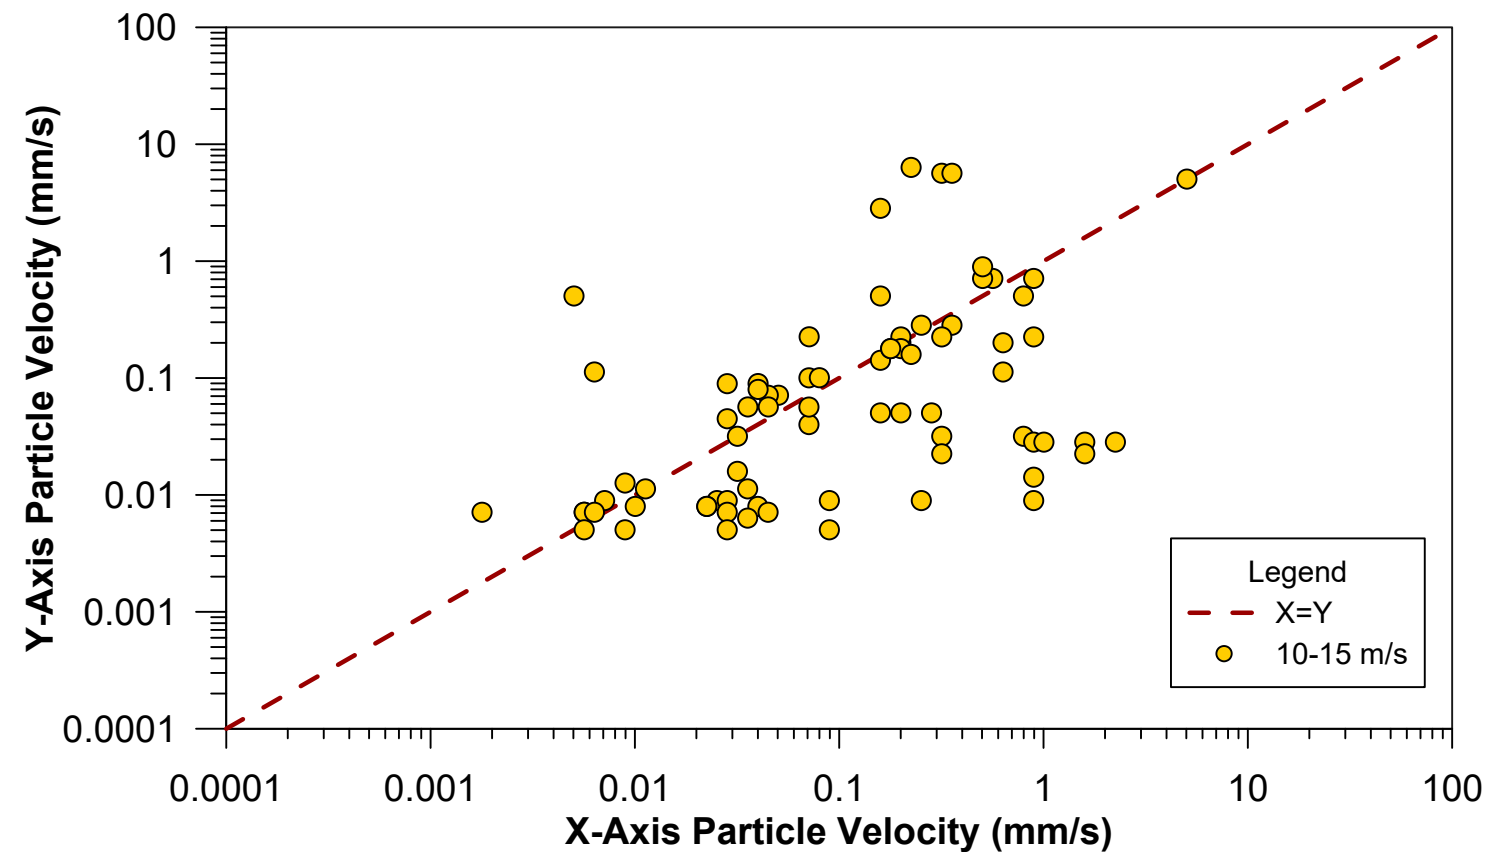
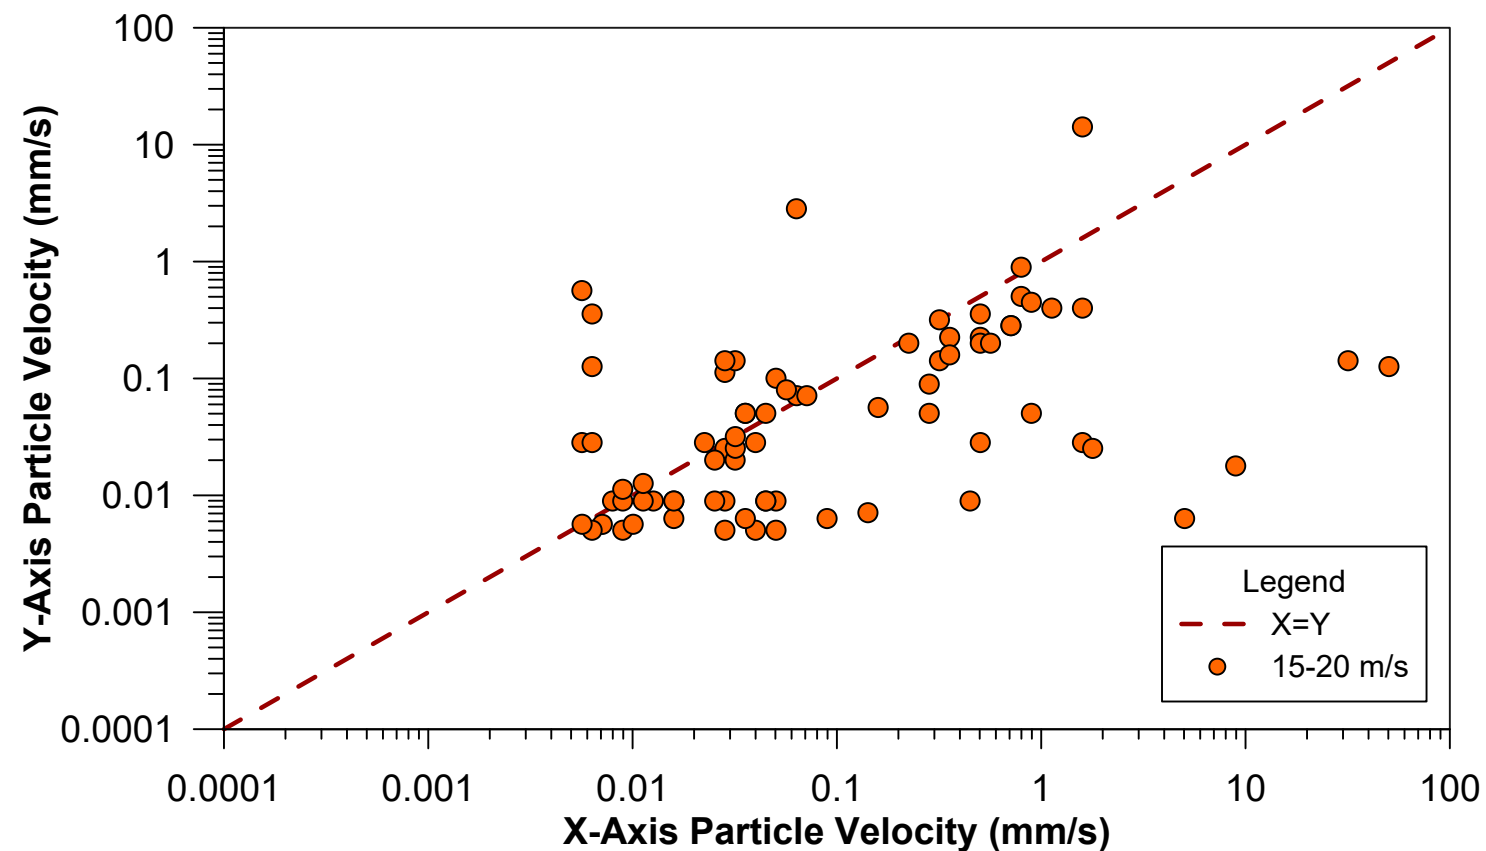
1. This figure must be read with accompanying report.
2. Foundation vibration measurements based on persistence spectra and exclude transient influences (e.g., traffic, farm equipment, etc.).

PROJECT		NORTH KENT 1 VIBRATION MONITORING	
TITLE		VIBRATION VELOCITY MEASURED AT DIFFERENT WIND SPEED RANGES FOR TURBINE FOUNDATIONS AT 1 Hz (PERIOD JANUARY 2018 TO APRIL 2021)

Figures 11A through 11D illustrate a comparison of foundation and mock well particle velocities measured in the horizontal plane. In general, the x axes were oriented to form a direct line between the foundation and nearby mock well with an azimuth ranging between west to west-northwest. The y axis was oriented at 90 degrees to the x axis at each location. For evaluation of mock well responses, data from the uniaxial accelerometers mounted to the

casing top were selected since these produced the best signal to noise ratios, would represent values greater than those measured within the bedrock (because of the effects of soil conditions and casing lengths) and, therefore, would be less likely to produce equivocal comparisons. For both the foundation and mock wells, the data illustrated in Figures 11A through 11D indicate that ground vibrations tend to be somewhat stronger in the x direction, consistent with prevailing wind velocity and direction trends (see Figure 7 in November 2018 report). Comparisons of Figures 11A and 11B to 11C and 11D also illustrate the attenuation of particle velocity magnitudes at the mock wells as compared to the data obtained for the foundations.
