Long-Term Vibration Monitoring Interim Report No.4

North Kent Wind 1, Chatham-Kent, Ontario

1668031-4000-R04-Rev3

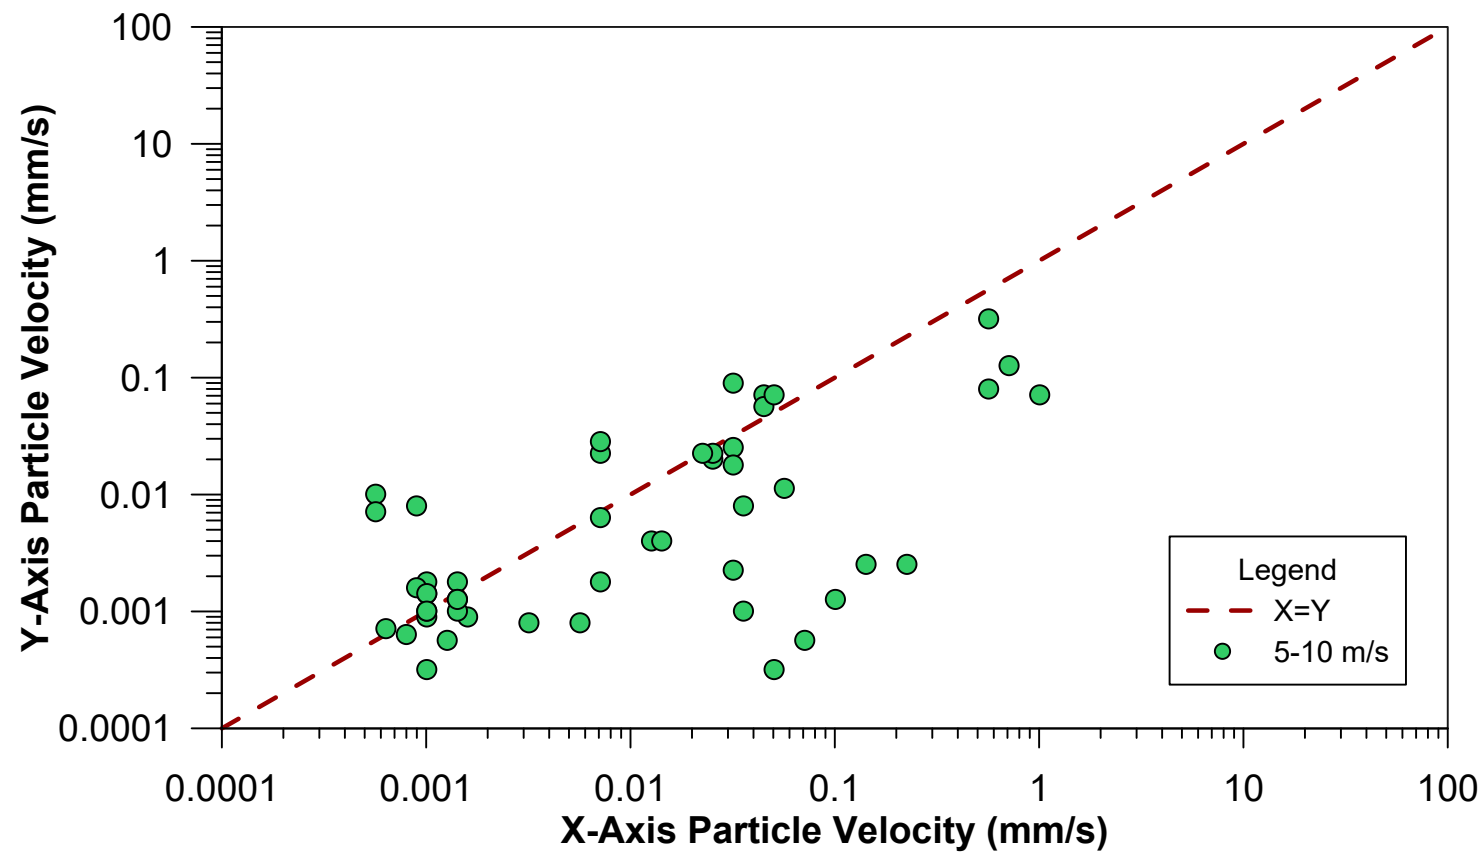
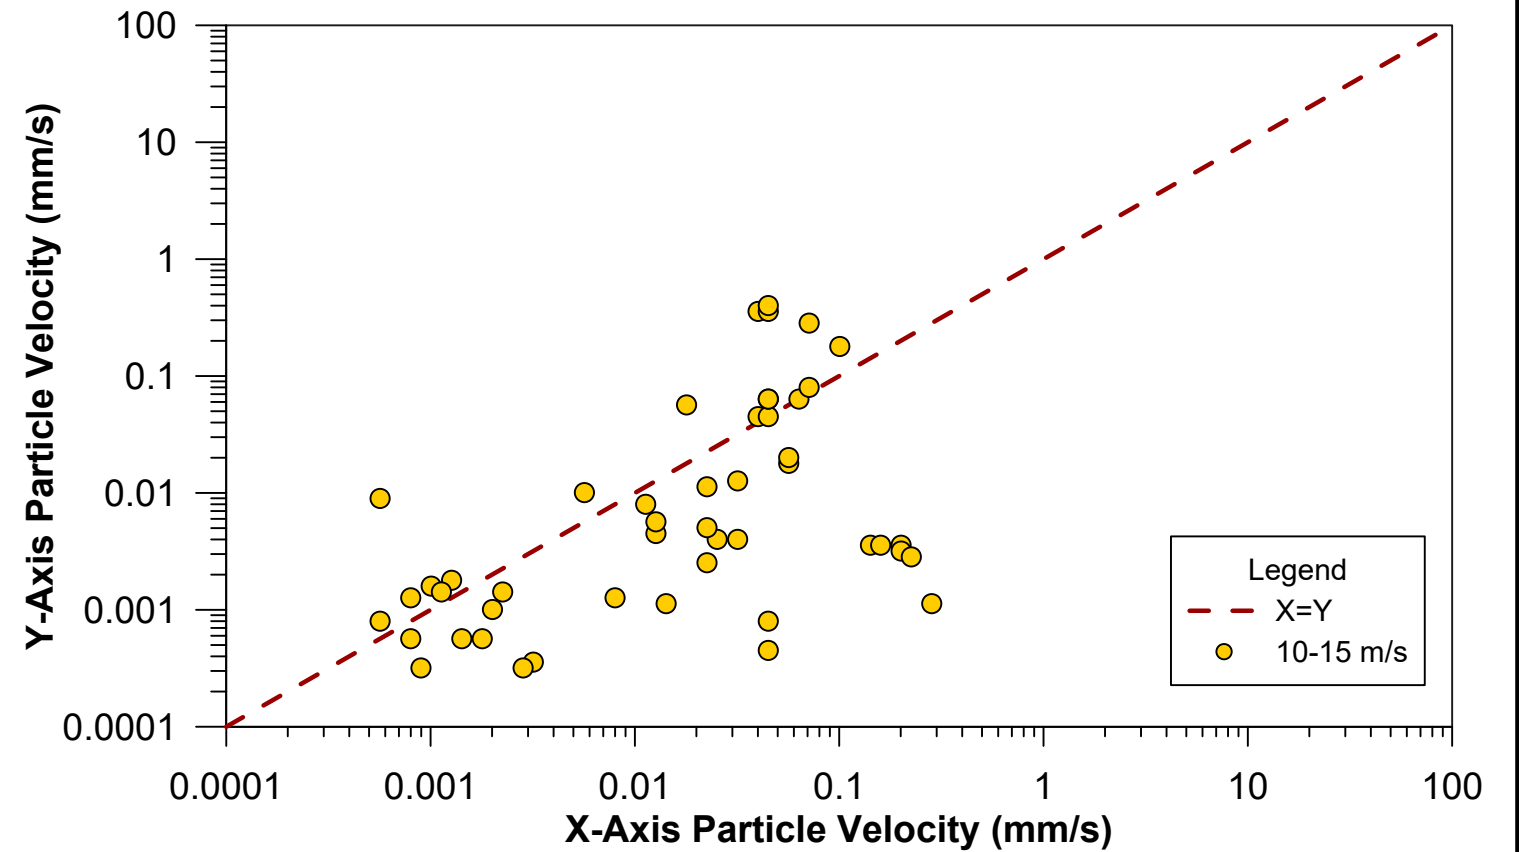
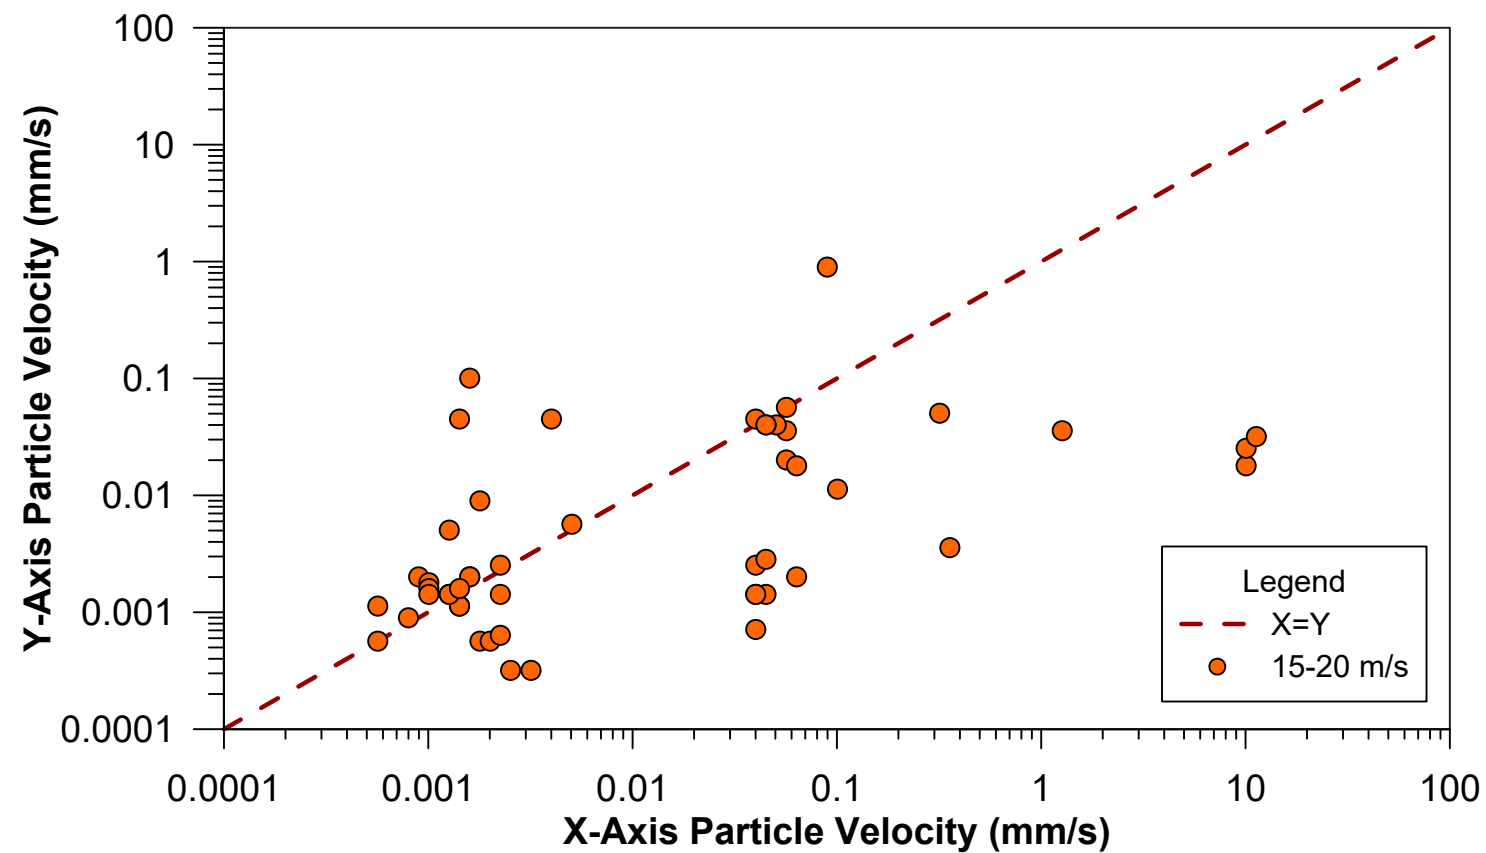
1. This figure must be read with accompanying report.
2. Foundation vibration measurements based on persistence spectra and exclude transient influences (e.g., traffic, farm equipment, etc.).

PROJECT		NORTH KENT 1 VIBRATION MONITORING	
TITLE		VIBRATION VELOCITY MEASURED AT DIFFERENT WIND SPEED RANGES FOR TURBINE FOUNDATIONS AT 5 Hz (PERIOD JANUARY 2018 TO APRIL 2021)	
PROJECT No. 1668031-4000		FILE No. 1668031-4000-R04011B (A4#3)	SCALE AS SHOWN
DRAWN JGH		June 2021	REV. 0
CHECK SSS			
GOLDER MEMBER OF WSP		FIGURE 11B

Figures 11A through 11D illustrate a comparison of foundation and mock well particle velocities measured in the horizontal plane. In general, the x axes were oriented to form a direct line between the foundation and nearby mock well with an azimuth ranging between west to west-northwest. The y axis was oriented at 90 degrees to the x axis at each location. For evaluation of mock well responses, data from the uniaxial accelerometers mounted to the

casing top were selected since these produced the best signal to noise ratios, would represent values greater than those measured within the bedrock (because of the effects of soil conditions and casing lengths) and, therefore, would be less likely to produce equivocal comparisons. For both the foundation and mock wells, the data illustrated in Figures 11A through 11D indicate that ground vibrations tend to be somewhat stronger in the x direction, consistent with prevailing wind velocity and direction trends (see Figure 7 in November 2018 report). Comparisons of Figures 11A and 11B to 11C and 11D also illustrate the attenuation of particle velocity magnitudes at the mock wells as compared to the data obtained for the foundations.

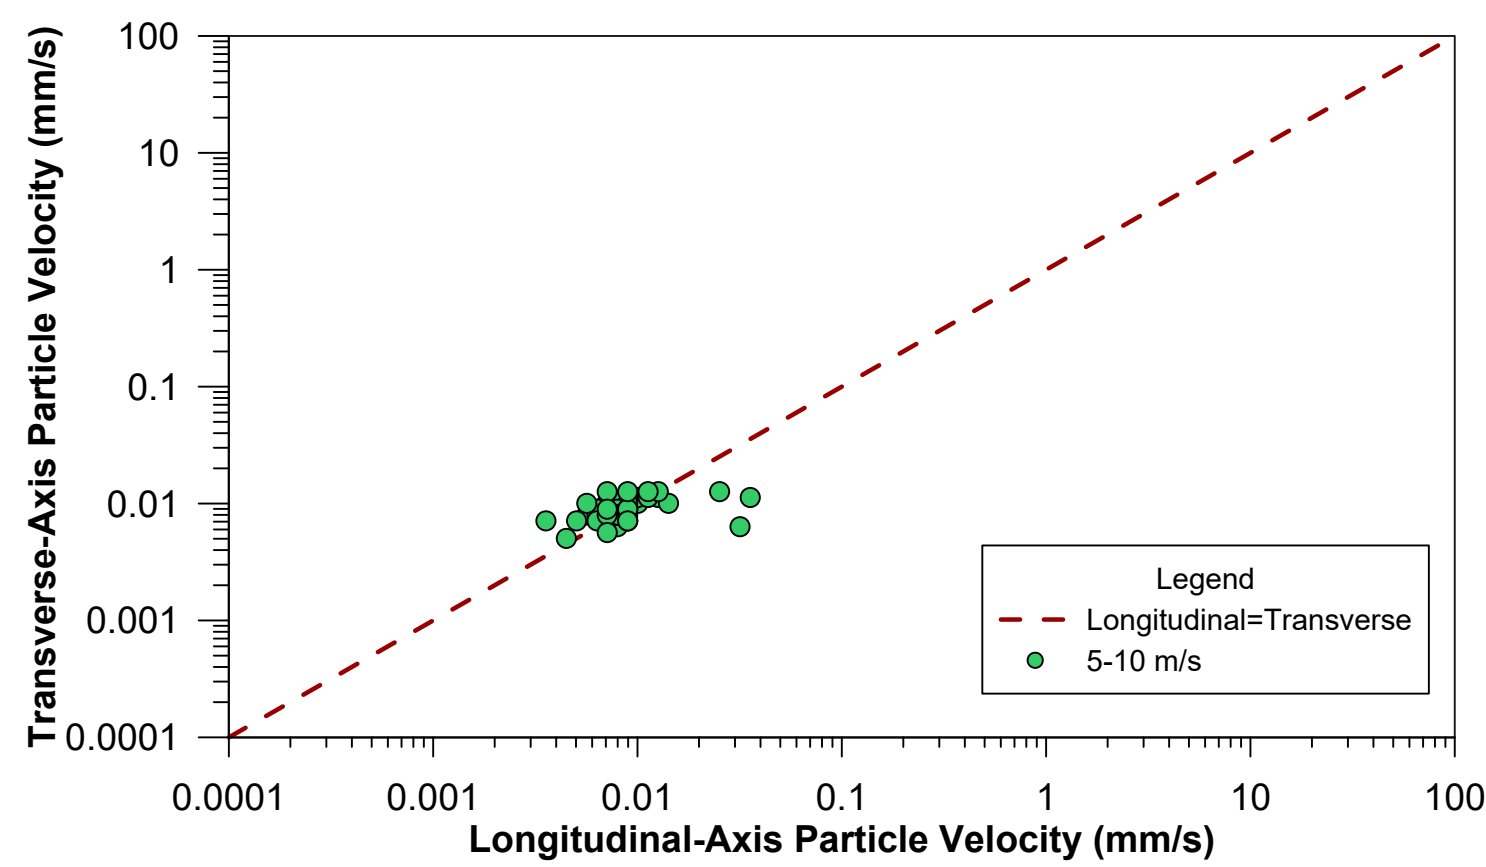
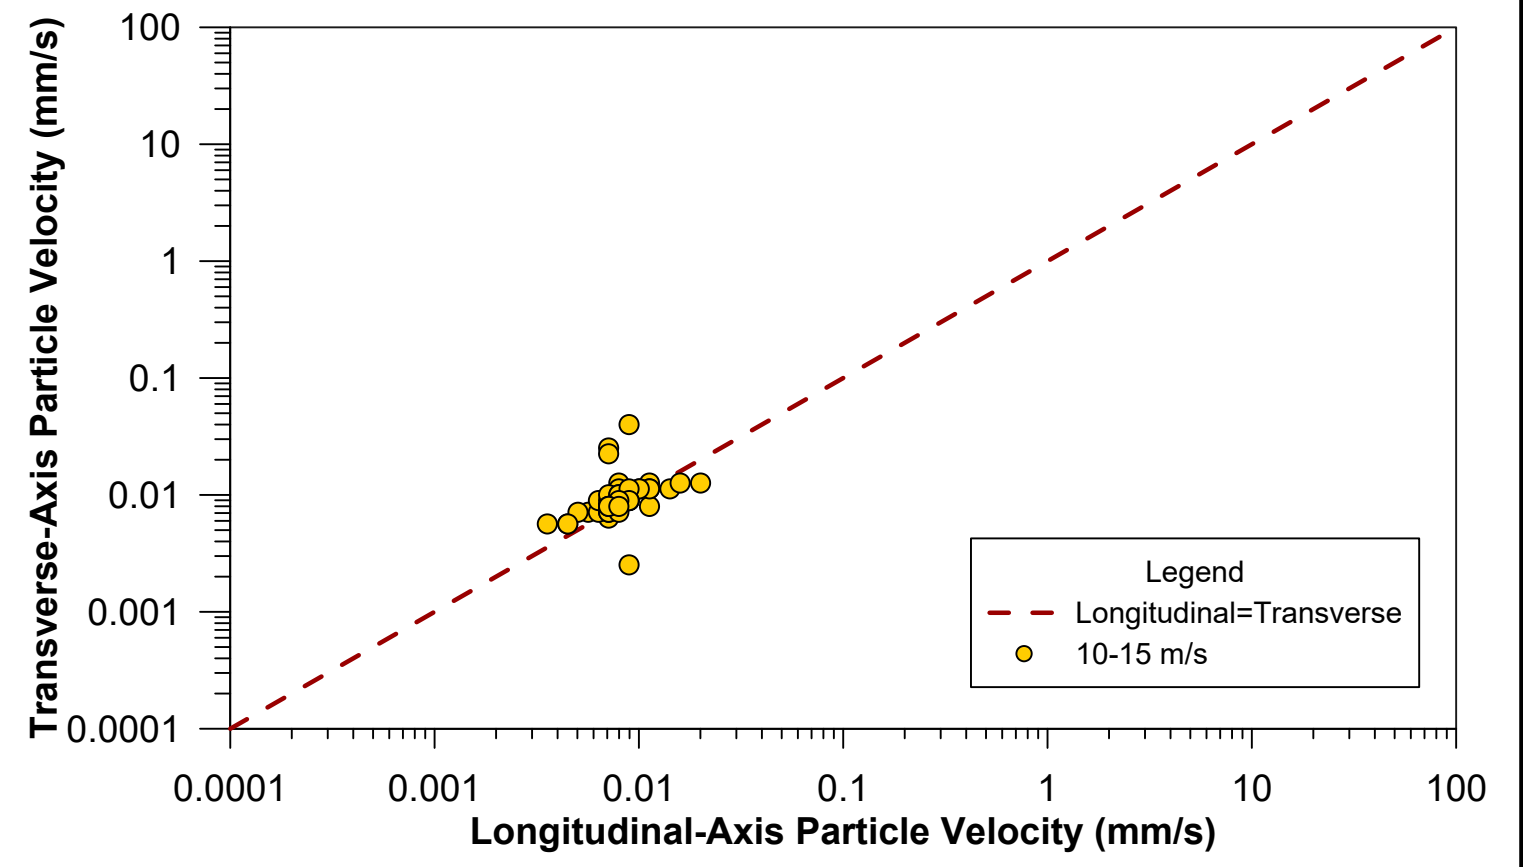
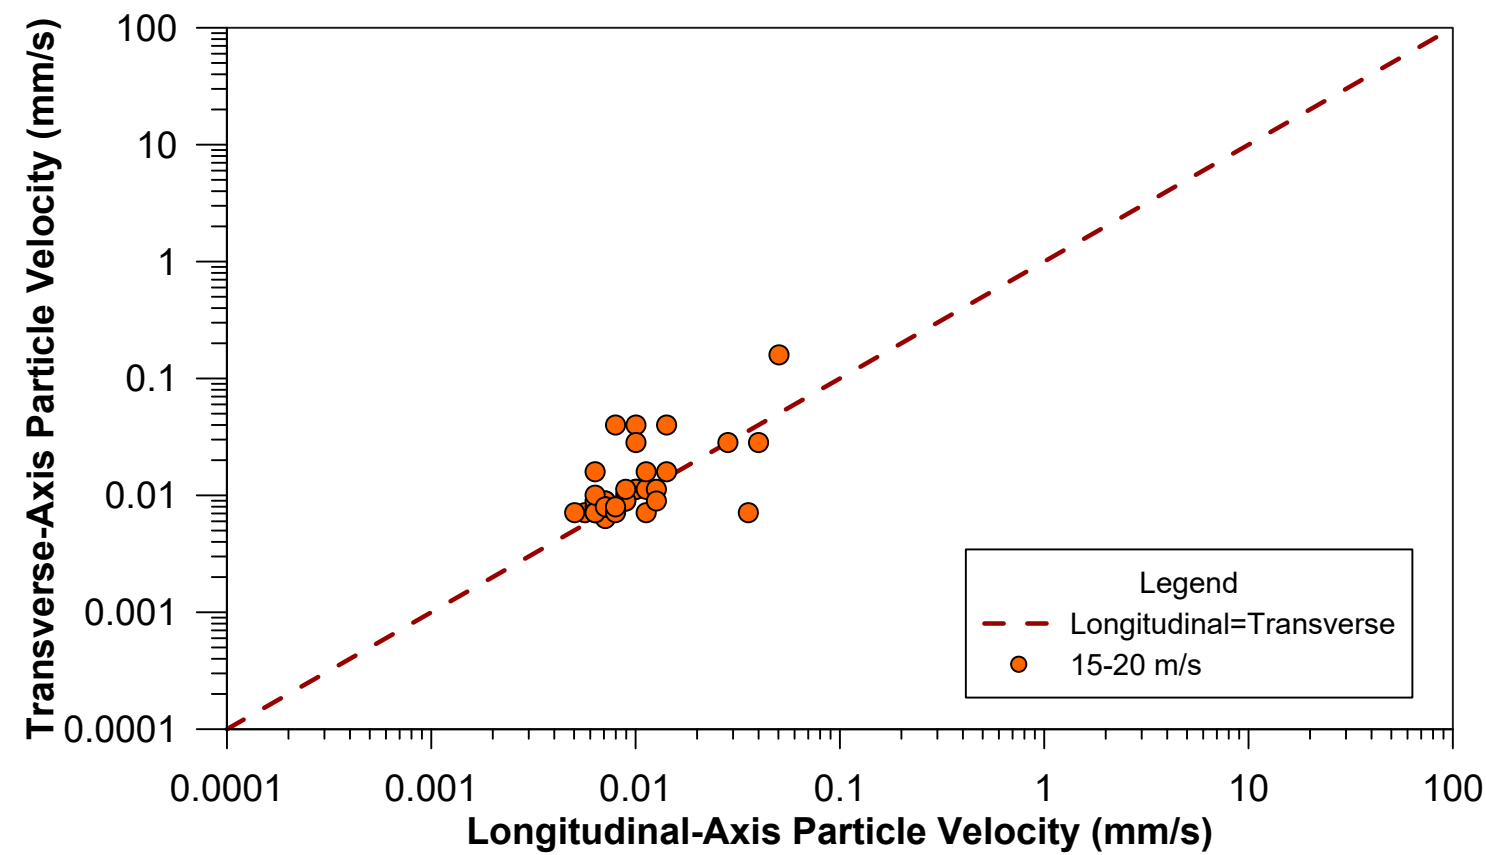
REV. 0
		FIGURE 11C

1. This figure must be read with accompanying report.
2. Well casing vibration measurements based on persistence spectra and exclude transient influences (e.g., traffic, farm equipment, etc.).

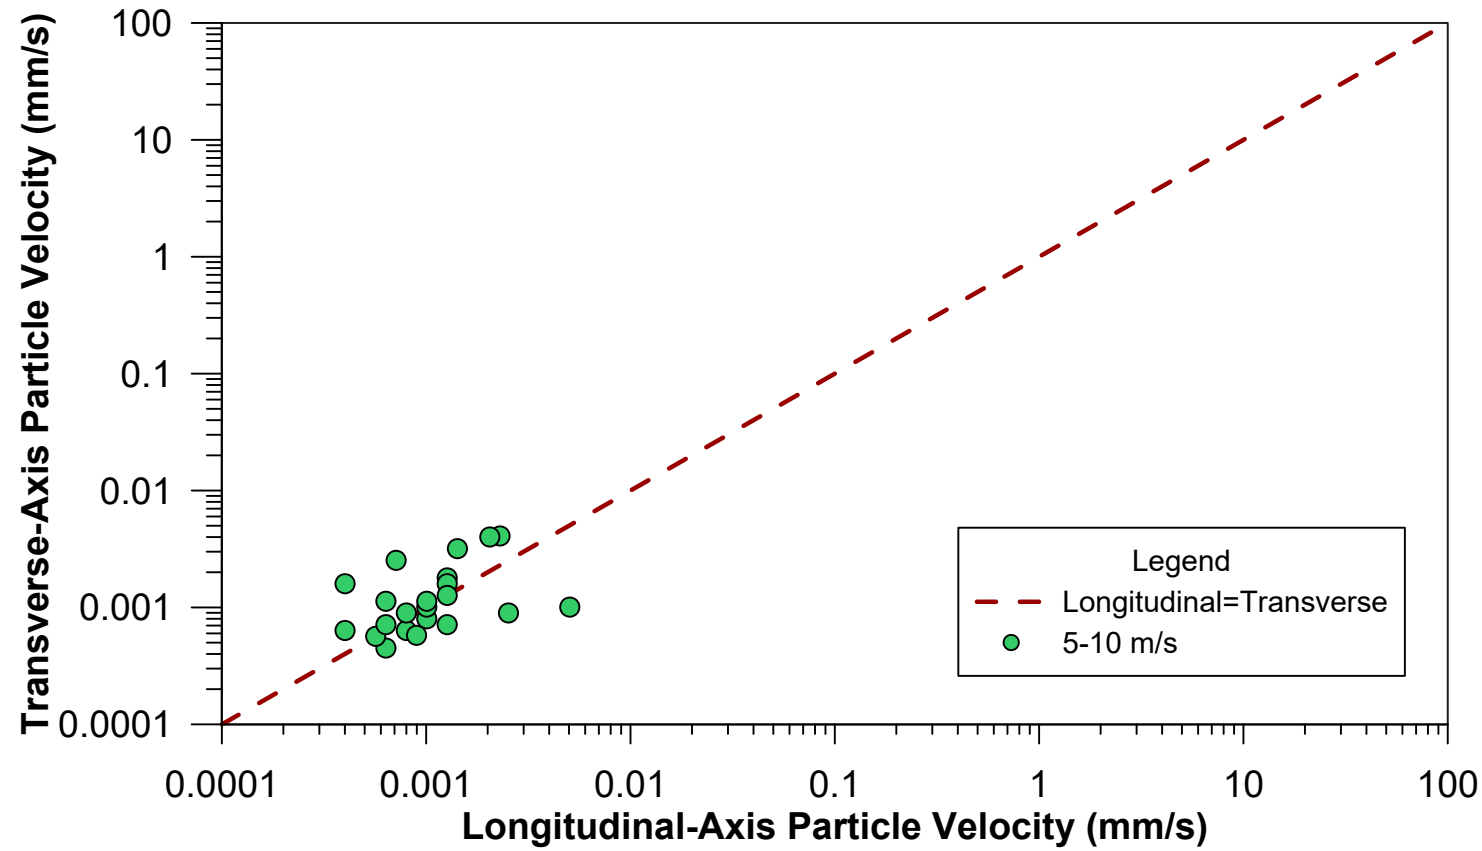
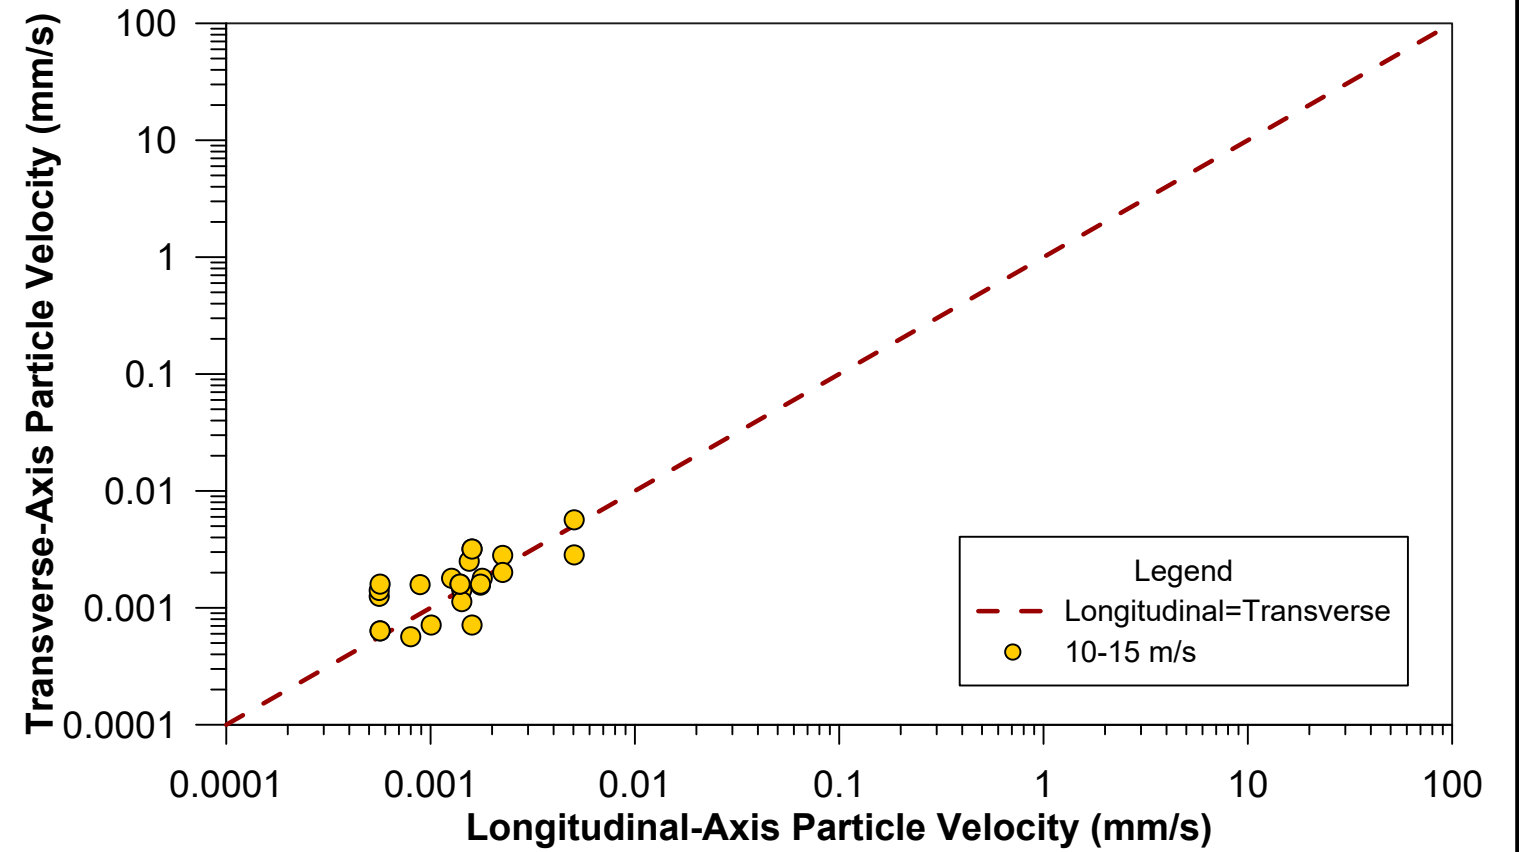
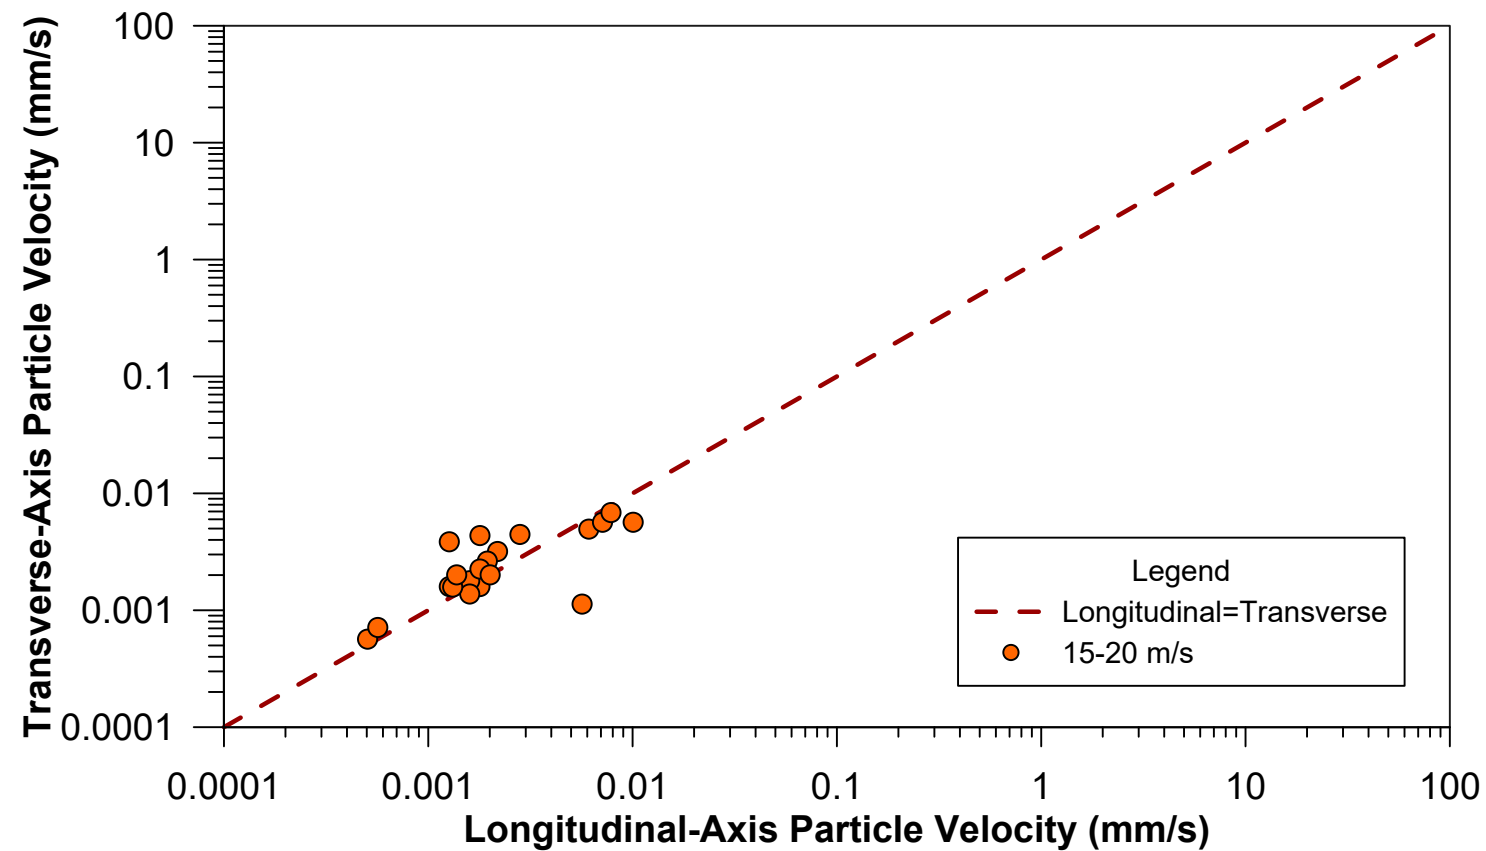
1. This figure must be read with accompanying report.
2. Well casing vibration measurements based on persistence spectra and exclude transient influences (e.g., traffic, farm equipment, etc.).
